Bell Lake 19 CTB 3

**RE: Liner Inspection and Closure Report  
Bell Lake 19 CTB 3  
API No. N/A  
GPS : Latitude 32.19711 Longitude -103.60613  
UL- P, Section 19, Township 24S, Range 33E  
Lea County, NM  
NMOCD Reference No. NAPP2409945367**

#### Liner Inspection

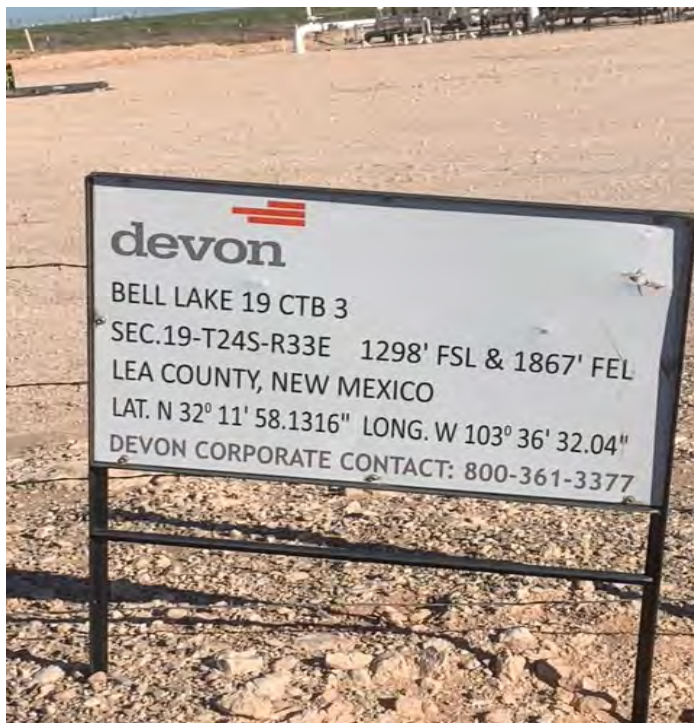
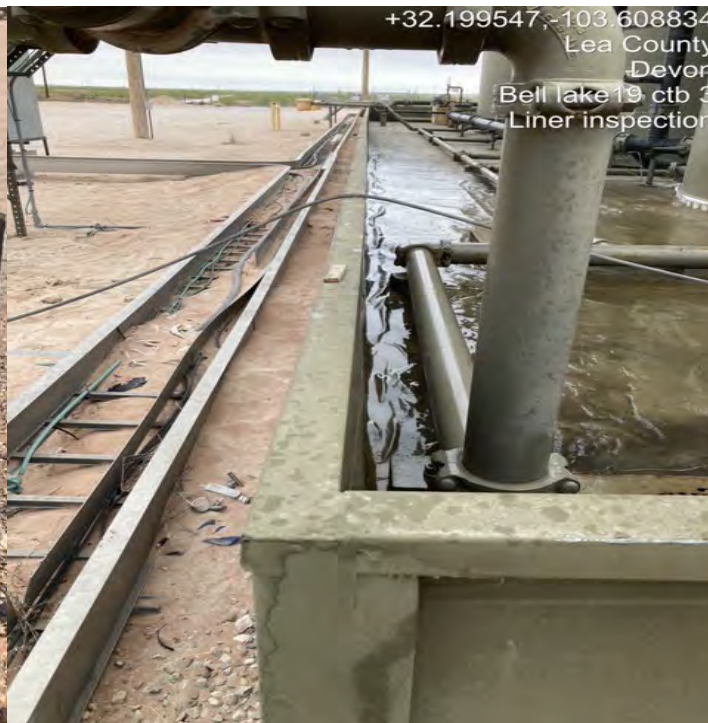
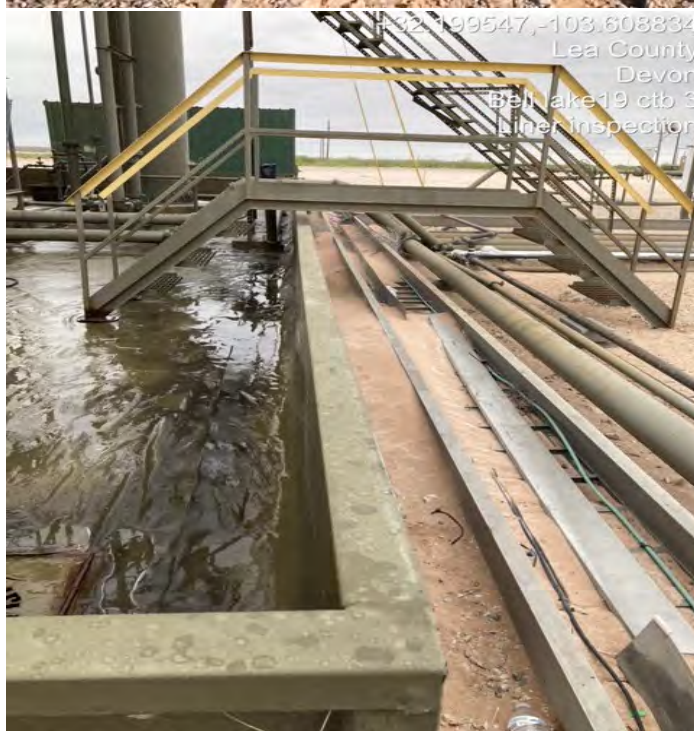
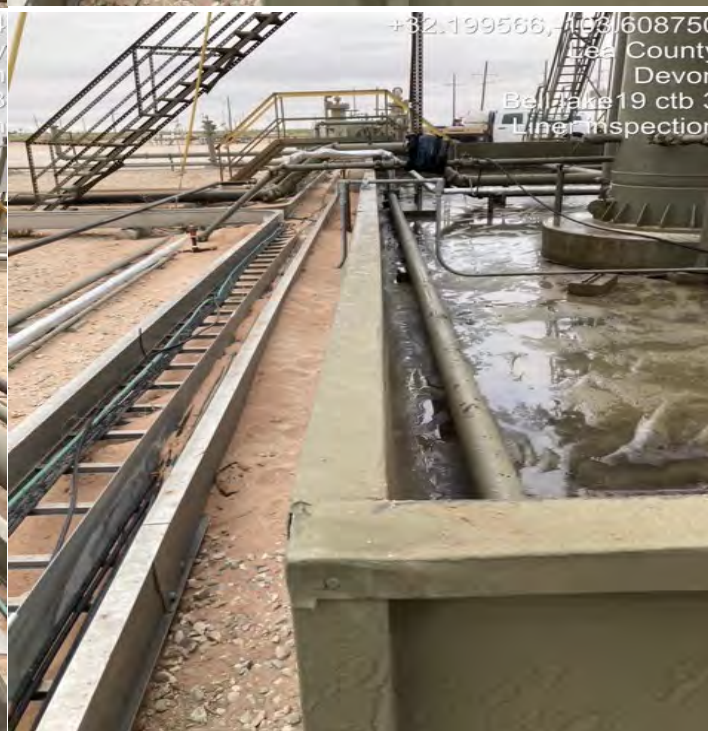
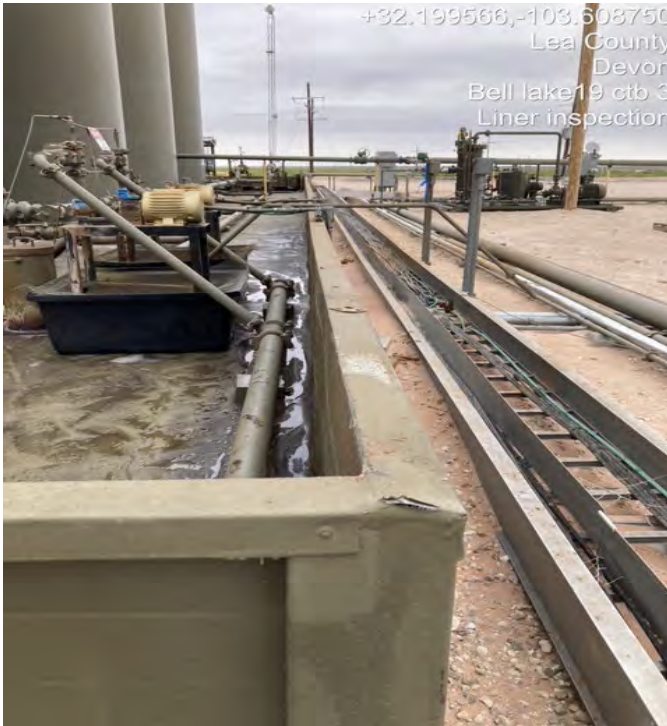
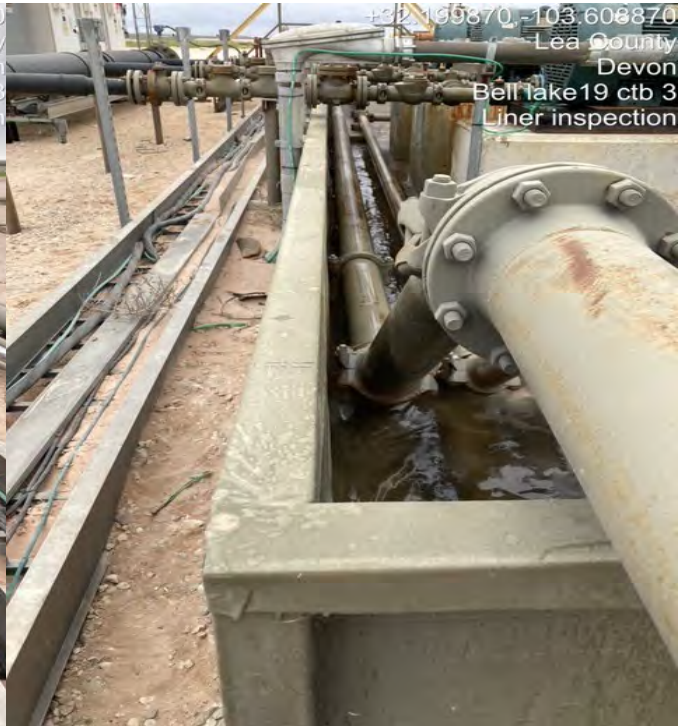
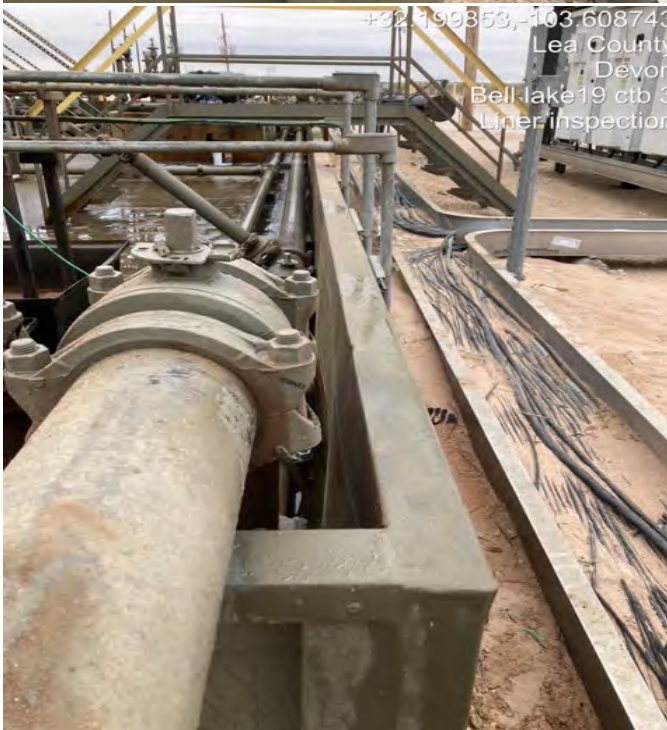
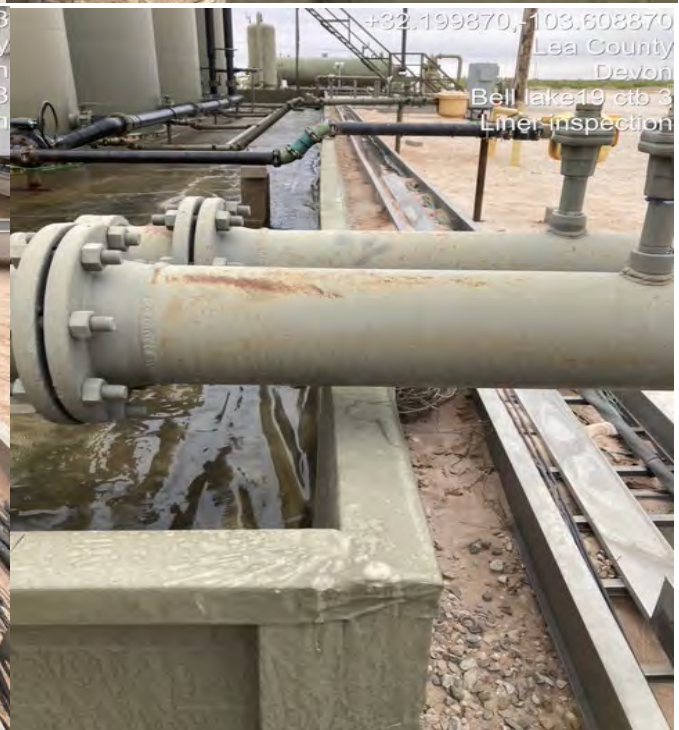
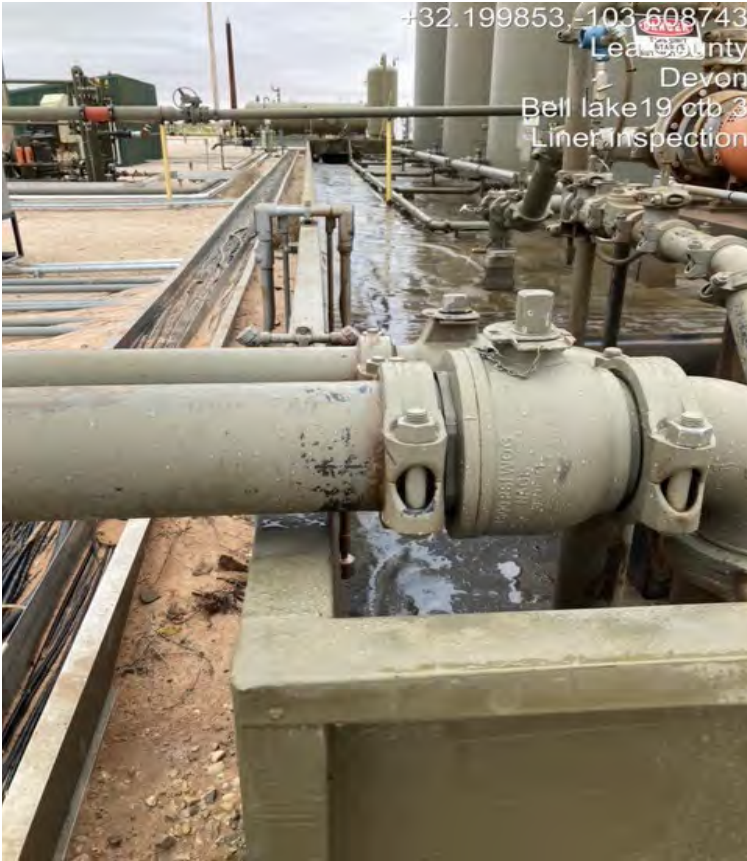
On April 26, 2024, after submitting the 48-hour notification application ID:337324 to the OCD, Pima Environmental conducted a liner inspection at this location. Pima concluded that this liner and containment maintained its integrity and was able to retain the fluids. The liner inspection form and photographic documentation can be found in Appendix C.

Visualization	Yes	No	Comments
Is there a tear in the liner?		X	
Are there holes in the liner?		X	
Is the liner retaining any fluids?	X		Fluid from power washing the Liner
Does the liner have integrity to contain a leak?	X
