MULE 23 CTB 1

OCD Incident Number nAPP2410633112

**RE: Liner Inspection and Closure Report
Mule 23 CTB 1
API No. N/A
GPS : Latitude 32.1218402 Longitude -103.7510917
UL- C, Section 23, Township 25S, Range 31E
Eddy County, NM
NMOCD Reference No. NAPP2410633112**

Mule 23 CTB 1

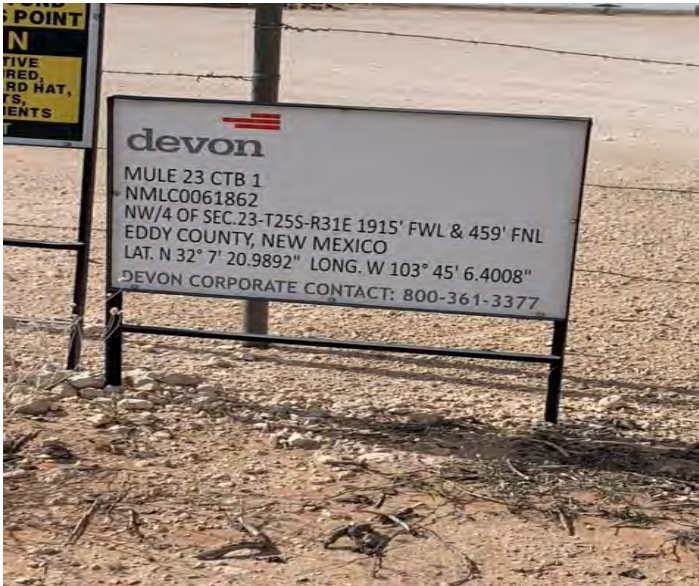
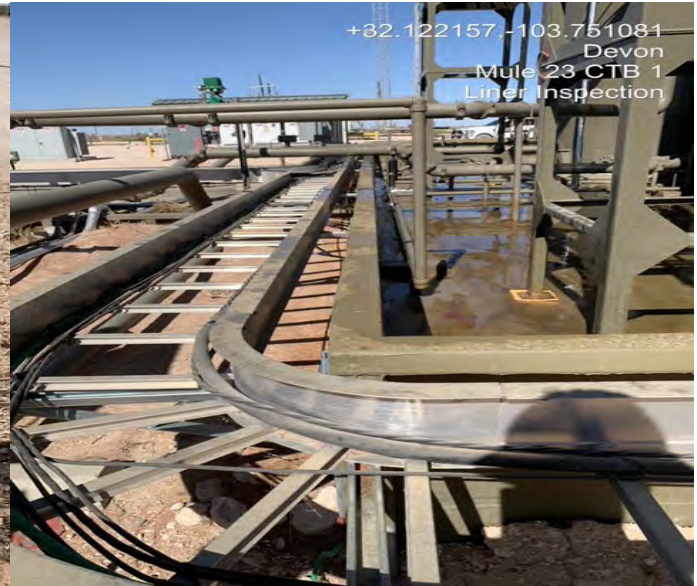
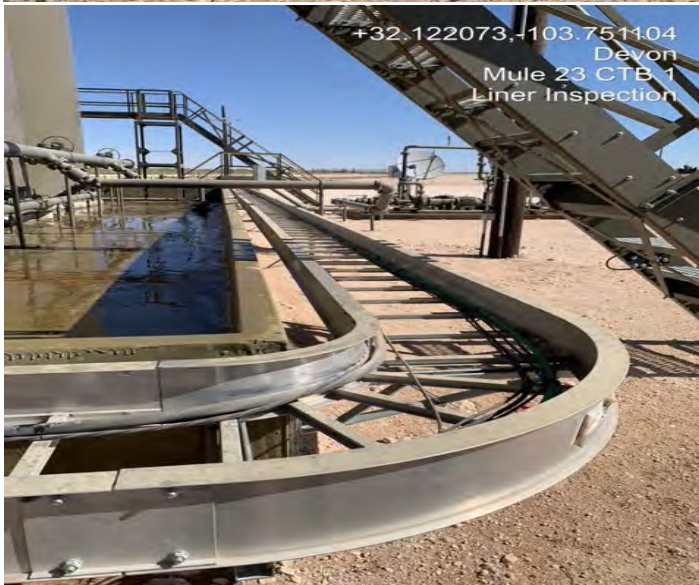
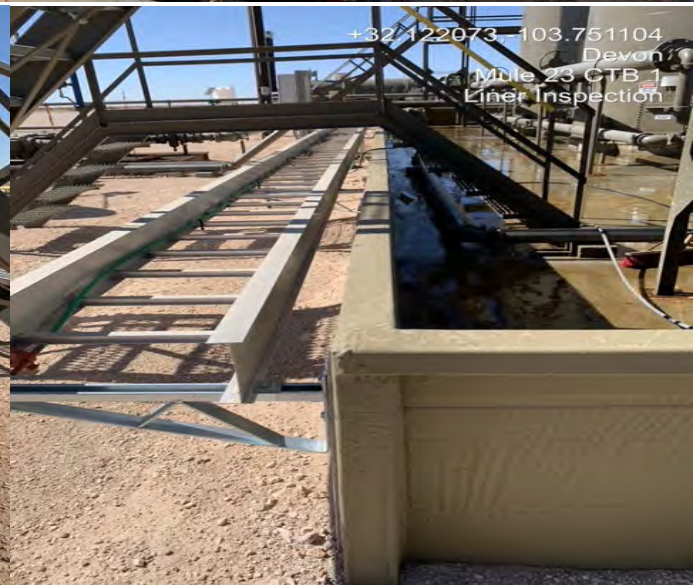
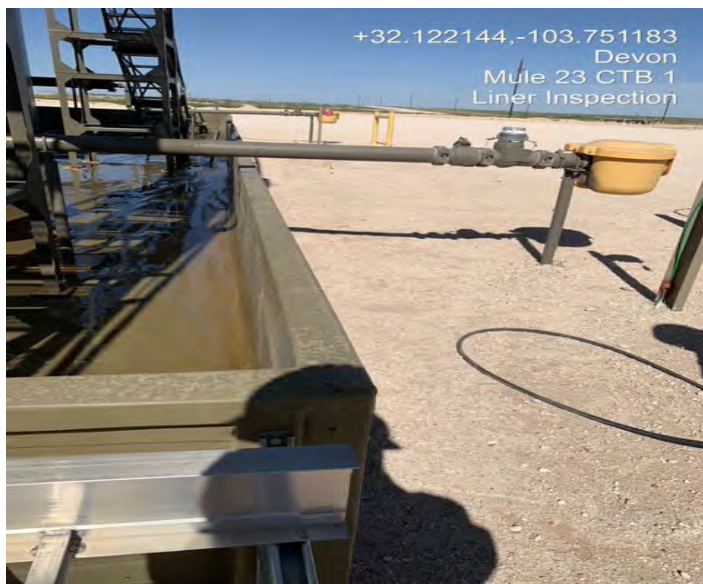
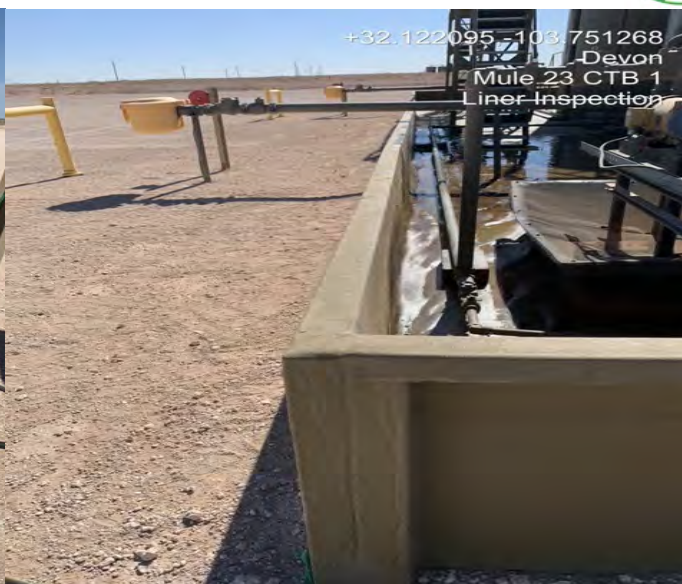
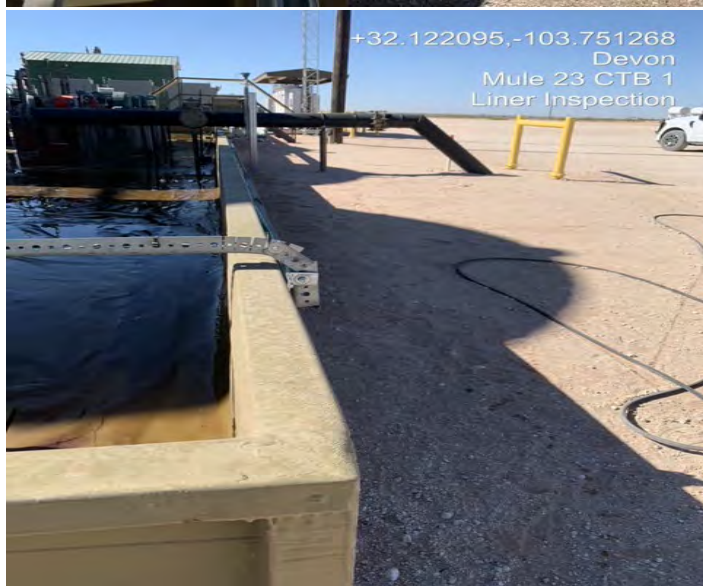
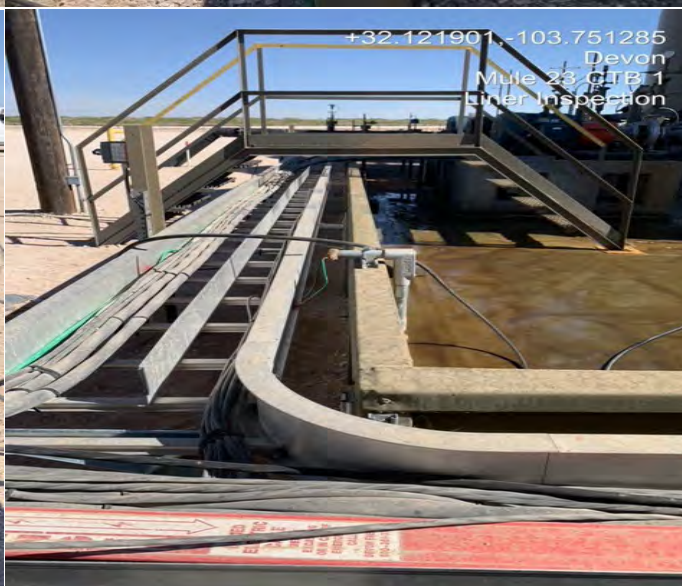
Liner Inspection

On April 22, 2024, after submitting the 48-hour notification application ID:335103 to the OCD, Pima Environmental conducted a liner inspection at this location. Pima concluded that this liner and containment maintained its integrity and was able to retain the fluids. The liner inspection form and photographic documentation can be found in Appendix C.

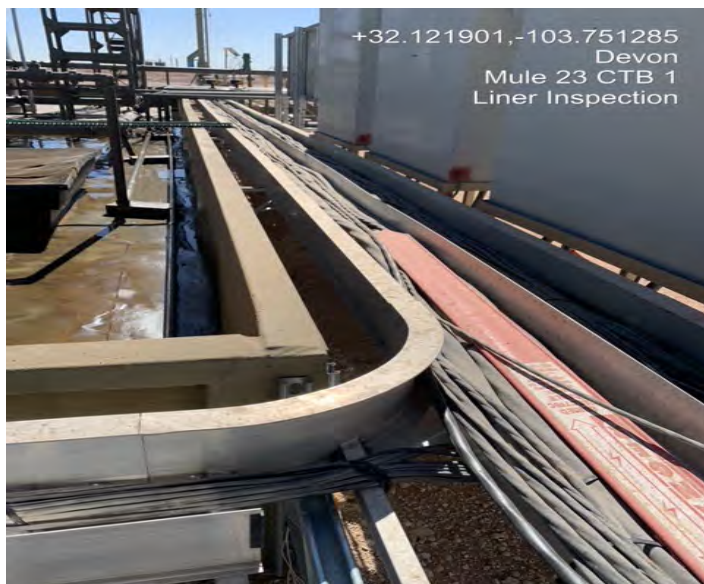
fluid from power washing the liner
