**Pima Environmental Services**  
**5614 N. Lovington Highway**  
**Hobbs, NM 88240**  
**575-964-7740**

March 19, 2024

**RE: Liner Inspection and Closure Report**  
**Lone Tree Draw 13 State Com 8H**  
**API No. 30-015-41738**  
**GPS: Latitude 32.4872093 Longitude -104.140892**  
**UL- B, Section 13, Township 21S, Range 27E,**  
**Eddy County, NM**  
**NMOCD Reference No. NAB1801735905**

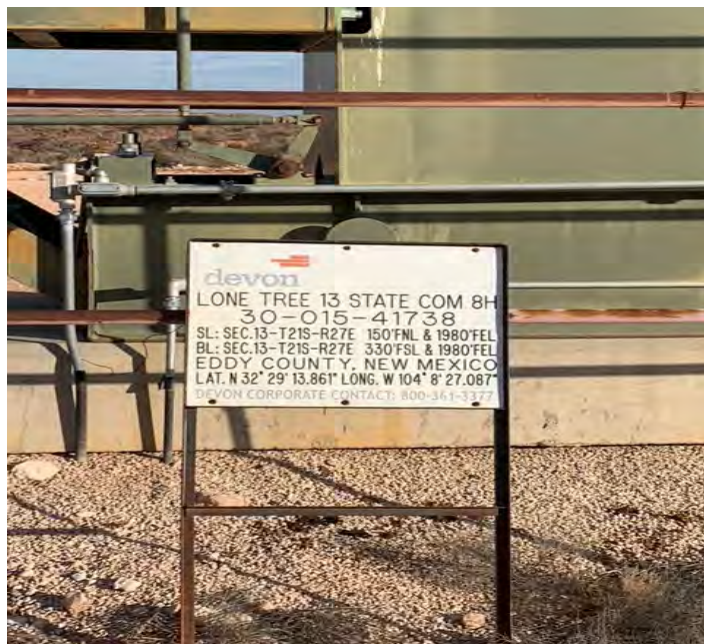
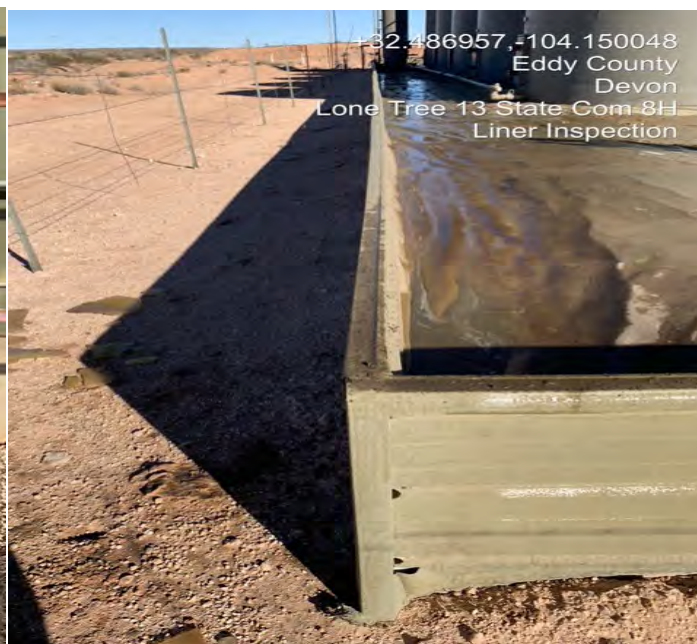
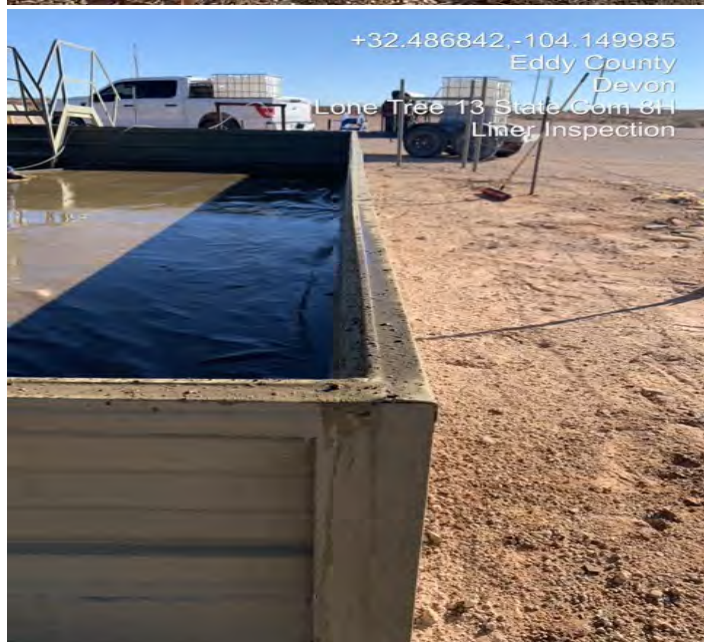
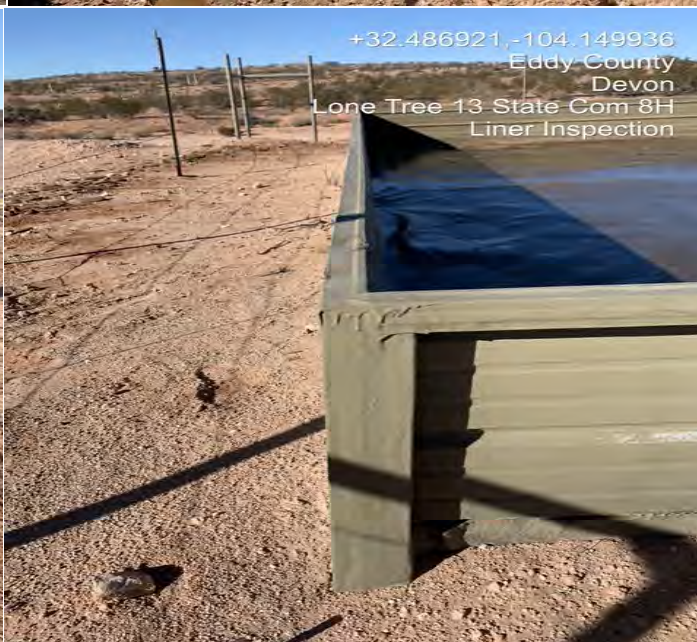
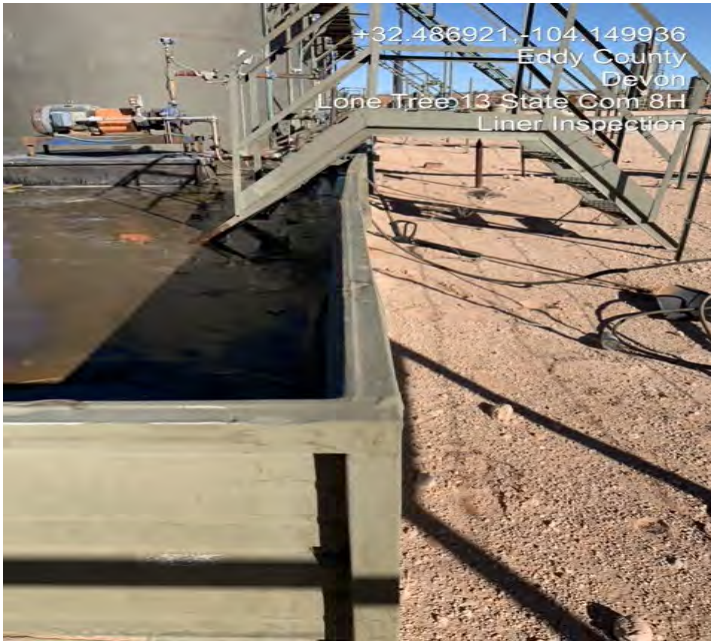
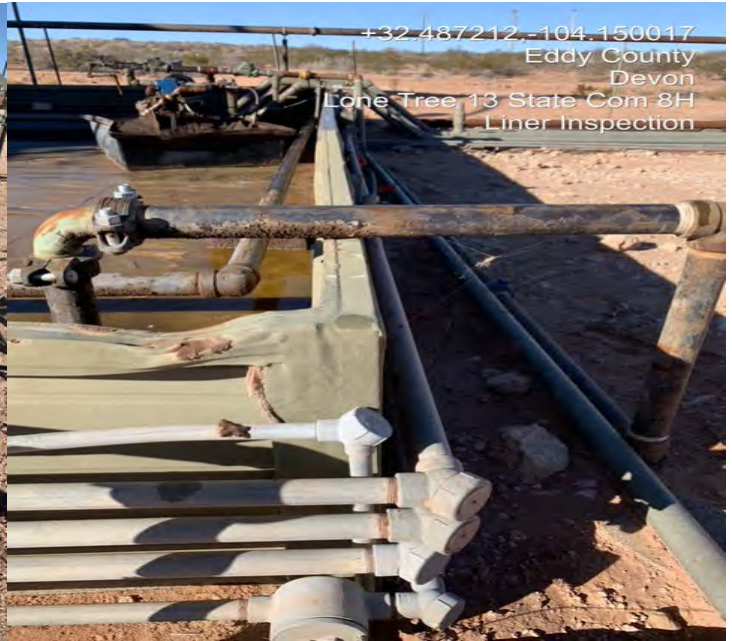
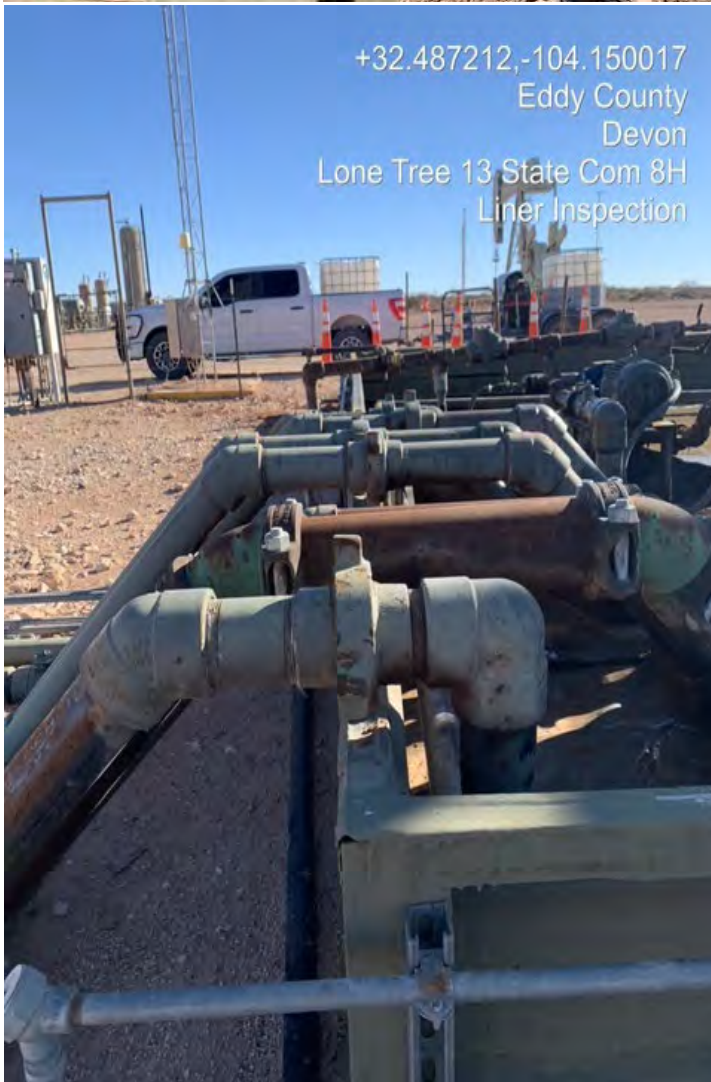
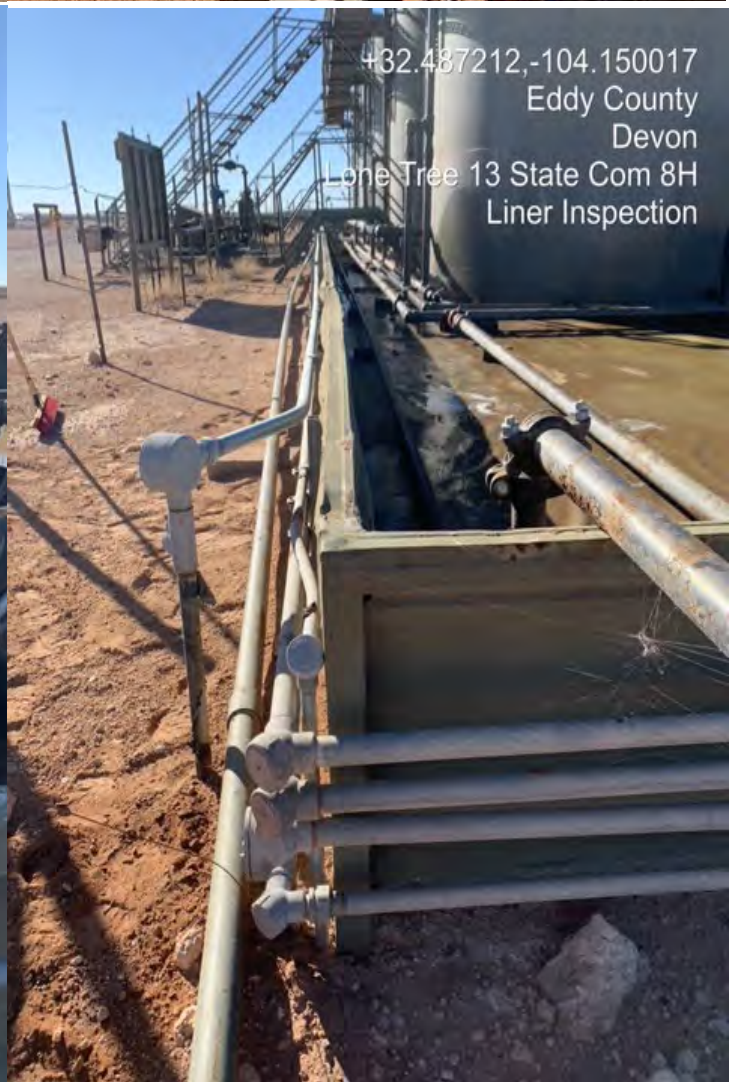
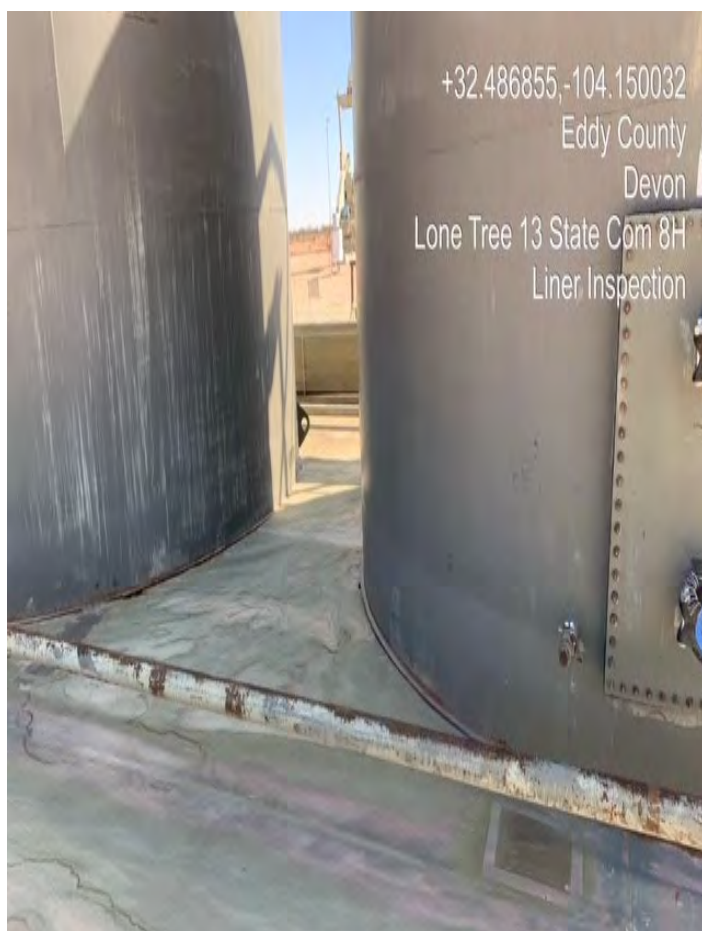
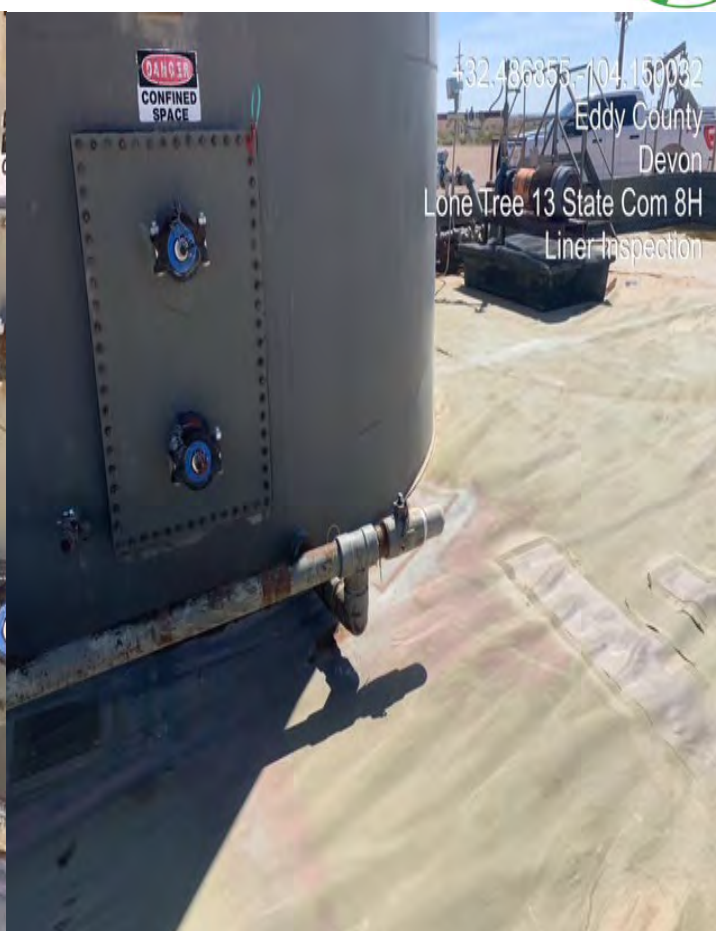
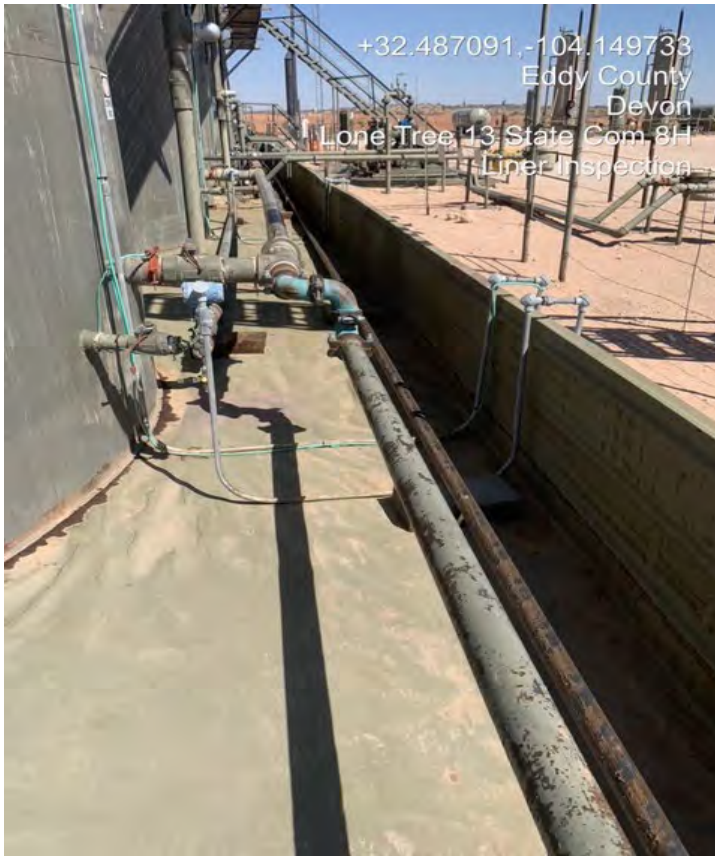
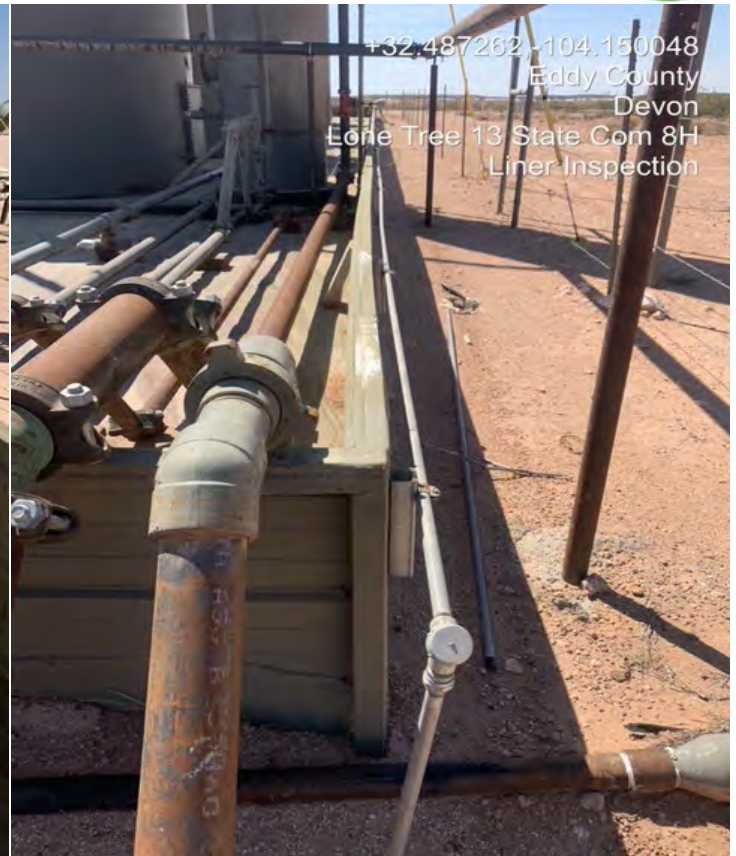
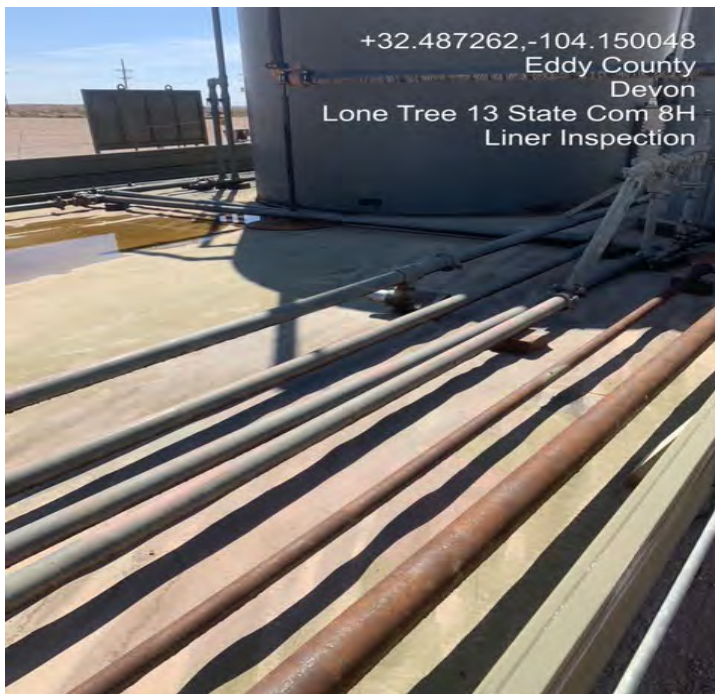
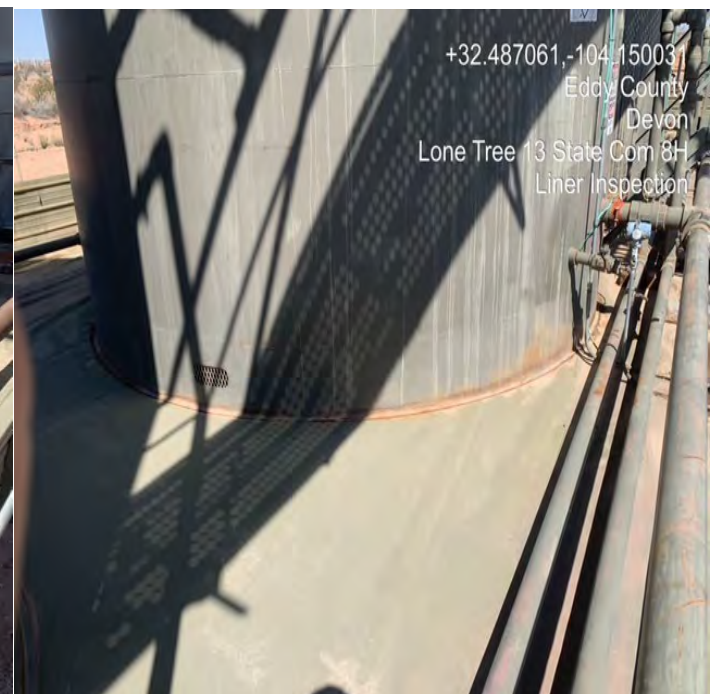
### Liner Inspection

On March 14, 2024, after submitting the 48-hour notification application ID:322209 to the OCD, Pima Environmental conducted a liner inspection at this location. Pima concluded that this liner and containment maintained its integrity and was able to retain the fluids. The liner inspection form and photographic documentation can be found in Appendix C.

- The Liner inspection photographs have been retaken displaying the power wash of the Liner and photographs around the tanks displaying containment liner integrity.

Visualization	Yes	No	Comments
Is there a tear in the liner?		X	
Are there holes in the liner?		X	
Is the liner retaining any fluids?	X		Fluid from the power washing of the liner
Does the liner have integrity to contain a leak?	X
