TODD 36 CTB 3

RE: Liner Inspection and Closure Report
Todd 36 CTB 3
Facility ID fAPP2123651847
GPS: Latitude 32.256506 Longitude -103.728627
ULSTR – N – 36 – 23S – 31E 330 FSL 1629 FWL Eddy County, NM
NMOCD Incident ID nAPP2417060670

PHOTOGRAPHIC LOG - nAPP2417060670

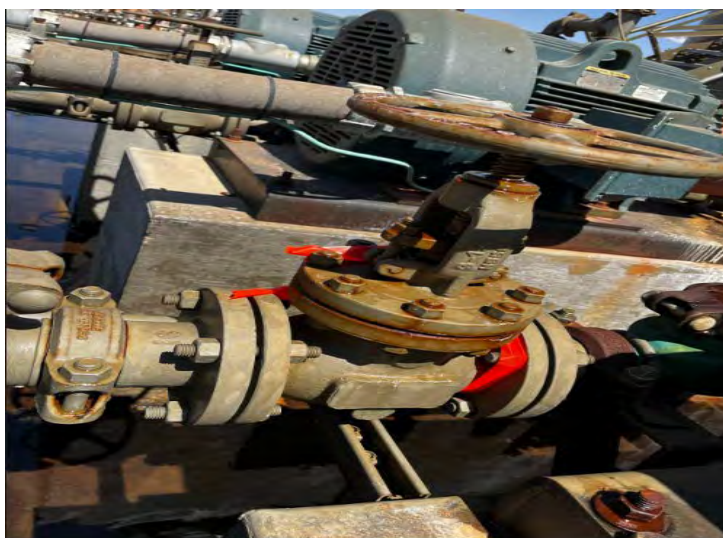
Photograph No. 1

nAPP2417060670: On June 18, 2024, LO observed fluid in the containment and found a gasket on the discharge side of a water transfer pump had failed. The pump was isolated to stop the leak. 17.4 bbls in lined containment were released. 16 bbls recovered. The liner was visually inspected by Devon field staff for any pinholes or punctures; none were found. Based on this inspection there is no evidence that the spilled fluids left containment.

Description: Point of release

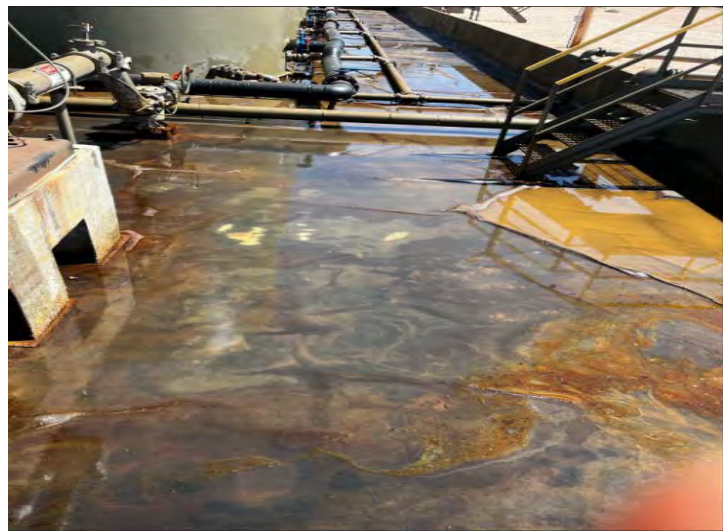
Photograph No. 2

Description: Fluid inside containment

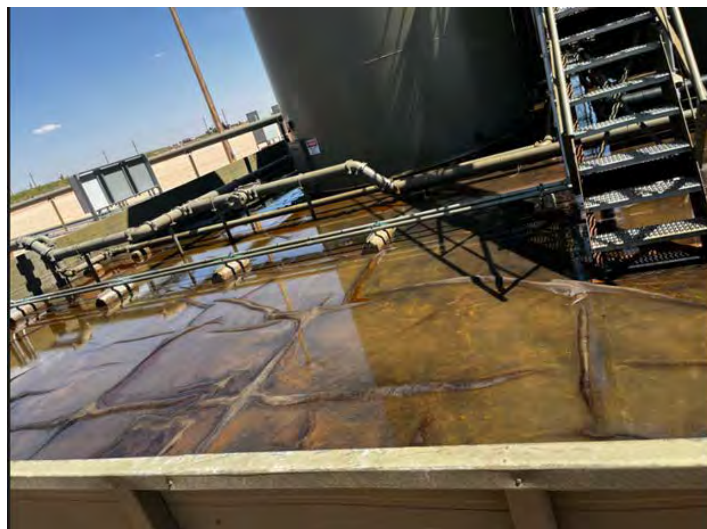
Photograph No. 3

Description: Fluid inside containment

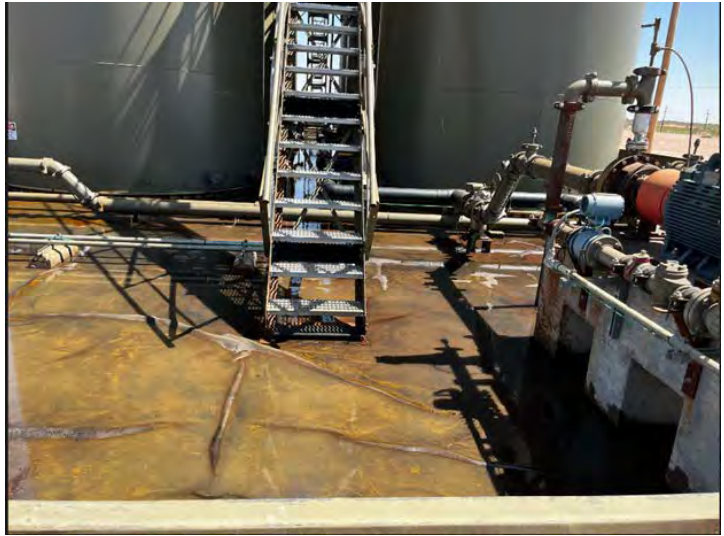
Photograph No. 4

Description: Fluid inside containment

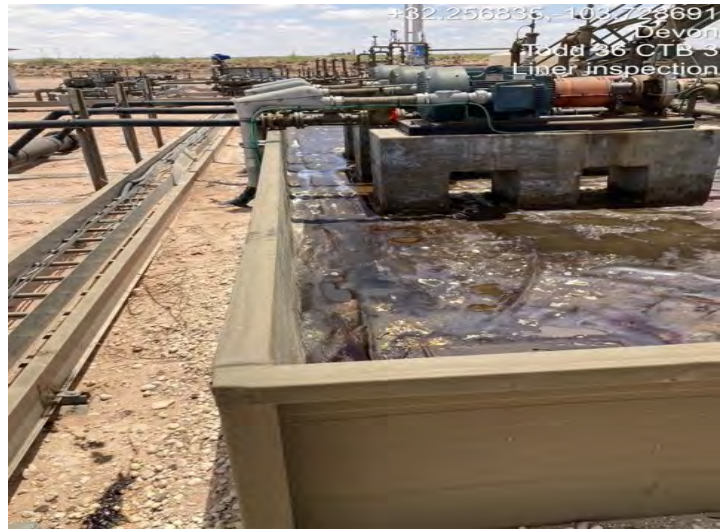
Photograph No. 5

Description: Pre-inspection, liner/containment needs power washed

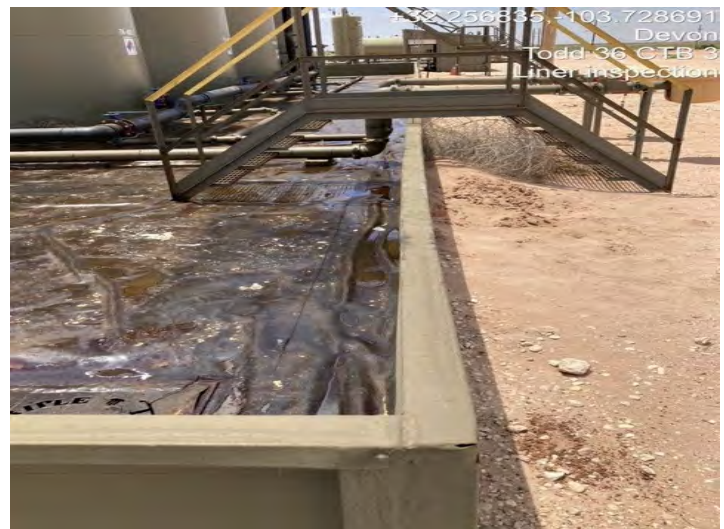
Photograph No. 6

Description: Pre-inspection, liner/containment needs power washed

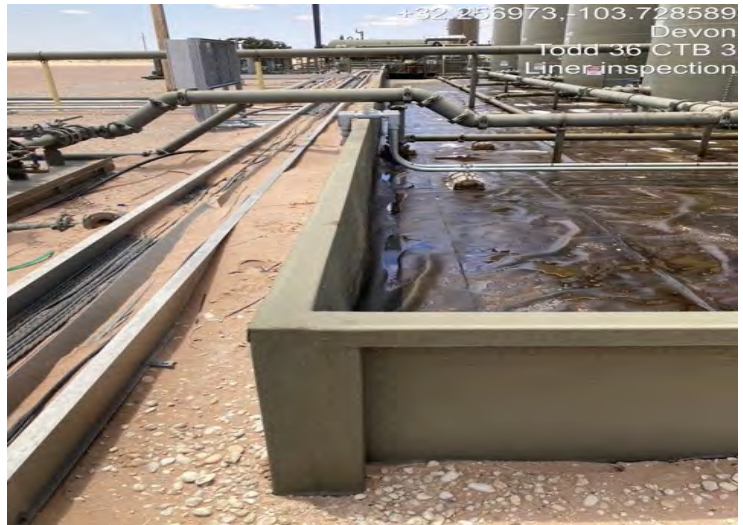
Photograph No. 7

Description: Pre-inspection, liner/containment
needs power washed

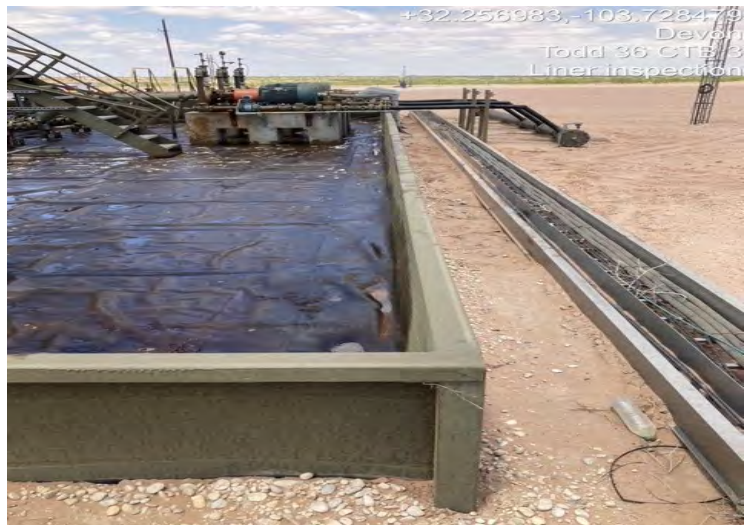
Photograph No. 8

Description: Pre-inspection, liner/containment
needs power washed

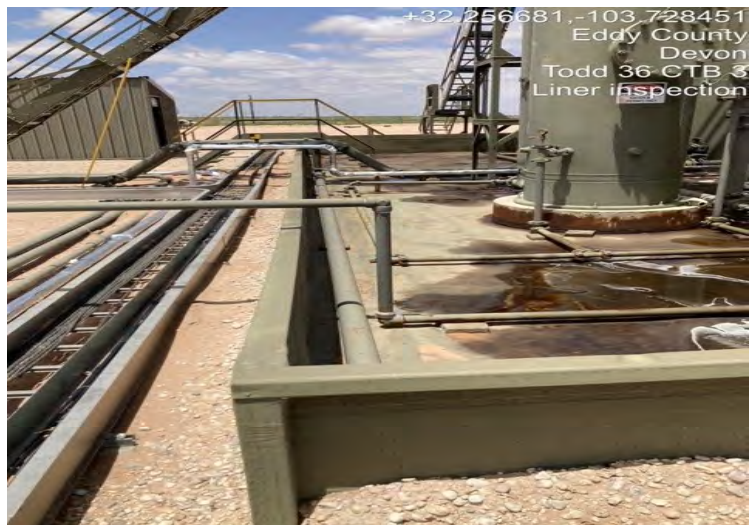
Photograph No. 9

Description: Pre-inspection, liner/containment
needs power washed

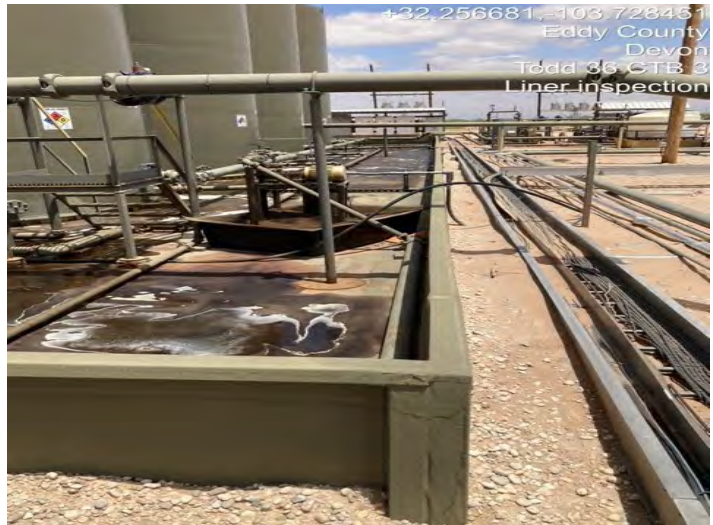
Photograph No. 10

Description: Pre-inspection, liner/containment needs power washed

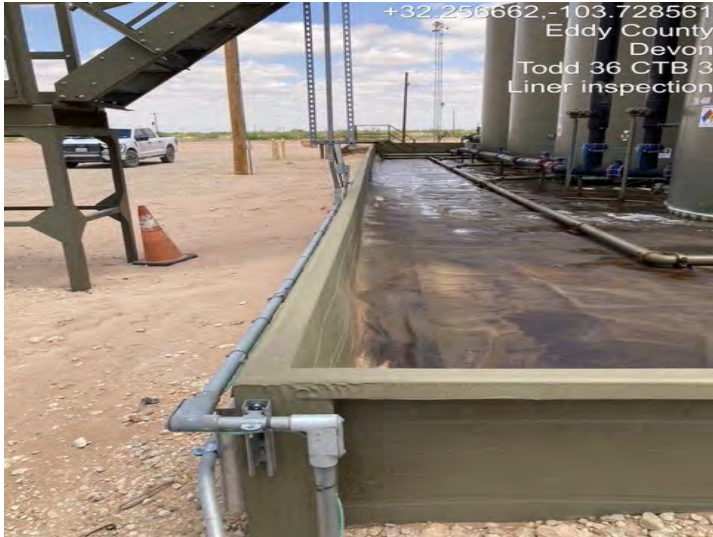
Photograph No. 11

Description: Pre-inspection, liner/containment needs power washed

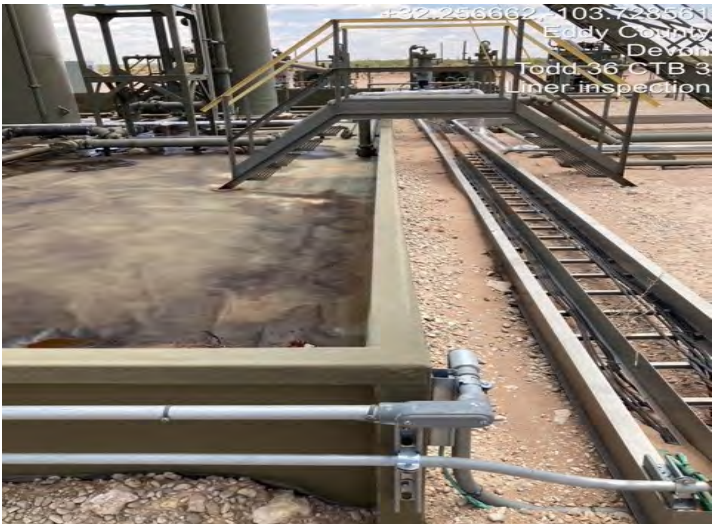
Photograph No. 12

Description: Pre-inspection, liner/containment needs power washed
