STATE 232 RELEASE

UYRRH-240621-NOR000

RELEASE DISCOVERY

<b>Prerequisites</b>	
Incident ID (n#)	nAPP2417353525
Incident Name	NAPP2417353525 STATE 23 @ 30-031-20646
Incident Type	Oil Release
Incident Status	Initial C-141 Received
Incident Well	[30-031-20646] STATE #023

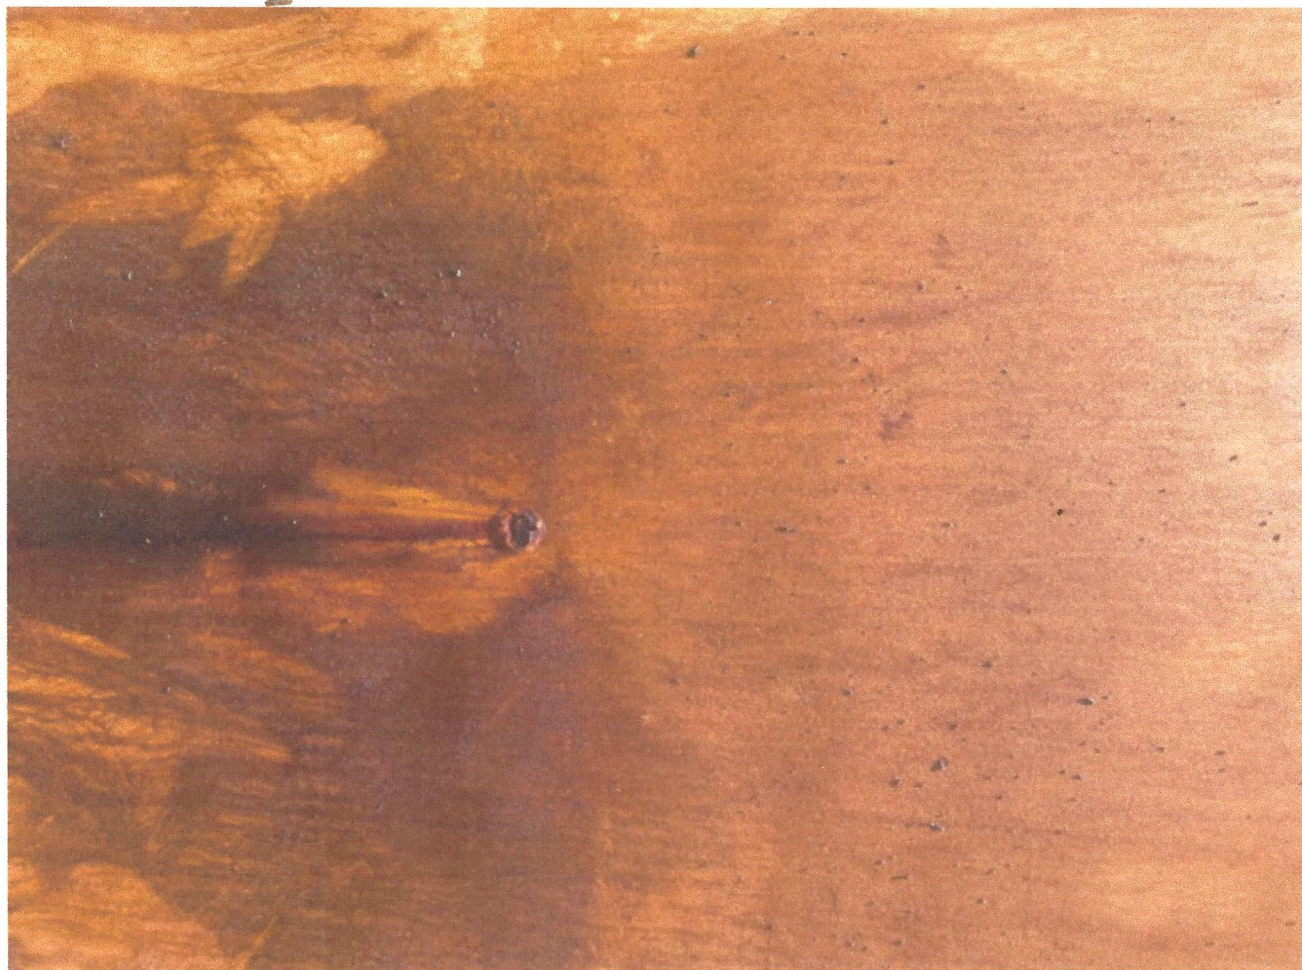
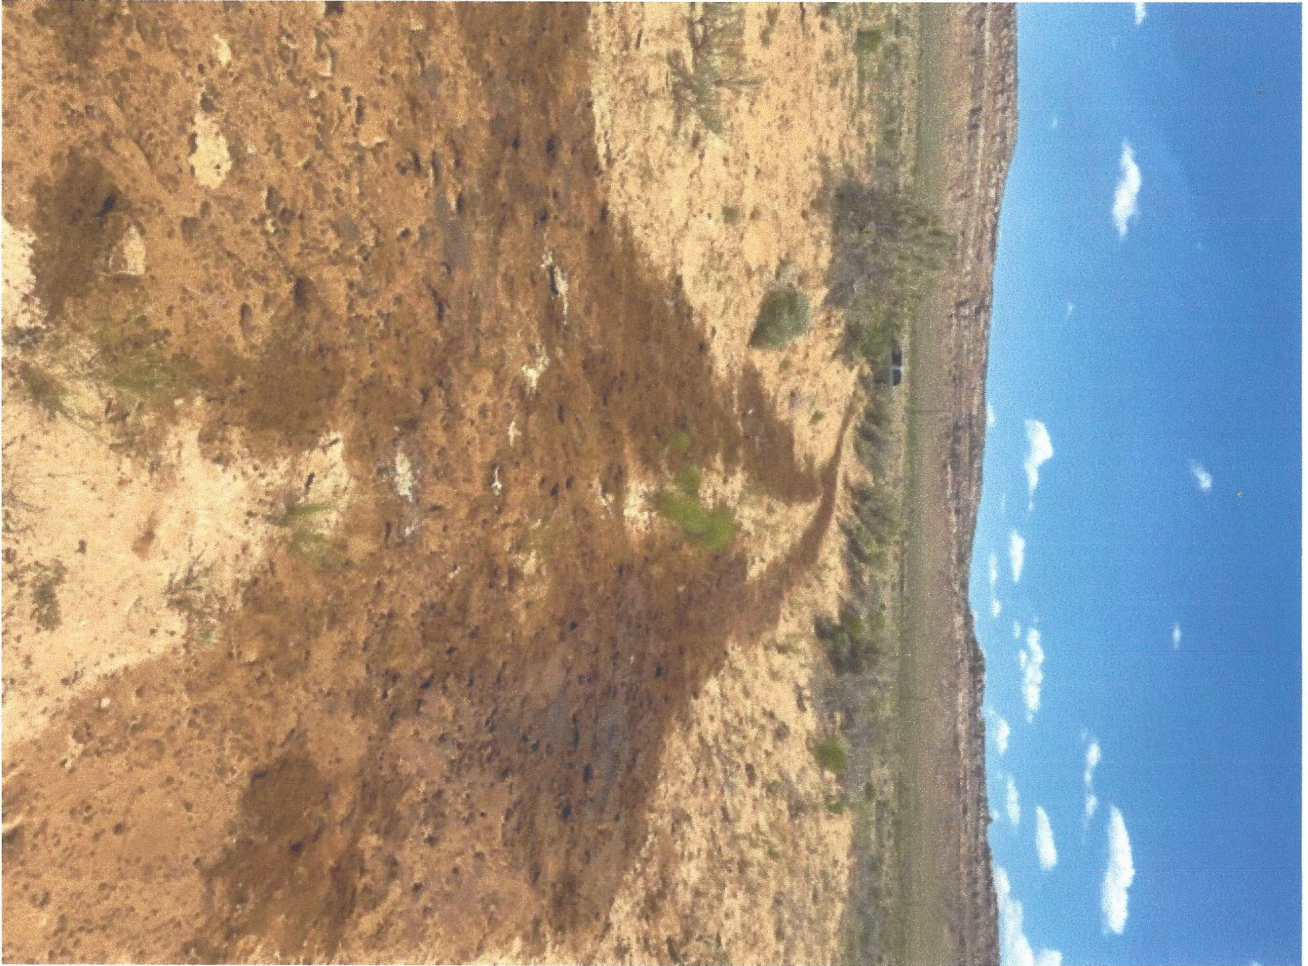
The State 23 tank is located on New Mexico State Section 28, T20N, R9W, McKinley County. It is a 300 bbl. oil and water production tank which is utilized for plugging operations on an expired NM State lease. On June 19, 2024, an oil release was discovered from the tank. On closer investigation, it was found that the tank was shot exactly 36" up from the bottom of the tank. The bullet was still lodged in the side wall of the tank however fluid was able to escape from around the penetration.

The tank is situated approximately 30 feet higher than a dirt lease road, which is adjacent to the tank, therefore the released oil flowed out the tank and down the lease road. The entire release was confined to the roadway and absorbed; there was no free oil present.

On July 24, 2024 minor cleanup around the tank was scheduled. Upon arrival, it was observed that approximately another 1/2 barrel had leaked from the tank, with a small amount of oil still flowing from a perfectly round hole in the tank. It appeared that someone drilled out the bullet lodged in the side of the tank with a 3/8" drill bit. The oil flow was stopped with a 3/8" bolt and rubber washer screwed into the hole.

After the hole was temporarily dealt with, the new oil release was hauled to the stockpile.

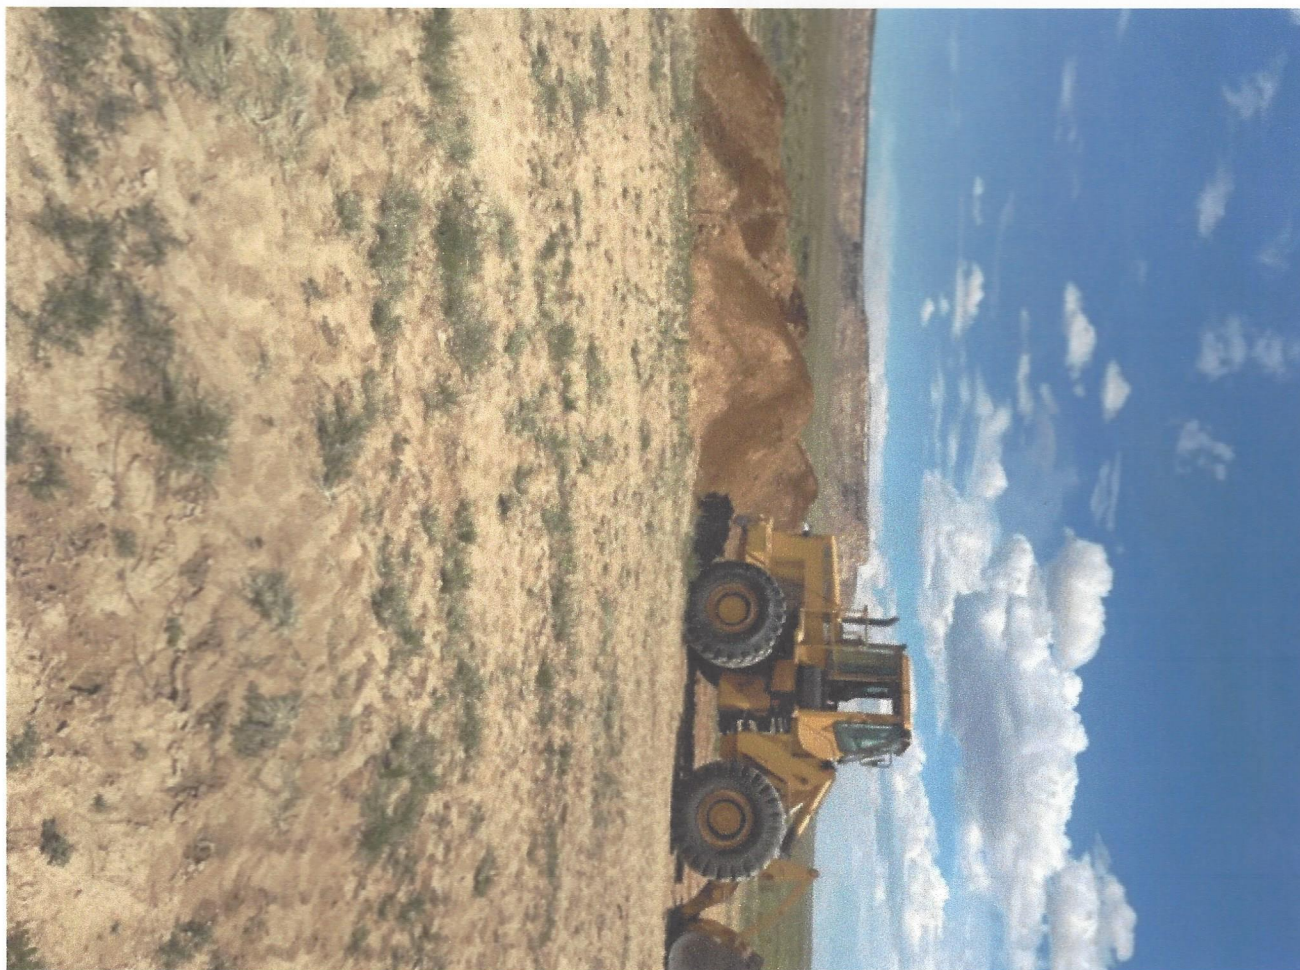
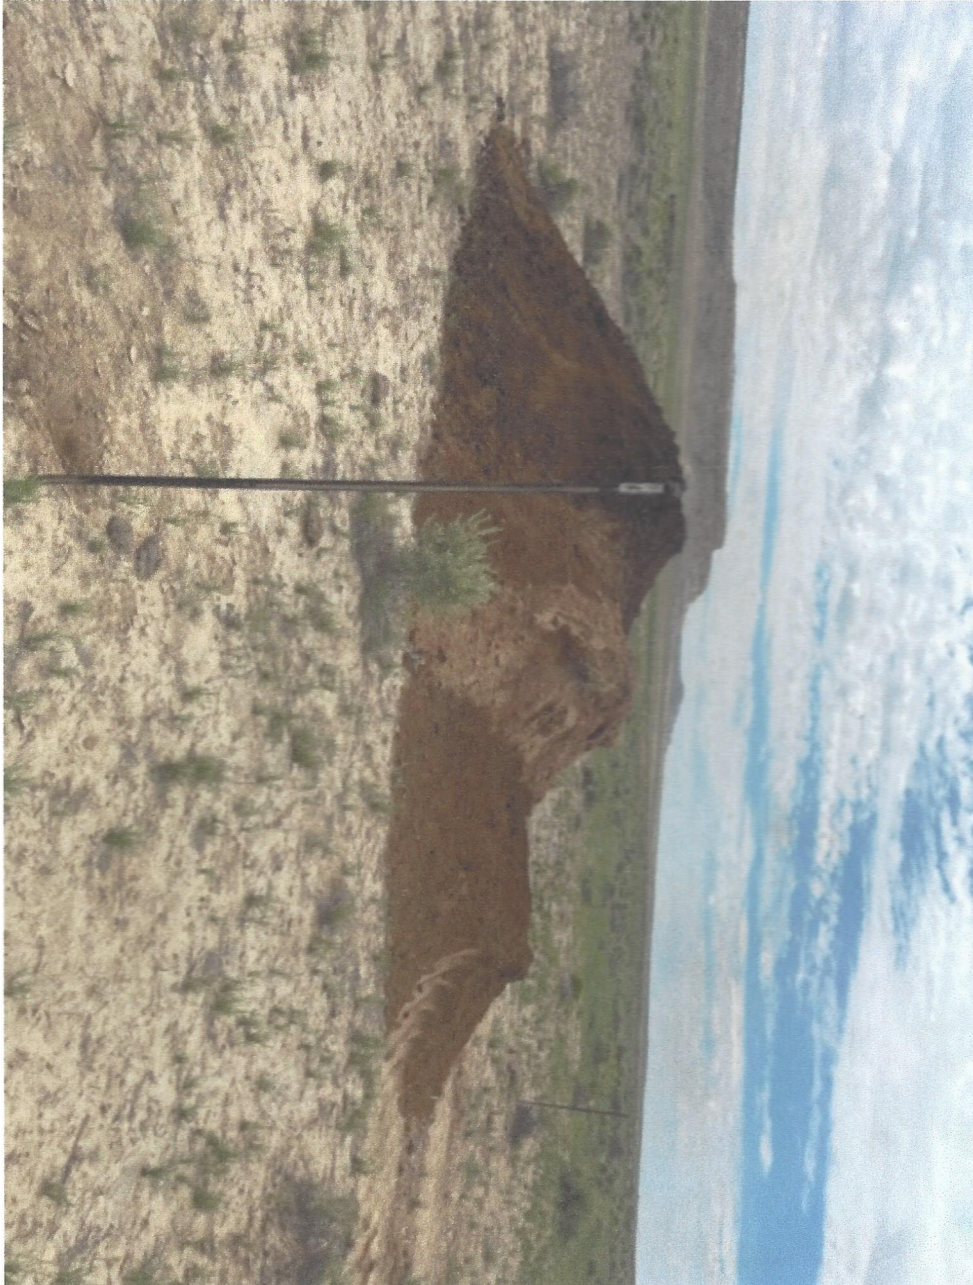
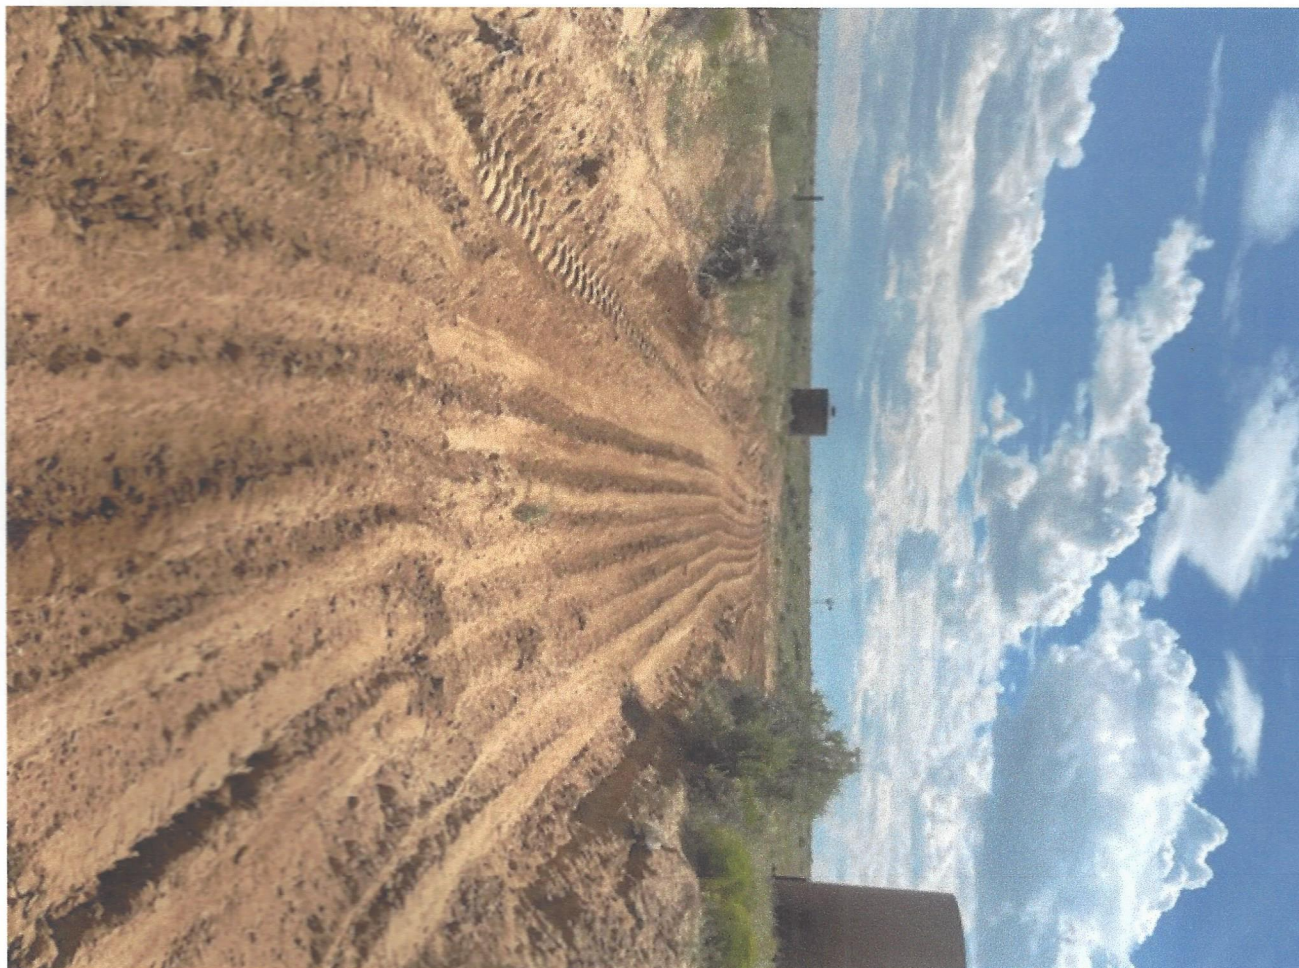
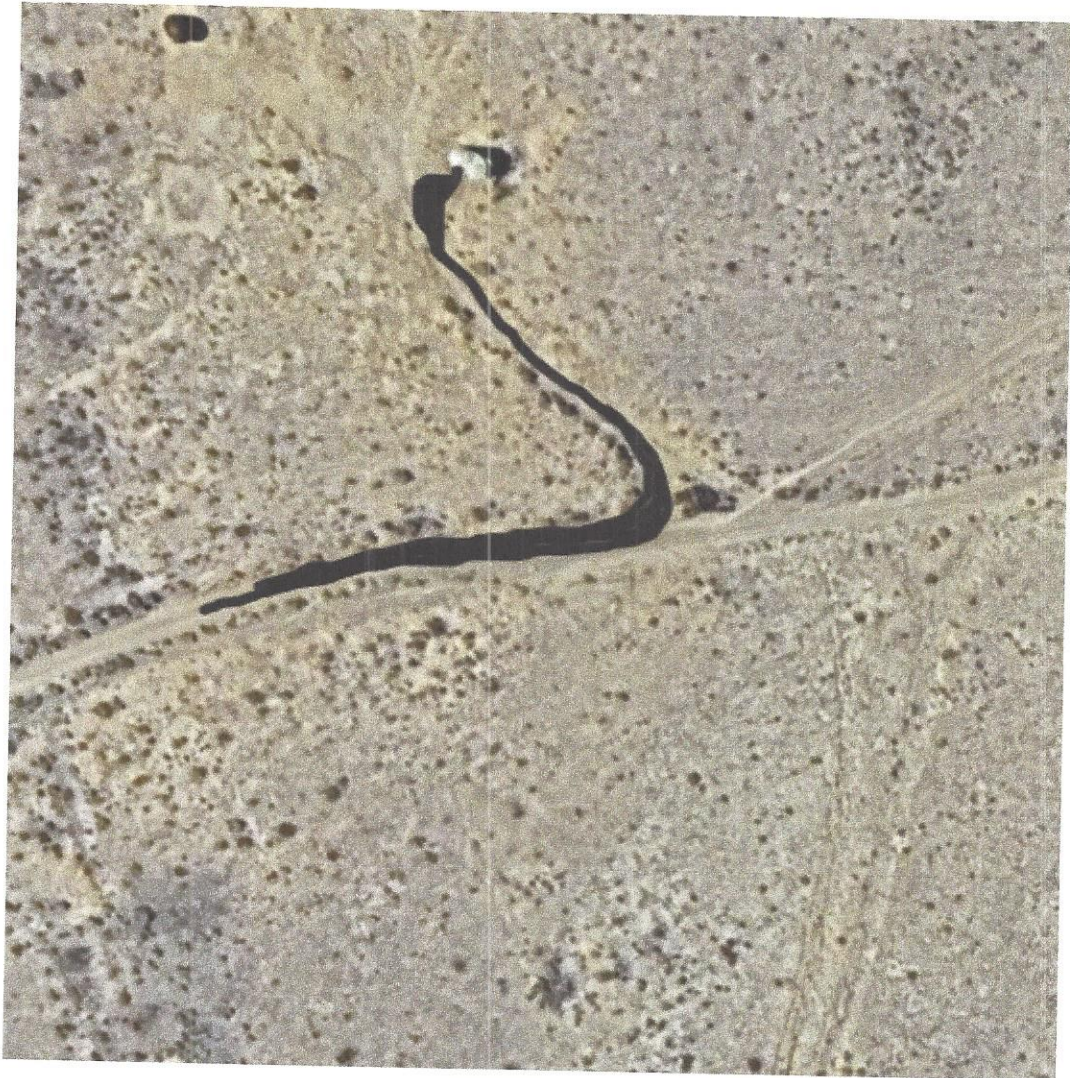
The State 23 tank is located on New Mexico State Section 28, T20N, R9W, McKinley County. It is a 300 bbl. oil and water production tank which is utilized for plugging operations on an expired NM State lease. On June 19, 2024, an oil release was discovered from the tank. On closer investigation, it was found that the tank was shot exactly 36" up from the bottom of the tank. The bullet was still lodged in the side wall of the tank however fluid was able to escape from around the penetration.

The tank is situated approximately 30 feet higher than a dirt lease road, which is adjacent to the tank, therefore the released oil flowed out the tank and down the lease road. The entire release was confined to the roadway and absorbed; there was no free oil present.

On July 24, 2024 minor cleanup around the tank was scheduled. Upon arrival, it was observed that approximately another ½ barrel had leaked from the tank, with a small amount of oil still flowing from a perfectly round hole in the tank. It appeared that someone drilled out the bullet lodged in the side of the tank with a 3/8" drill bit. The oil flow was stopped with a 3/8' bolt and rubber washer screwed into the hole.

After the hole was temporarily dealt with, the new oil release was hauled to the stockpile.
