**RE: Liner Inspection and Closure Report**  
**Boot Hill 25-1 Battery**  
**API No. 30-015-38552**  
**GPS: Latitude 32.63128 Longitude -104.43617**  
**UL- J, Section 25, Township 19S, Range 25E**  
**NMOCD Reference No. NAPP2420443181**

PHOTO LOG TYPE: Pre Wash

PHOTO LOG TYPE: Liner Inspection-Post Wash

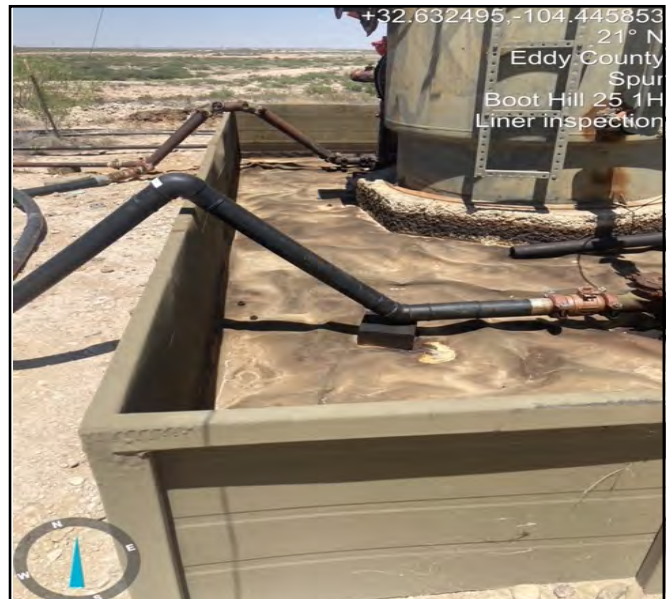
Photograph documenting the assessment of the liner facing North.

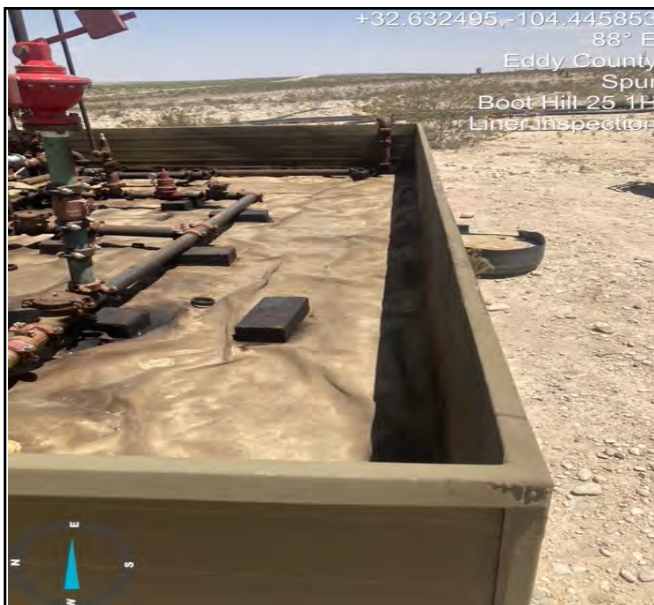
Photograph documenting the assessment of the liner facing East.

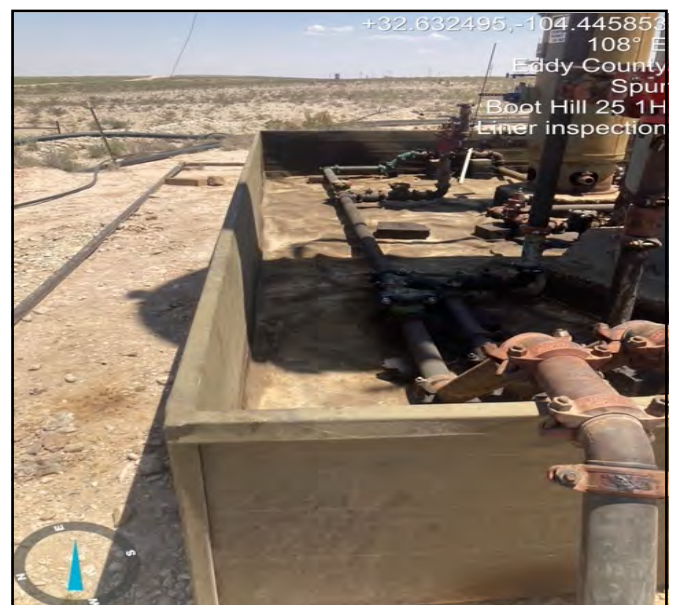
Photograph documenting the assessment of the liner facing East.

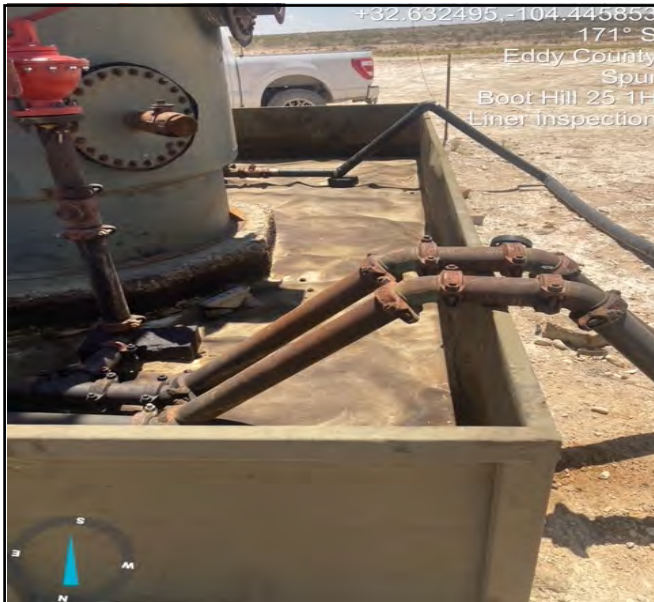
Photograph documenting the assessment of the liner facing South.

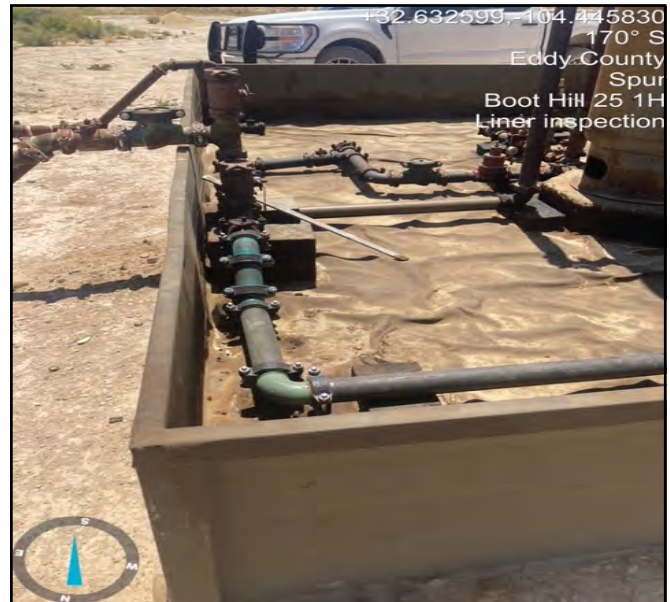
Photograph documenting the assessment of the liner facing South.

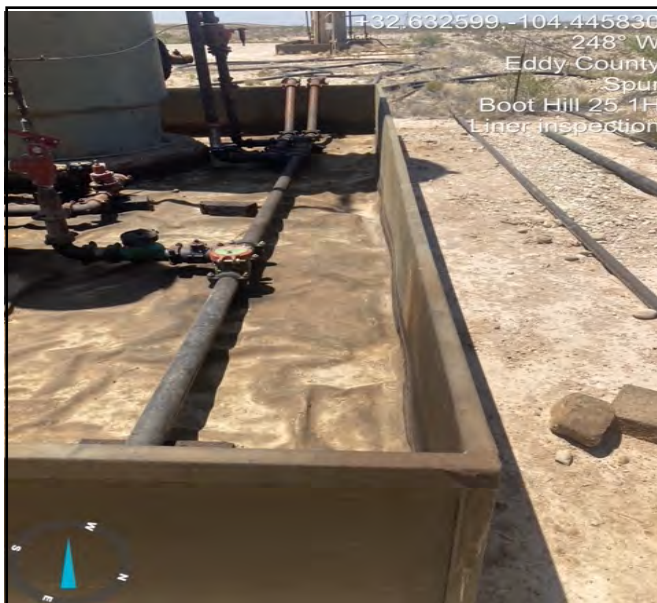
Photograph documenting the assessment of the liner facing West.

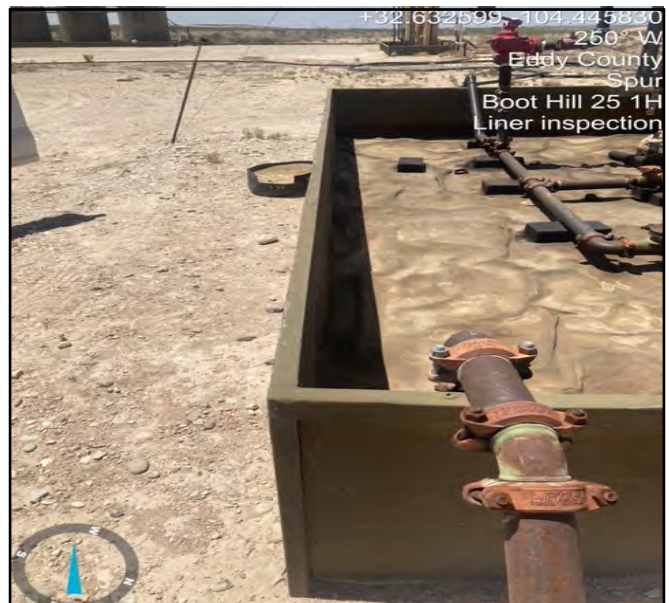
Photograph documenting the assessment of the liner facing West.

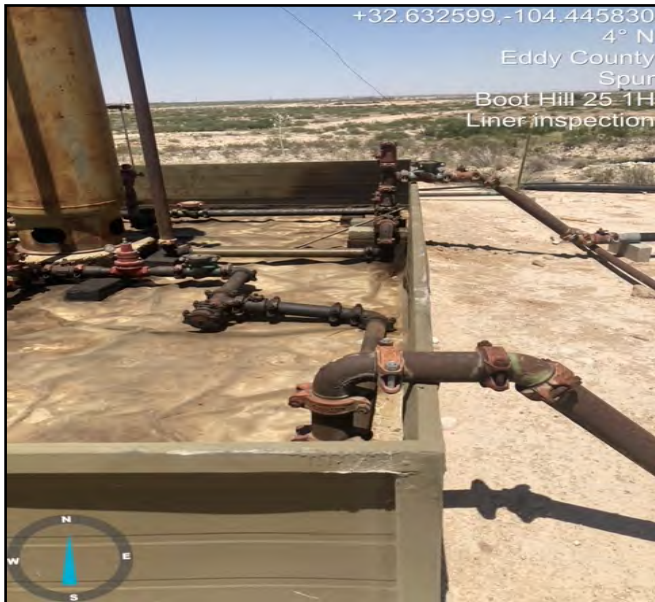
Photograph documenting the assessment of the liner facing North.

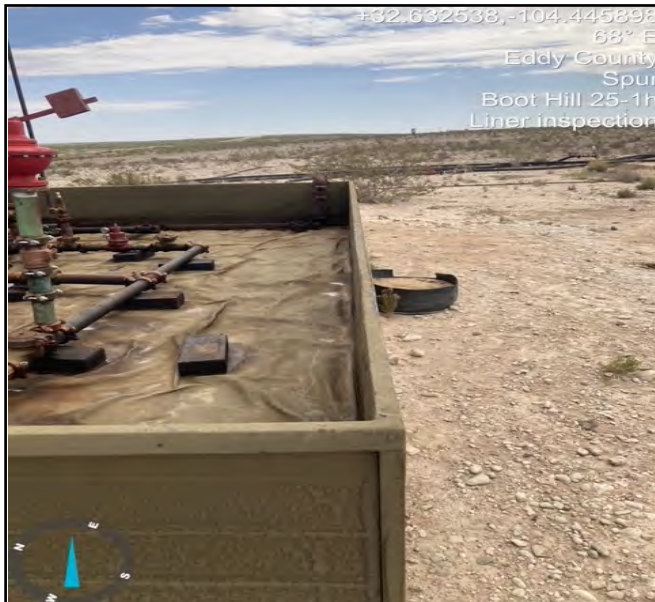
Photograph depicting the liner post-power washing facing East.

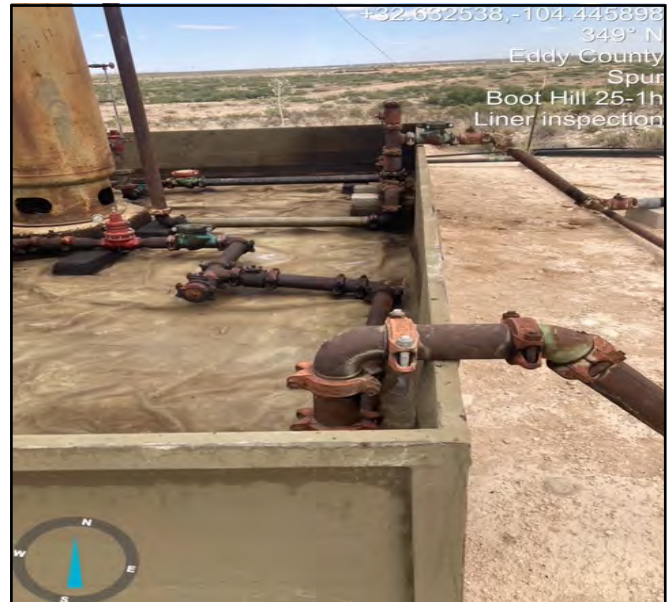
Photograph depicting the liner post-power washing facing North.

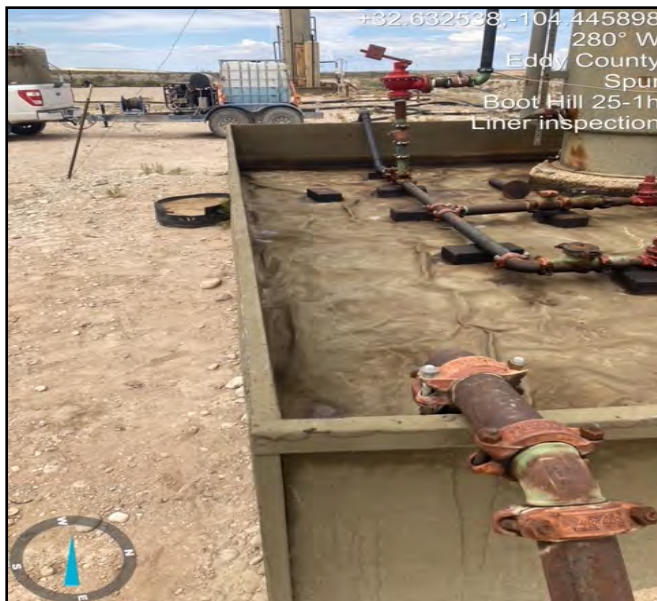
Photograph depicting the liner post-power washing facing West.

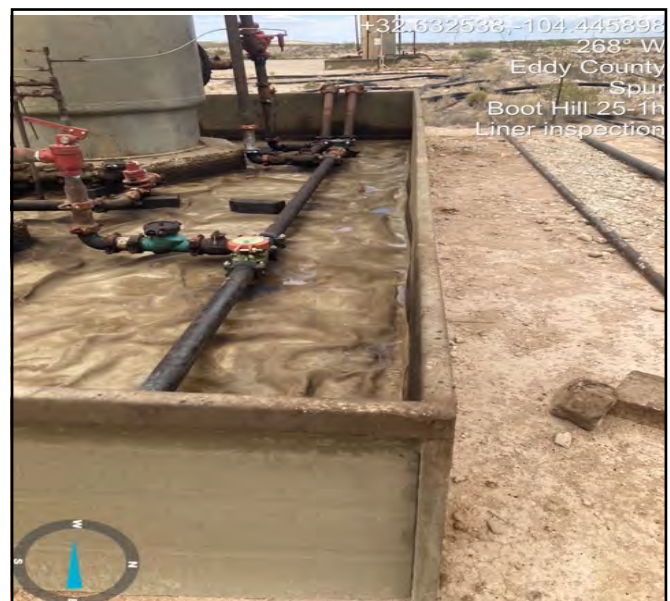
Photograph depicting the liner post-power washing facing West.

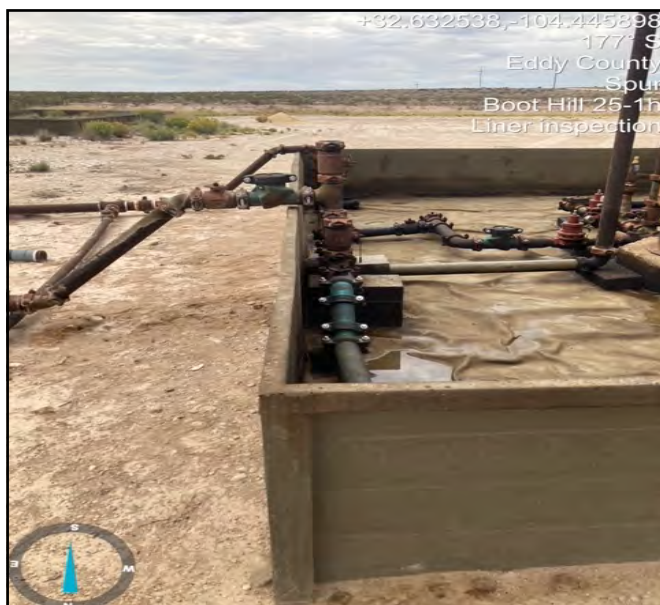
Photograph depicting the liner post-power washing facing South.

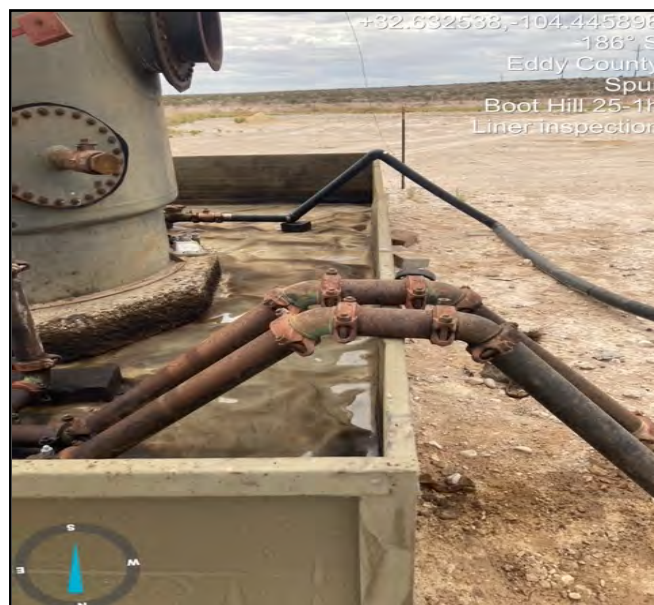
Photograph depicting the liner post-power washing facing South.
