**Pima Environmental Services**  
**5614 N. Lovington Highway**  
**Hobbs, NM 88240**  
**575-964-7740**

August 25, 2024

**RE: Liner Inspection and Closure Report**  
**Bone Yard 11 Fee 16H Battery**  
**API No. N/A**  
**GPS: Latitude 32.6021 Longitude -104.4566**  
**UL- K, Section 02, Township 20S, Range 25E**  
**NMOCD Reference No. NAPP2422547586**

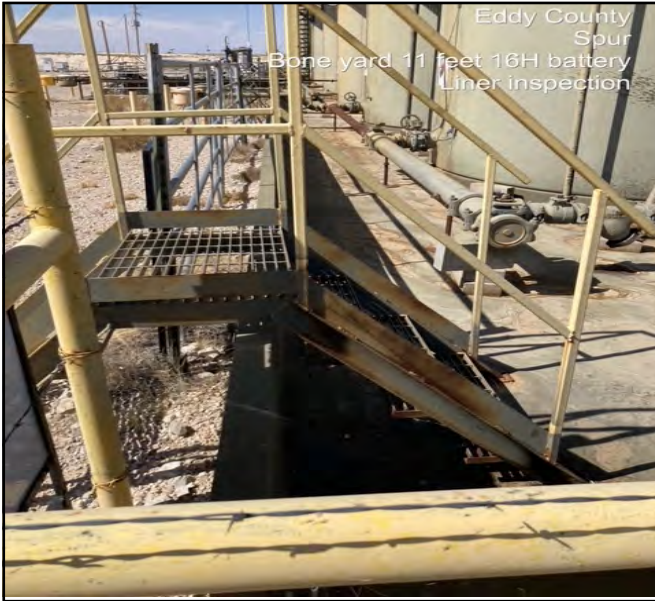
Detailed photograph of the liner inspection, highlighting key areas of interest. Facing North.

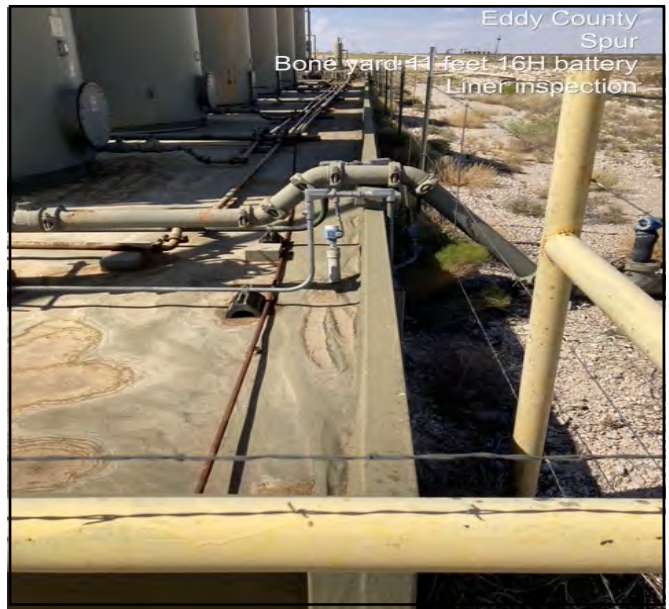
Detailed photograph of the liner inspection, highlighting key areas of interest. Facing North.

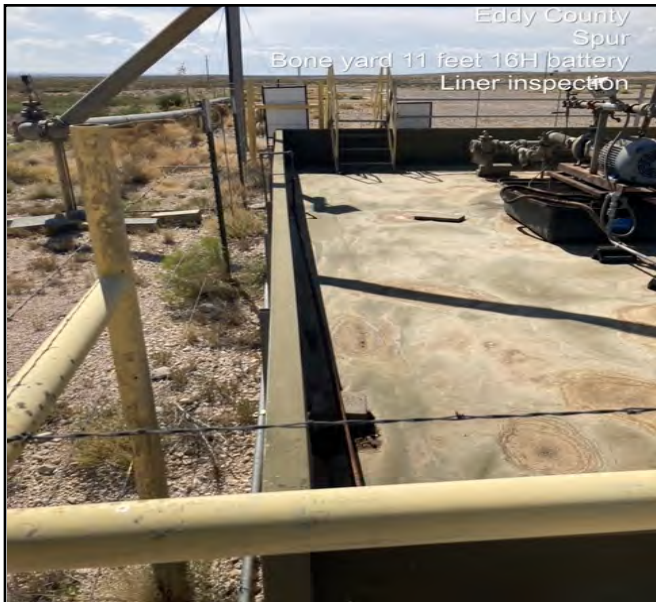
Detailed photograph of the liner inspection, highlighting key areas of interest. Facing West.

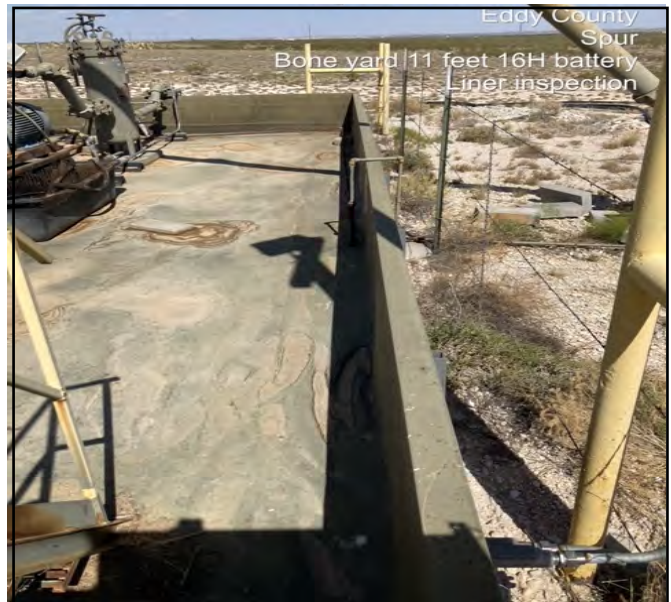
Detailed photograph of the liner inspection, highlighting key areas of interest. Facing East.

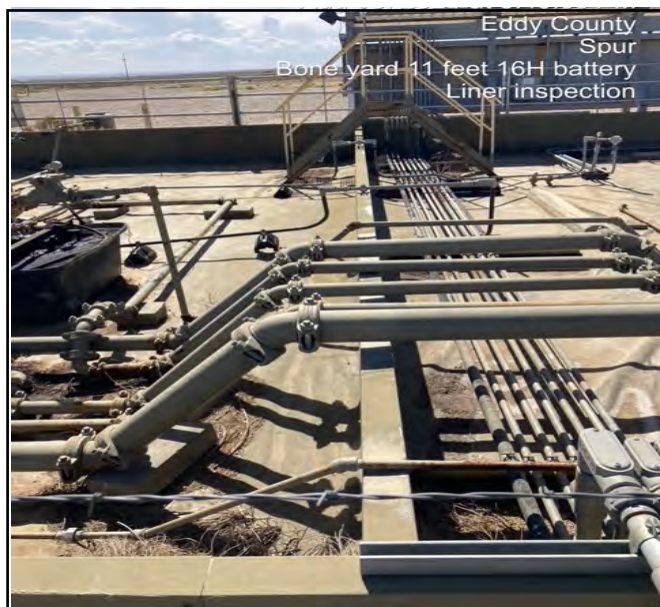
Detailed photograph of the liner inspection, highlighting key areas of interest. Facing West.

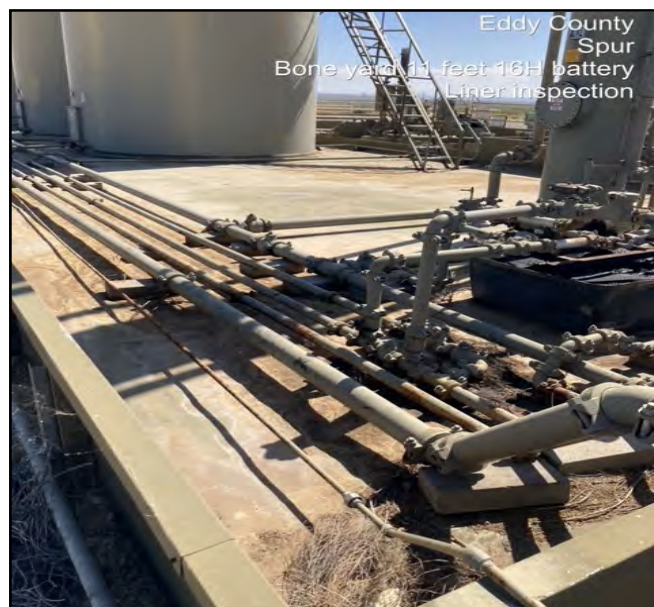
Detailed photograph of the liner inspection, highlighting key areas of interest. Facing South.

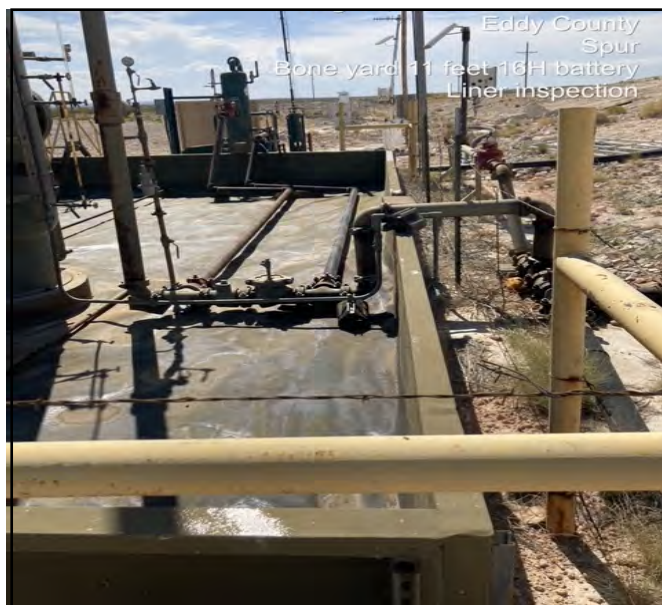
Detailed photograph of the liner inspection, highlighting key areas of interest. Facing East.

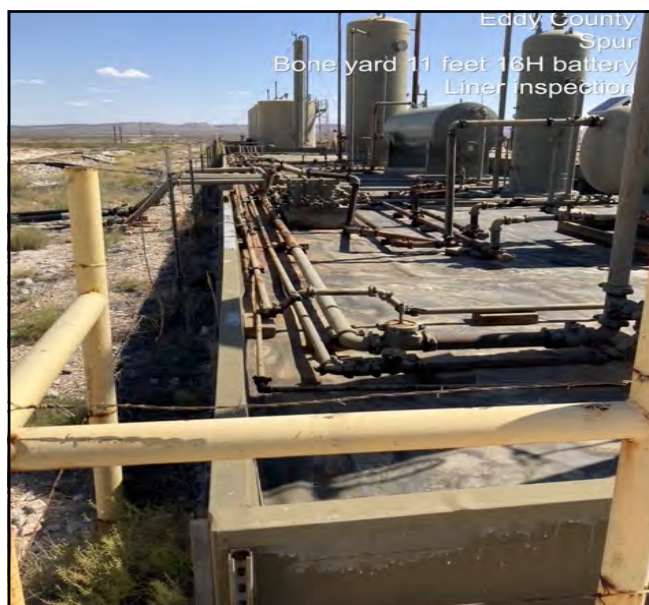
Detailed photograph of the liner inspection, highlighting key areas of interest. Facing South.

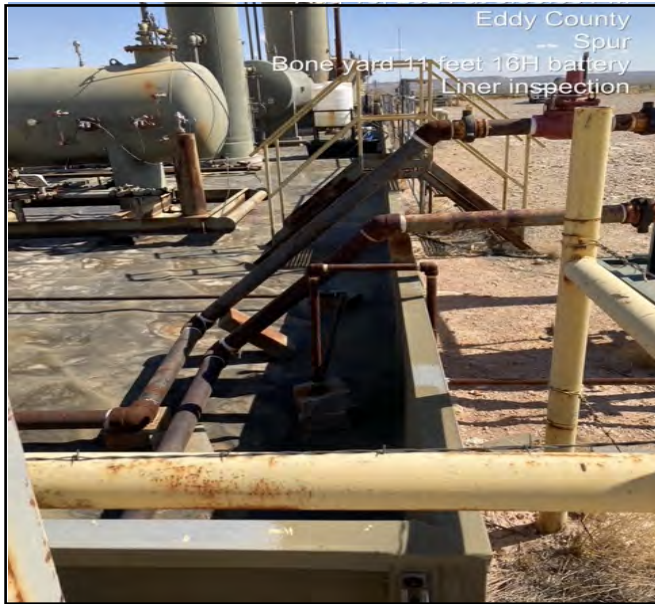
Detailed photograph of the liner inspection, highlighting key areas of interest. Facing South.

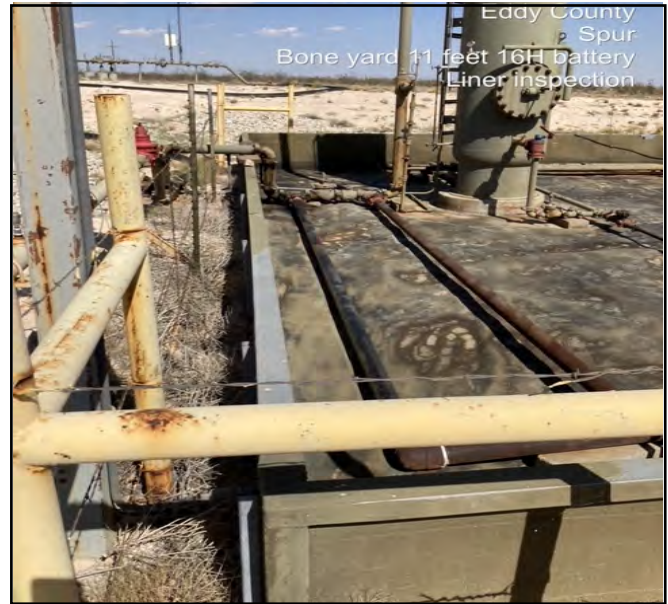
Detailed photograph of the liner inspection, highlighting key areas of interest. Facing West.
