LINER INSPECTION CLOSURE REPORT

Incident ID NAPP2428330737

ONYXPWU 29 Battery

Prepared By:
Pima Environmental Services, LLC

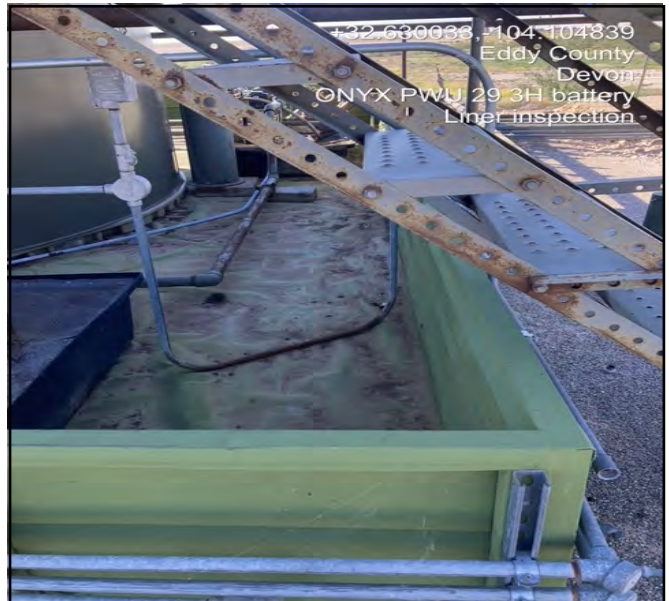
Photo of liner taken prior to power washing.
Facing South

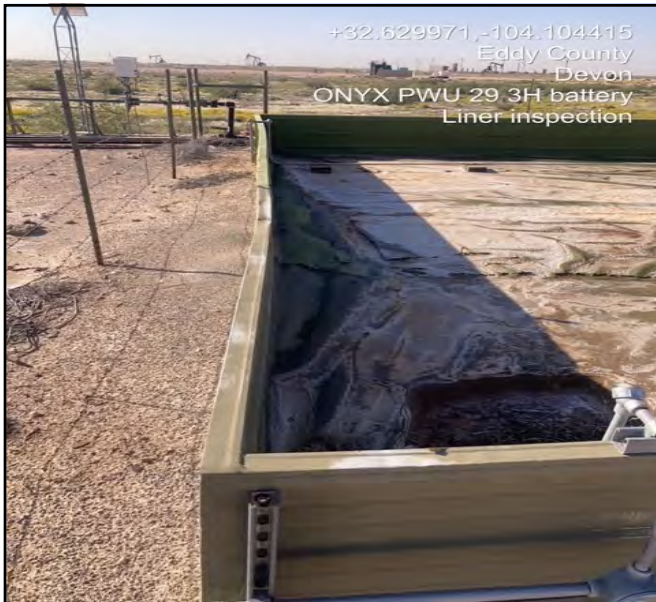
Photo of liner taken prior to power washing.
Facing South

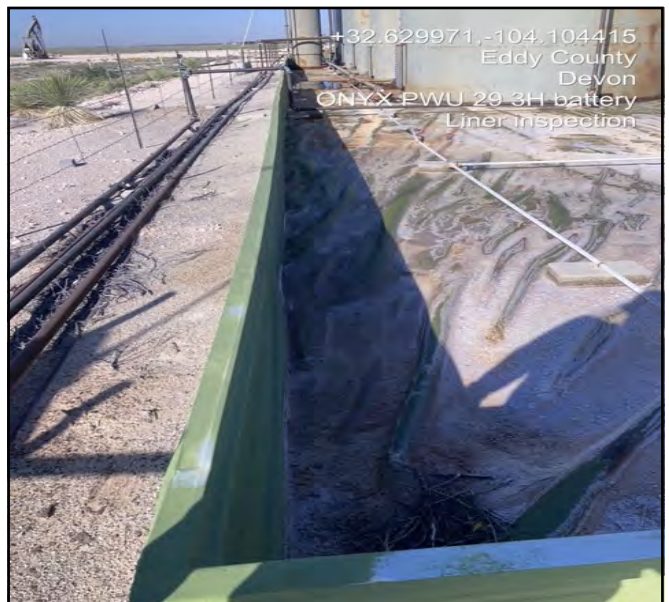
Photo of liner taken prior to power washing.
Facing West

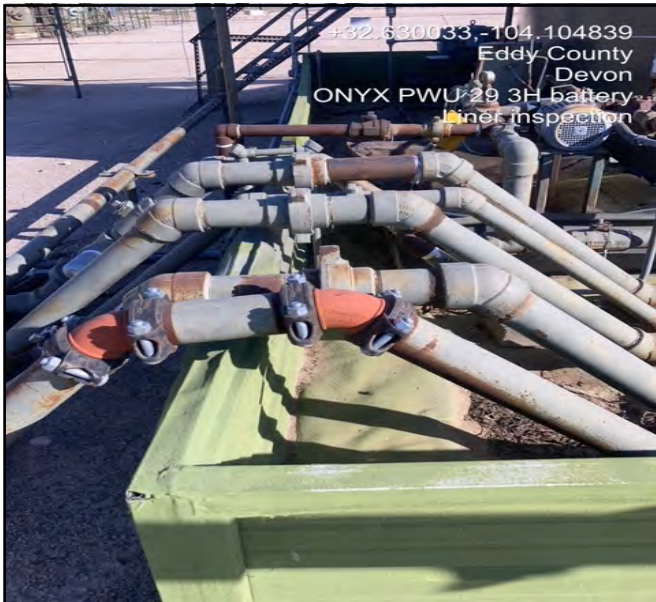
Photo of liner taken prior to power washing.
Facing North

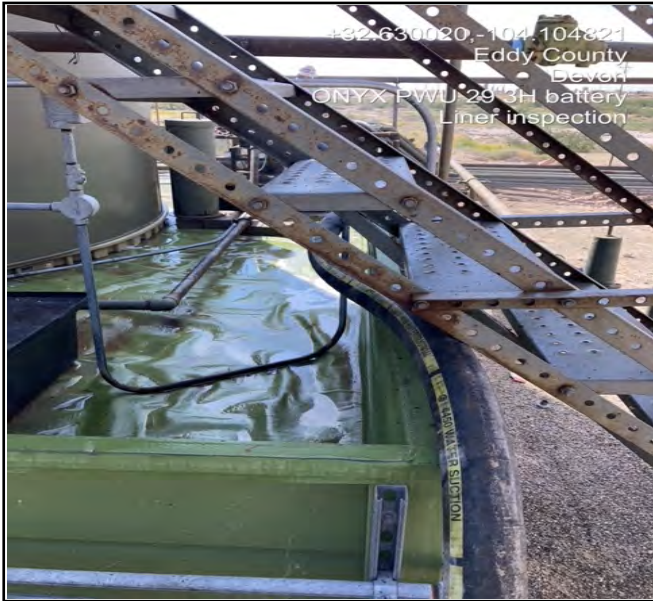
Photo taken pursuant to power washing.
Facing South

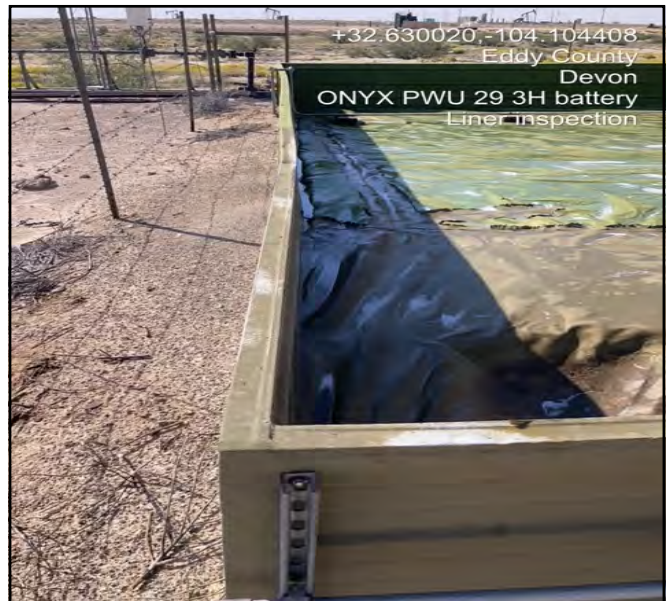
Photo taken pursuant to power washing.
Facing South, The Liner displays a different color on the
Northwest corner.

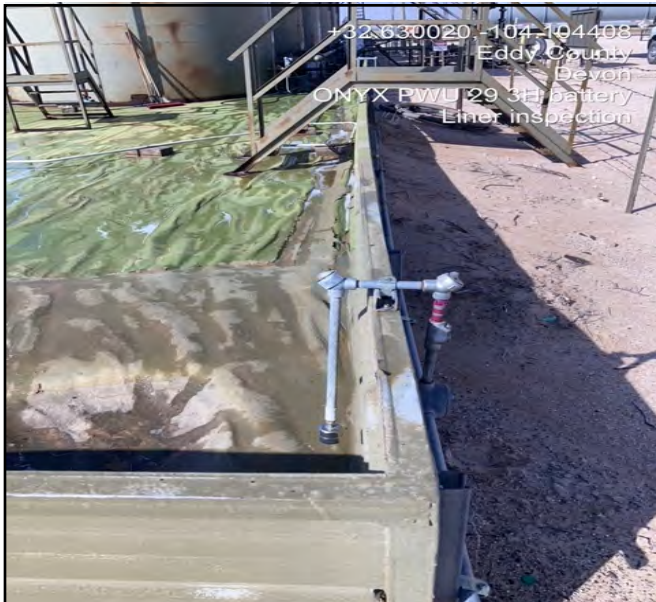
Photo taken pursuant to power washing.
Facing West

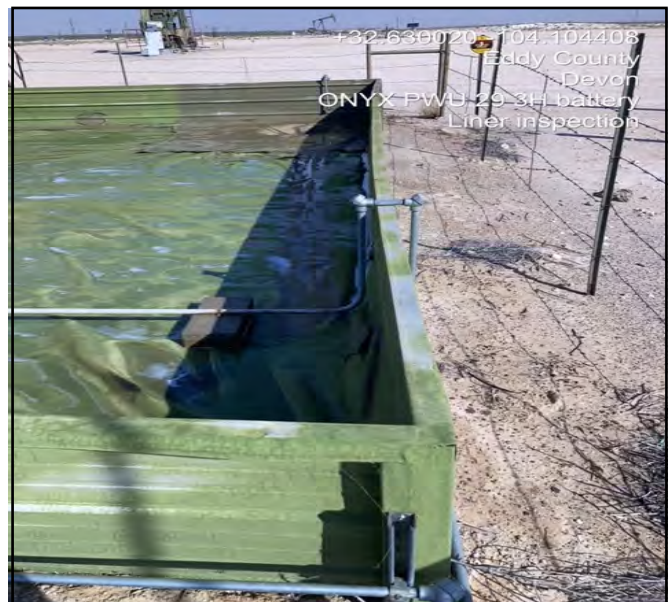
Photo taken pursuant to power washing.
Facing North.

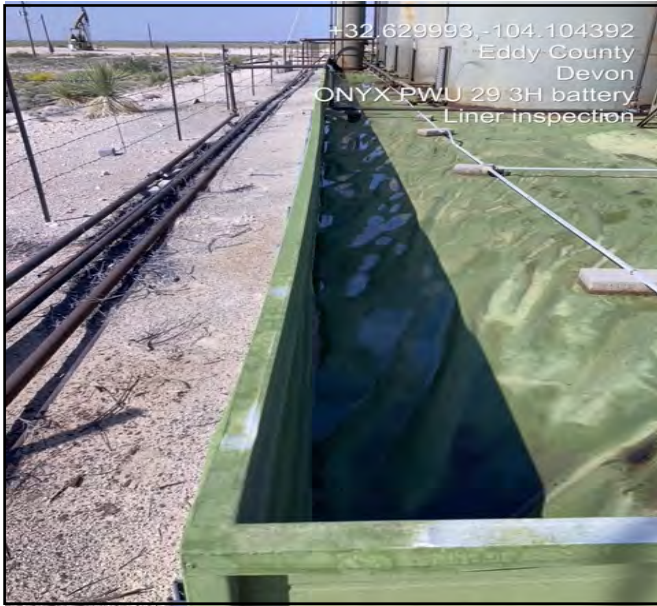
Photo taken pursuant to power washing.
Facing West.

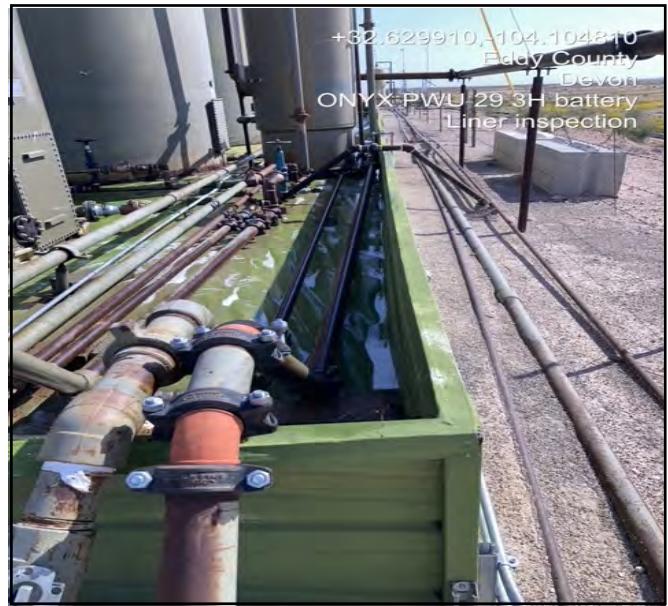
Photo taken pursuant to power washing.
Facing East.

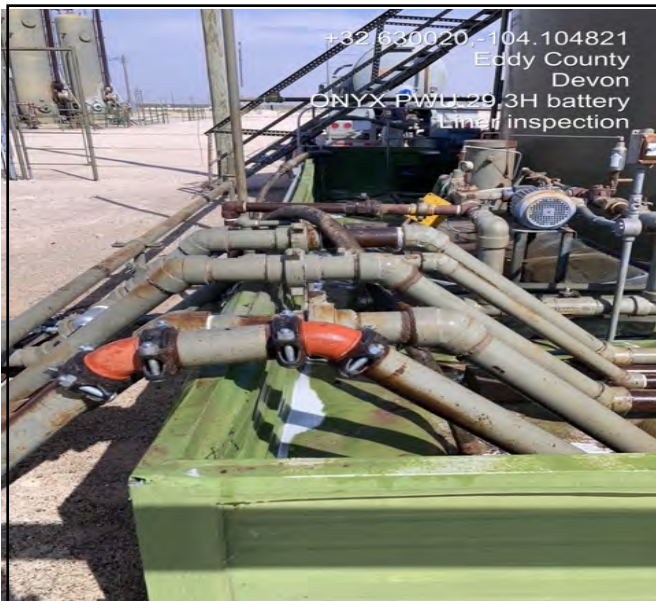
Photo taken pursuant to power washing.
Facing North.

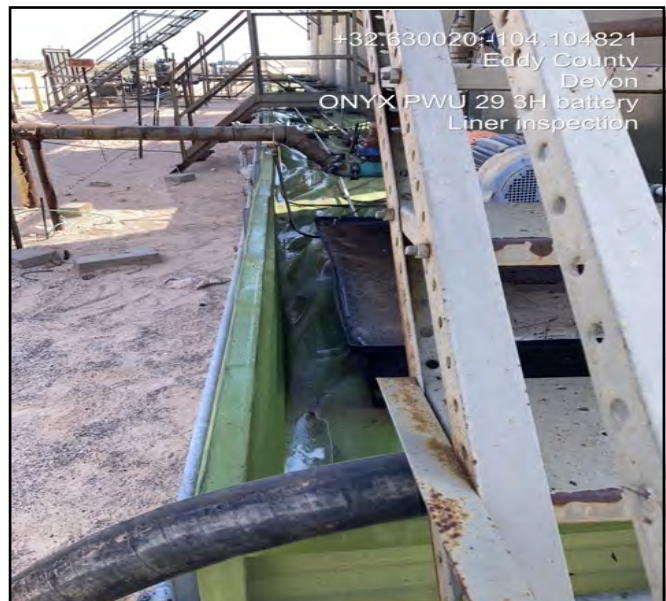
Photo taken pursuant to power washing.
Facing East.

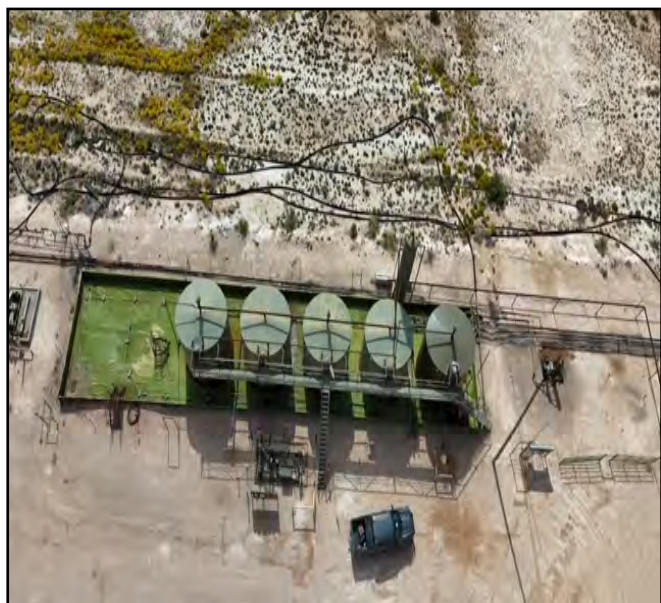
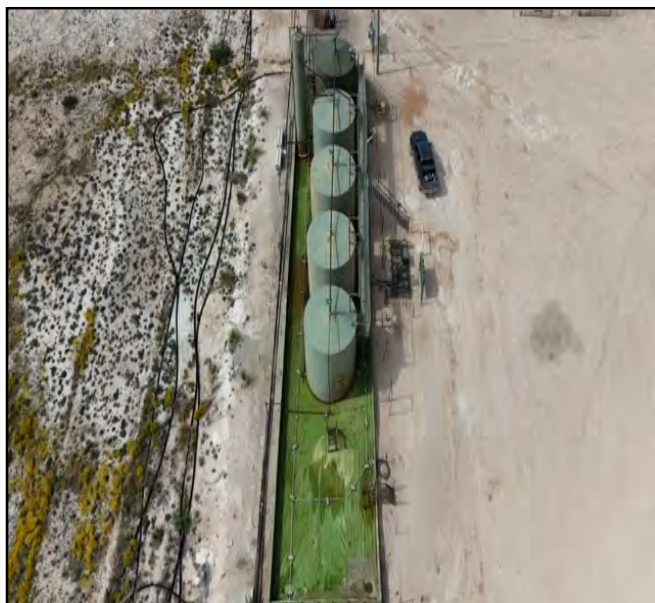
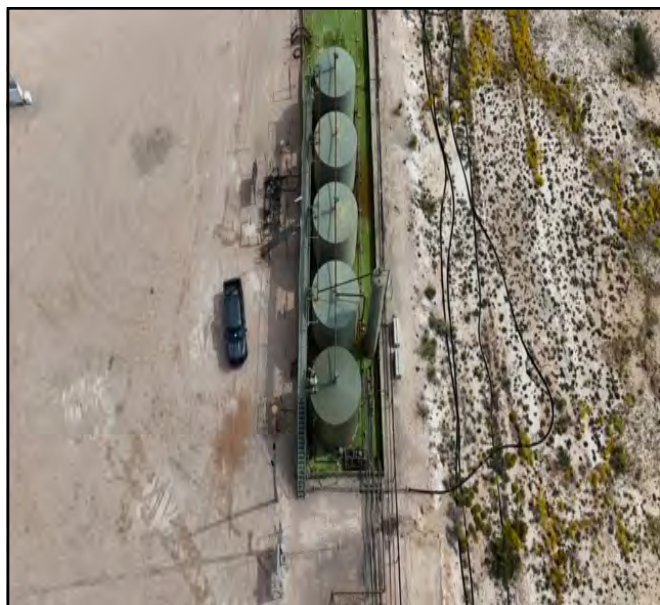
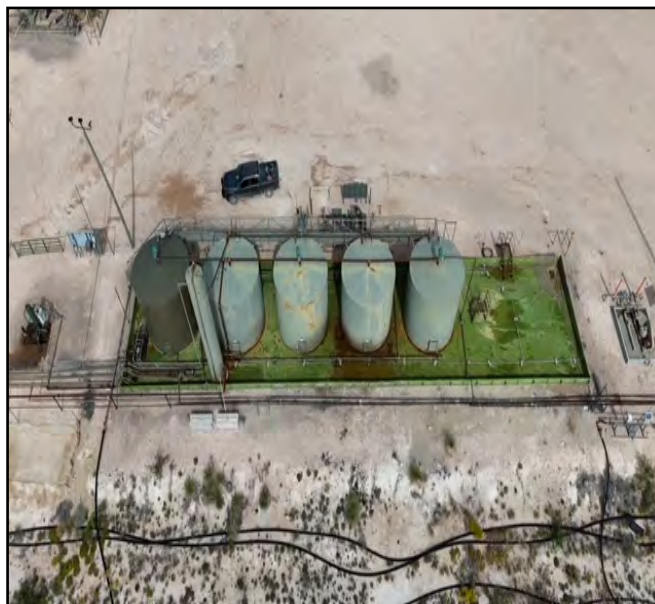
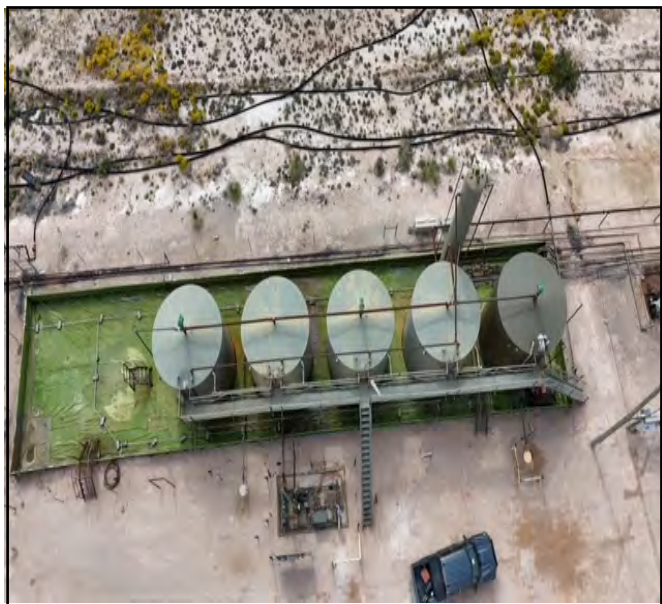
Aerial Photos :

Aerial photo of liner.
