STROS 29 Tank Battery

Incident ID nAPP2423238572

Liner Inspection and Closure Report

September 25, 2024

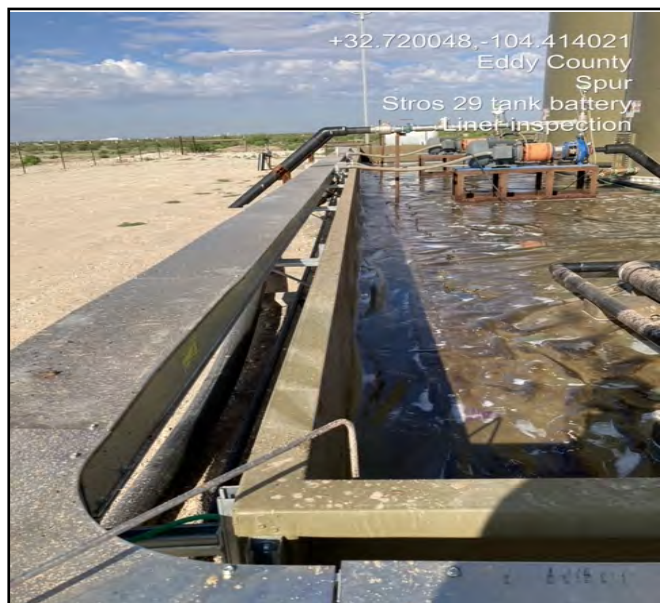
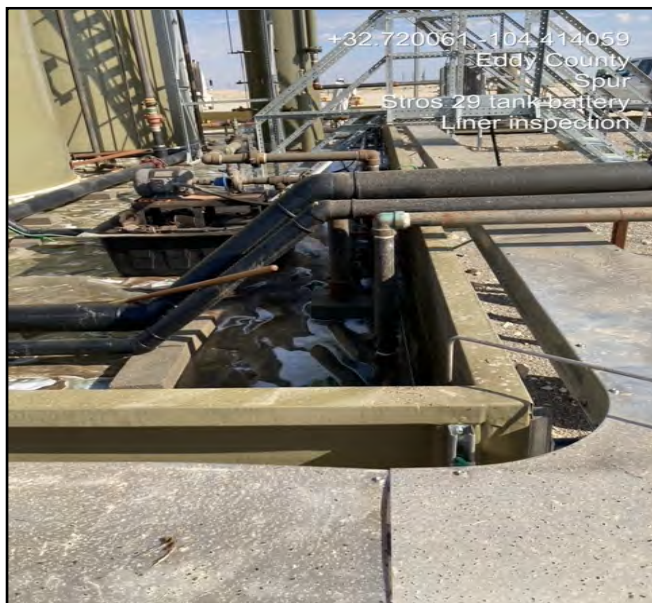
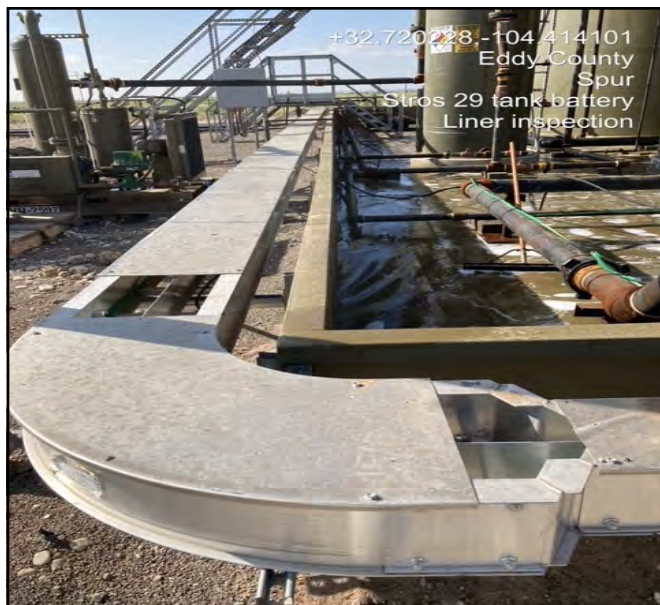
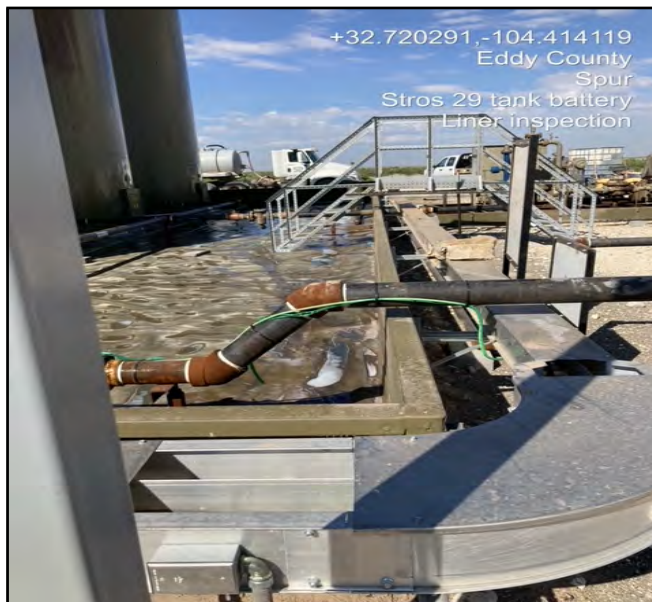
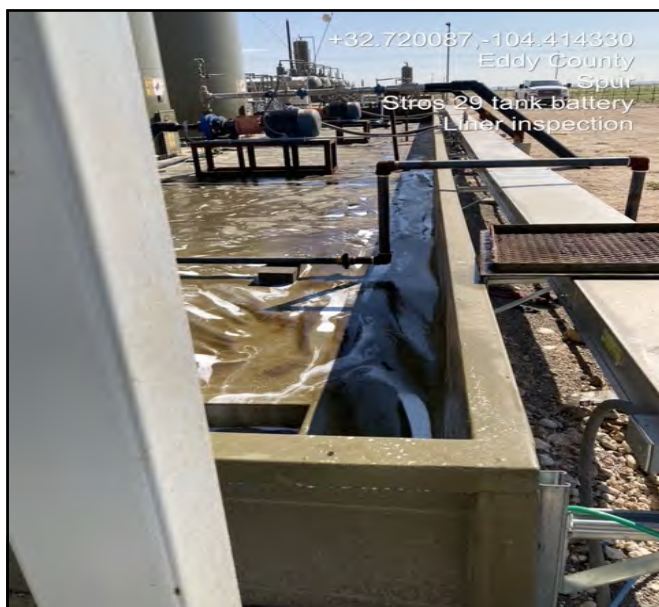
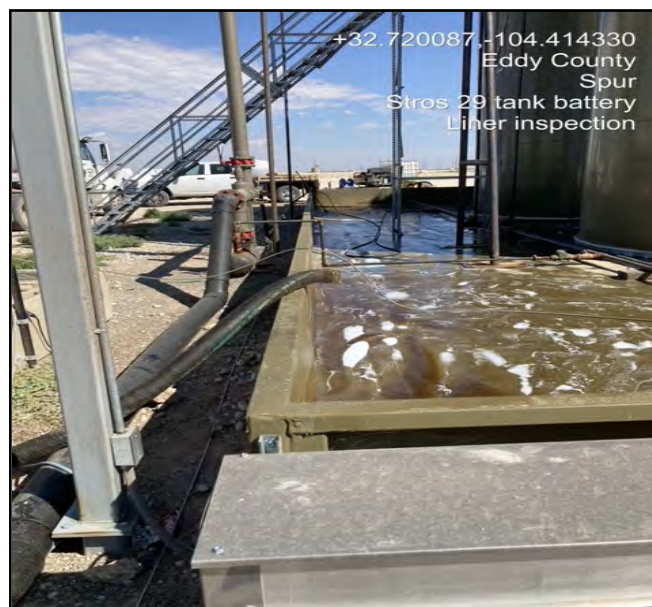
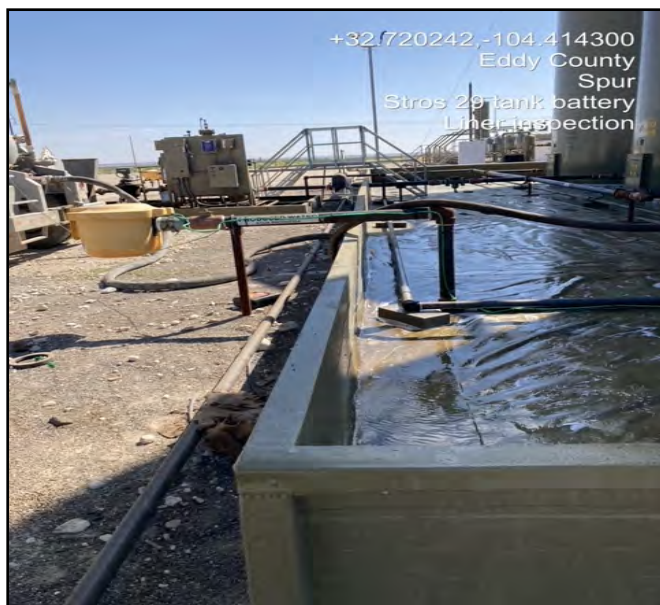
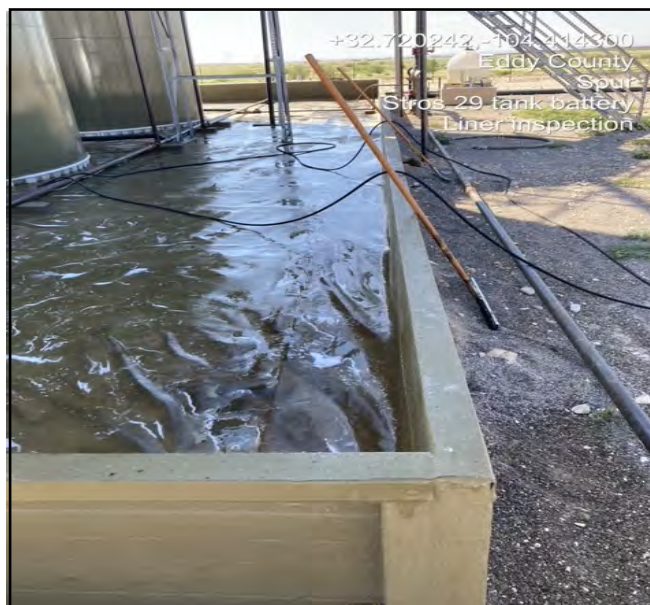
Visualization	Yes	No	Comments
Is there a tear in the liner?		X	
Are there holes in the liner?		X	
Is the liner retaining any fluids?	X		Standing fluid from pressure washing activities.
Does the liner have integrity to contain a leak?	X

Photo of liner pursuant to power washing. Fluid from power washer.

Photo of liner pursuant to power washing.
Fluid from power washer.
