PREPARED BY: PIMA ENVIRONMENTAL SERVICES, LLC

HT Federal #1-4-5 Tank Battery
Incident ID nAPP2423430255

Liner Inspection and Closure Report

September 25, 2024

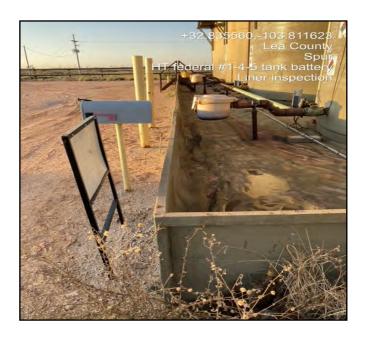
Photo of liner pursuant to power wash. Liquid from power washer.

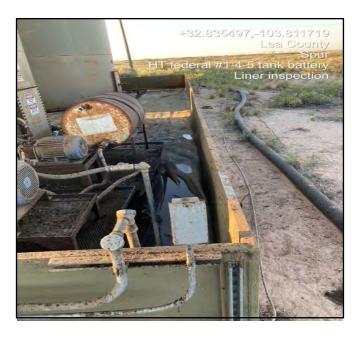
Photo of liner pursuant to power wash. Liquid from power washer.

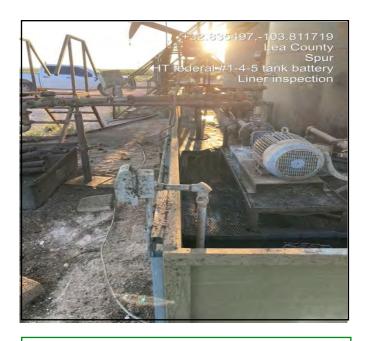
Photo of liner pursuant to power wash. Liquid from power washer.

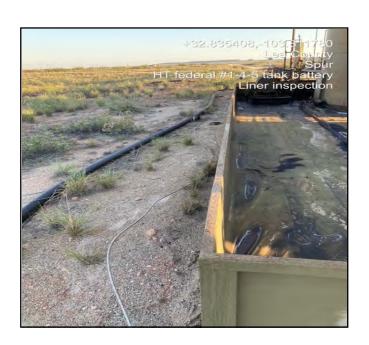
Photo of liner pursuant to power wash. Liquid from power washer.

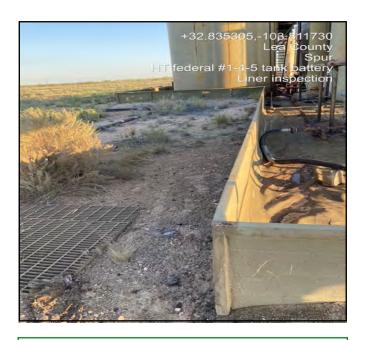
Photo of liner pursuant to power wash. Liquid from power washer.

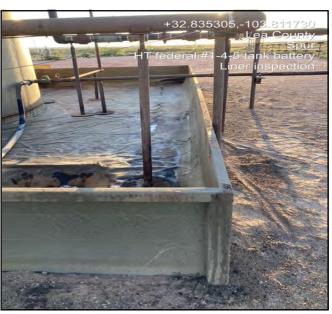
Photo of liner pursuant to power wash. Liquid from power washer.

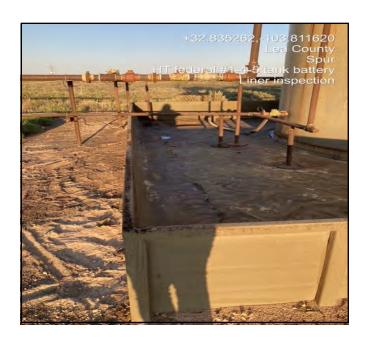
Photo of liner pursuant to power wash. Liquid from power washer.

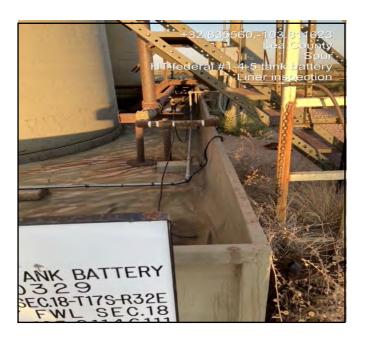
Photo of liner pursuant to power wash.

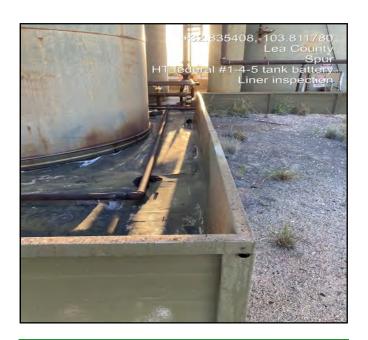
Photo of liner pursuant to power wash. Liquid from power washer.

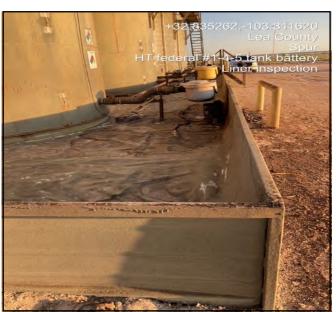
Photo of liner pursuant to power wash.
