SUBJECT: Closure Request Report for the Jayhawk 6 CTB 2, Incident ID # nAPP2504226053, Facility ID fAPP2130256531, Lea County, New Mexico

ATTACHMENT 1: SITE ASSESSMENT REPORT

Site Assessment Photolog

Site: Jayhawk 6 CTB 2

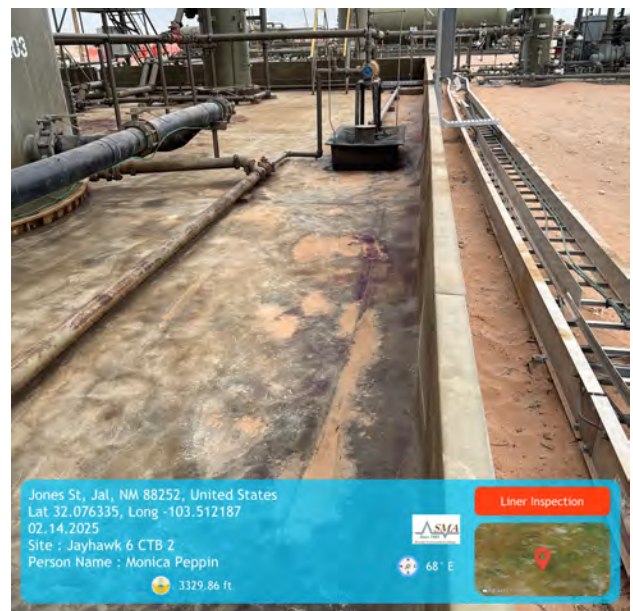
Photograph #2: South wall facing east from middle point.

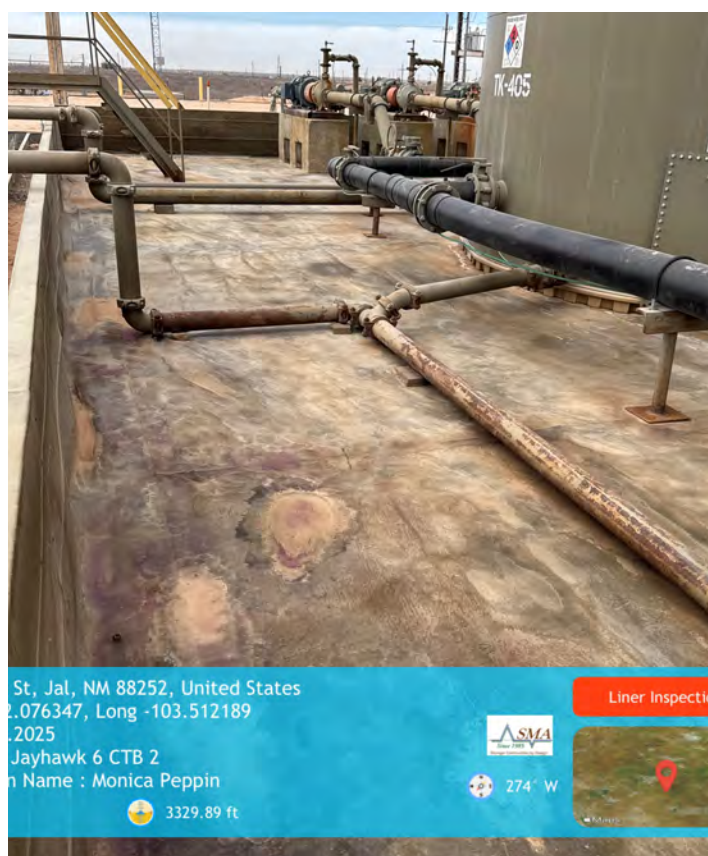
Photograph #3: South wall area facing west from middle point.

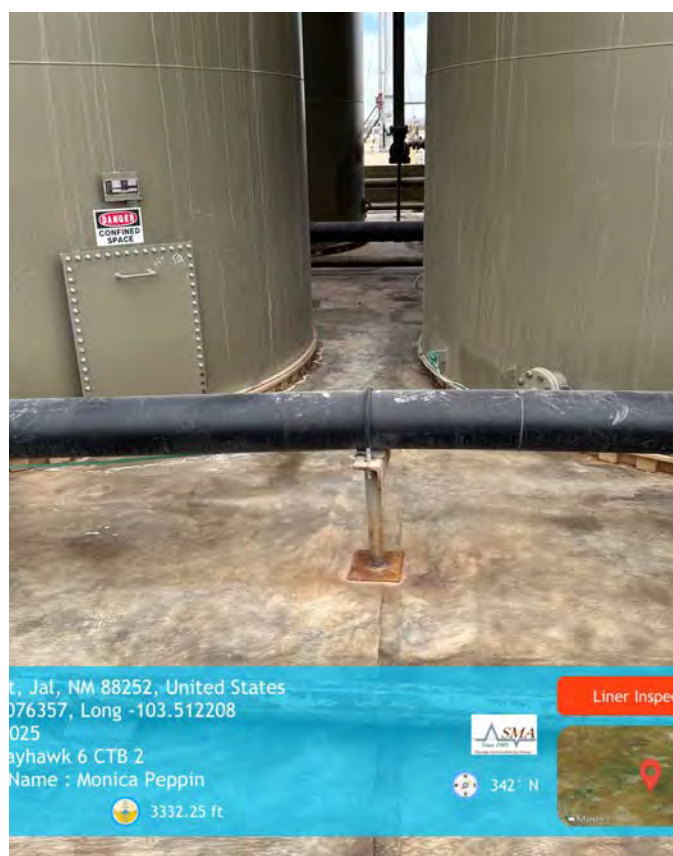
Photograph #4: Liner between tanks furthest west.

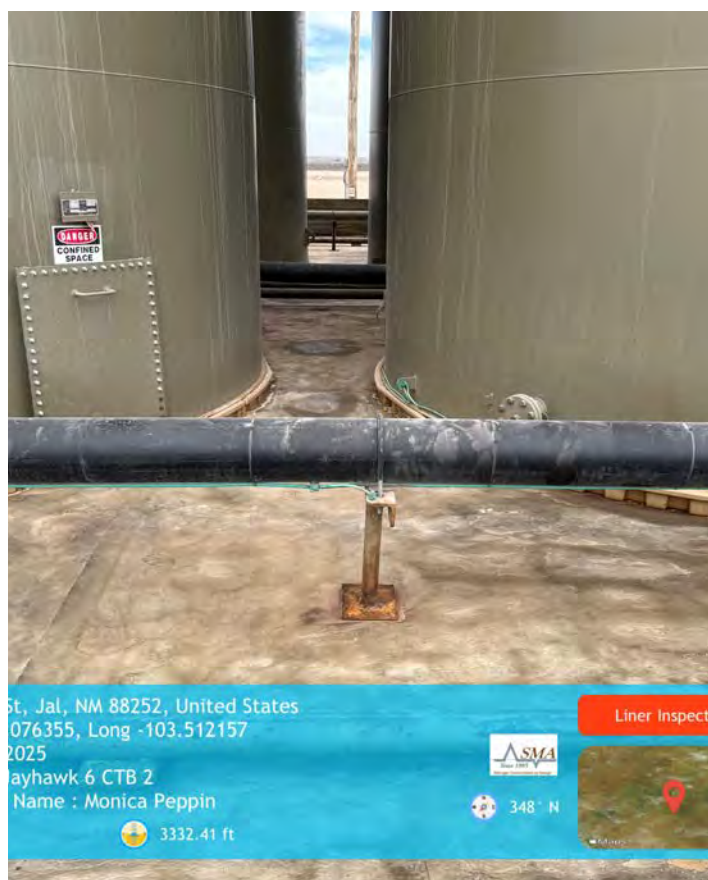
Photograph #5: Liner between middle tanks facing north.

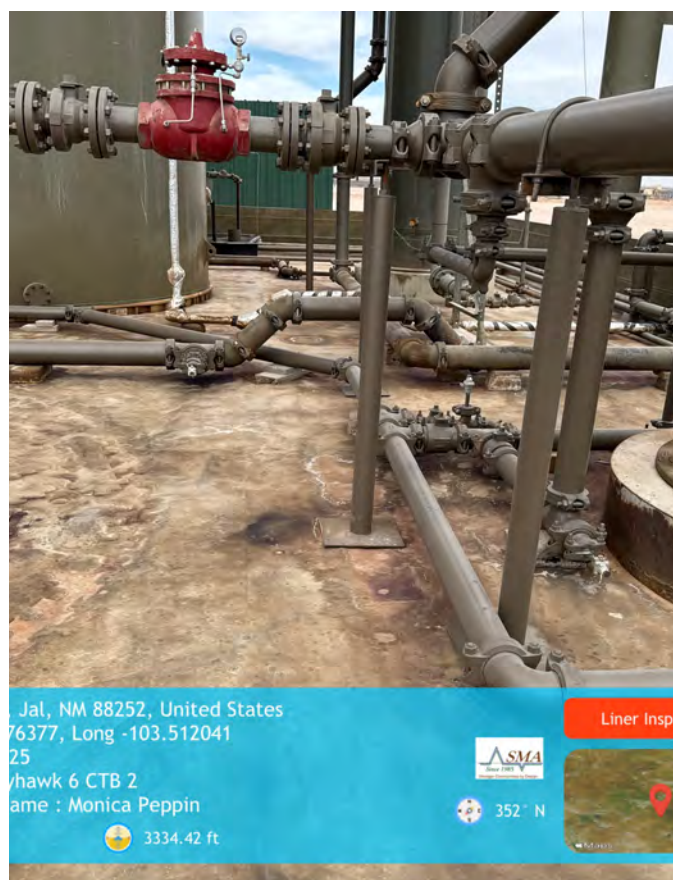
Photograph #6: Looking north viewing east side of containment.

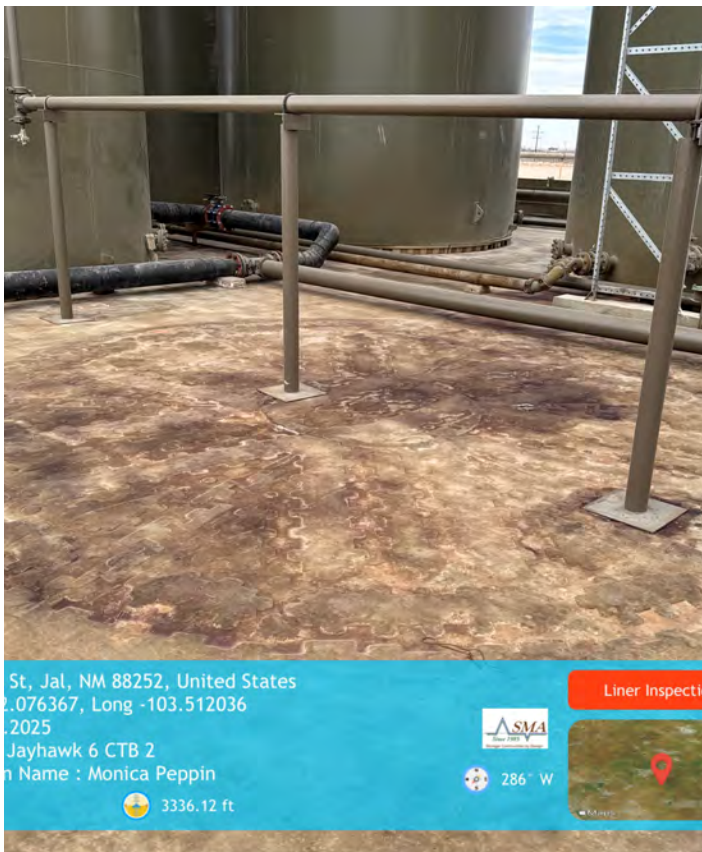
Photograph #7: Facing west from northeast corner.

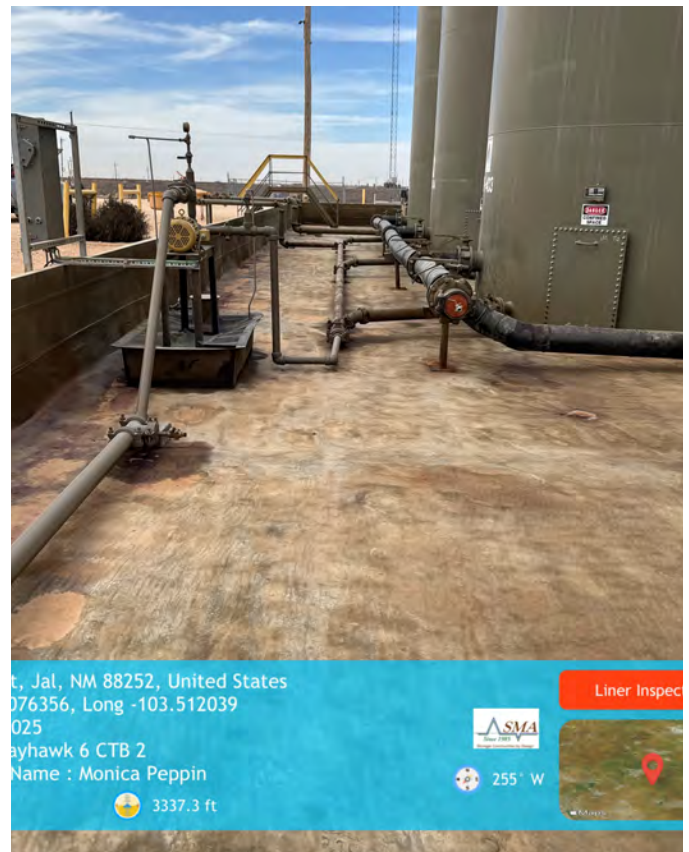
Photograph #8: Facing west viewing south wall of containment.

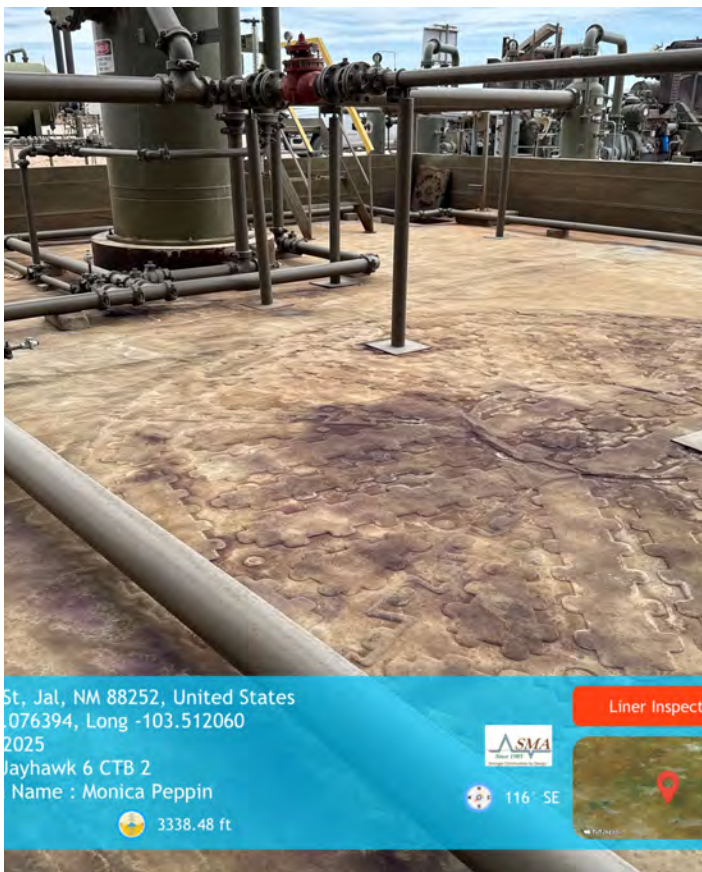
Photograph #9: Southeast corner view from east end standing near tanks.

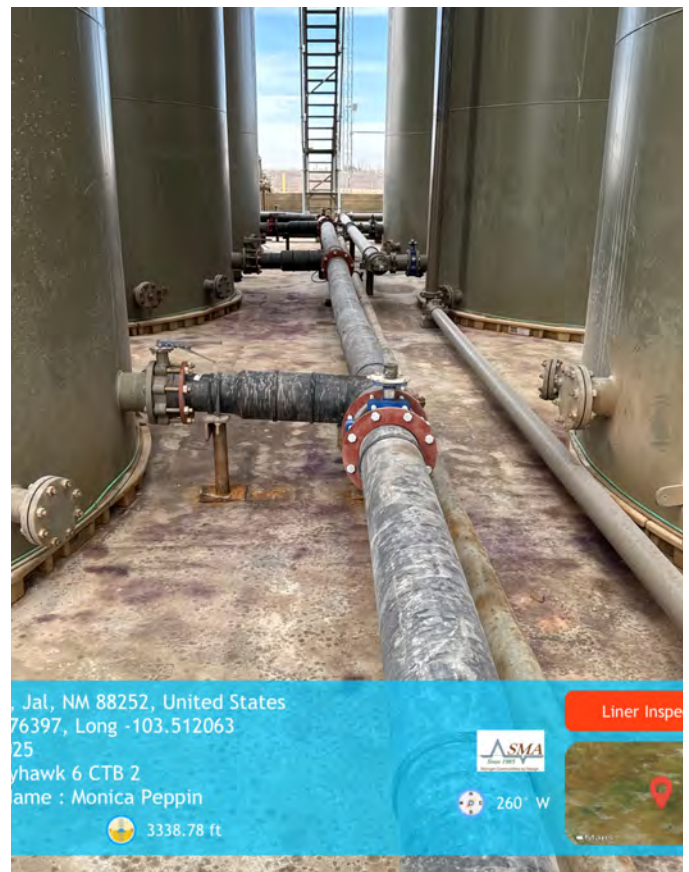
Photograph #10: Facing west viewing between tanks from east end.

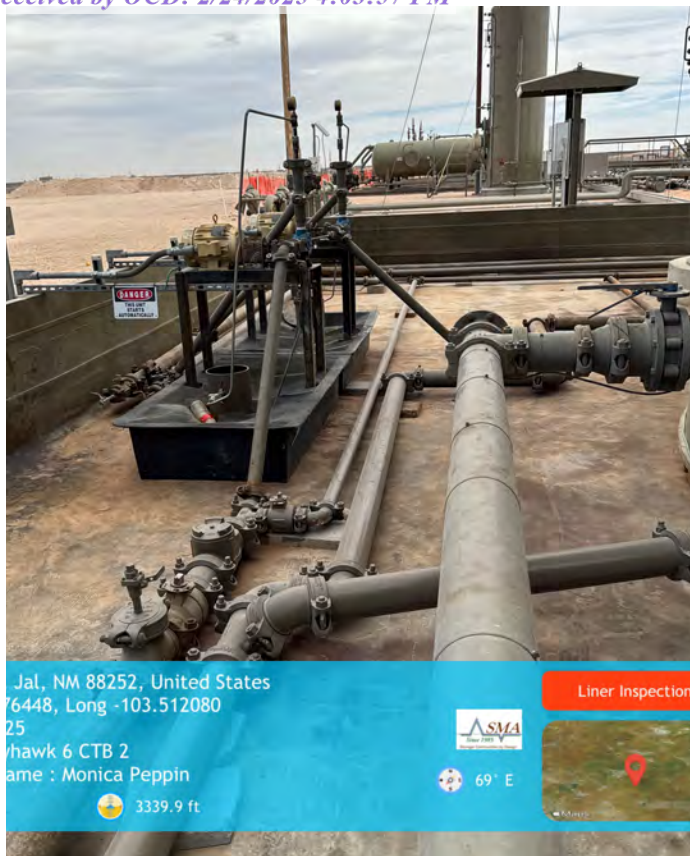
Photograph #11: Northeast corner standing near tanks on north wall.

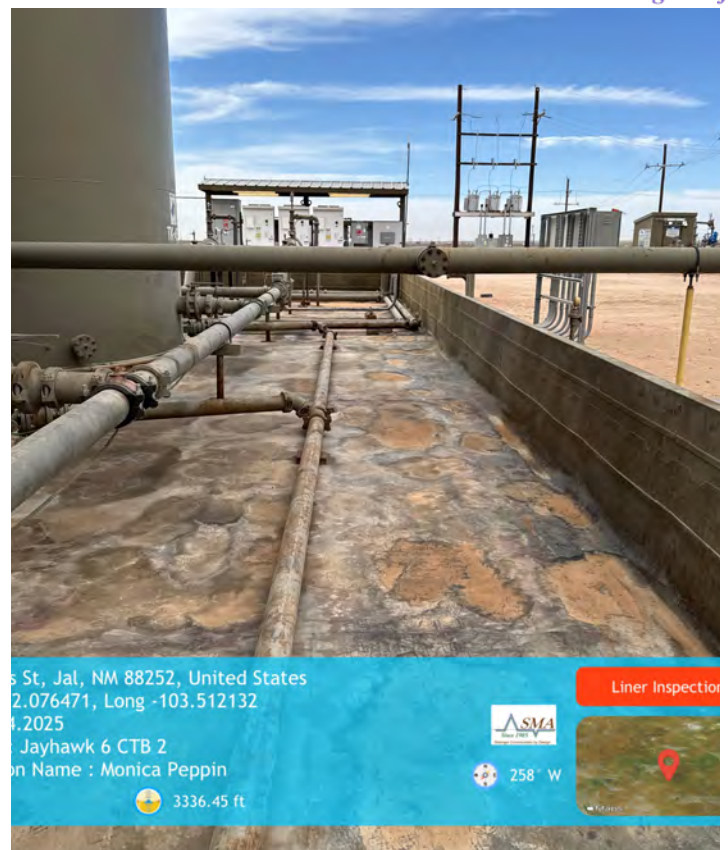
Photograph #12: Viewing north wall from east end facing west.

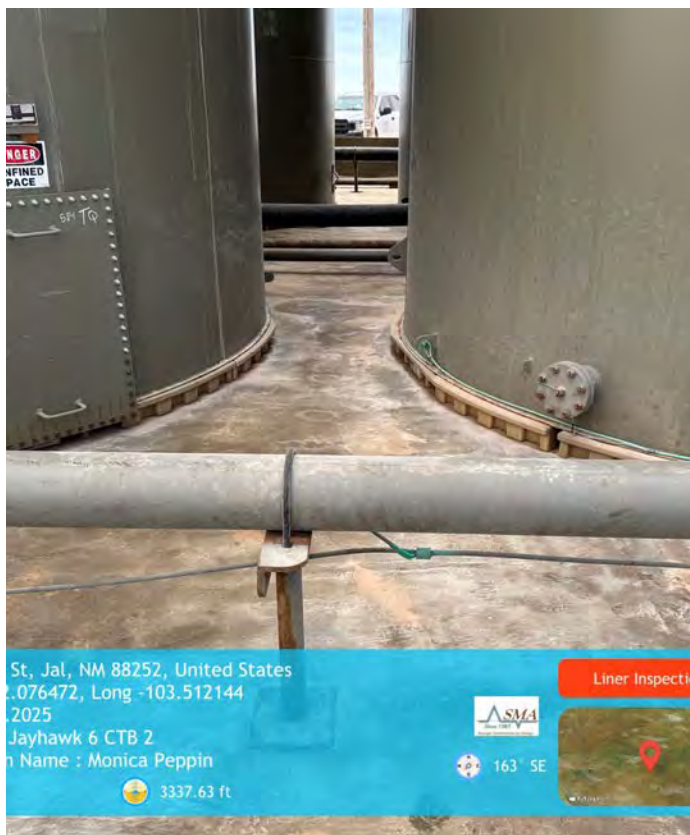
Photograph #13: Liner between tanks facing south from north side.

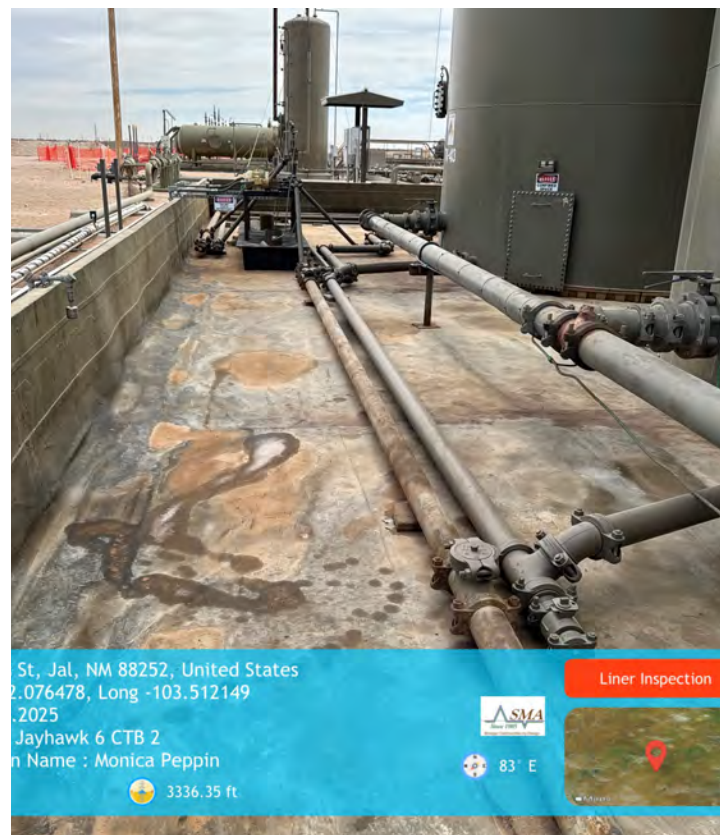
Photograph #14: View of north end of containment from west wall.

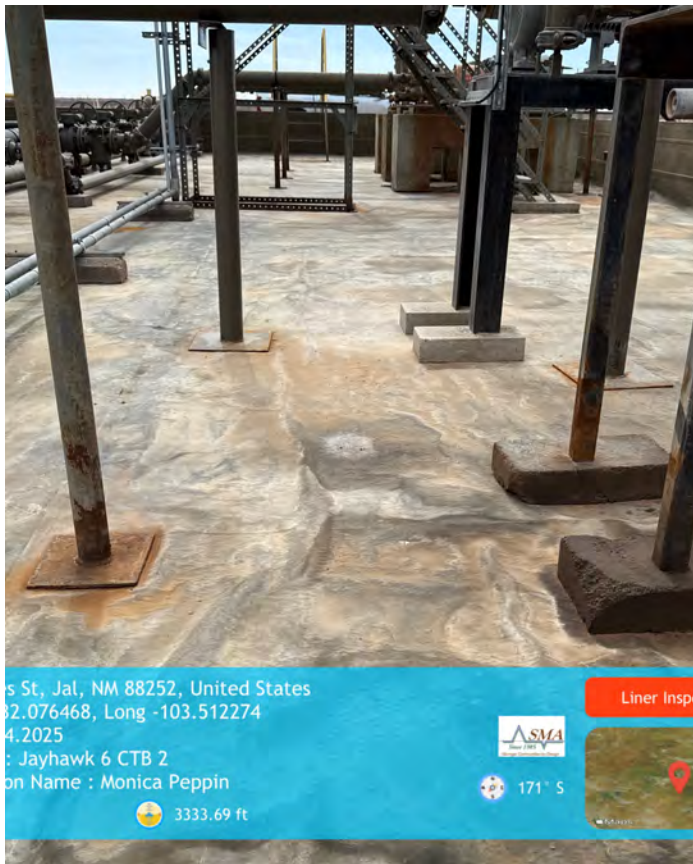
Photograph #15: Looking south viewing east end of containment under equipment.

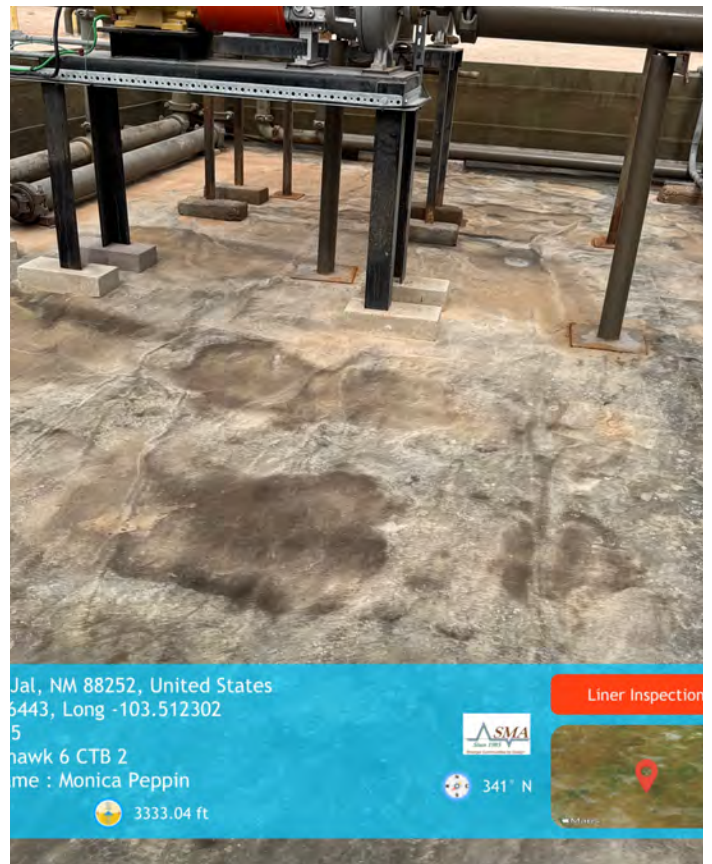
Photograph #16: Facing north viewing west side of containment under equipment.

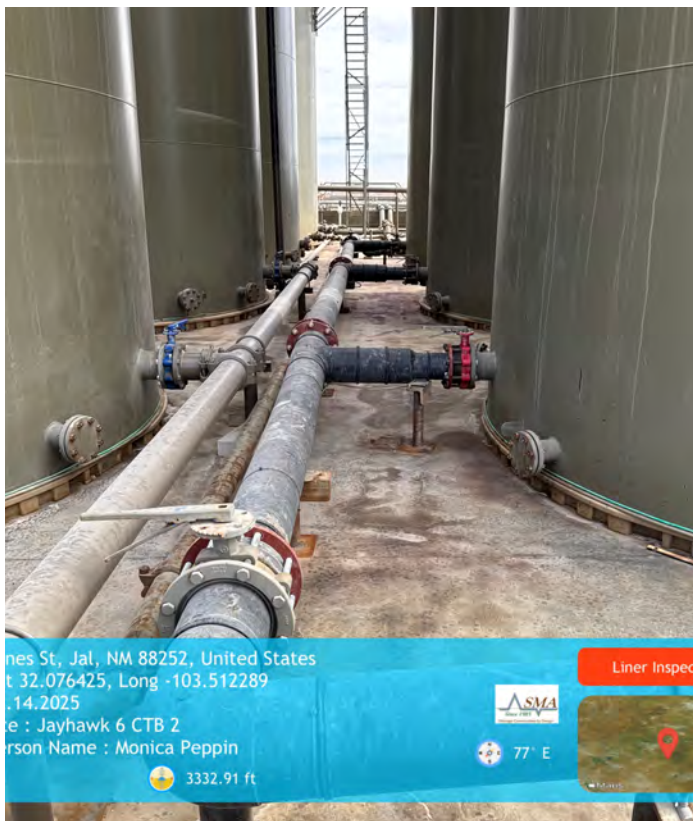
Photograph #17: Liner between tanks from west side looking east.

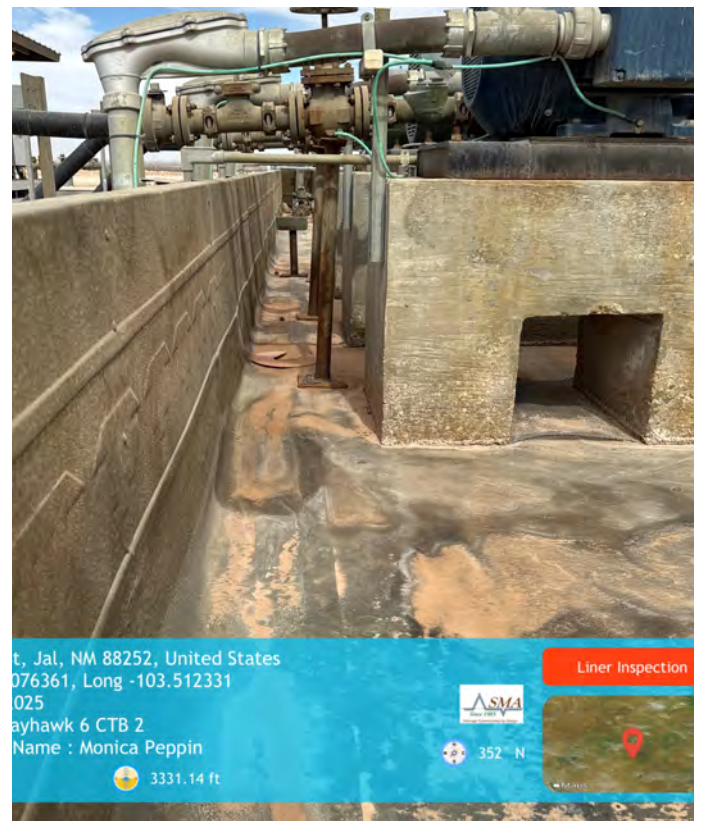
Photograph #18: Liner between east wall and transfer pumps.

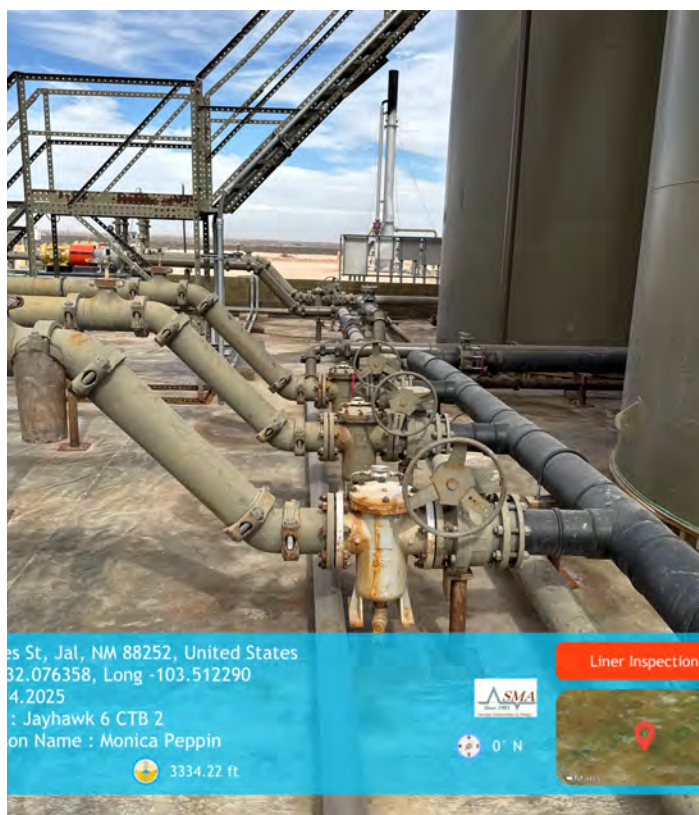
Photograph #19: West side of containment looking north.

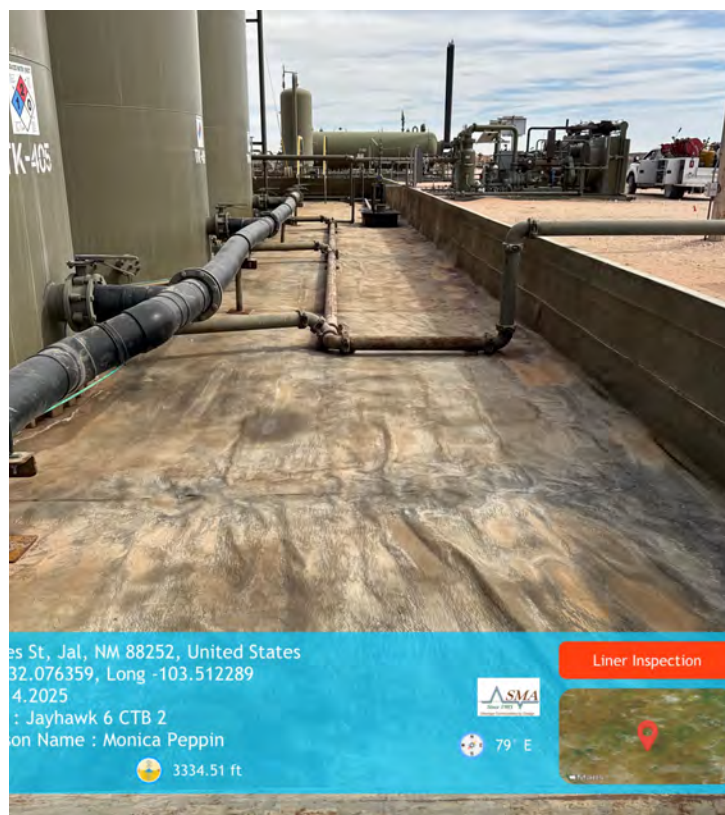
Photograph #20: Liner on north side of tanks
