February 13, 2025;
rev. March 11, 2025

5E33088 BG#14

SUBJECT: Closure Request Report for the Lusitano 27 CTB 3, Incident ID # nAPP2433728357, Facility ID fAPP2122855364, Eddy County, New Mexico.

Site Assessment Photolog

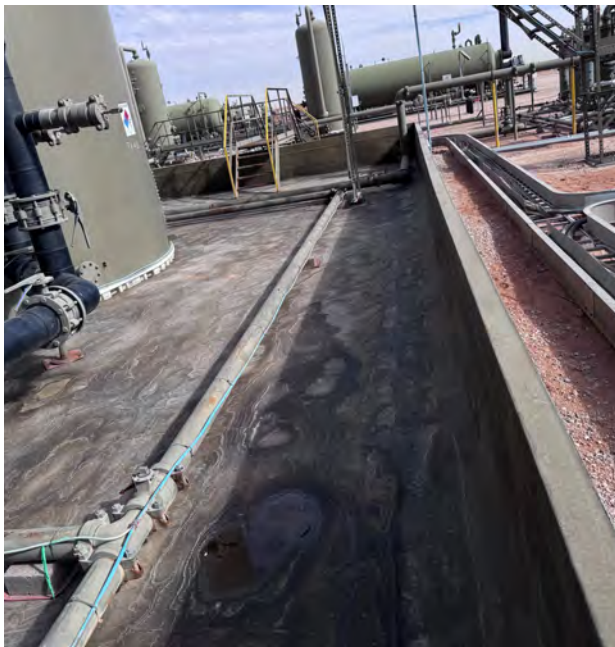
Photograph #1: Viewing east wall from south end of containment.

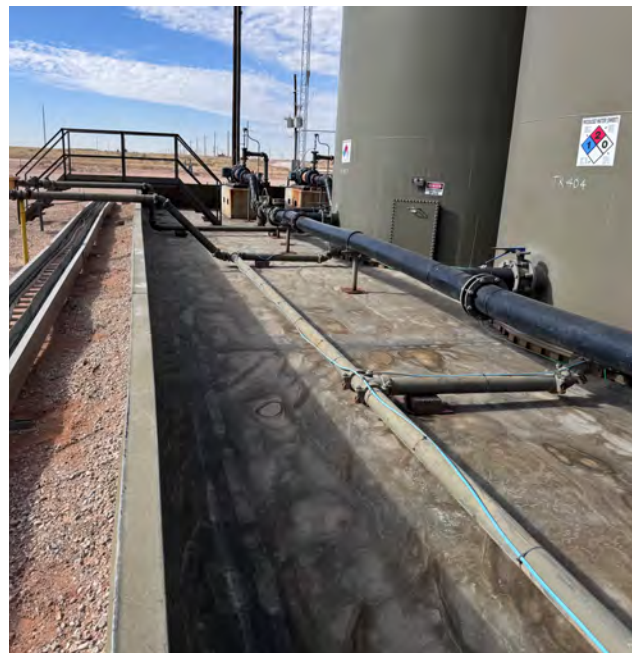
Photograph #2: South side of containment looking west.

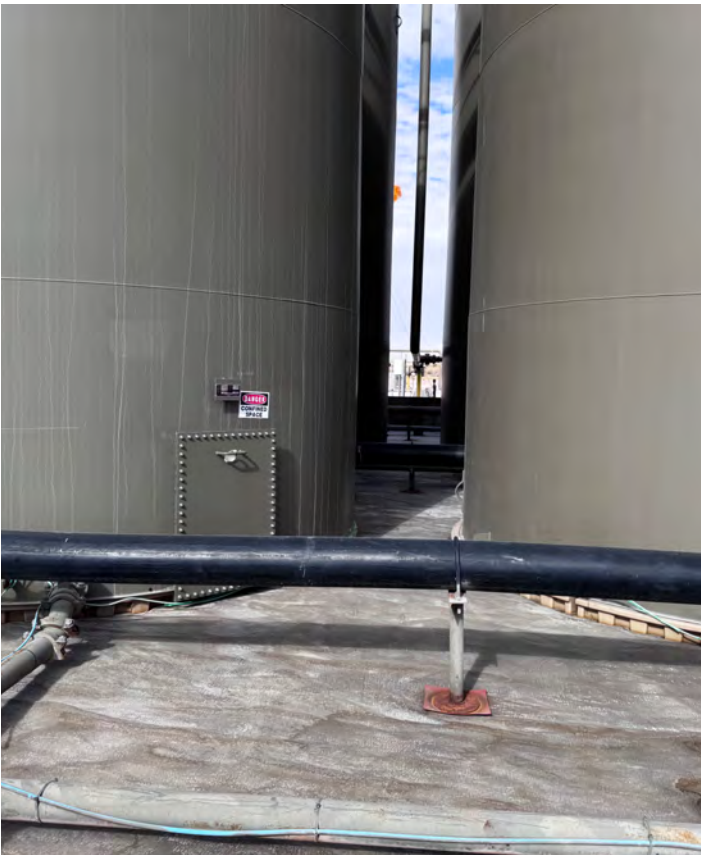
Photograph #3: Liner between tanks viewing north from east middle area.

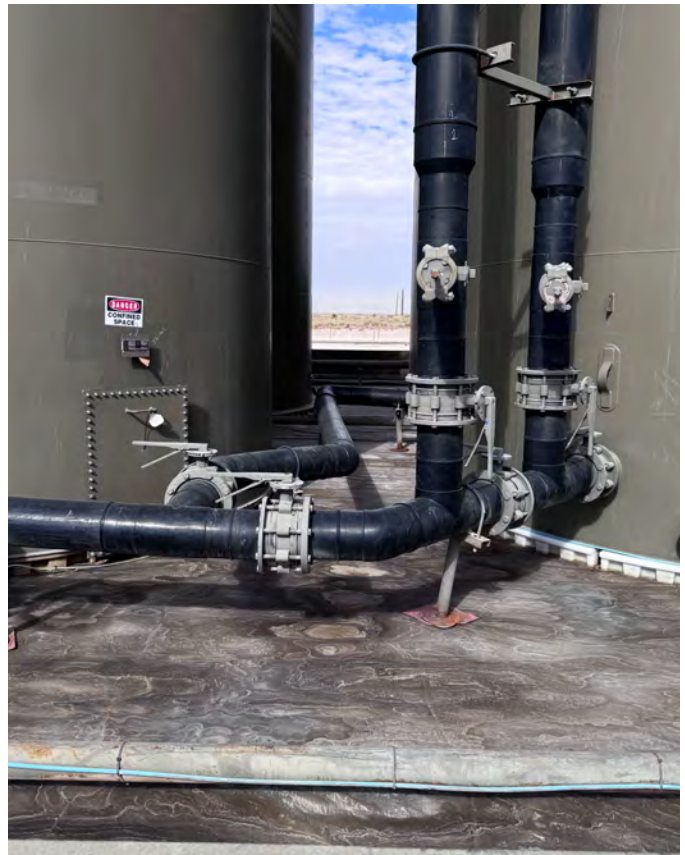
Photograph #4: Liner between tanks viewing north on east end.

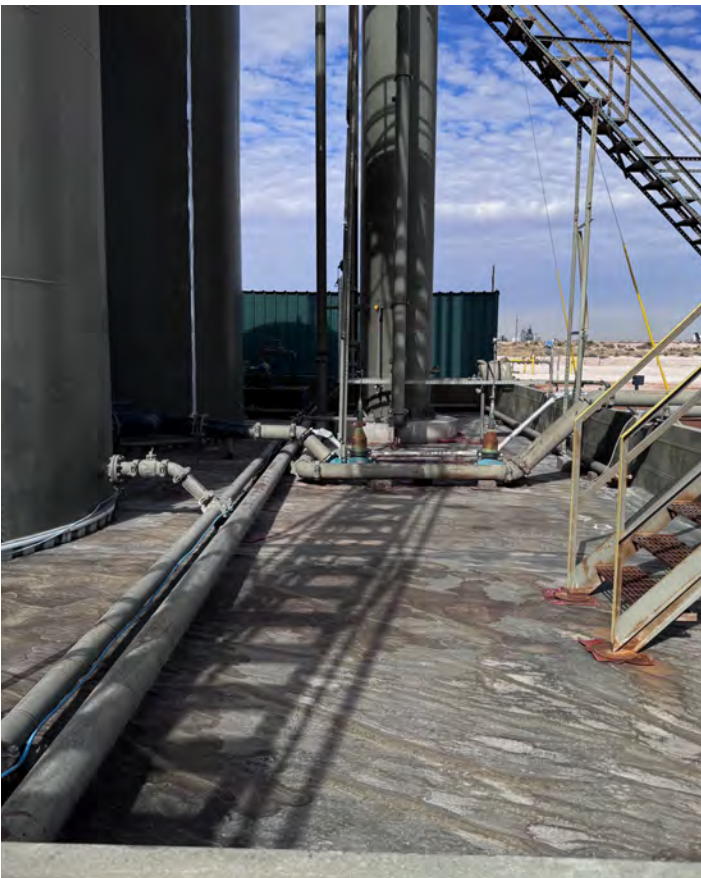
Photograph #5: Facing north showing east side of containment.

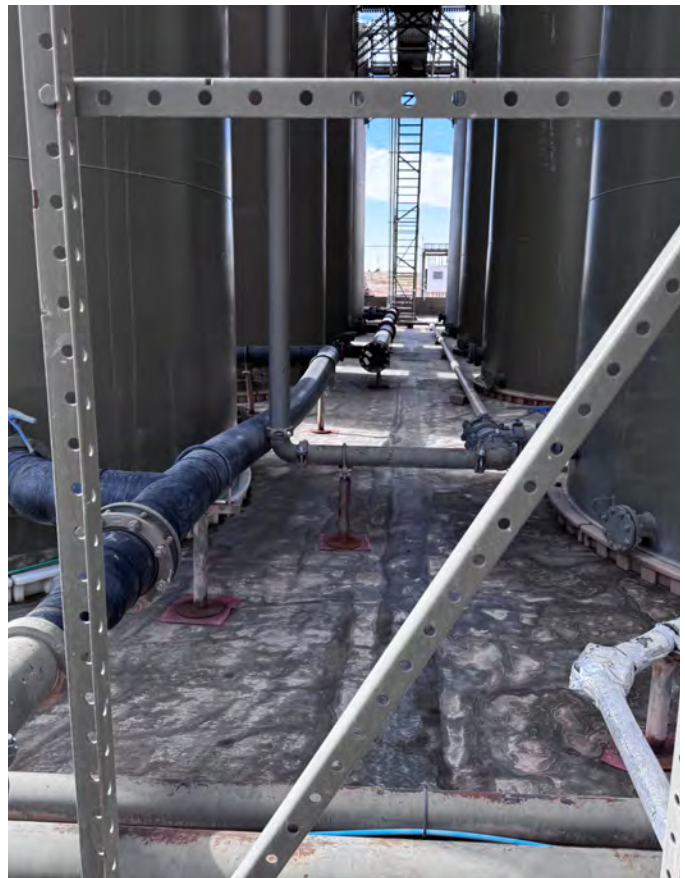
Photograph #6: Viewing liner between tanks from east end looking west.

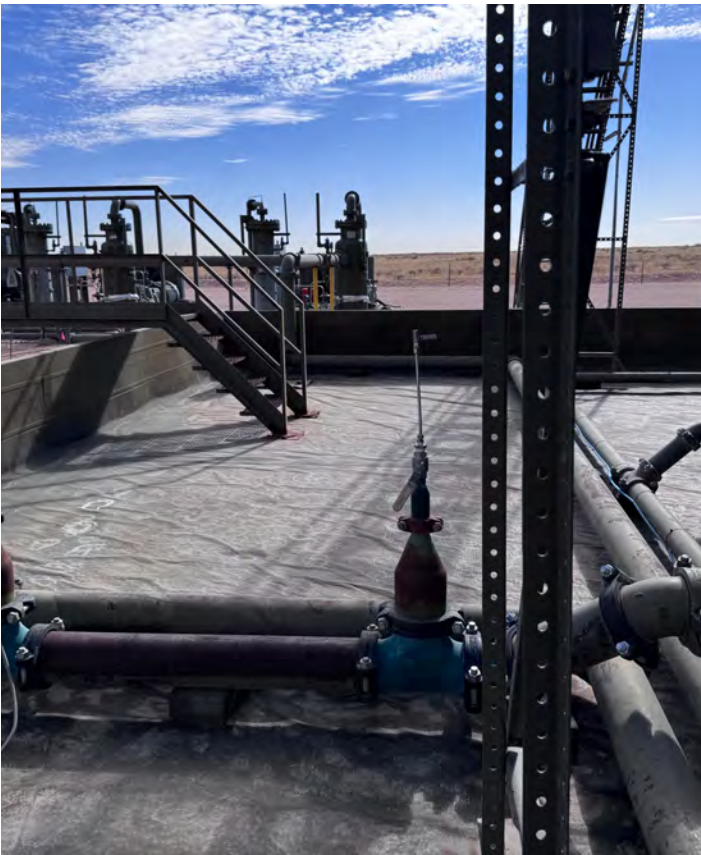
Photograph #7: Facing south from southeast corner.

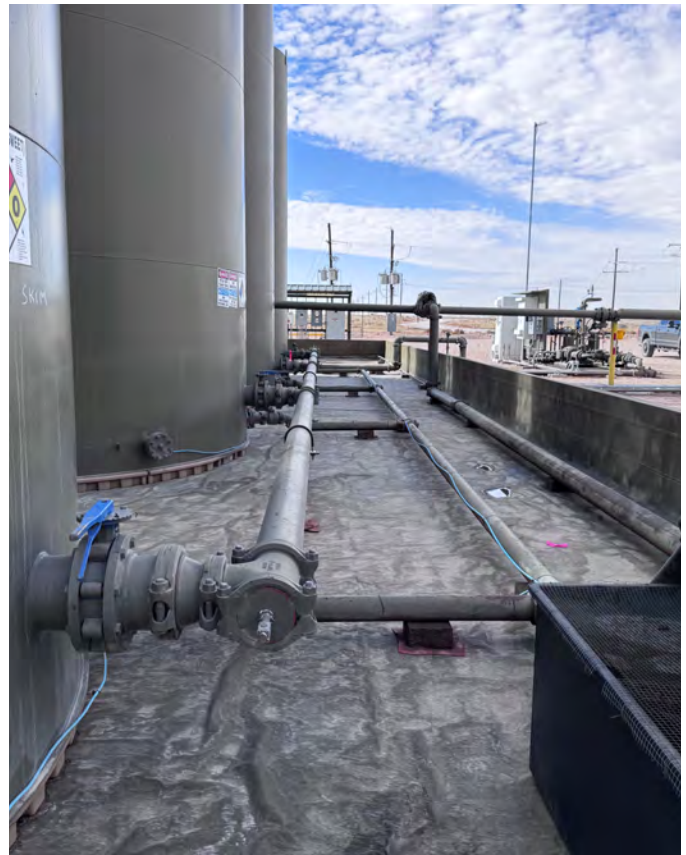
Photograph #8: Facing west on north side.

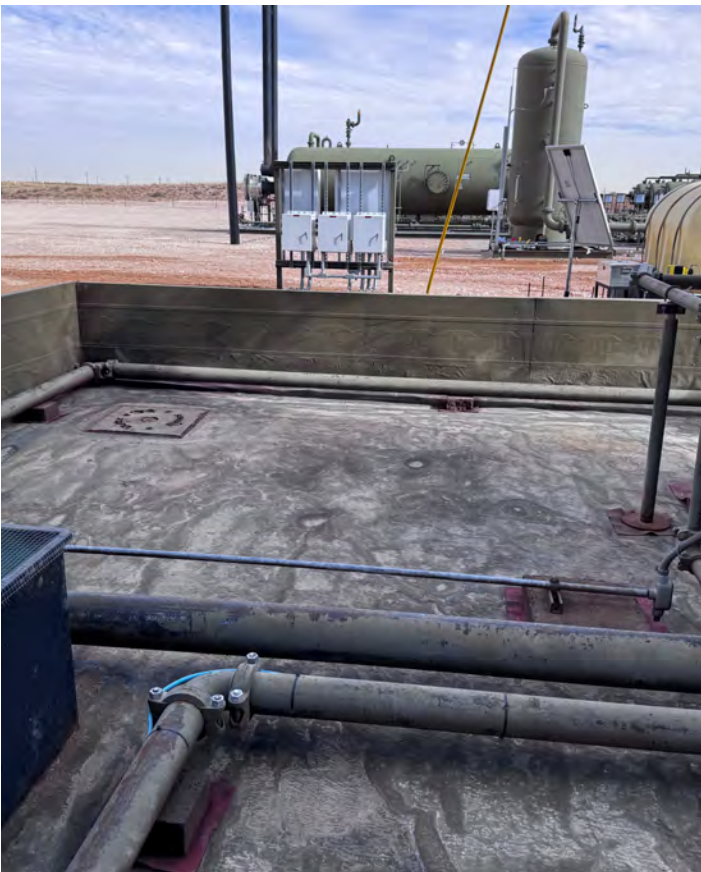
Photograph #9: Northwest corner of containment looking east.

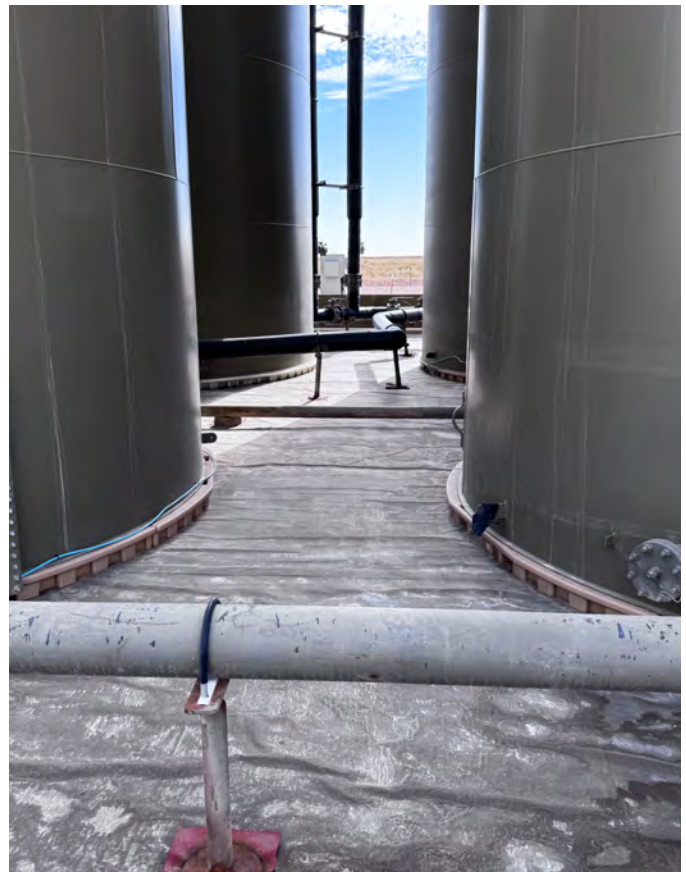
Photograph #10: Liner between tanks from south side.

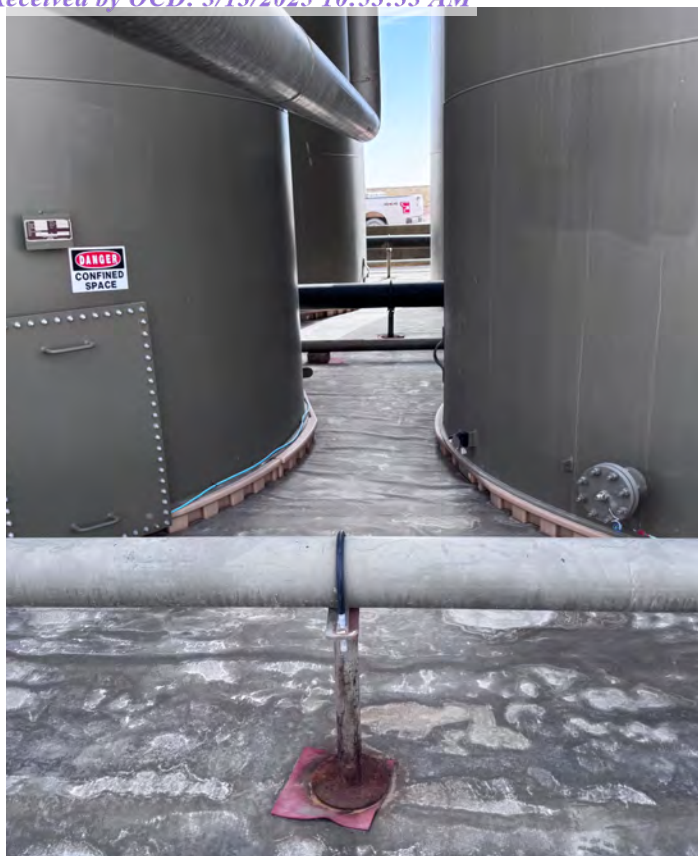
Photograph #11: Viewing liner between tanks facing south.

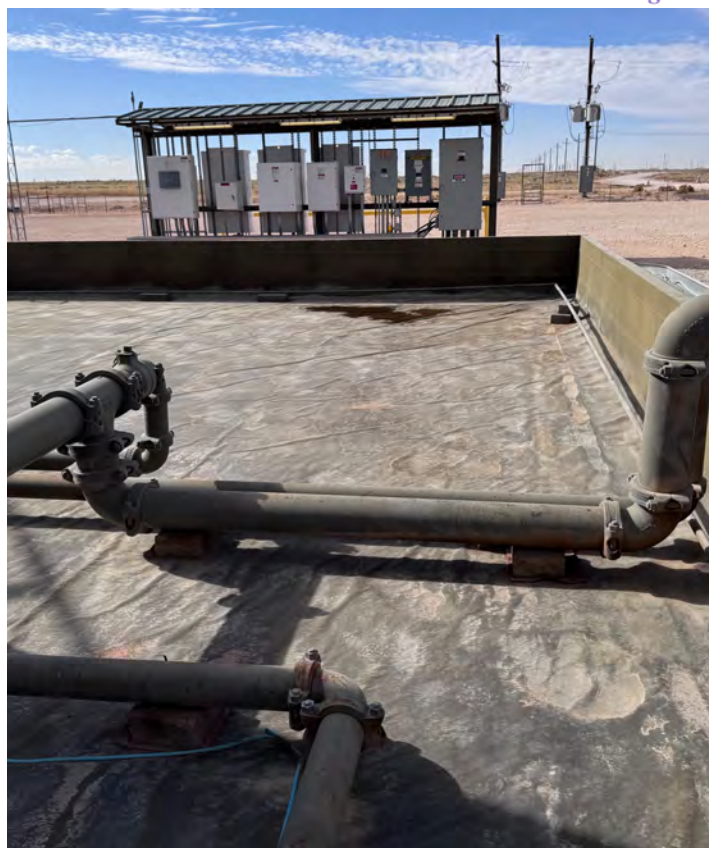
Photograph #12: Facing west viewing northwest corner.

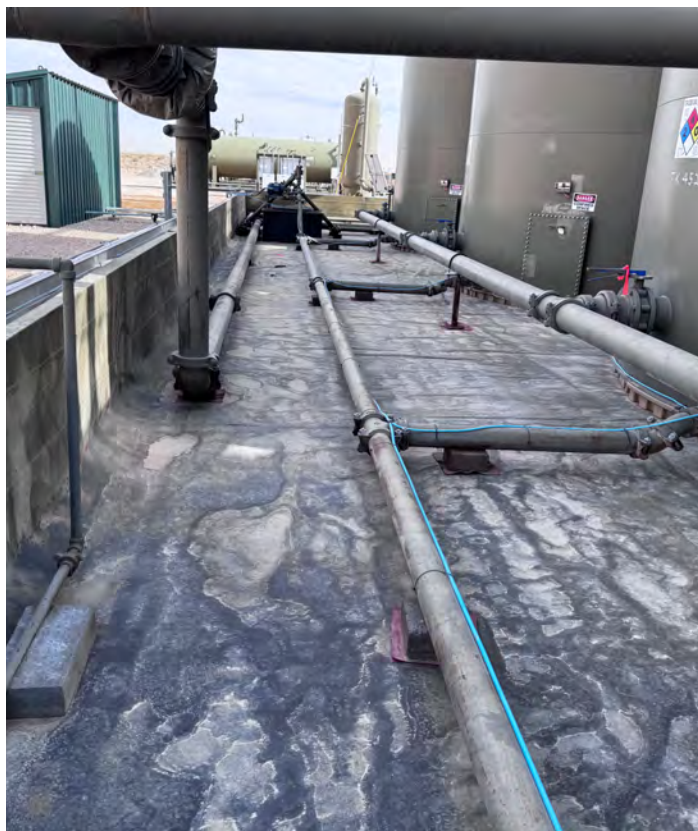
Photograph #13: Facing east showing north wall area.

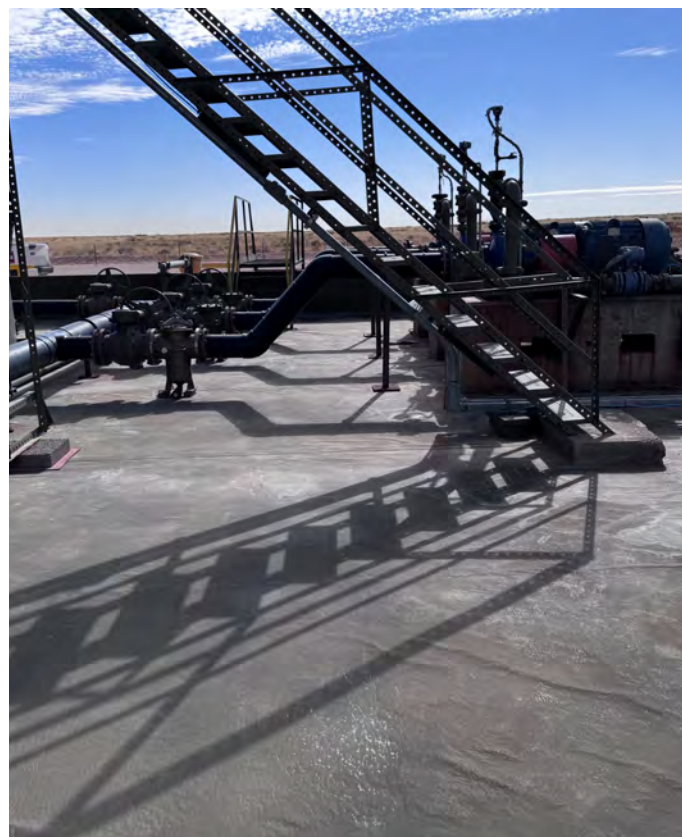
Photograph #14: Facing south showing liner under equipment on west side.

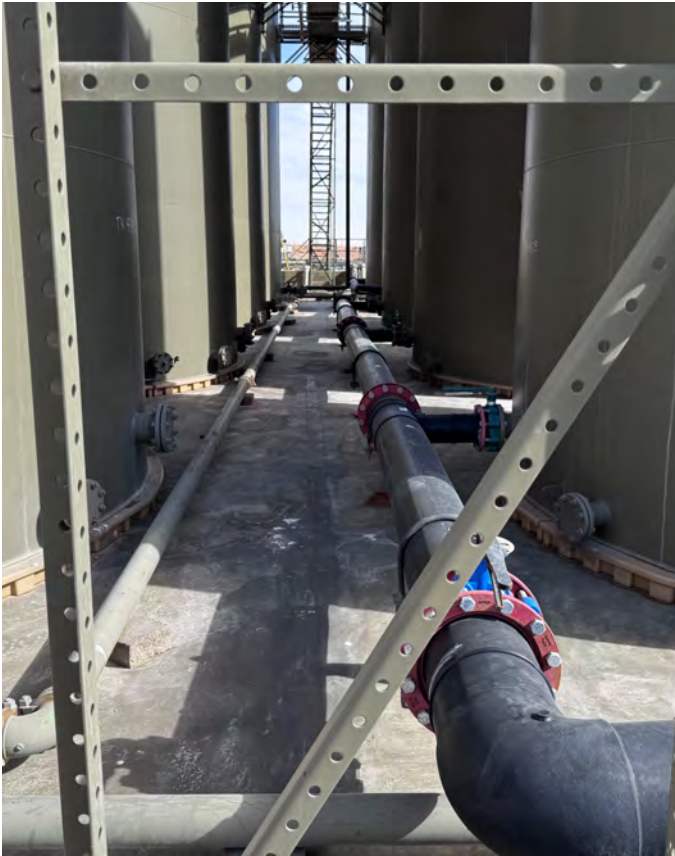
Photograph #15: Liner between tanks looking west from east side.

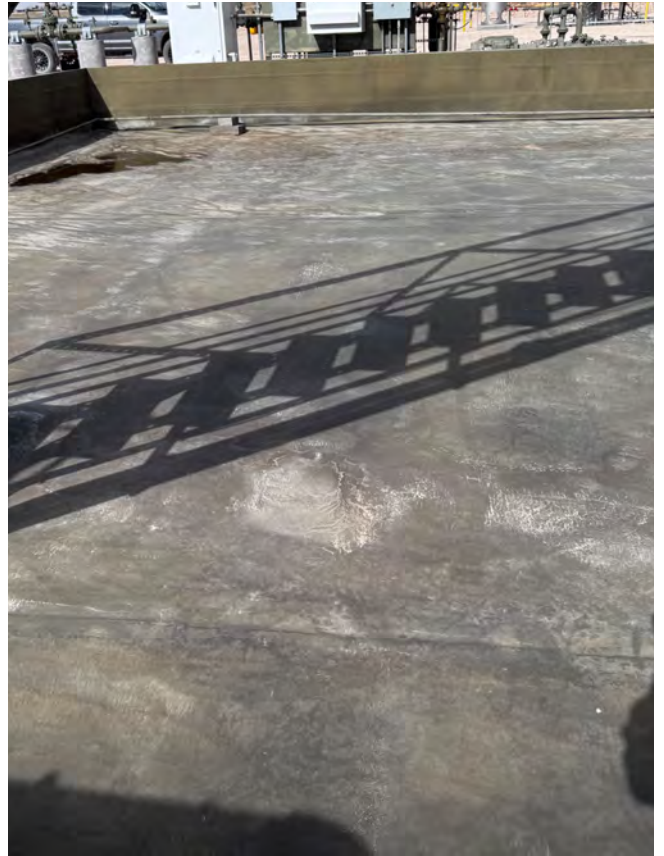
Photograph #16: Facing north viewing northwest corner.

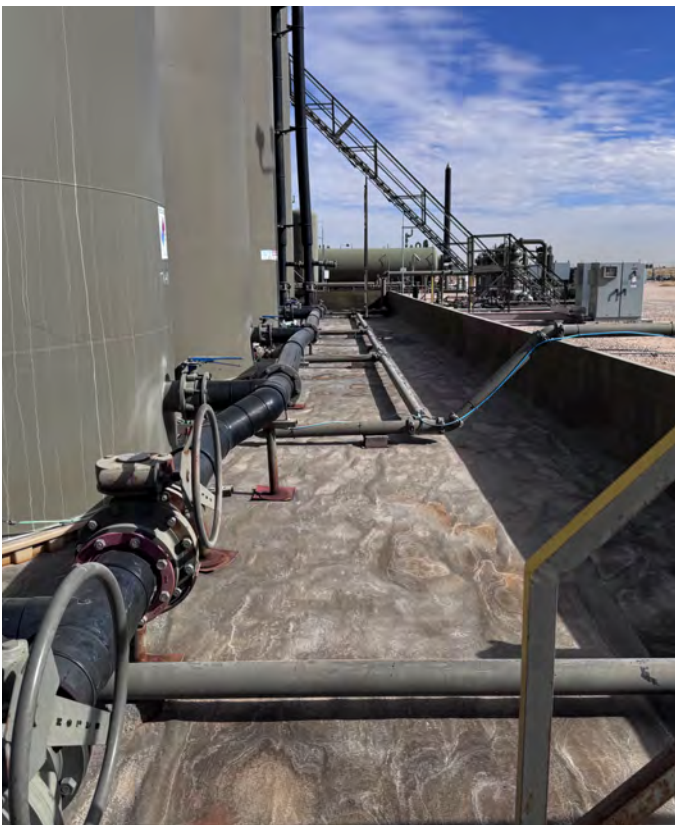
Photograph #17: Facing east viewing south end of containment.

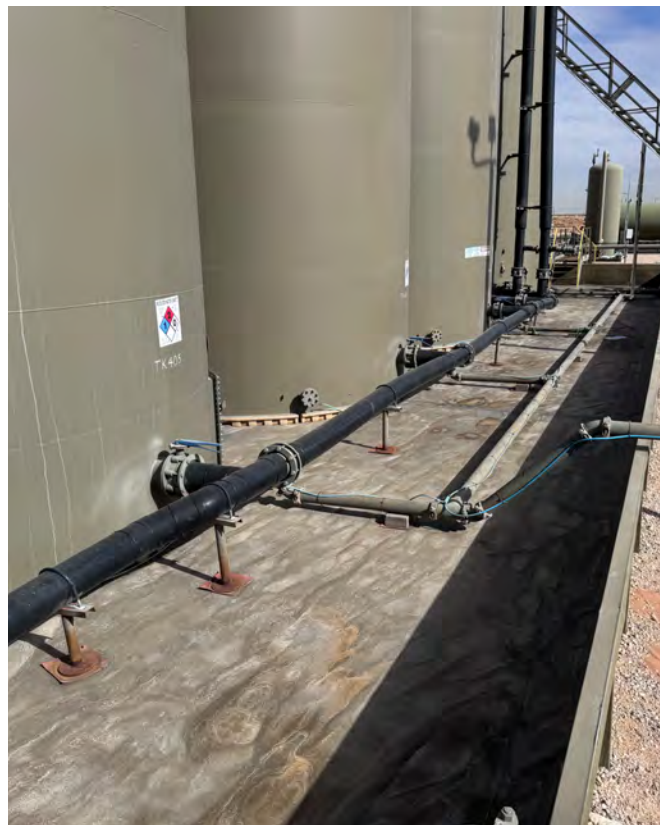
Photograph #18: View of liner from steps facing northeast.

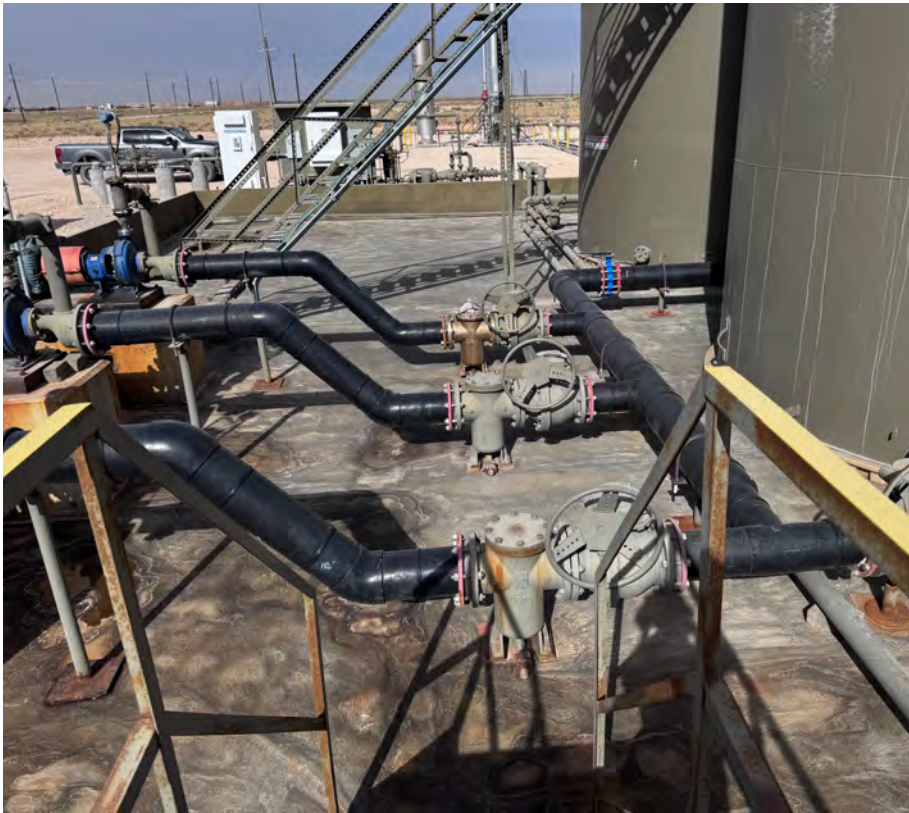
Photograph #19: West end of containment facing north.
