## LINER INSPECTION

Facility/Well Name: HAYHURST NM SECTION 26 DIGNITAS SWD

Inspection Date: 2-21-25 @08:00

Incident Number: NAPP2435175937

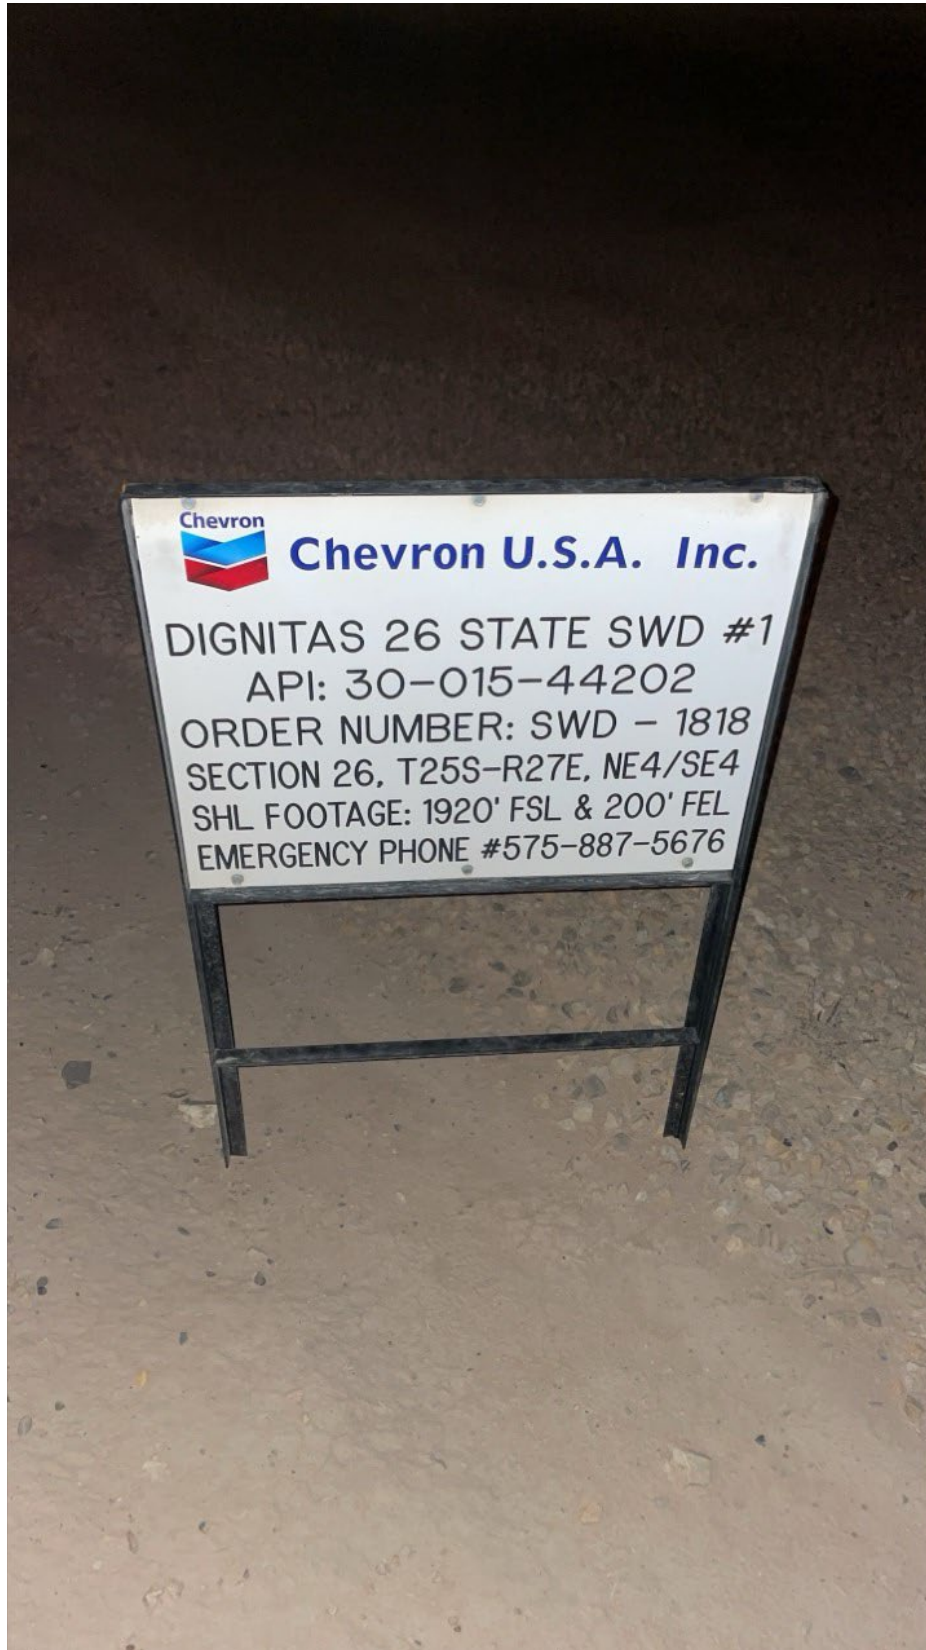
Sign:

Picture of the well location sign (name, location, emergency contact, etc..) included: Yes

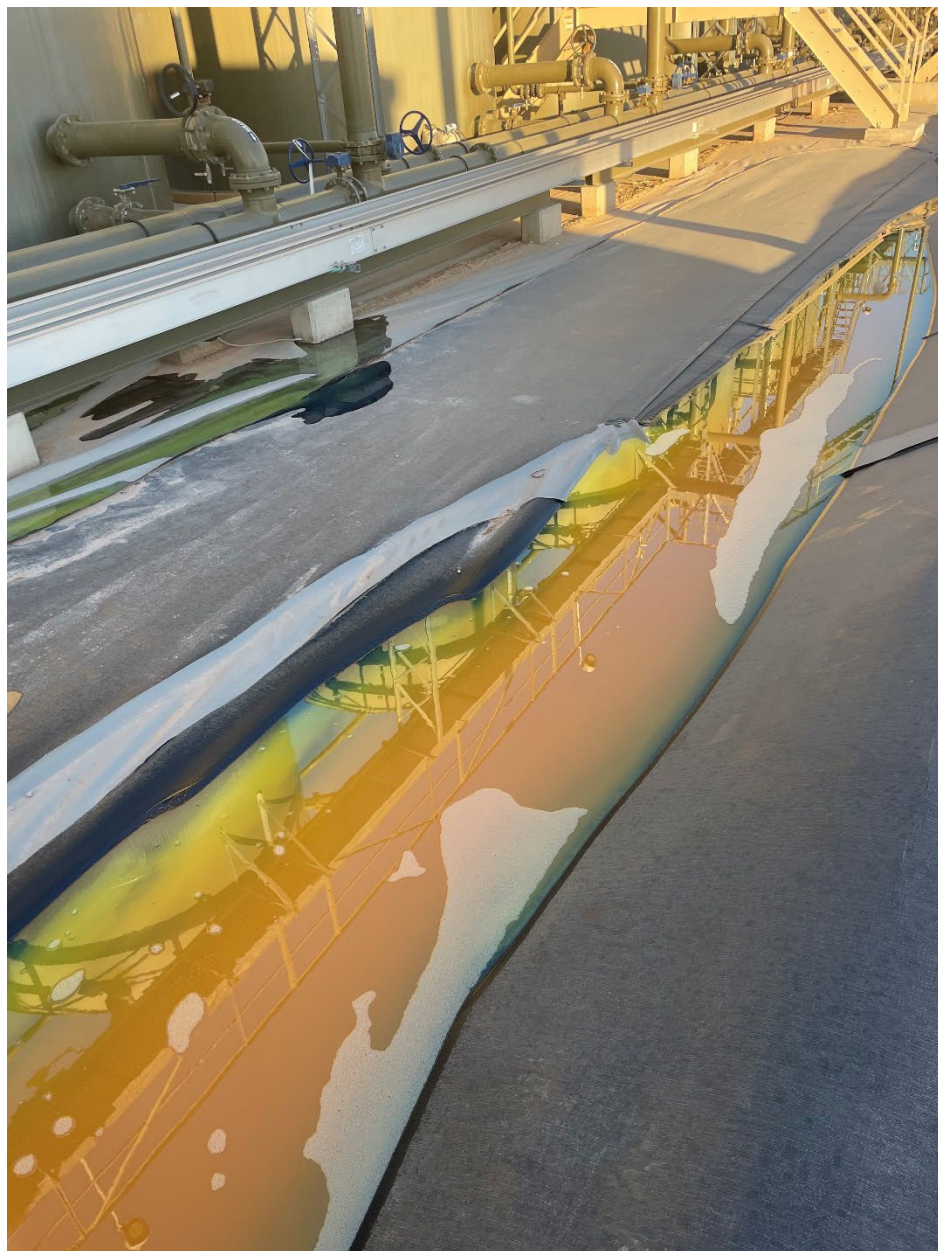
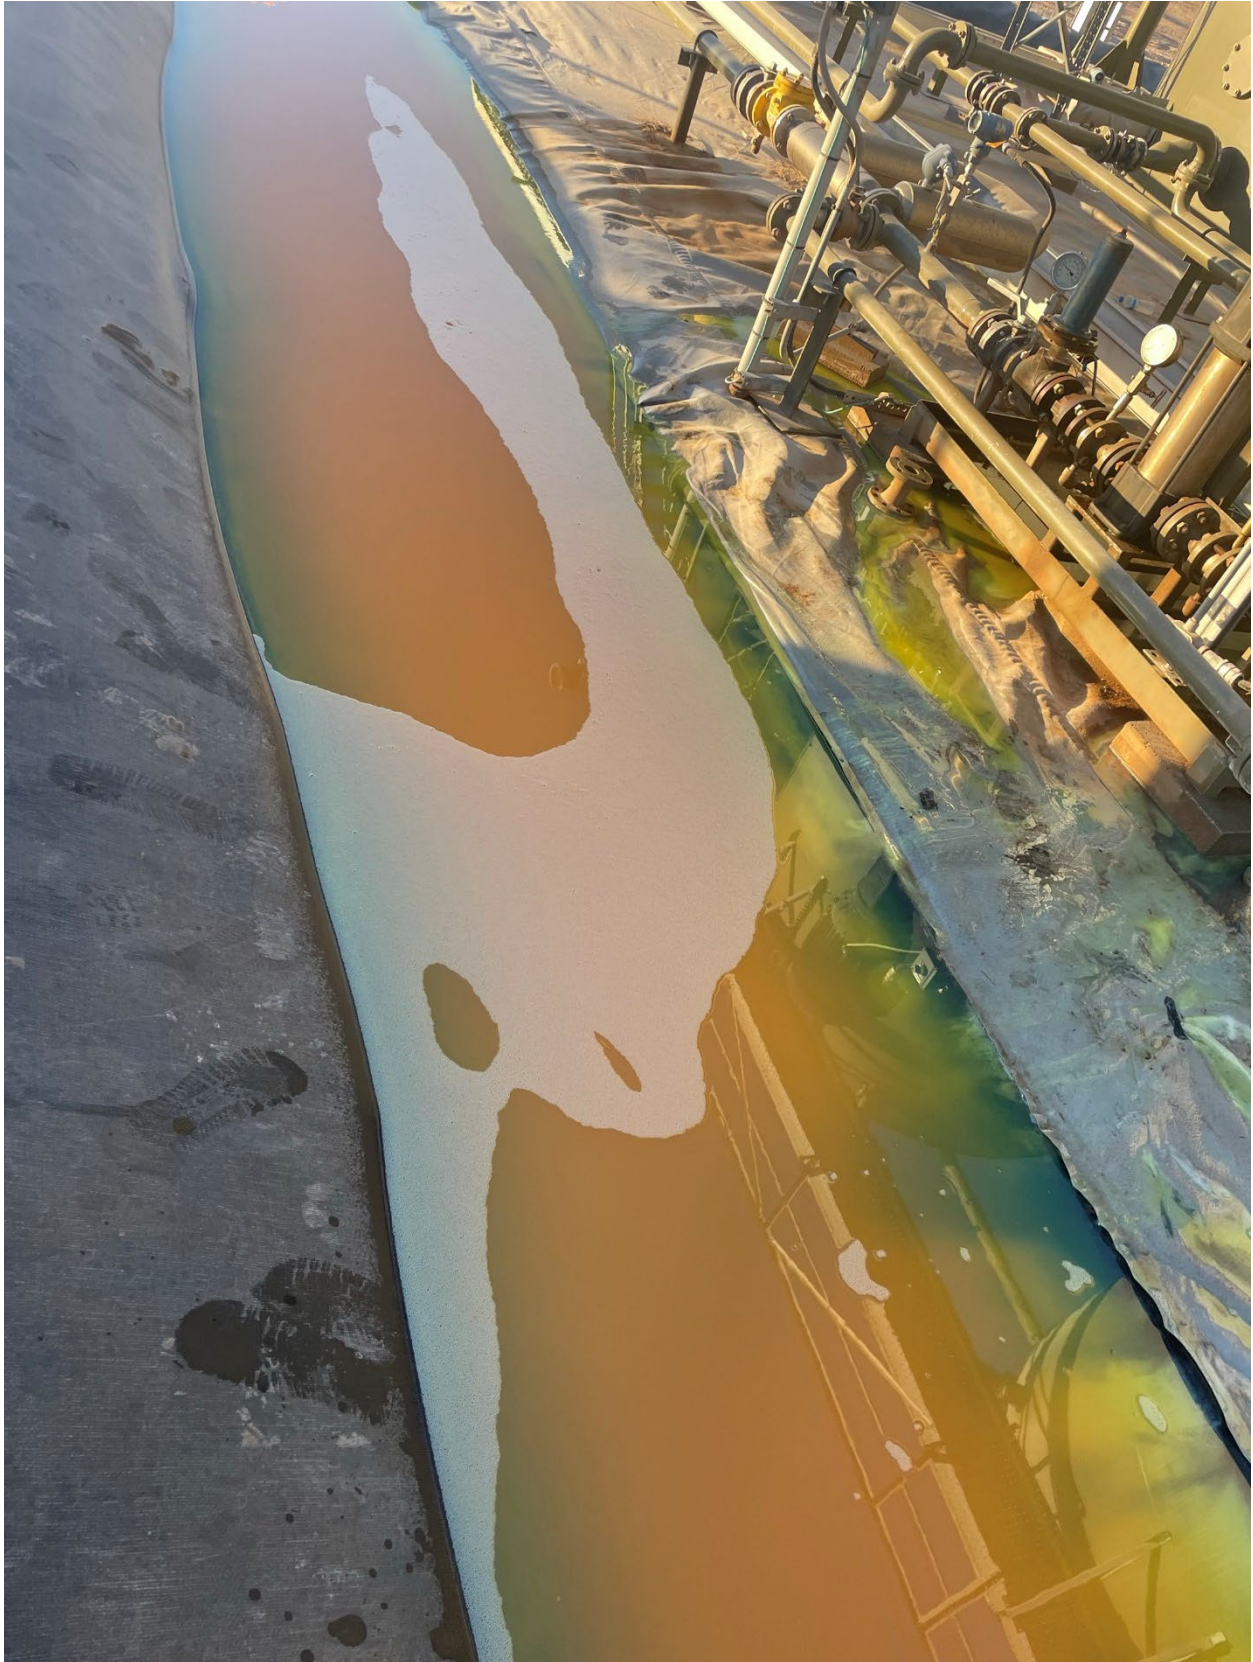
Before:

Gravel was removed: Yes

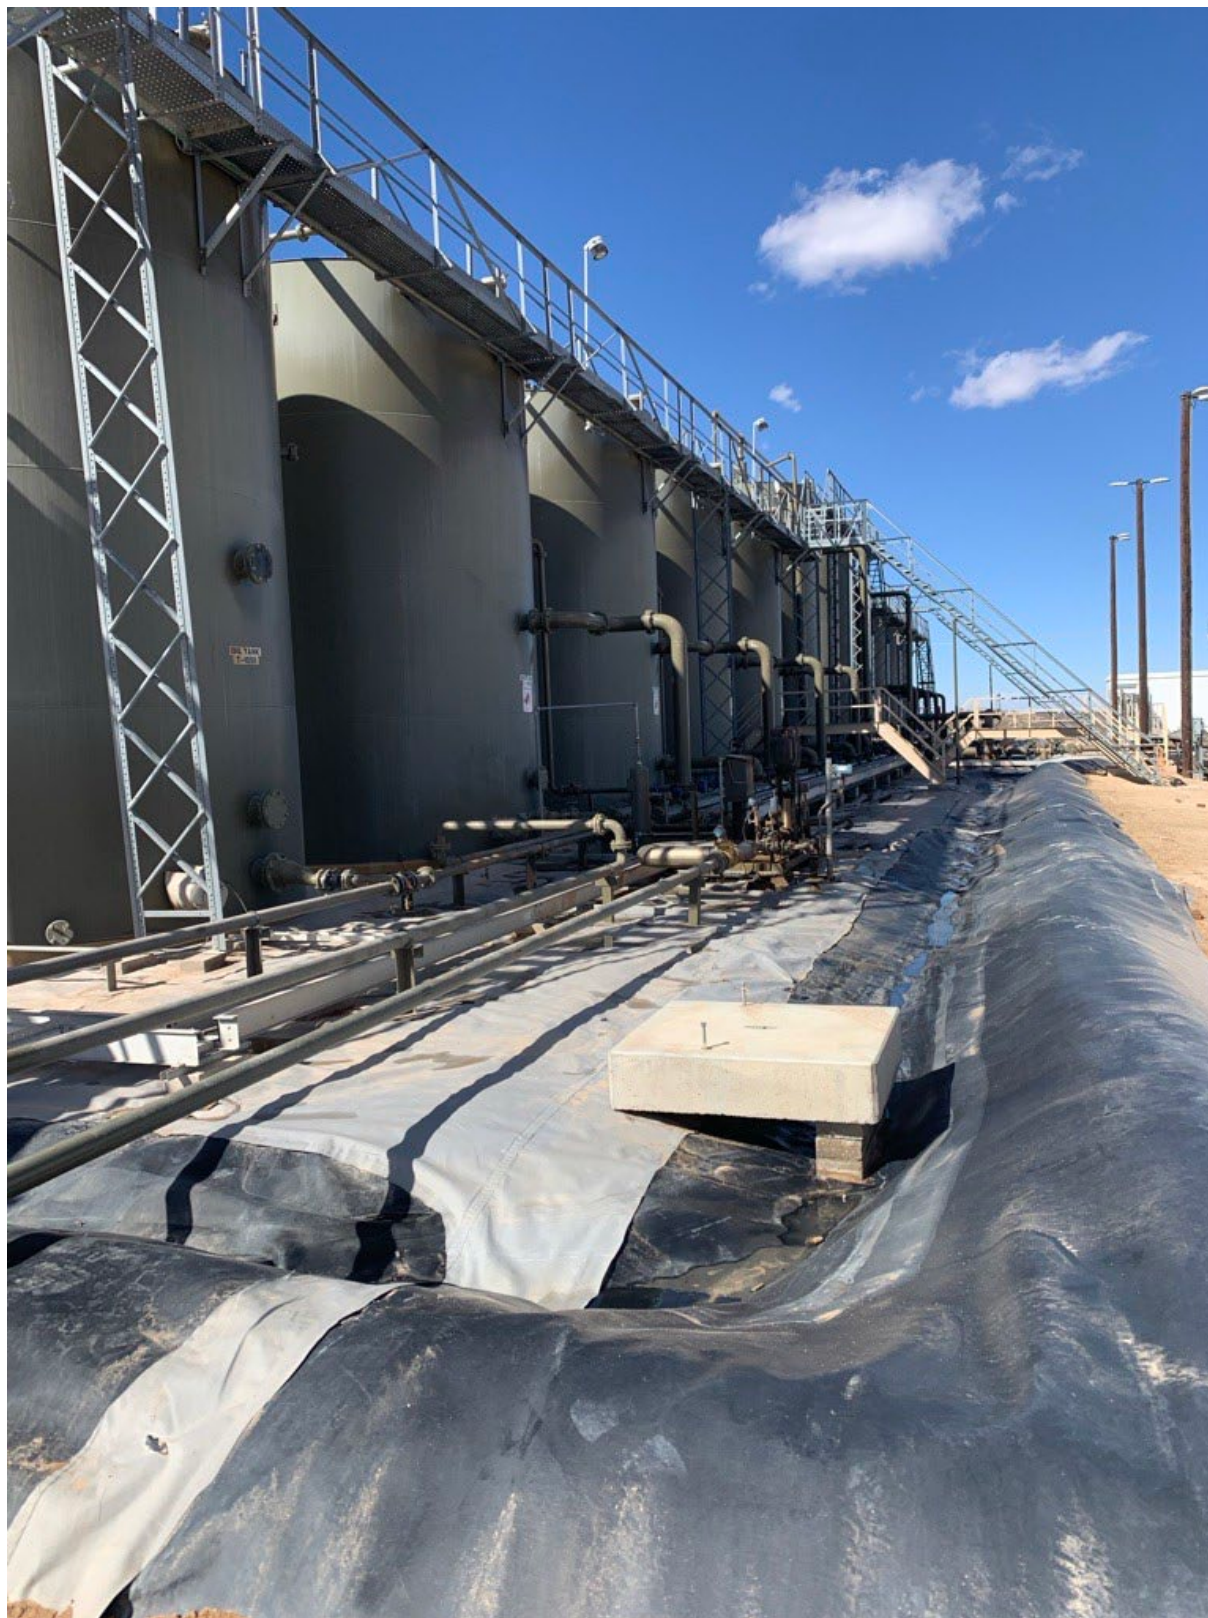
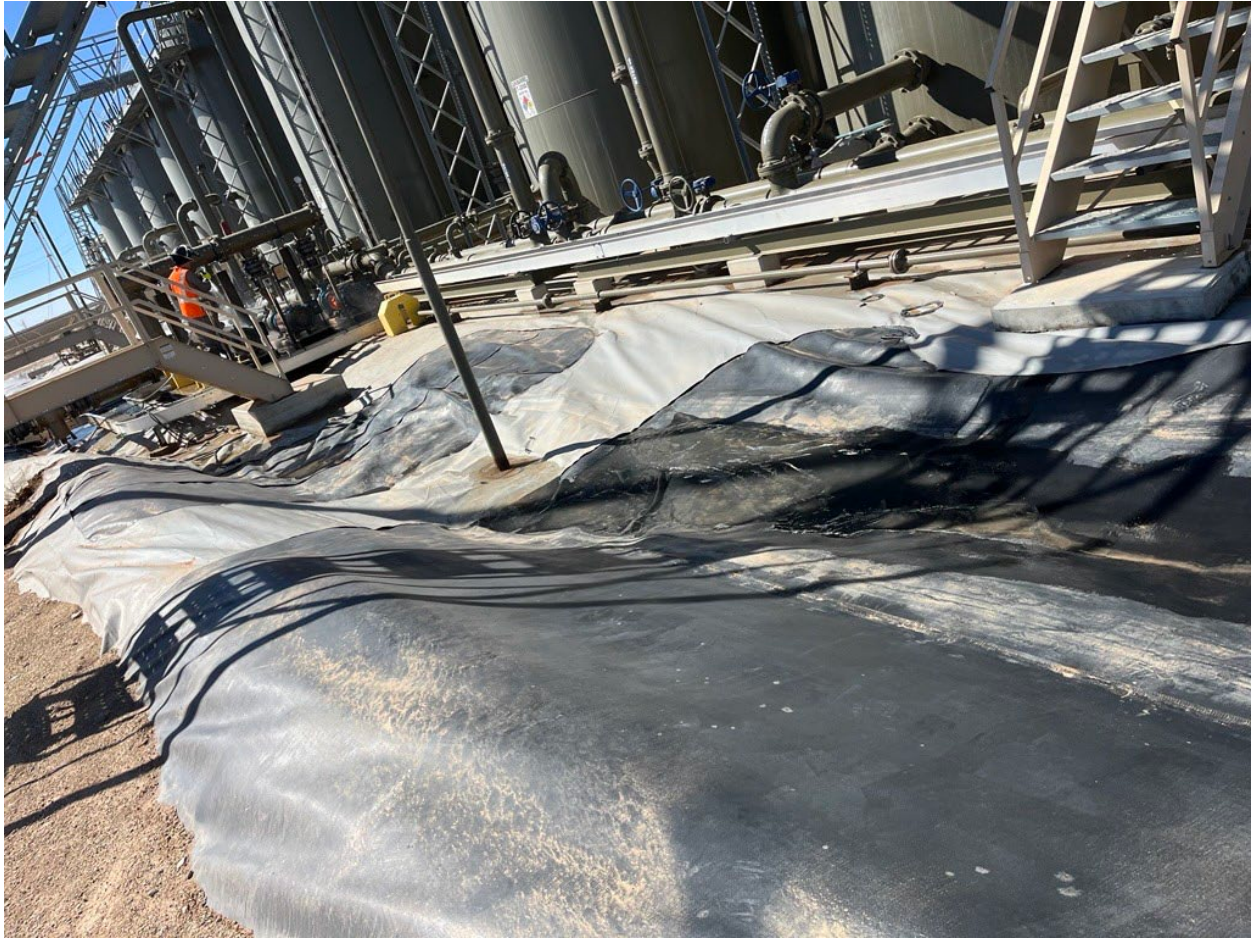
After:

Liner was able to contain the leak in question (no rips, tears, or holes) and remained intact: Yes

Date stamped photographs of clean intact liner included: Yes
