Our Ref.: 12661700-NMOCD-1

March 14, 2025

Closure Report  
Devon Energy Production Company, LP  
Cobber 21 CTB 2  
Unit Letter C, Section 21, T26S, R34E  
GPS: 32.033133, -103.47621  
Lea County, New Mexico

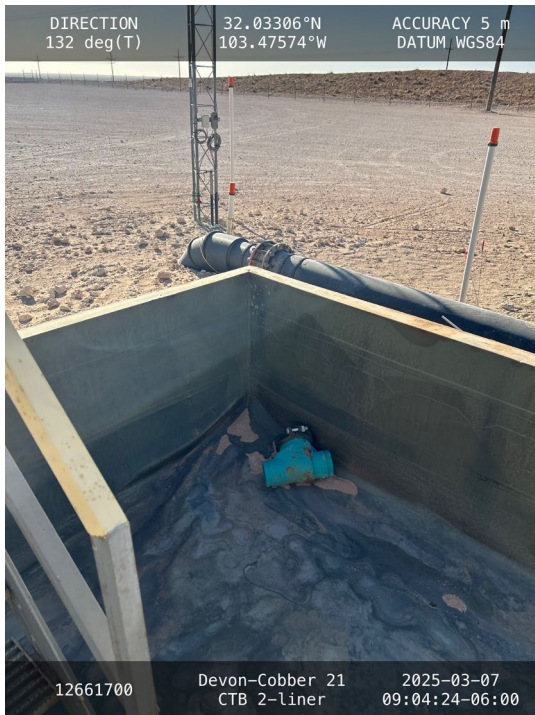
**Photo 1** View of southeastern corner of secondary containment.

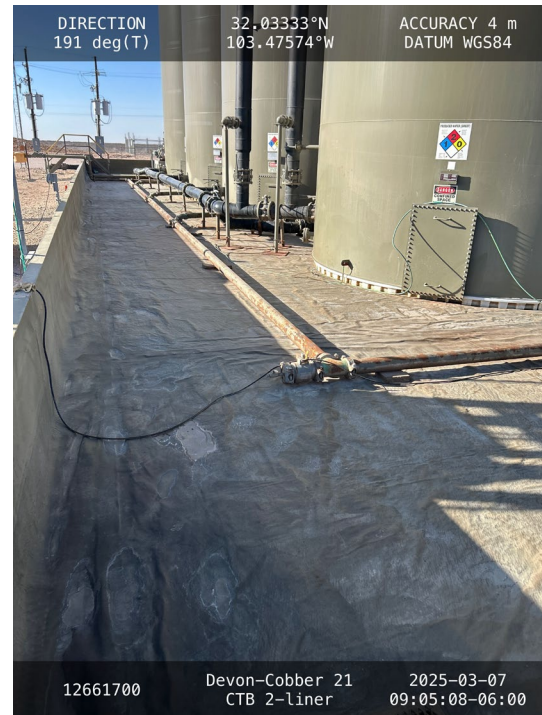
**Photo 2** View of eastern portion of secondary containment towards south.

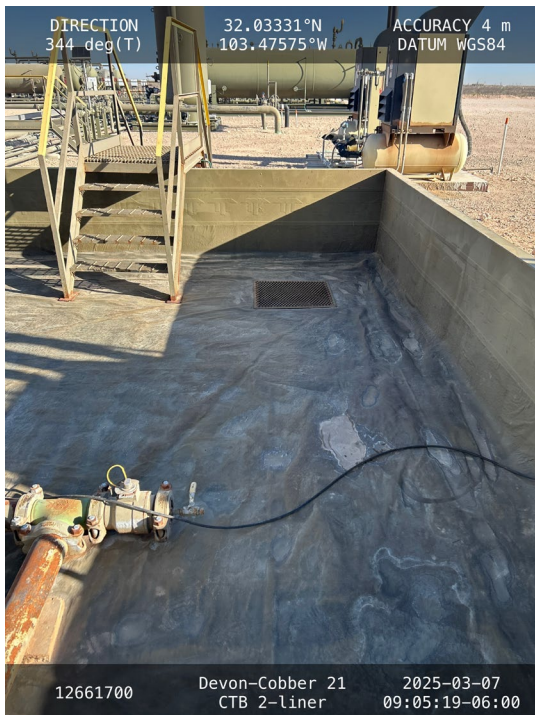
**Photo 3** View of northeastern corner of secondary containment.

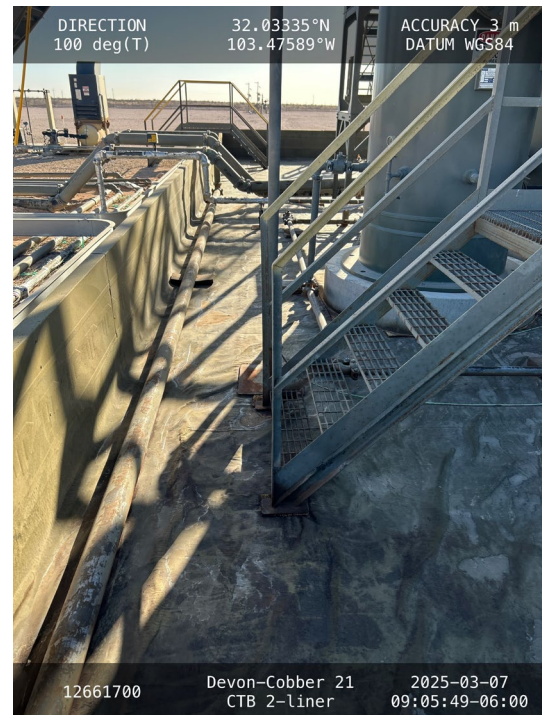
**Photo 4** View of northern portion of secondary containment towards east.

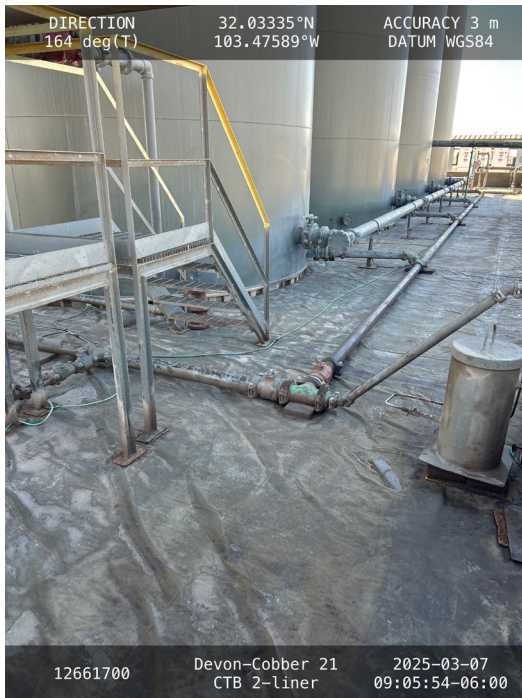
**Photo 5** View of the west side of secondary containment.

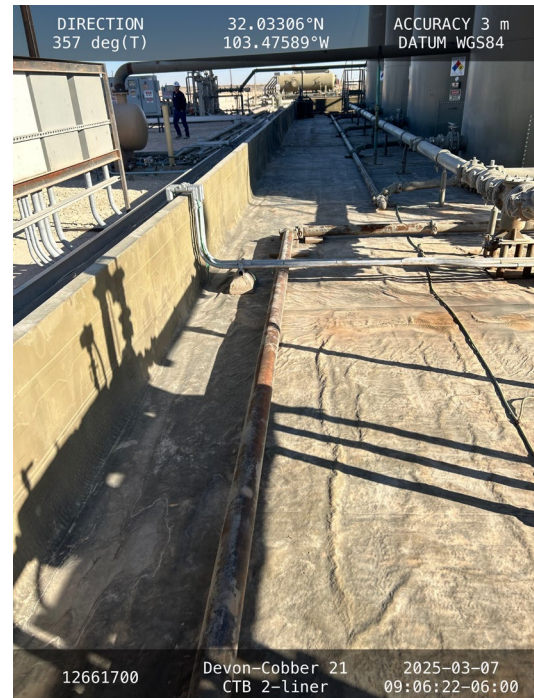
**Photo 6** View of the west side of secondary containment towards north.

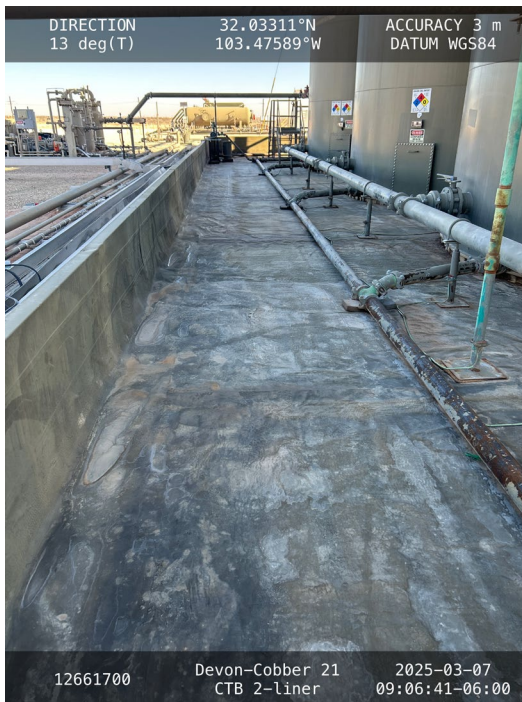
**Photo 7** View of the west side of secondary containment towards south.

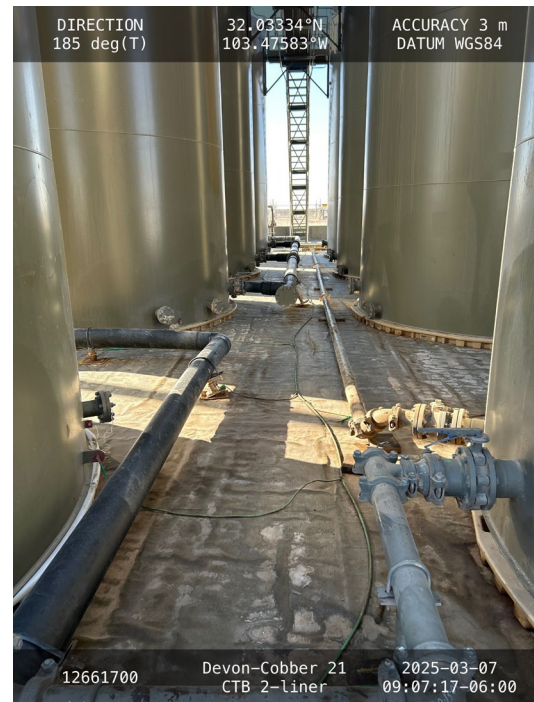
**Photo 8** View of central portion of secondary containment.

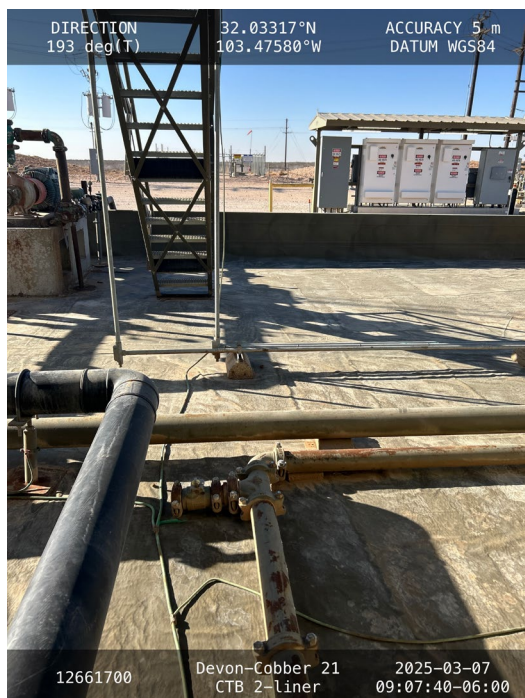
**Photo 9** View of northside of secondary containment.

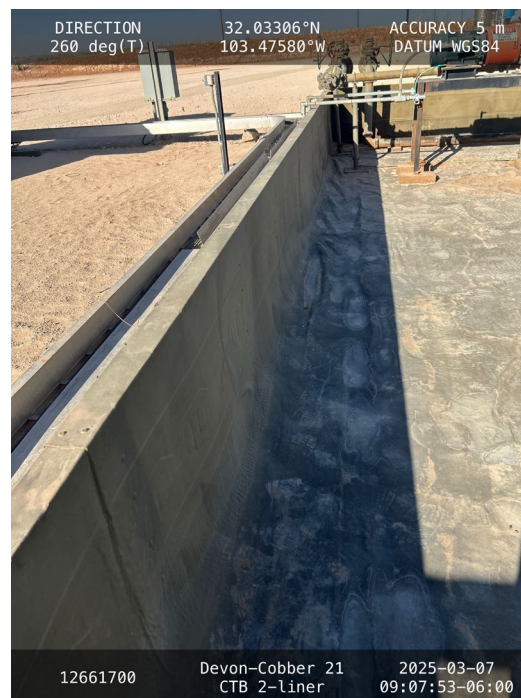
**Photo 10** View of southern portion of secondary containment towards west.

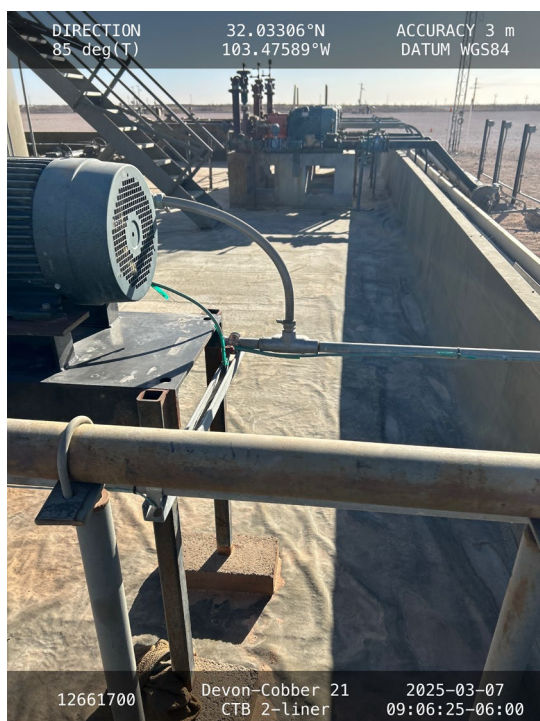
**Photo 11** View of southern portion of secondary containment towards east.

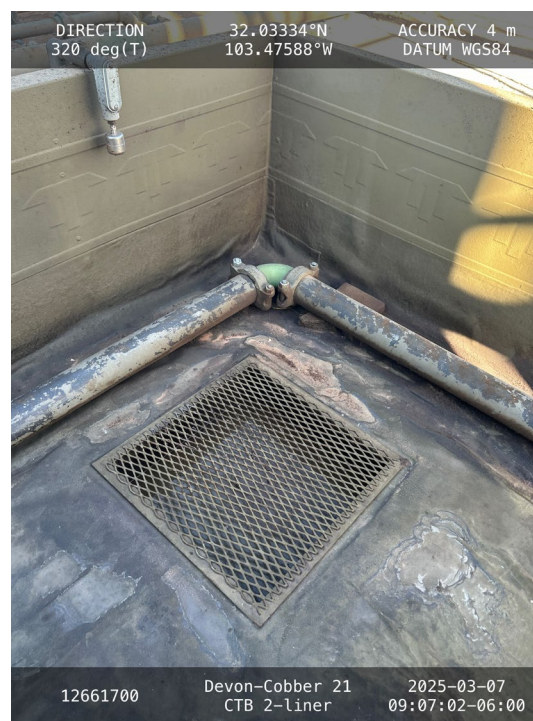
**Photo 12** View of northwestern corner of secondary containment.
