Our Ref.: 12664408-NMOCD-NMSLO-1

Closure Report
Devon Energy Production Company, LP
Serpentine 2 Facility 1
Unit Letter O, Section 2, T23S, R33E
GPS: 32.329689, -103.53964
Lea County, New Mexico

GHD Services Inc. (GHD), on behalf of Devon Energy Production Company, LP (Devon Energy), has prepared this *Closure Report* to document site assessment activities at the Serpentine 2 Facility 1 (Site). The purpose of the assessment was to determine the presence or absence of impacts to soil following a release of produced water within a lined containment at the Site. Based on field observations, Devon Energy is submitting this *Closure Report*, describing site assessment activities that have occurred and requesting closure for Incident Number nAPP2505038646.

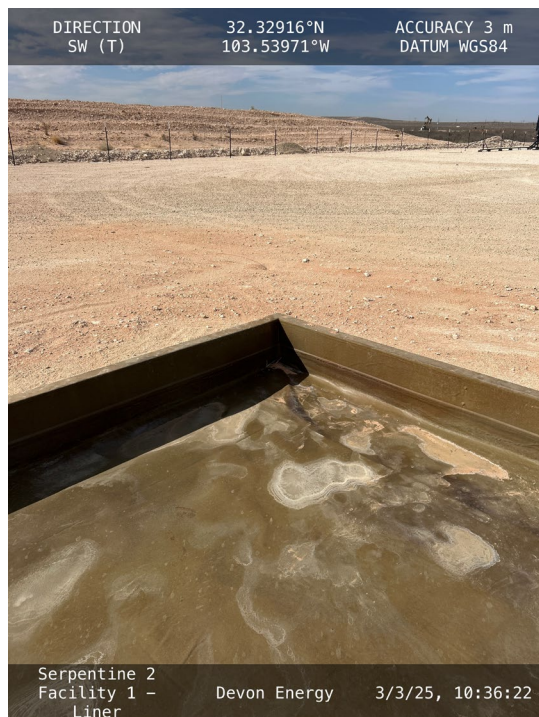
Photo 1 View of southwestern corner of secondary containment.

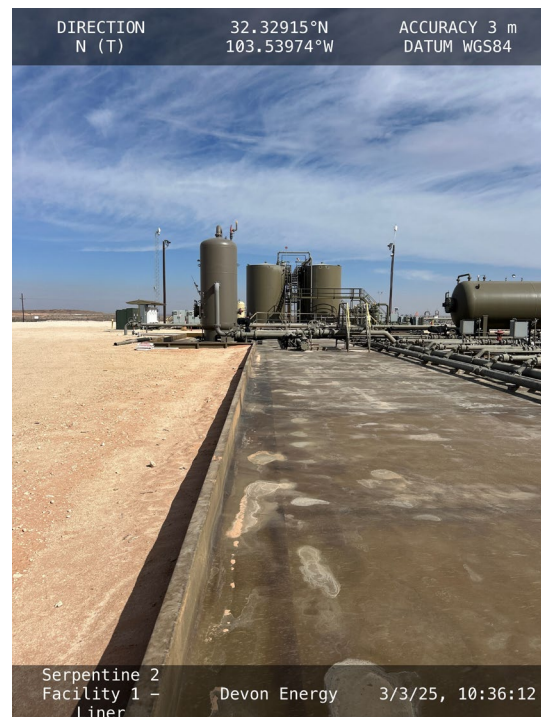
Photo 2 View towards northern portion of west side secondary containment.

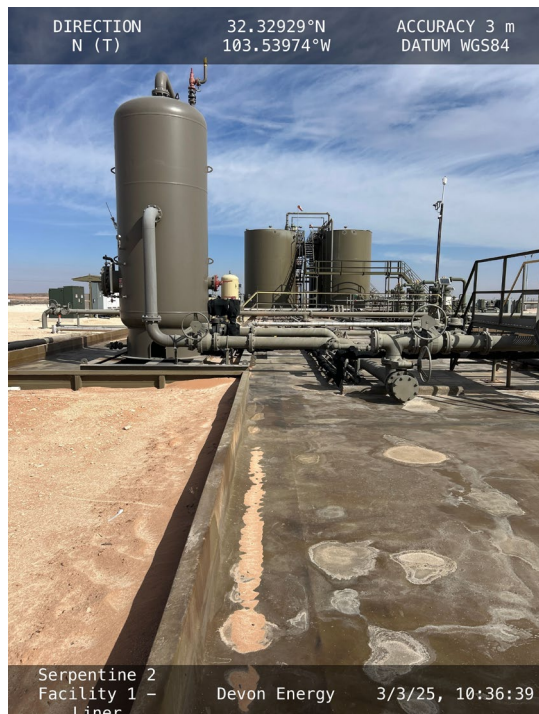
Photo 3 View towards northern portion of west side secondary containment.

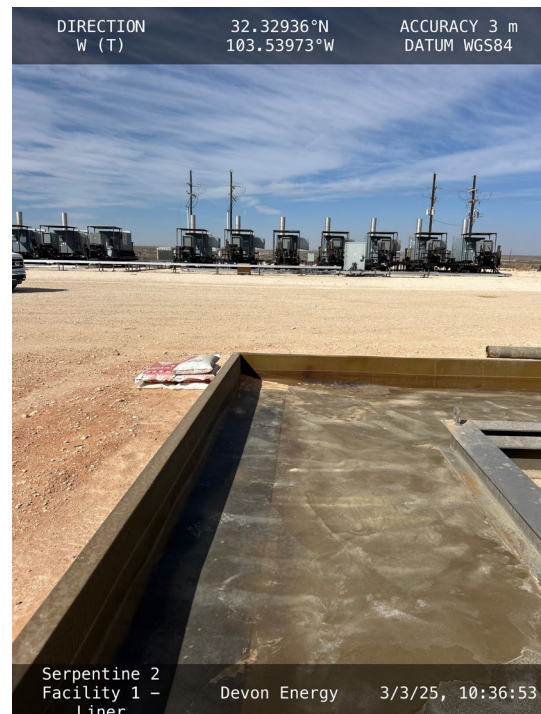
Photo 4 View towards the west of secondary containment.

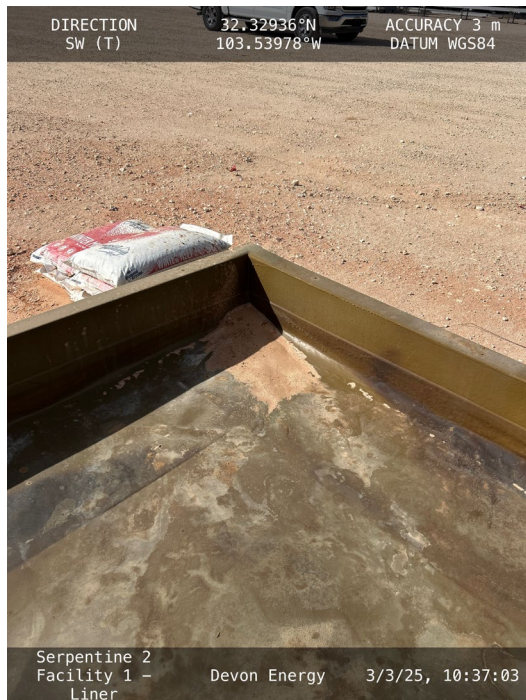
Photo 5 View of southwestern corner of secondary containment.

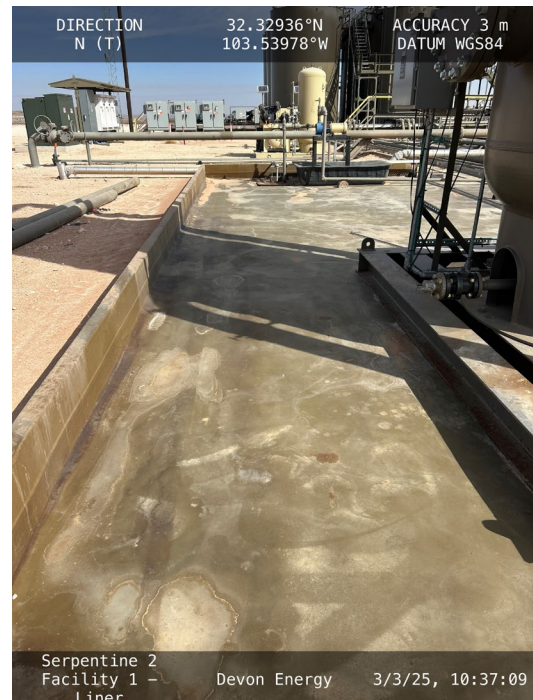
Photo 6 View towards northern portion of west side secondary containment.

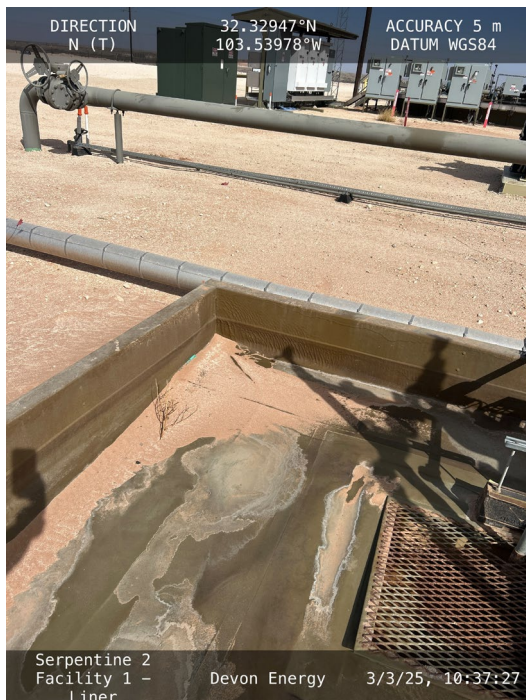
Photo 7 View of northwestern corner of secondary containment.

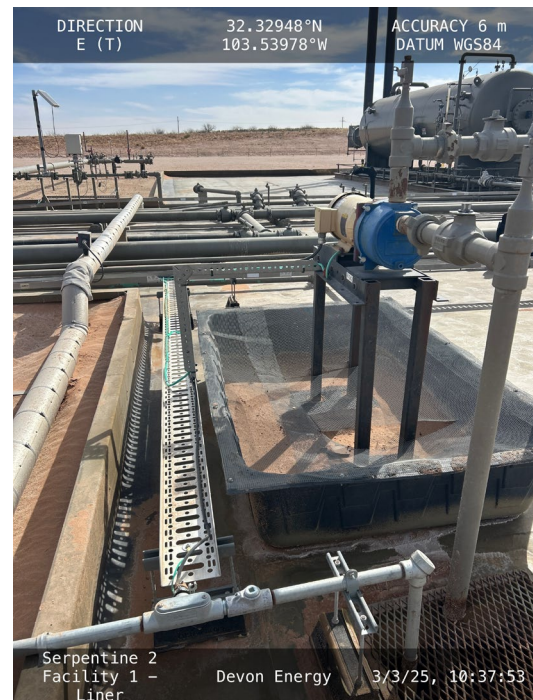
Photo 8 View of northside secondary containment to the east.

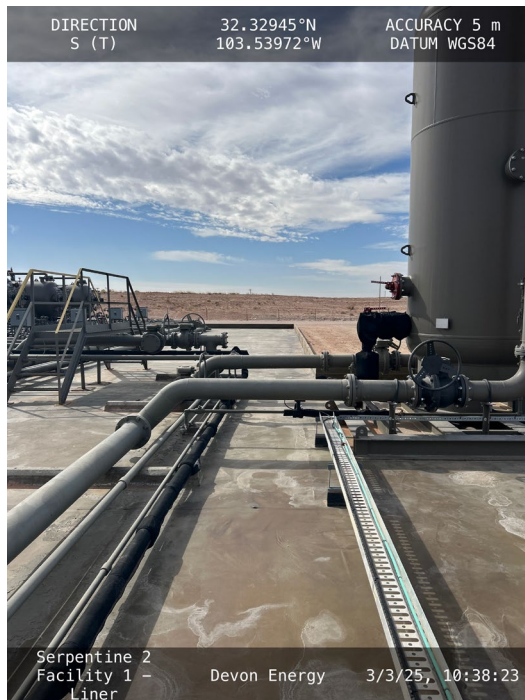
Photo 9 View of westside secondary containment towards south.

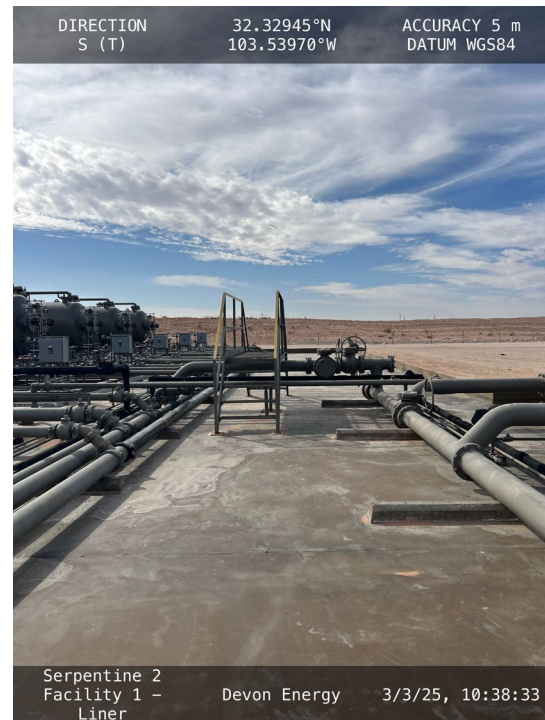
Photo 10 View of interior containment towards the south.

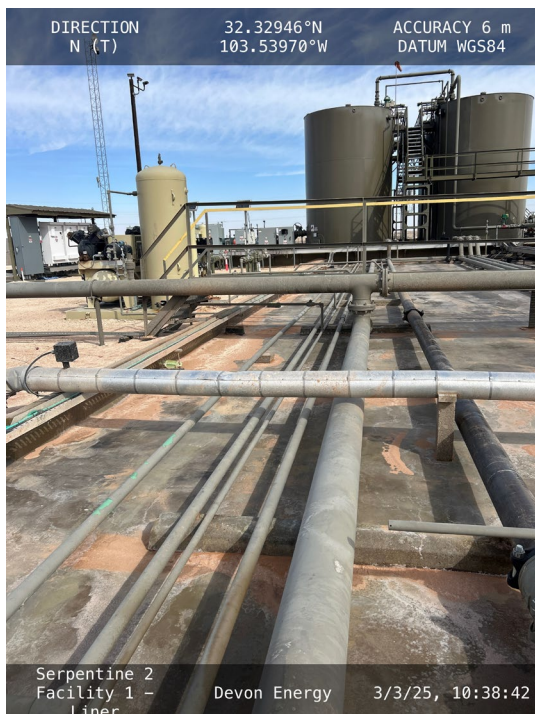
Photo 11 View of north additional northern portion of secondary containment, west side.

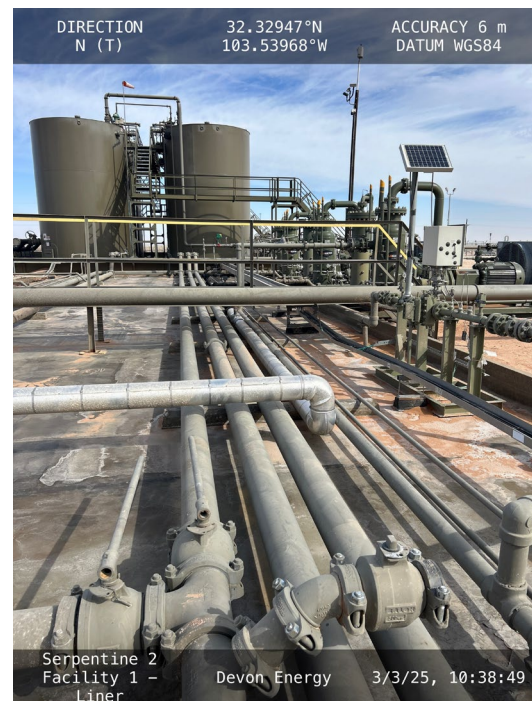
Photo 12 View of north additional northern portion of secondary containment, east side.

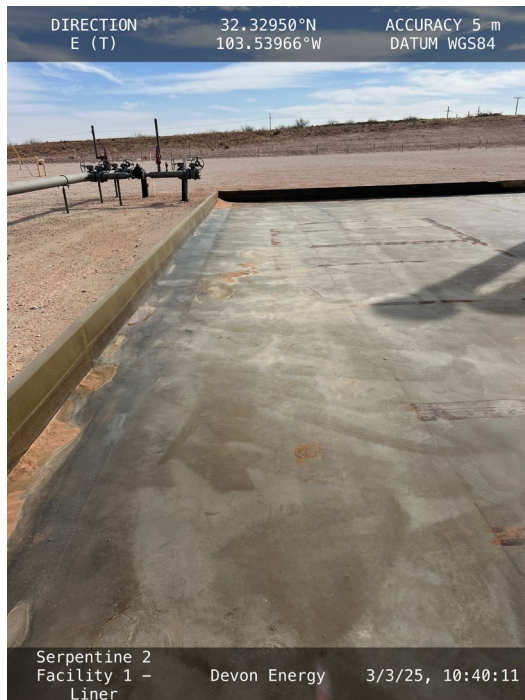
Photo 13 View of the east side secondary containment towards east.

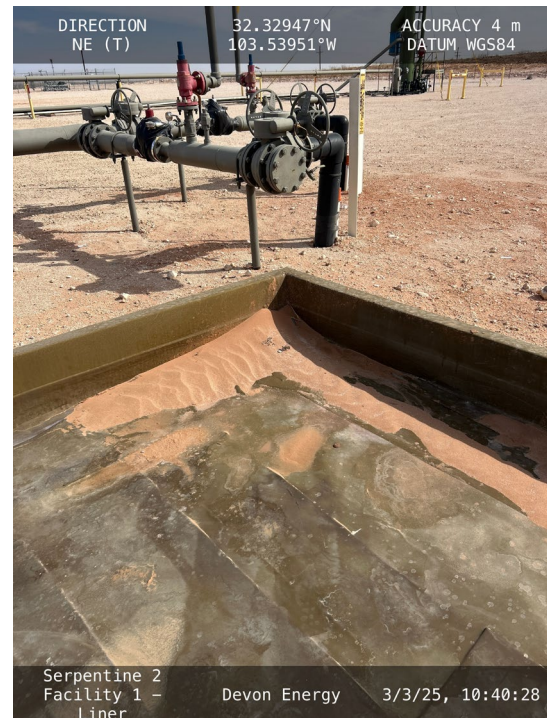
Photo 14 View of northeastern corner of secondary containment.

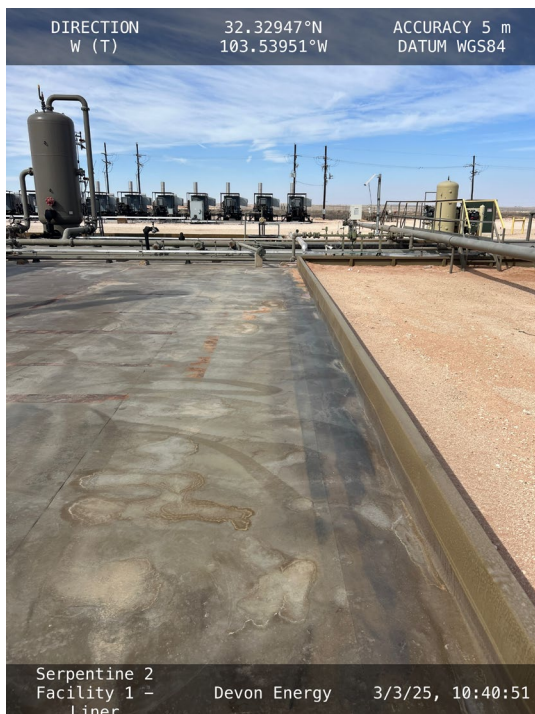
Photo 15 View of northside of secondary containment towards the west.

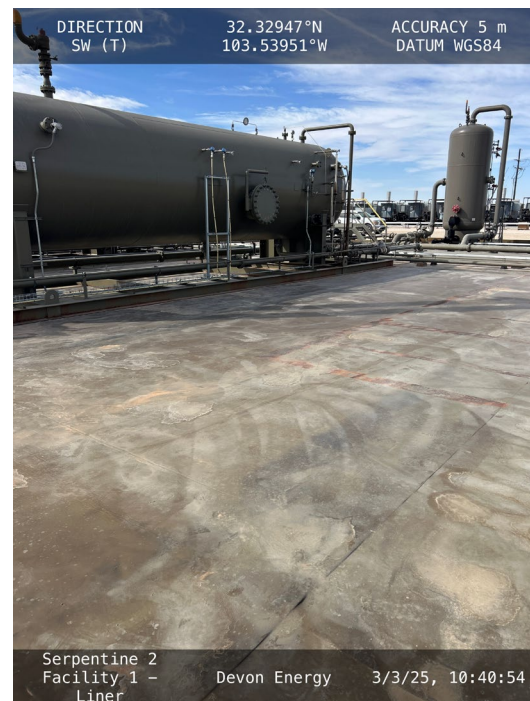
Photo 16 View of central portion of secondary containment towards southwest.

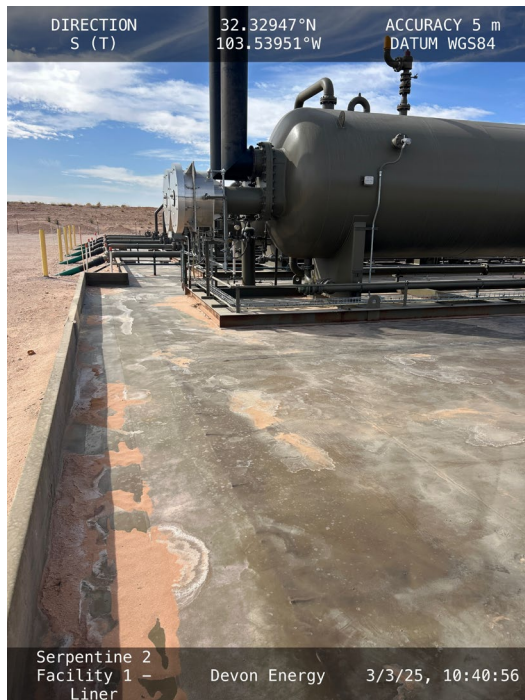
Photo 17 View of eastern side of secondary containment towards the south.

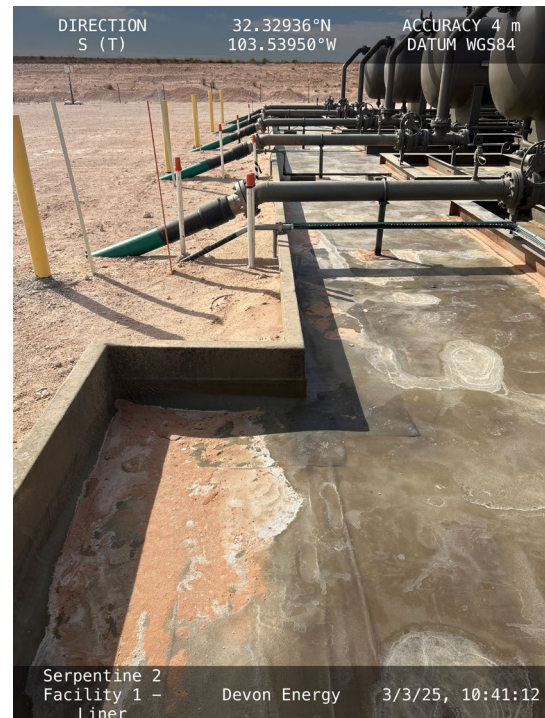
Photo 18 View of eastern side of secondary containment towards the south.

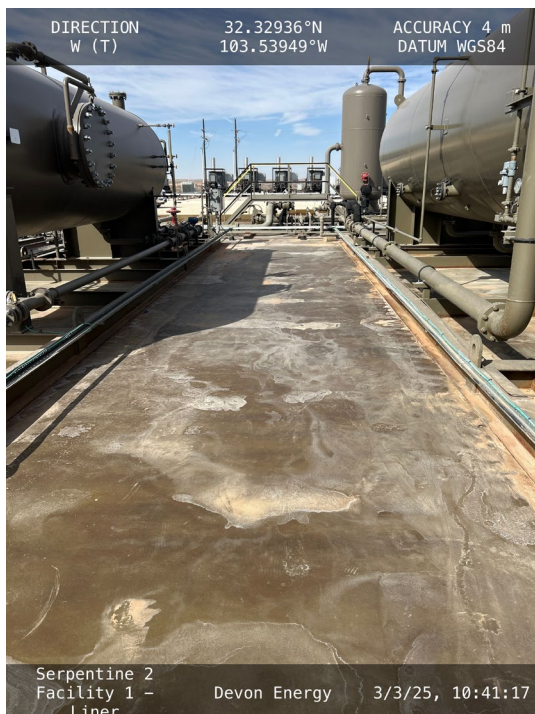
Photo 19 View of central portion of secondary containment towards the west.

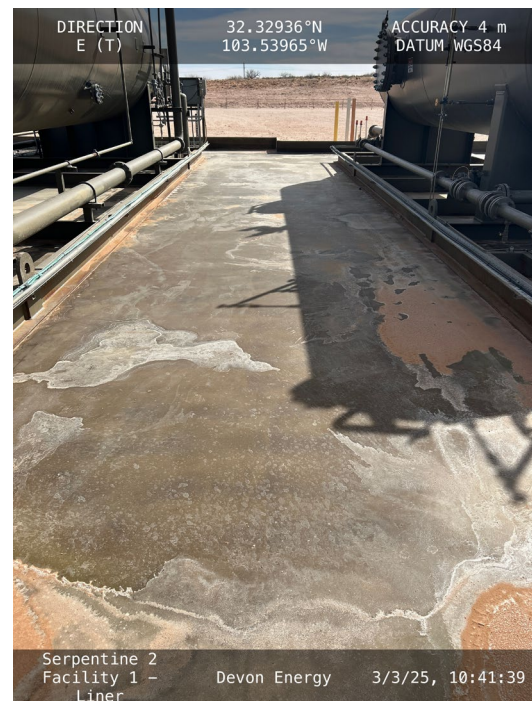
Photo 20 View of central portion of secondary containment towards the east.

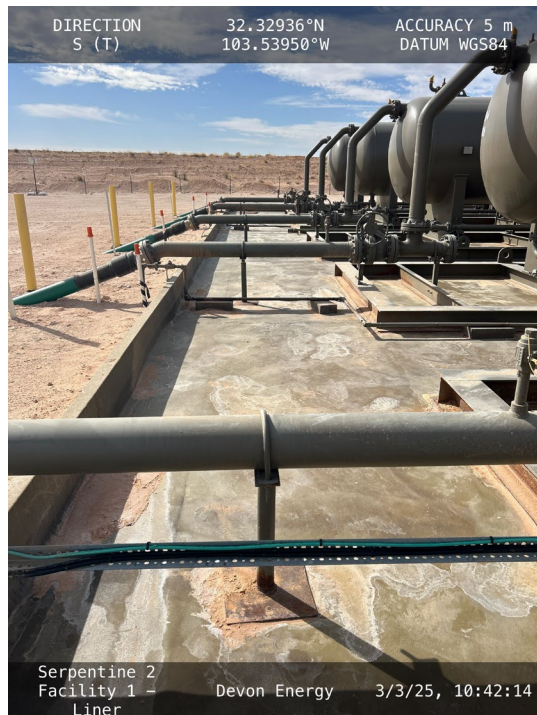
Photo 21 View of eastern side of secondary containment towards south.

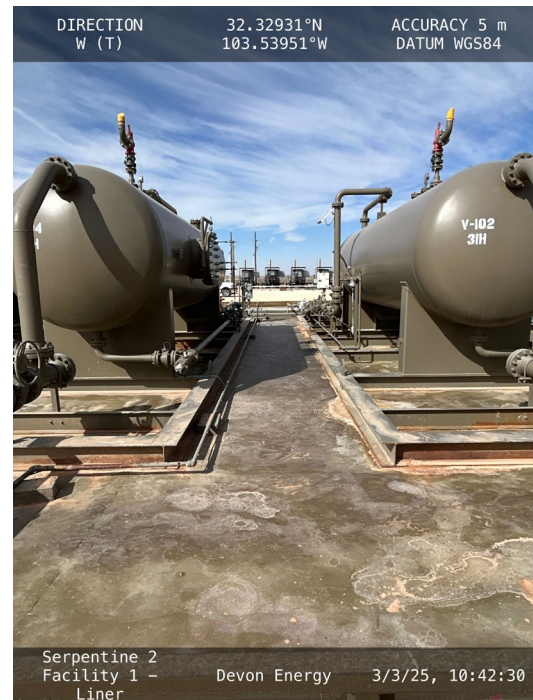
Photo 22 View of interior secondary containment.

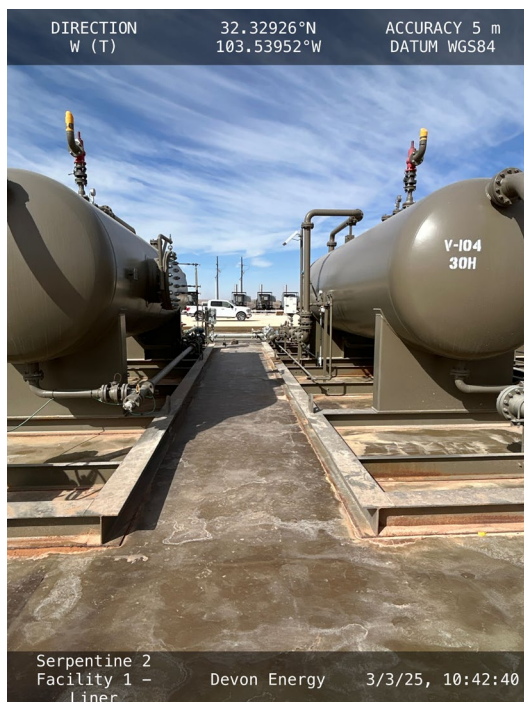
Photo 23 View of interior secondary containment.

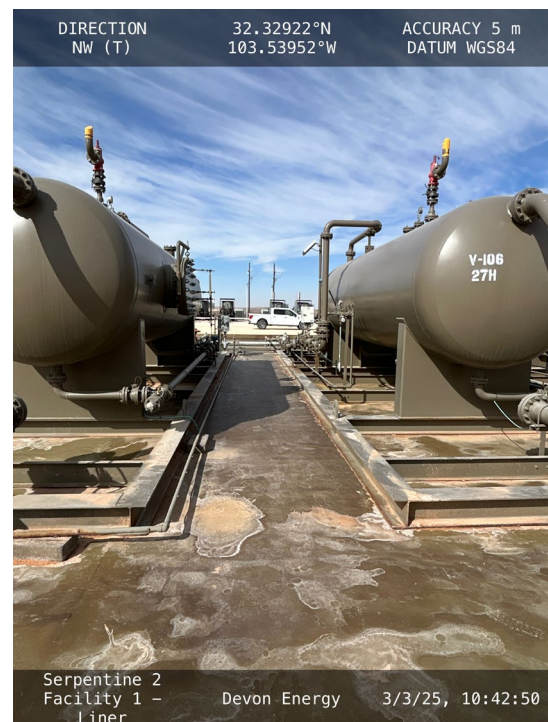
Photo 24 View of interior secondary containment.

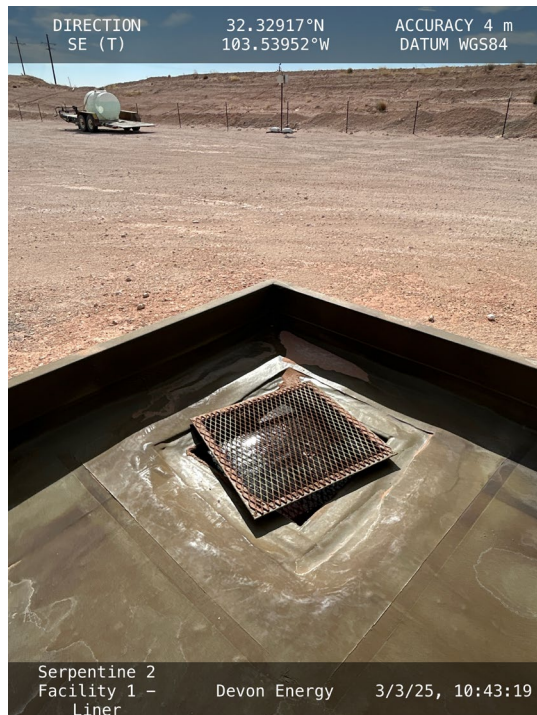
Photo 25 View of southeastern corner of the secondary containment.

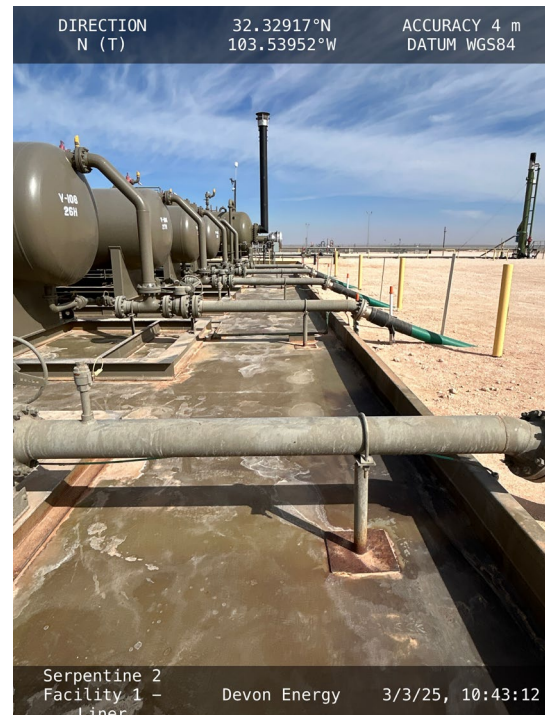
Photo 26 View of eastern side of secondary containment to the north.

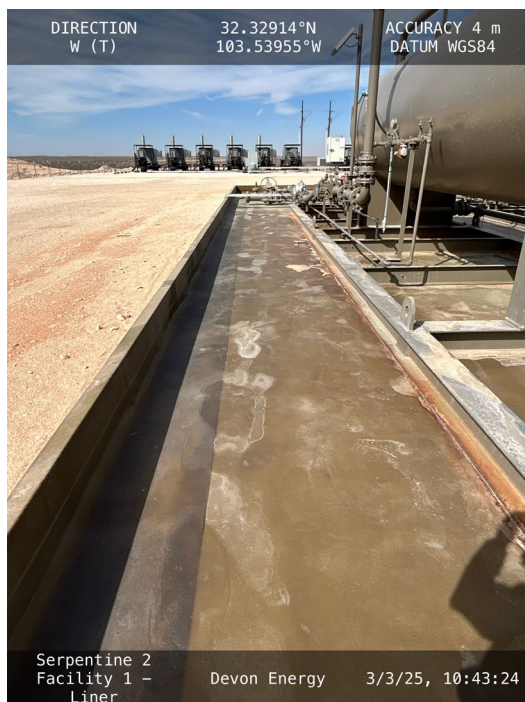
Photo 27 View of southern side of secondary containment to west.

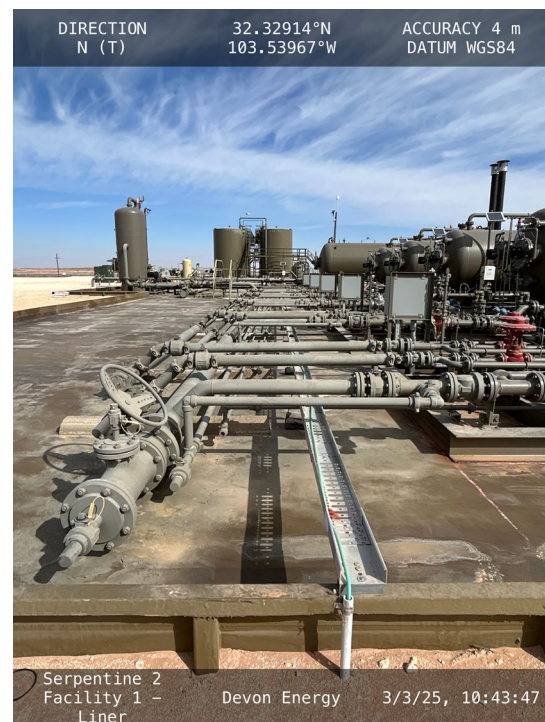
Photo 28 View of central portion of secondary containment towards the north.

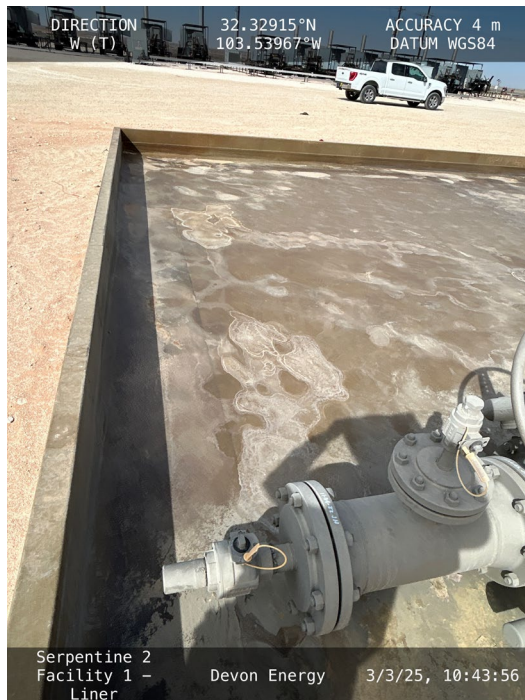
Photo 29 View of southern side of secondary containment to west.

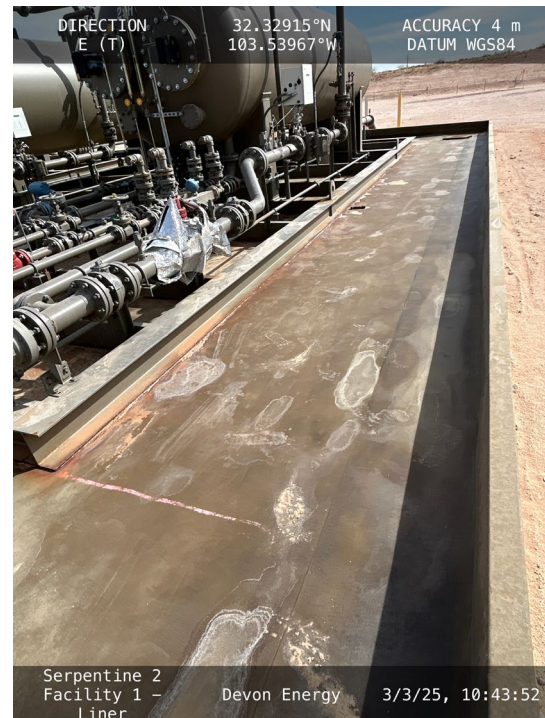
Photo 30 View of southern side of secondary containment to east.

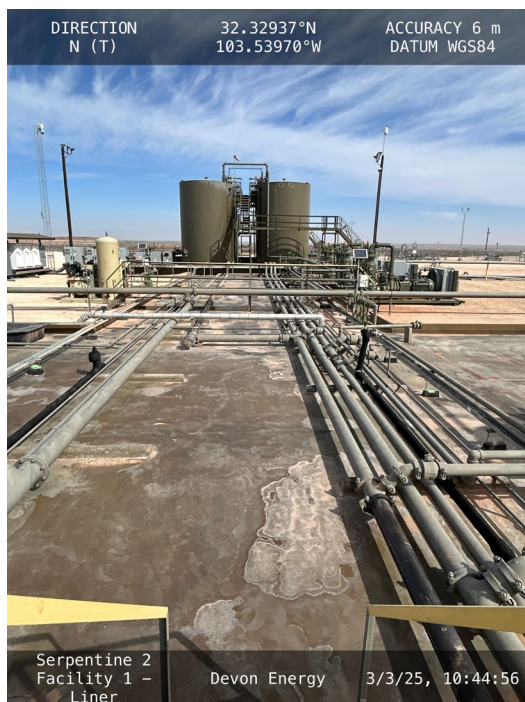
Photo 31 View of central portion of secondary containment towards the north.

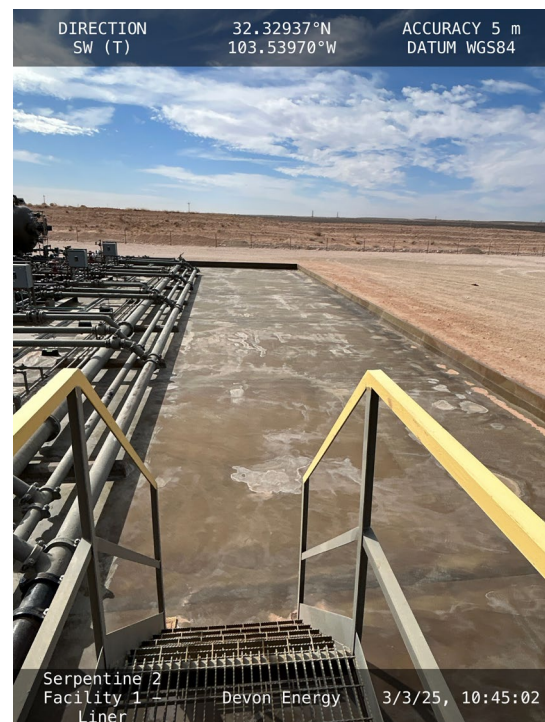
Photo 32 View of central portion of secondary containment towards the south.
