BKU 23A Battery

Incident ID NAPP2503429264

Liner Inspection and Closure Report

February 25, 2025

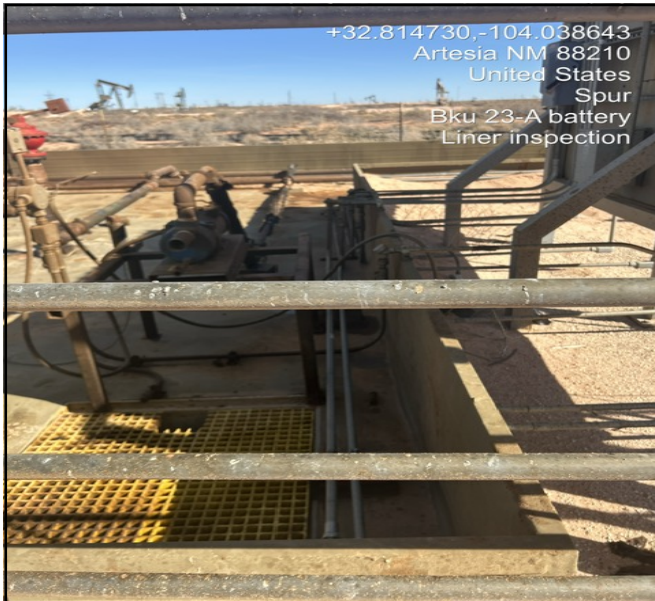
Photo of liner taken prior to power washing.

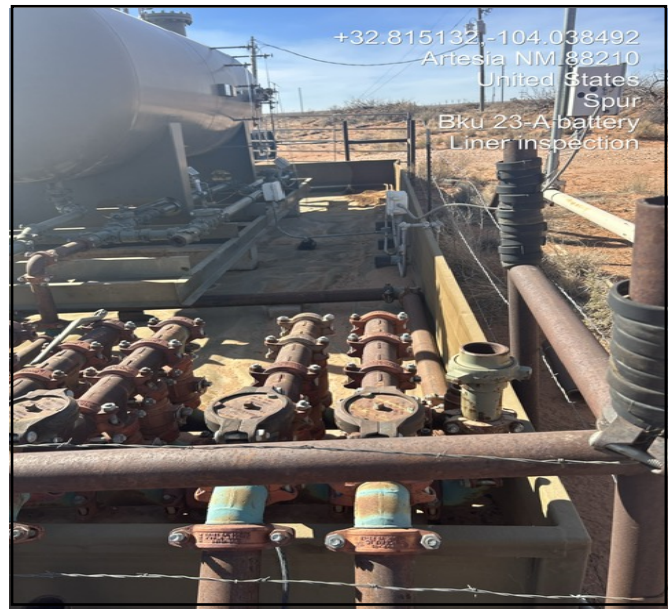
Photo of liner taken prior to power washing.

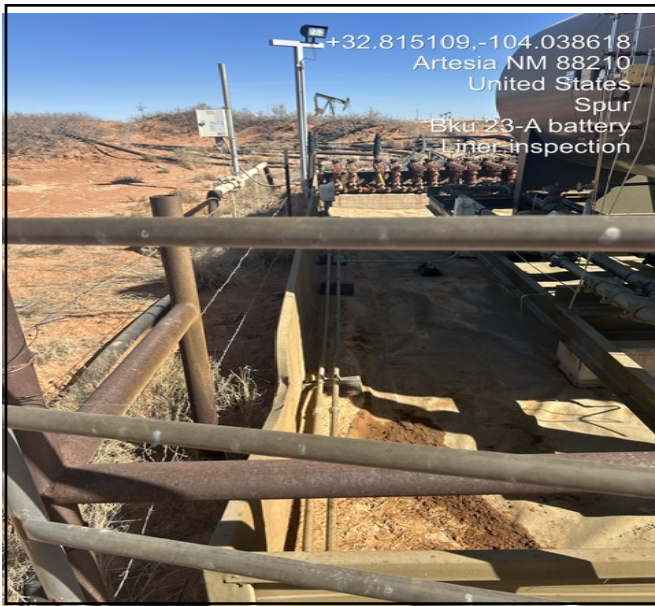
Photo of liner taken prior to power washing.

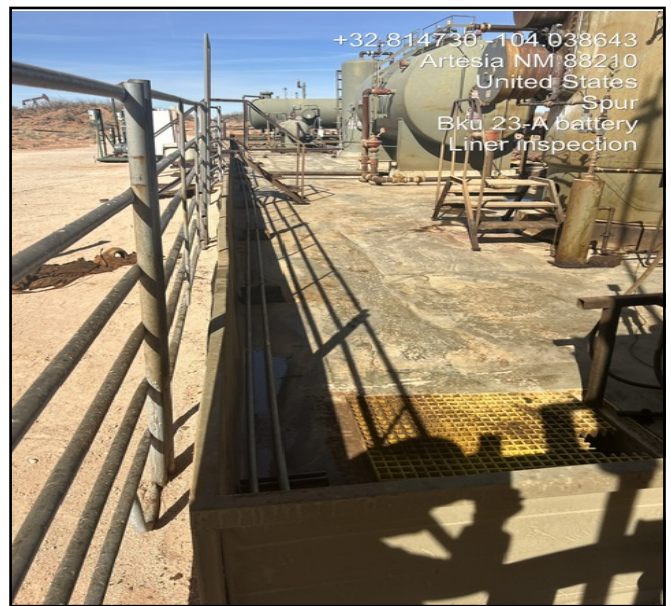
Photo of liner taken prior to power washing.

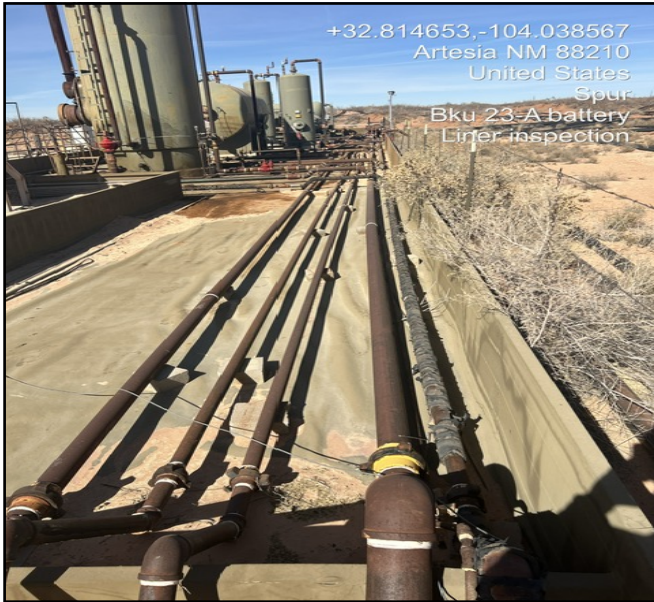
Photo of liner taken prior to power washing.

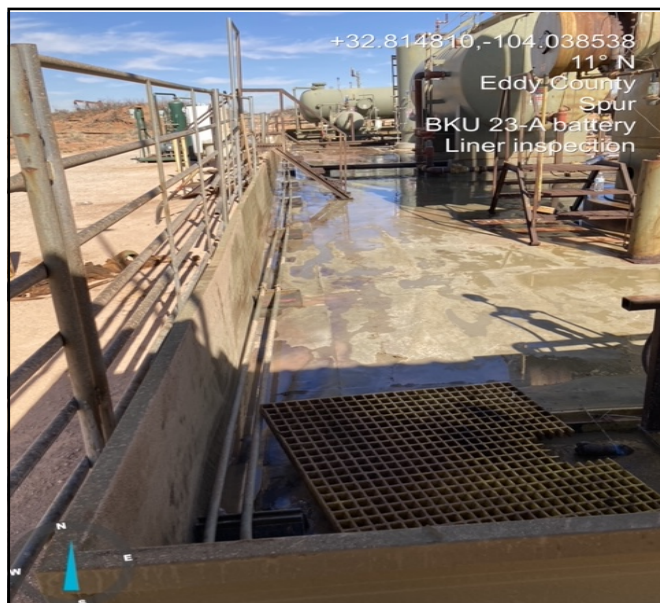
Visualization	Yes	No	Comments
Is there a tear in the liner?		X	
Are there holes in the liner?		X	
Is the liner retaining any fluids?	X		Residual liquid is visible in the photo log from the power washing cleaning event.
Does the liner have integrity to contain a leak?	X

Photo taken pursuant to power washing facing north.

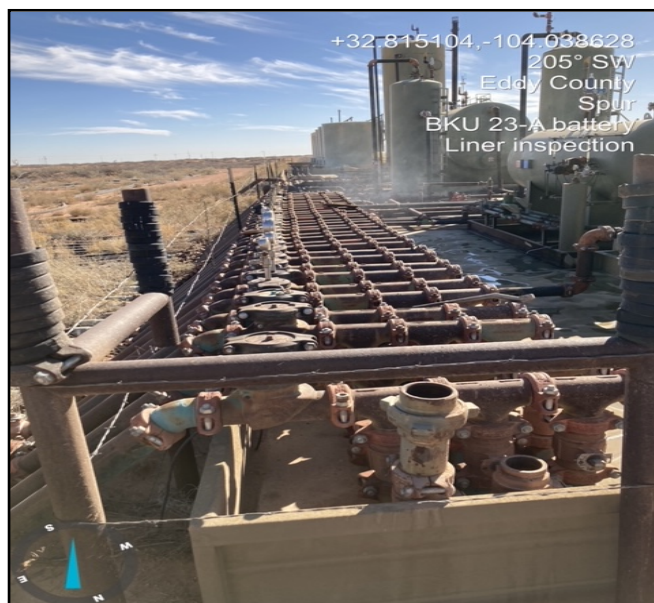
Photo taken pursuant to power washing facing southwest.

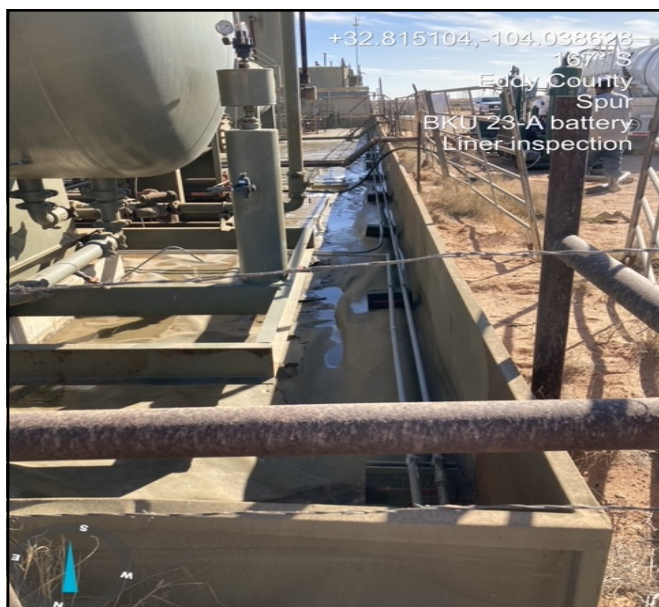
Photo taken pursuant to power washing facing south.

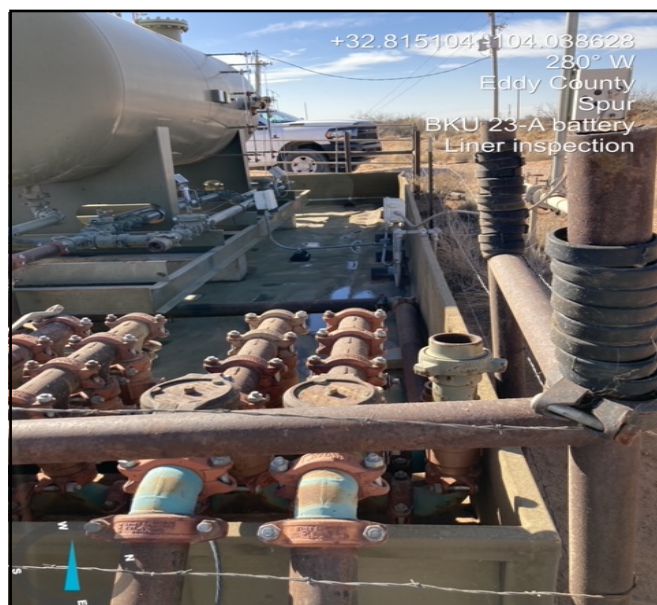
Photo taken pursuant to power washing facing west.

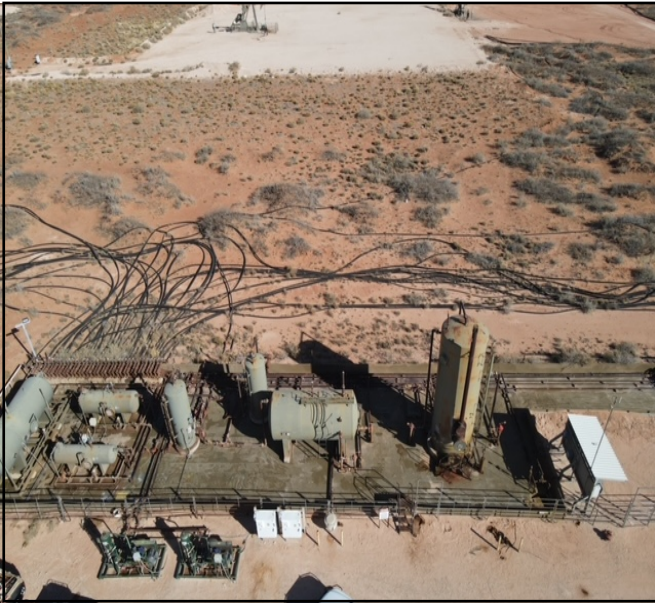
Aerial photo of location post power wash.

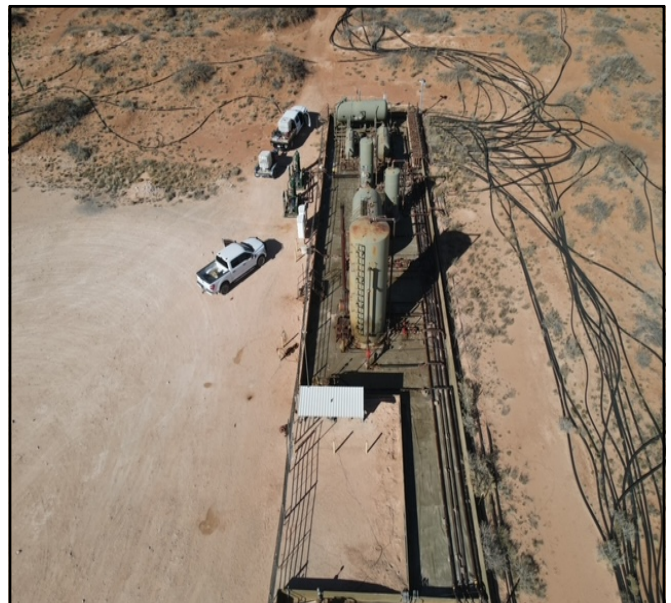
Aerial photo of location post power wash.

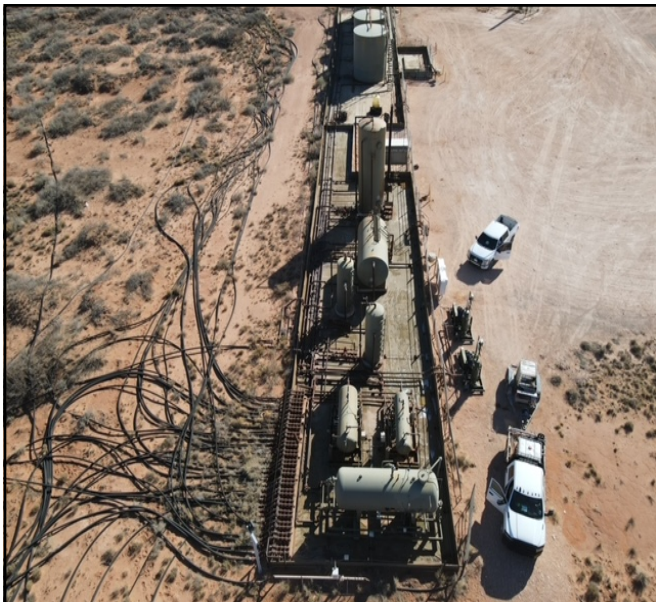
Aerial photo of location post power wash.
