SUBJECT: Closure Request Report for the Thistle North Central CTB, Incident ID # nAPP2436353195,
 Facility ID fAPP2122855808, State Lease ID V02818001, Lea County, New Mexico

Site Assessment Photolog

Client: Devon Energy Corporation
Facility ID: fAPP2122855808
Site: Thistle North Central CTB

Incident ID: nAPP2436353195
Project Manager: Monica Peppin
Project Owner: Jim Raley

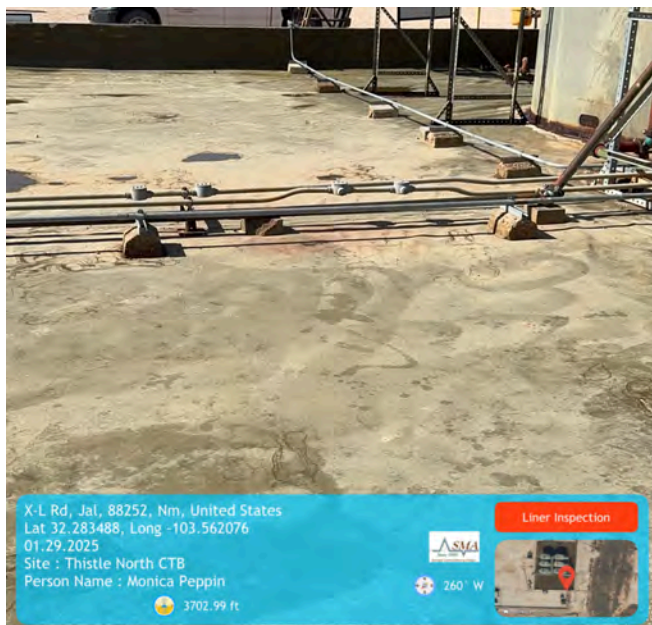
Photograph #1: Viewing open area of liner facing west on south end of containment.

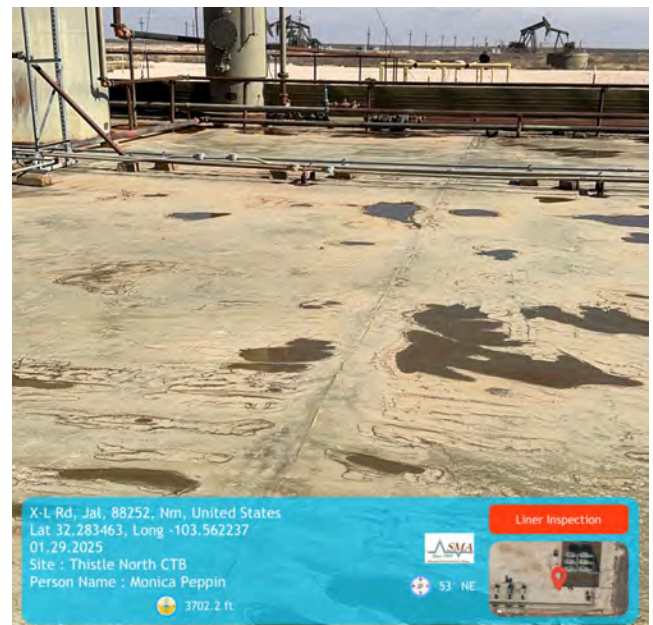
Photograph #2: Open area of containment facing east from west wall.

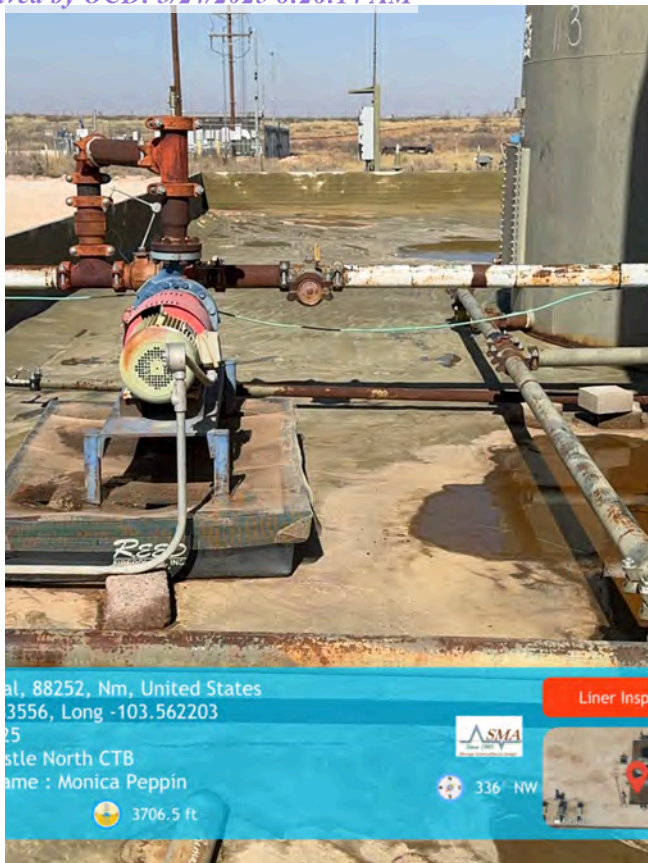
Photograph #3: Facing east from west side viewing north wall.

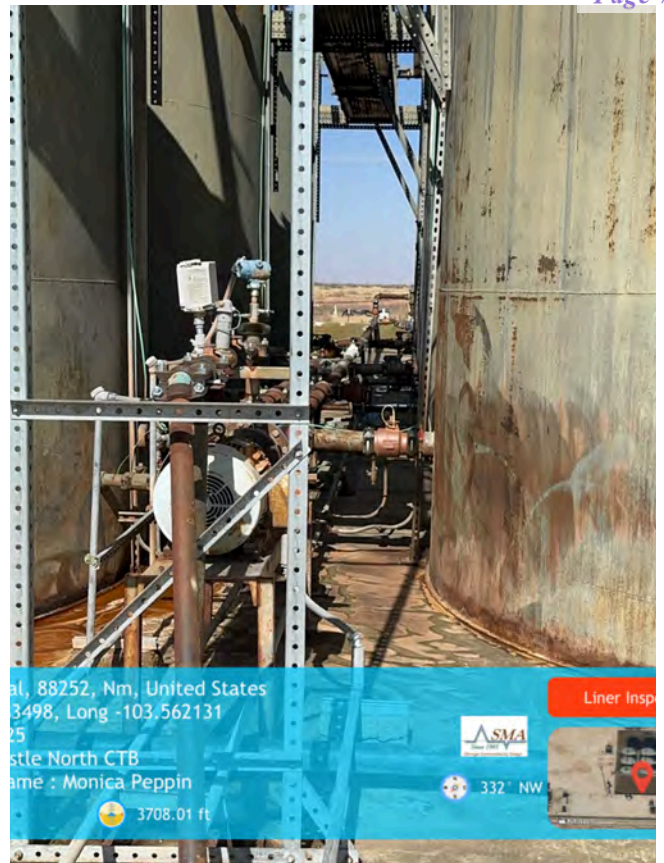
Photograph #4: View of east area facing south.

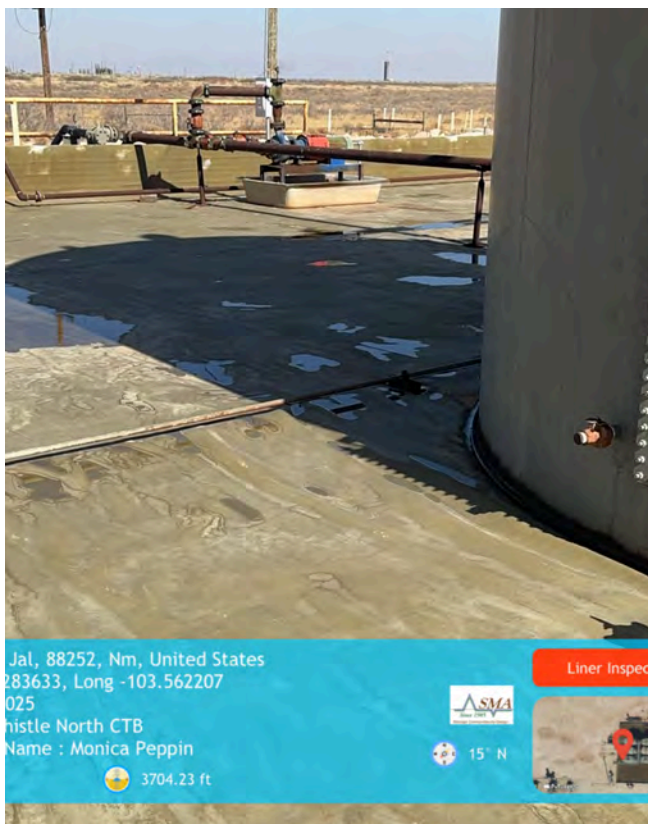
Photograph #5: North area of containment from west side.

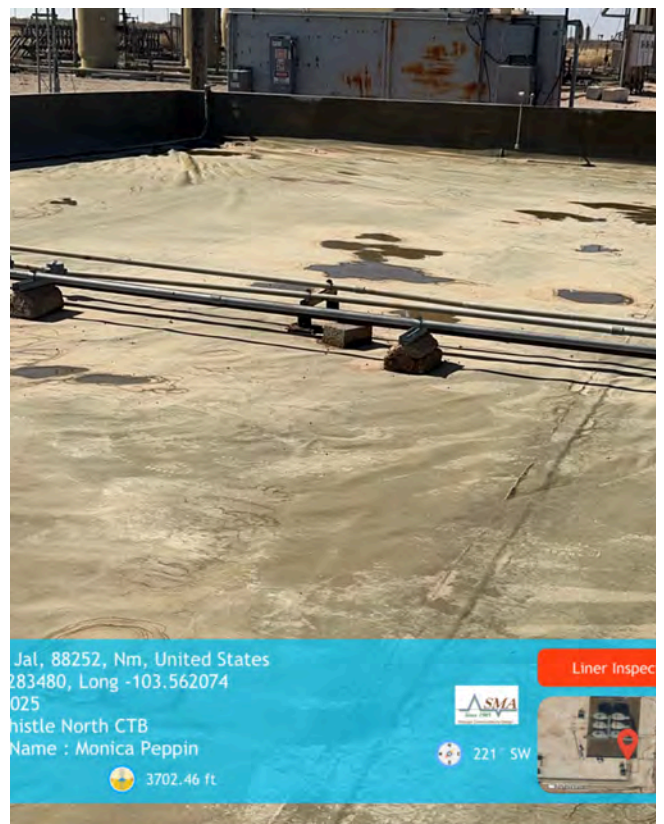
Photograph #6: Southwest view of containment from east side.

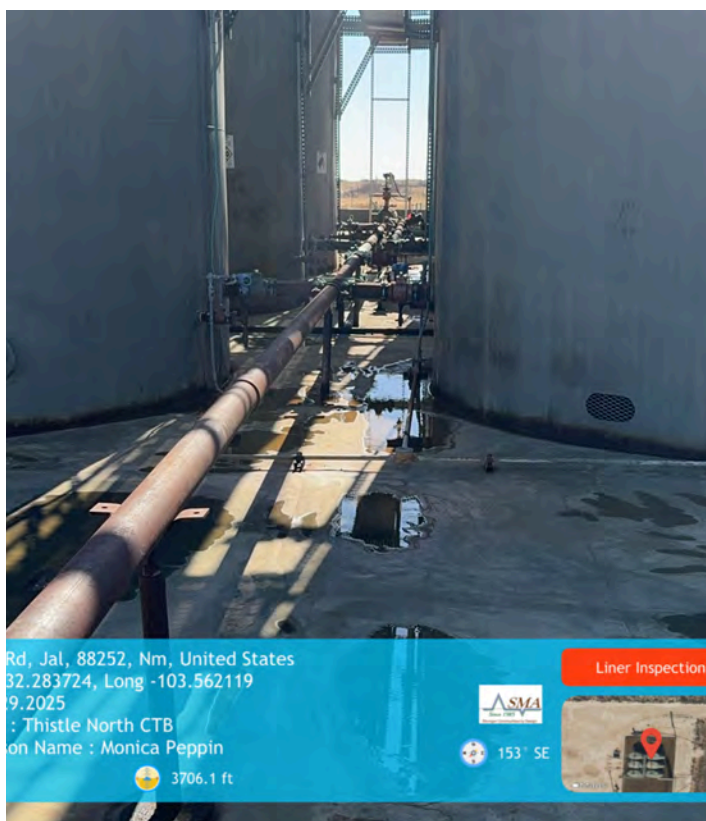
Photograph #7: Liner between tanks facing south from north side.

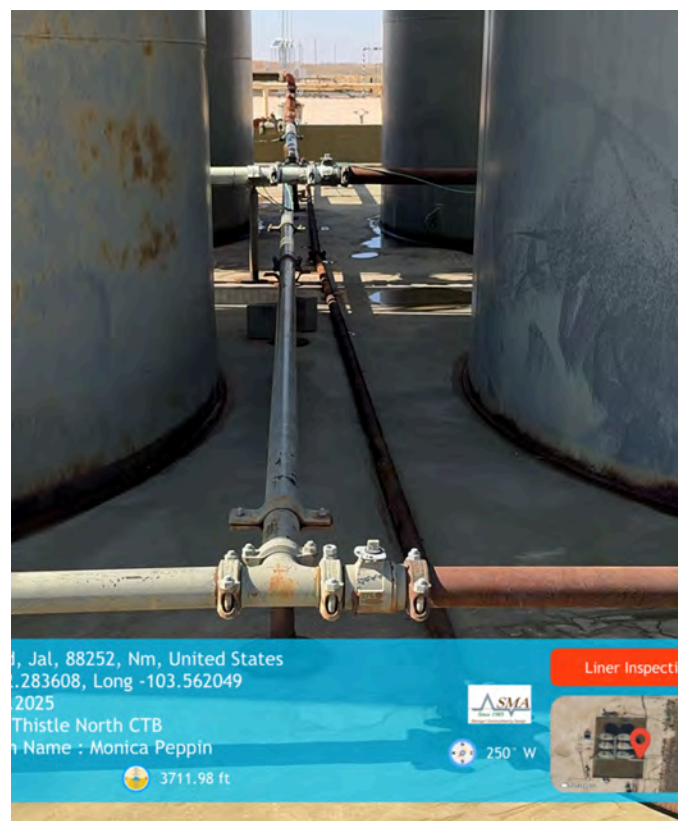
Photograph #8: Between tanks facing west on southern most end.

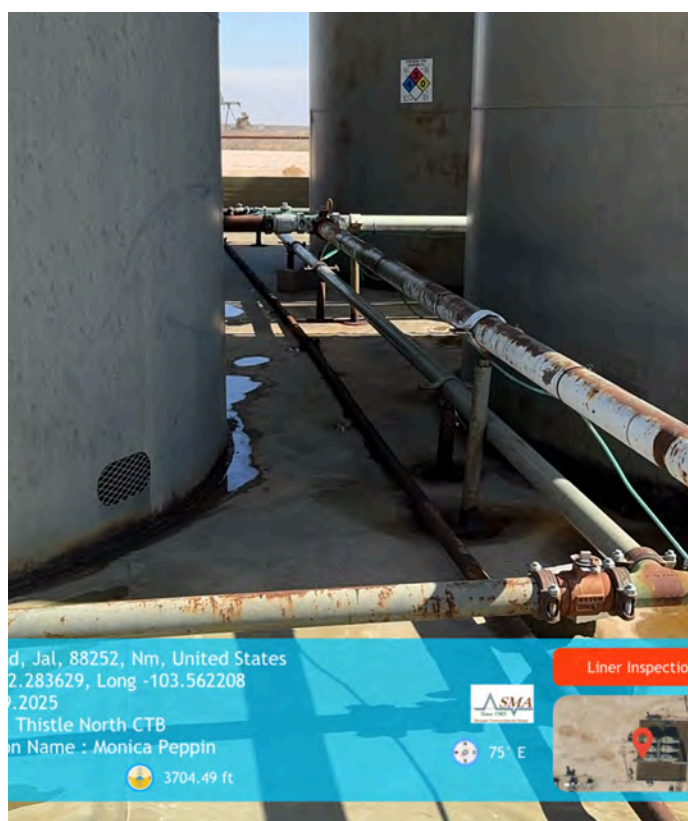
Photograph #9: Looking east viewing liner between tanks from west side.

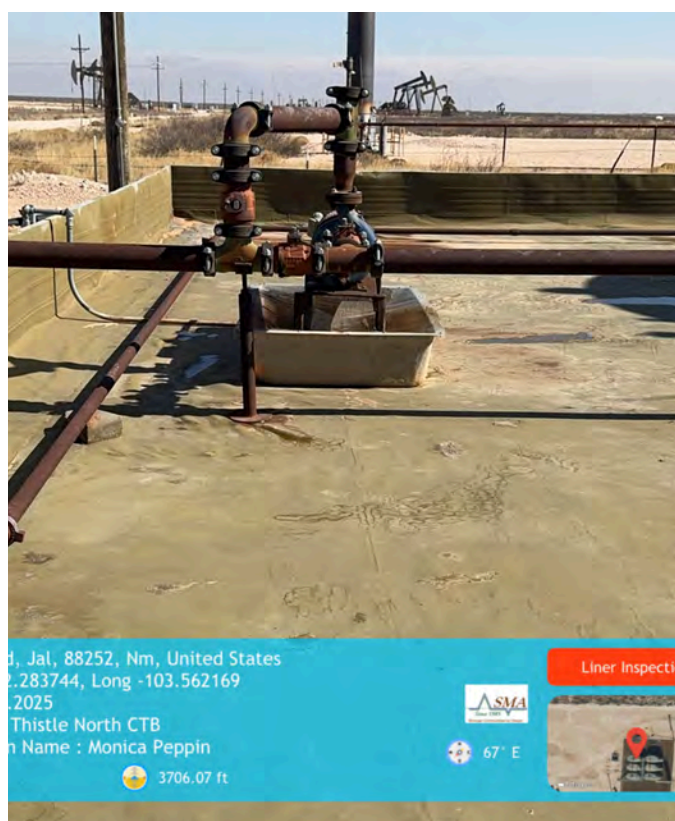
Photograph #10: Viewing liner around transfer pump on north wall facing east.

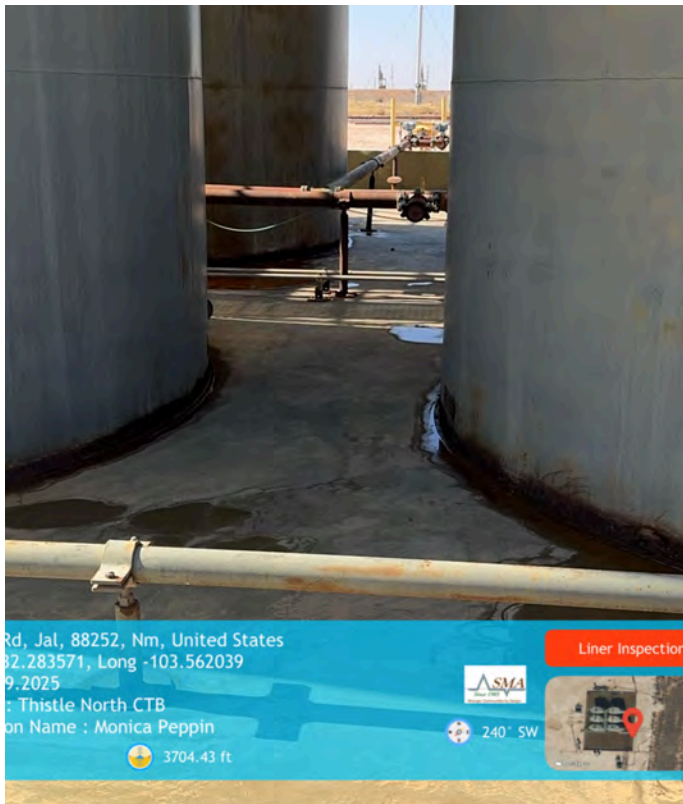
Photograph #11: Liner between tanks in middle of containment facing west.

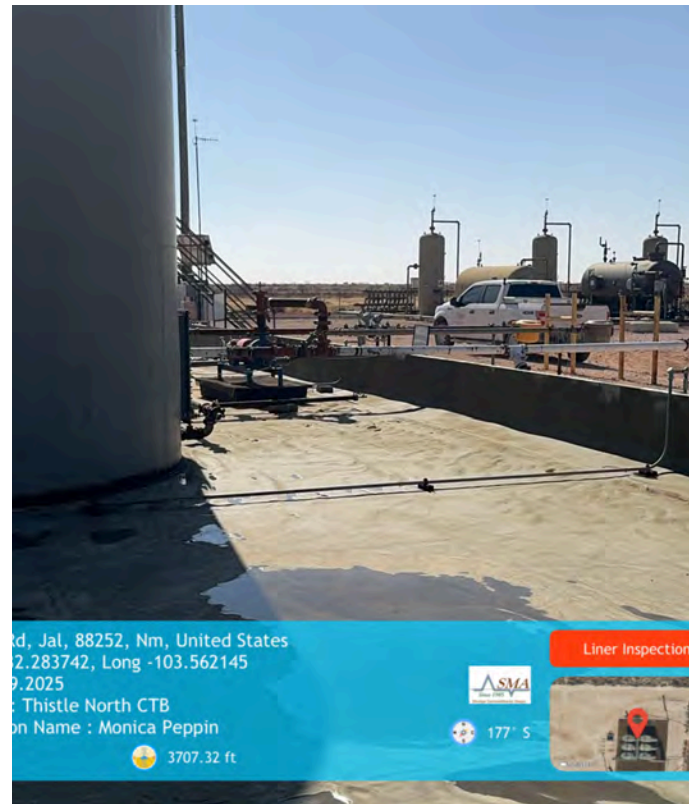
Photograph #12: Viewing liner on west side of containment from north side.

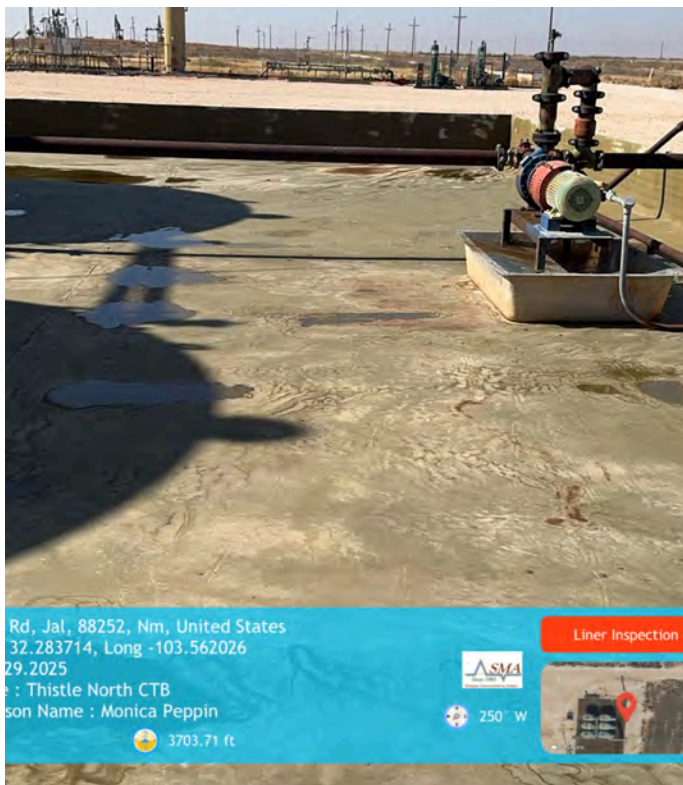
Photograph #13: Facing west viewing liner on north end.

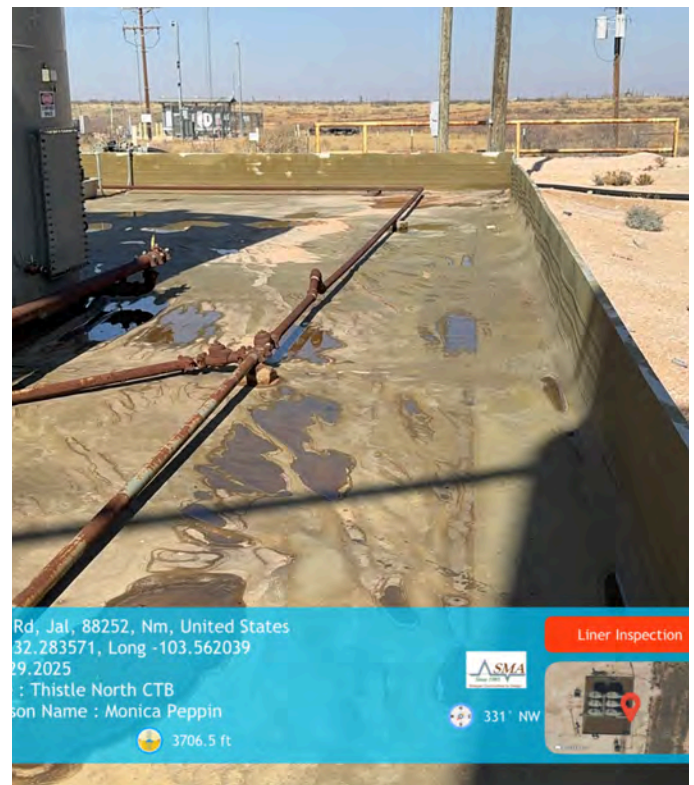
Photograph #14: Liner on east side of containment facing north.

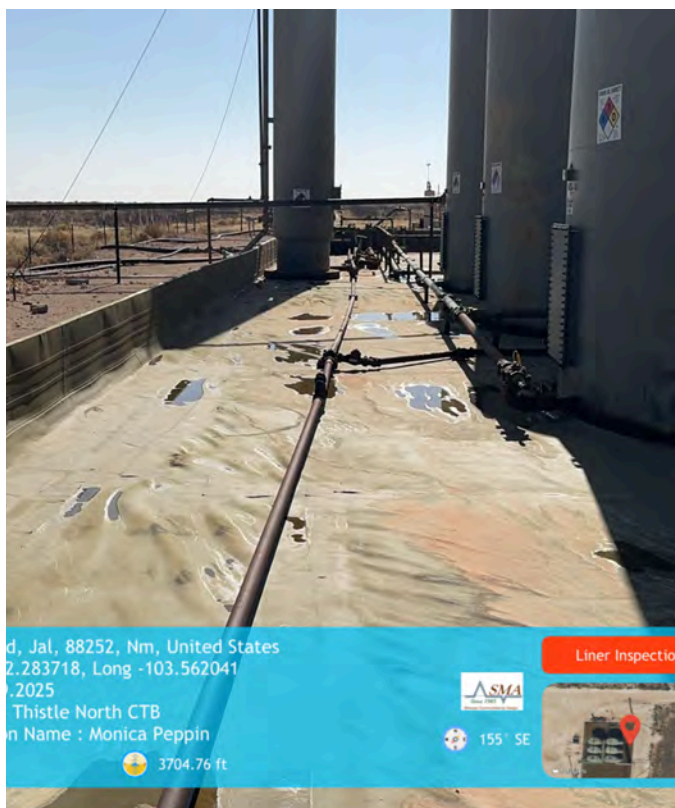
Photograph #15: East side of containment from north end.

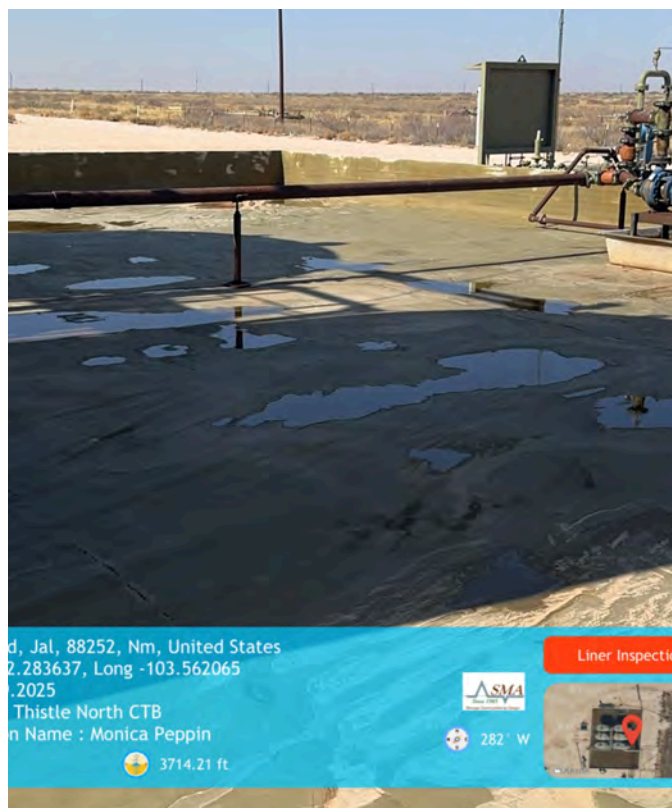
Photograph #16: View of northwest corner from east wall area.

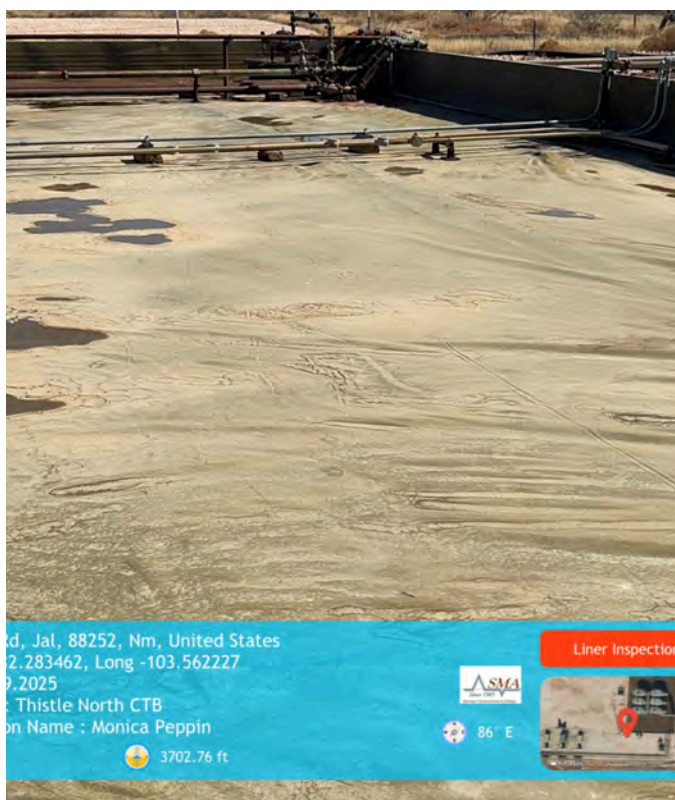
Photograph #17: Viewing south wall area from west side.

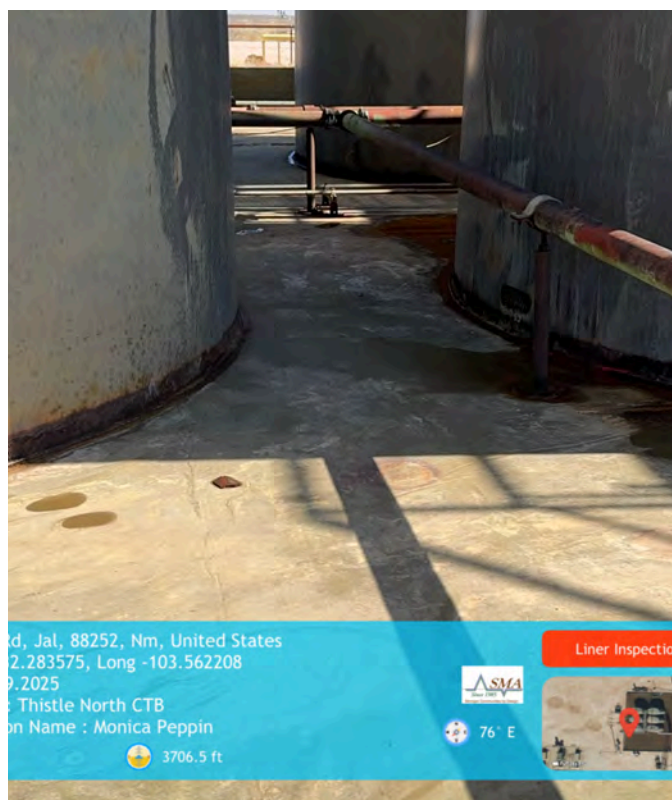
Photograph #18: Liner between tanks furthest south facing east.

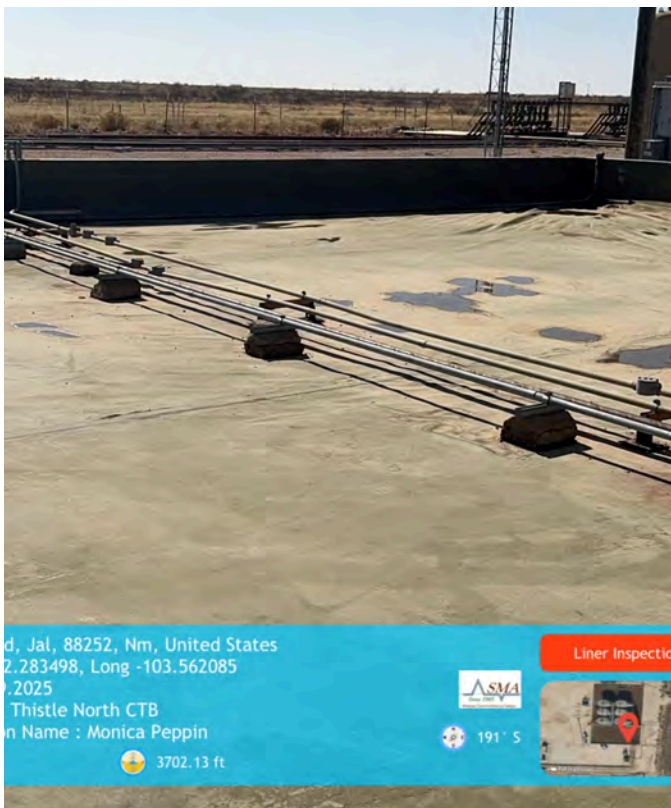
Photograph #19: View of south area from east wall facing southwest.

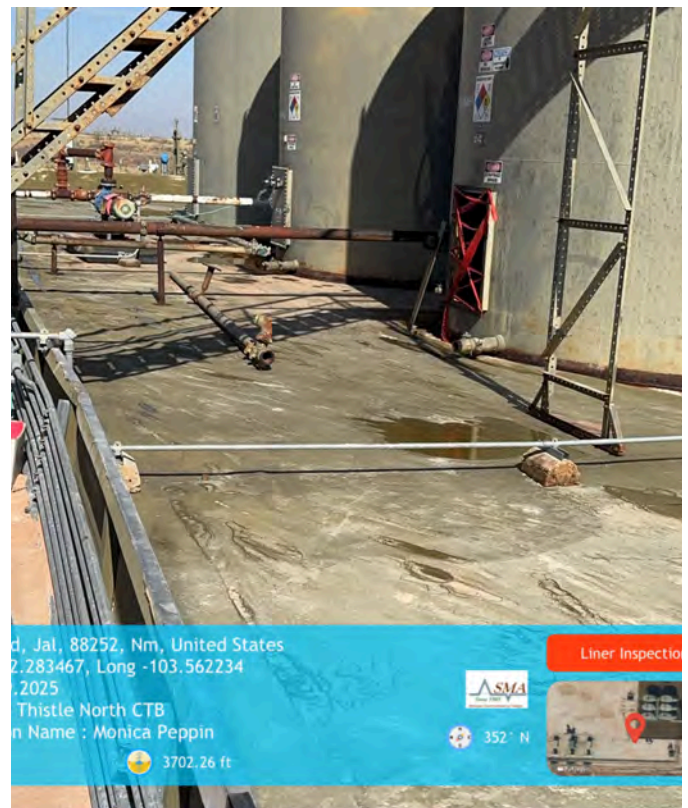
Photograph #20: Viewing west wall area from southwest corner.

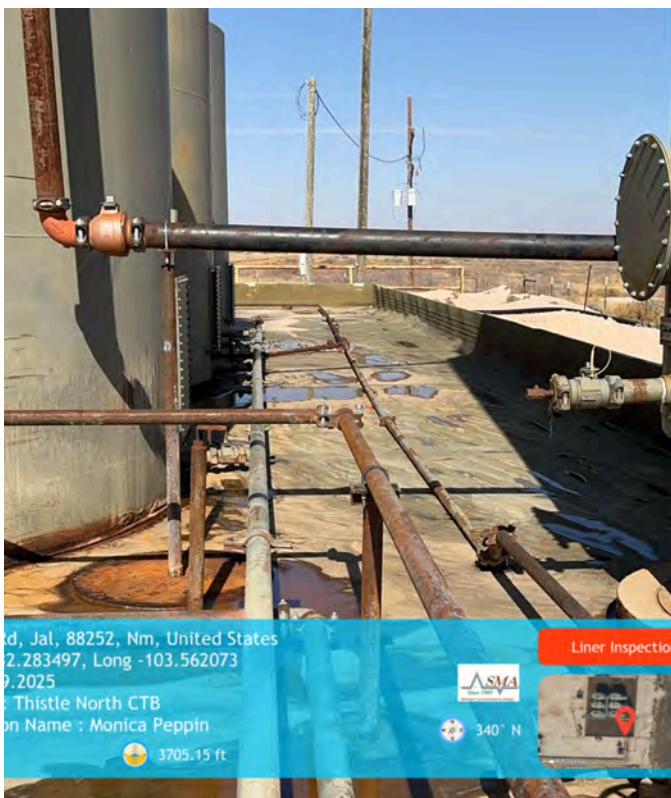
Photograph #21: Facing north viewing east side of containment from south wall.

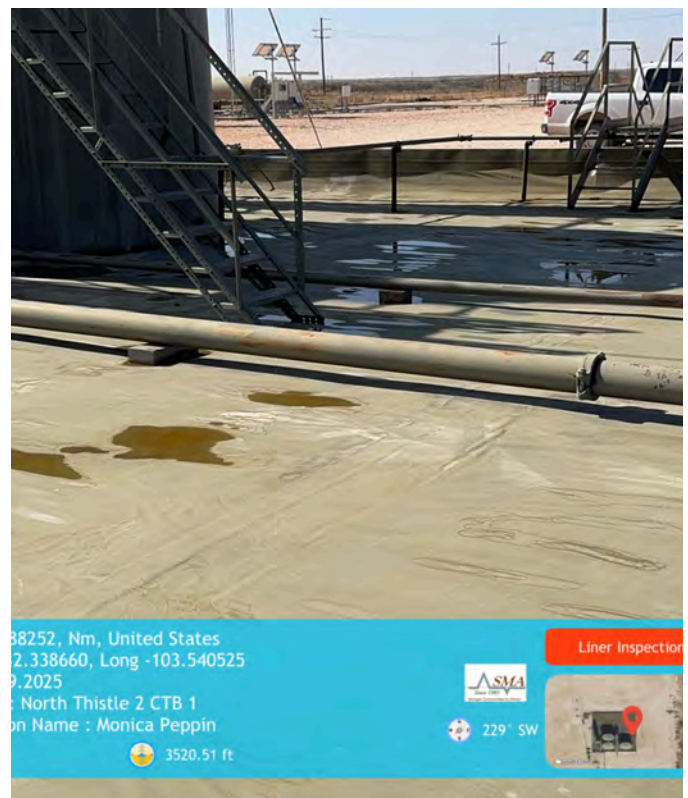
Photograph #22: View from northeast corner facing southwest.

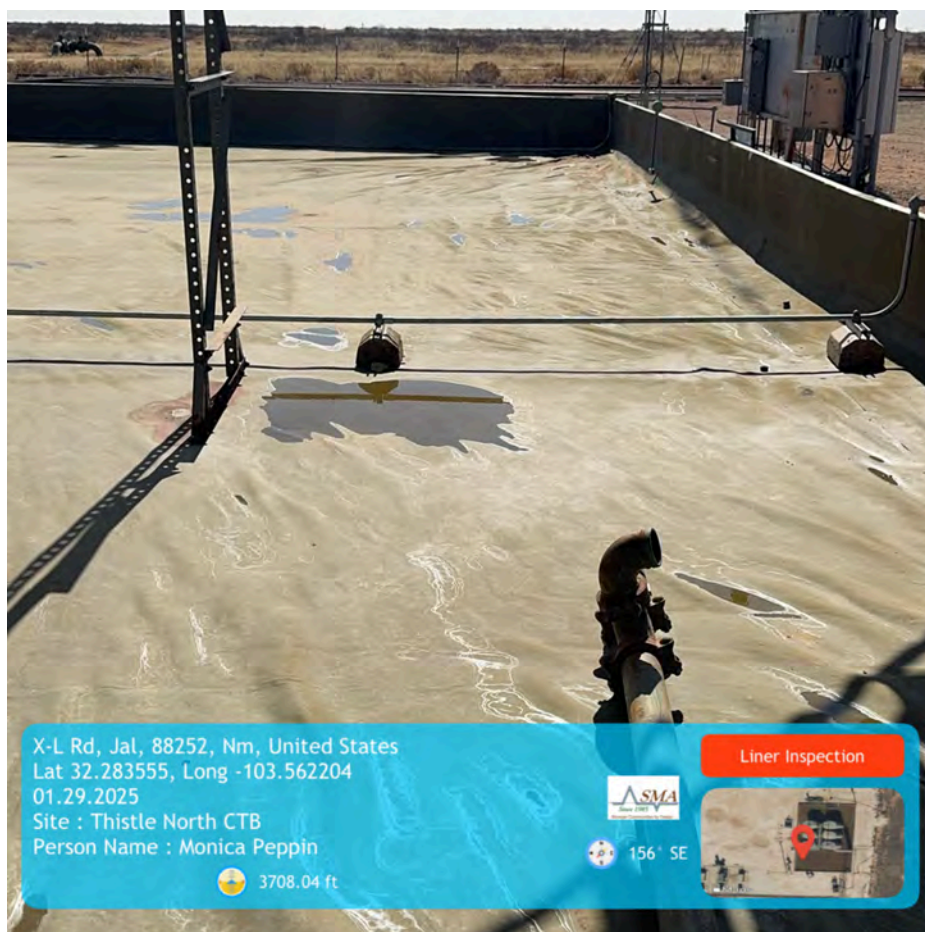
Photograph #23: Southwest corner view from west wall facing south.
