Our Ref.: 12665218-NMOCD-2

May 20, 2025

Closure Report
Devon Energy Production Company, LP
Arena Roja 28 CTB 2
Unit Letter B, Section 28, T26S, R35E
Lea County, New Mexico
(32.01863, -103.372447)

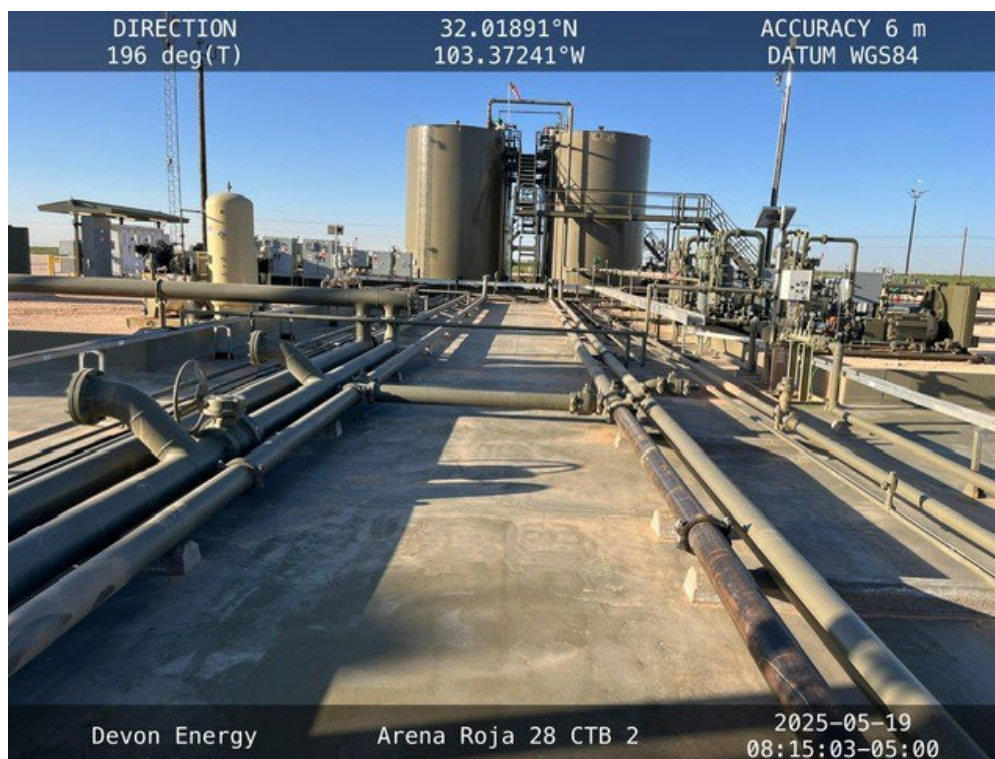
The secondary containment was scheduled for a secondary cleaning, and a liner inspection notice was provided on May 14, 2025. The liner inspection was completed on May 19, 2025. The liner was visually inspected and no rips, tears, holes, or damages in the liner were observed. The liner was determined to be intact with no integrity issues. Photographic documentation of the liner inspection is presented in

Photo 2 View of secondary containment facing south.

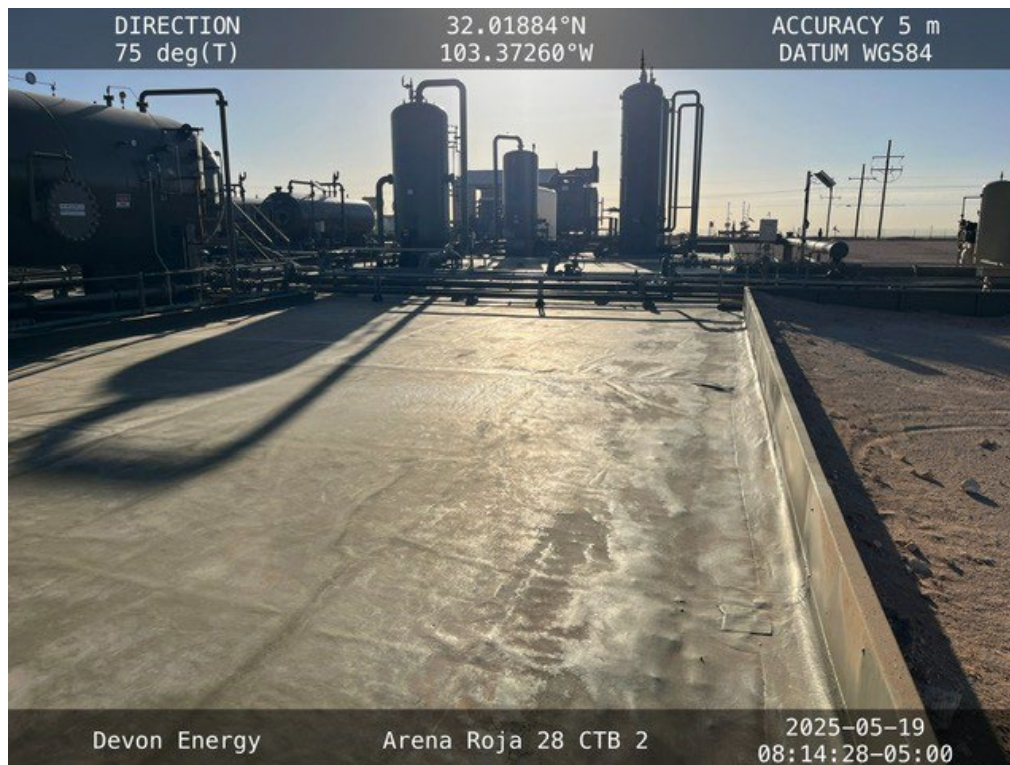
Photo 3 View of secondary containment facing northeast.

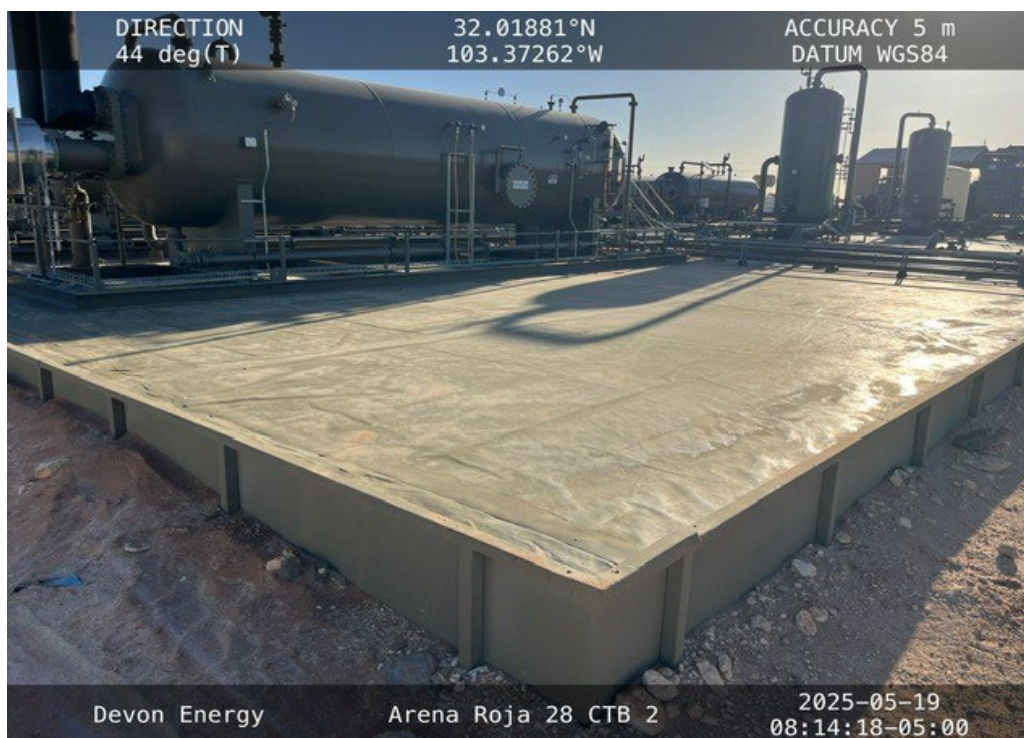
Photo 4 View of secondary containment facing northeast.

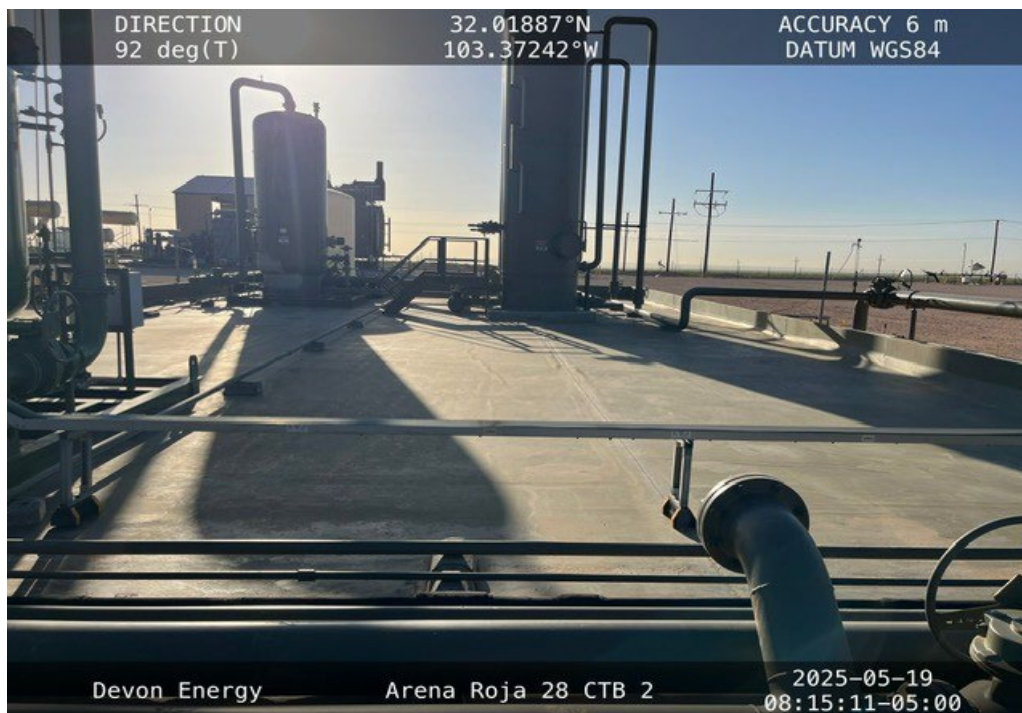
Photo 5 View of secondary containment facing east.

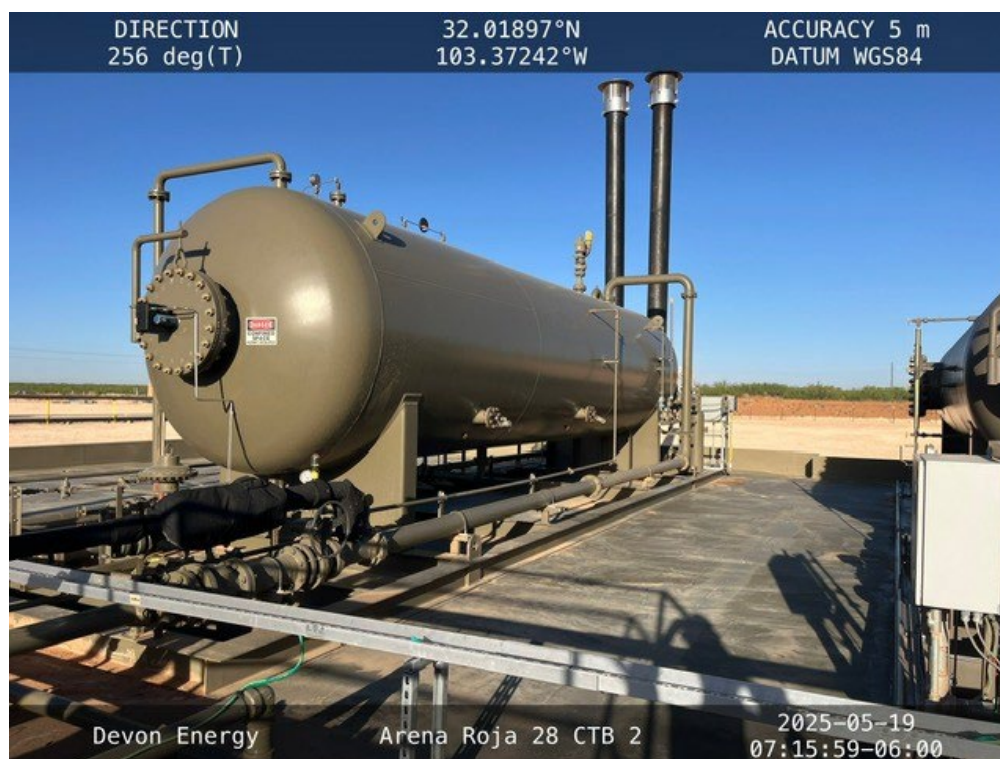
Photo 6 View of secondary containment facing northwest.

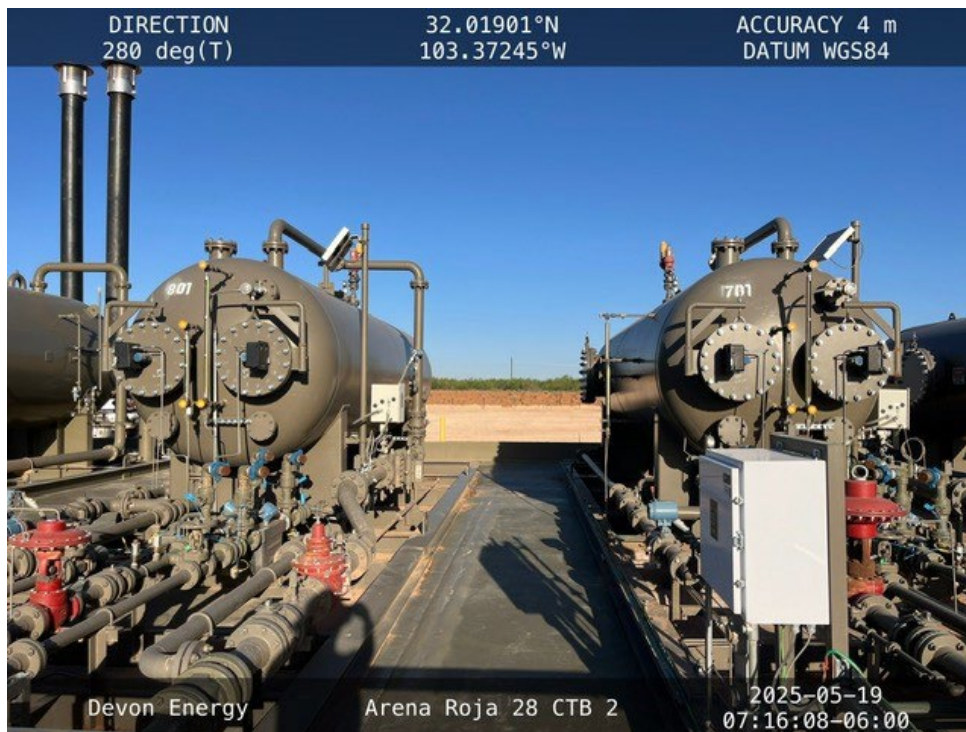
Photo 7 View of secondary containment facing west.

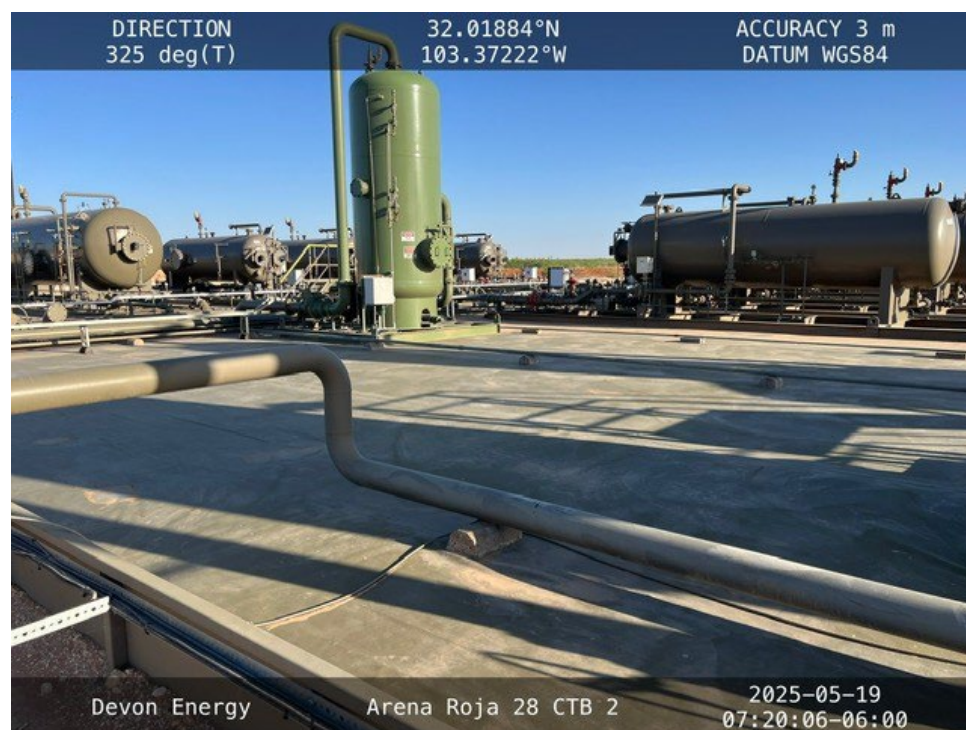
Photo 8 View of secondary containment facing northwest.

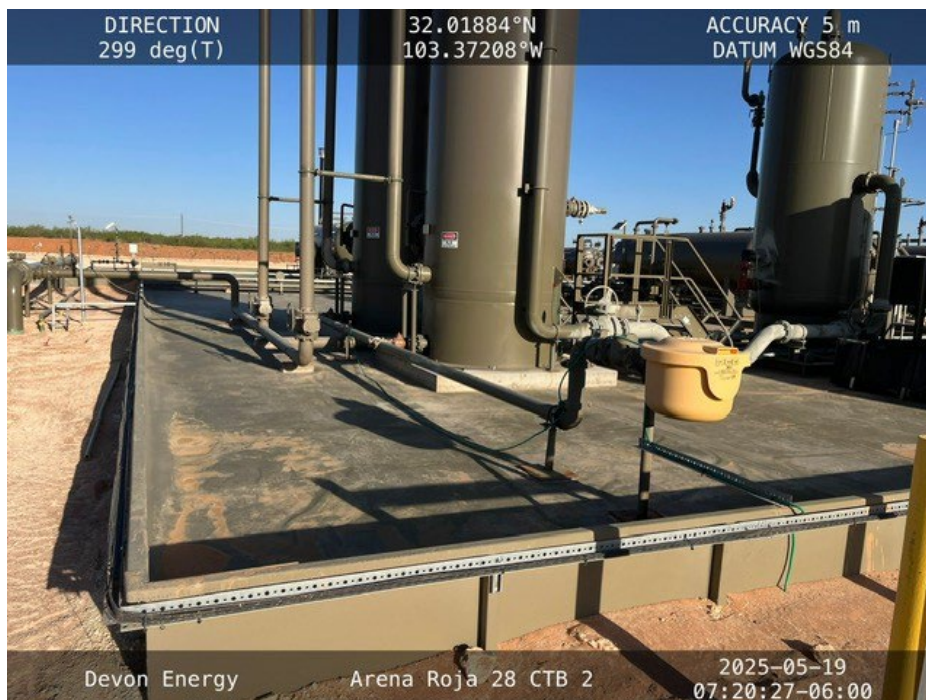
Photo 9 View of secondary containment facing northwest.

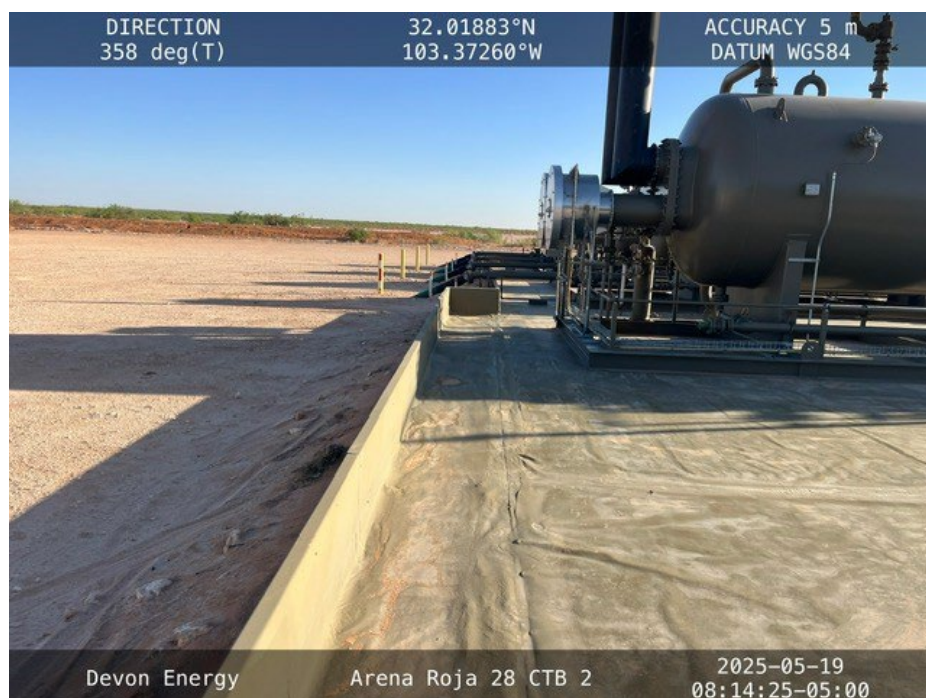
Photo 10 View of secondary containment facing north.
