SUBJECT: Liner Inspection and Closure Report for Cotton Draw Unit 219 Battery – May 16, 2025 Site Visit

Incident ID: nAPP2511826834  
Facility ID (Name): fAPP2123135798 (COTTON DRAW UNIT 219 CTB)  
Facility Location: Unit M of Section 2, Township 25 South, Range 31 East, New Mexico  
Facility GPS Coordinates: 32.152331, -103.743680  
Eddy County, New Mexico

# Environmental Liner Inspection Field Notes & Photolog Report

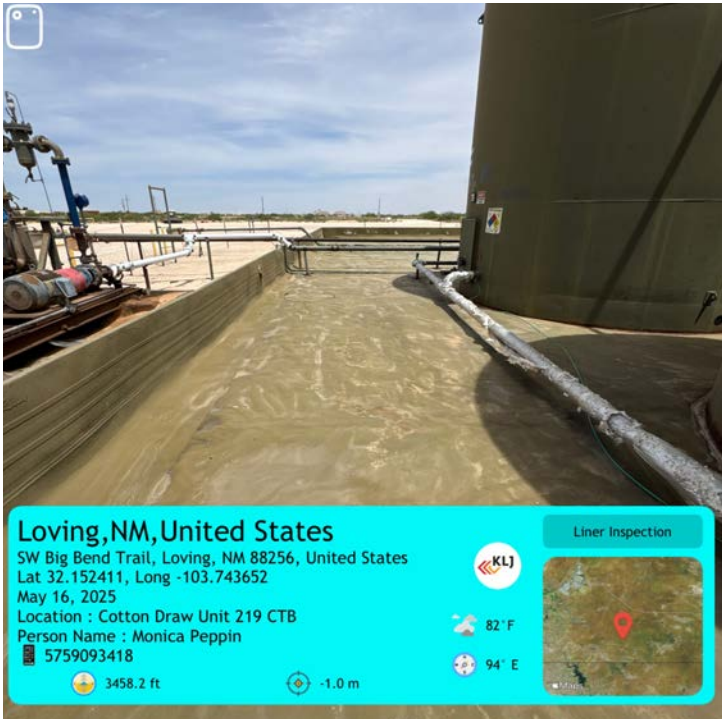
East view of north wall of containment.

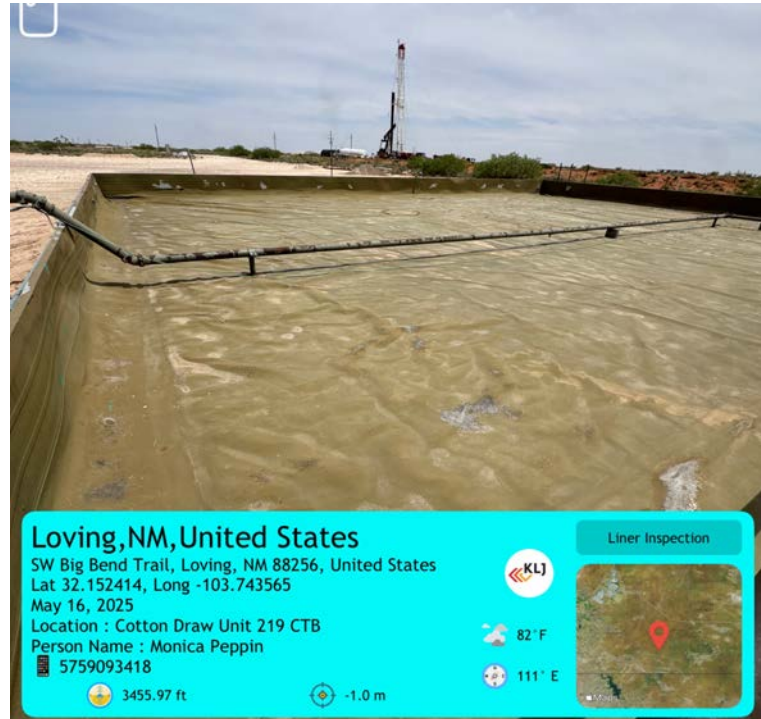
Southeast view of open area from north wall.

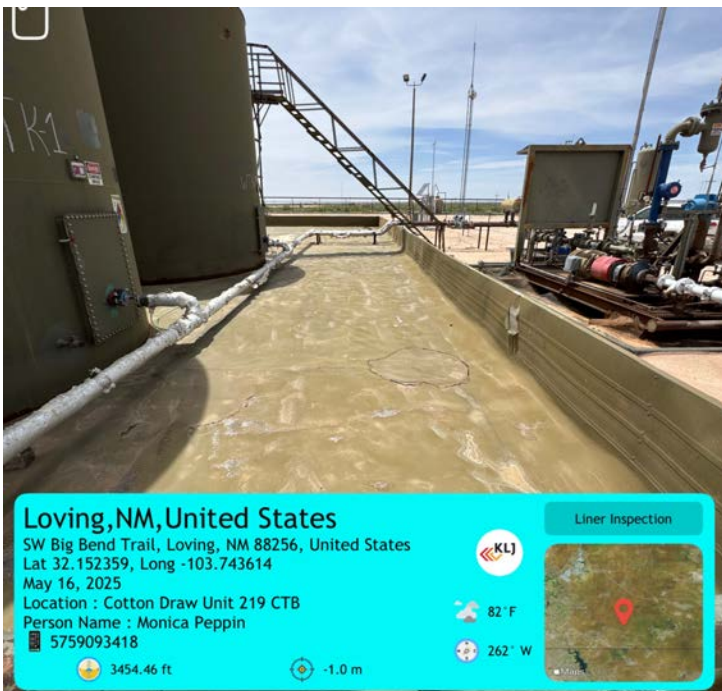
East view of north wall of containment.

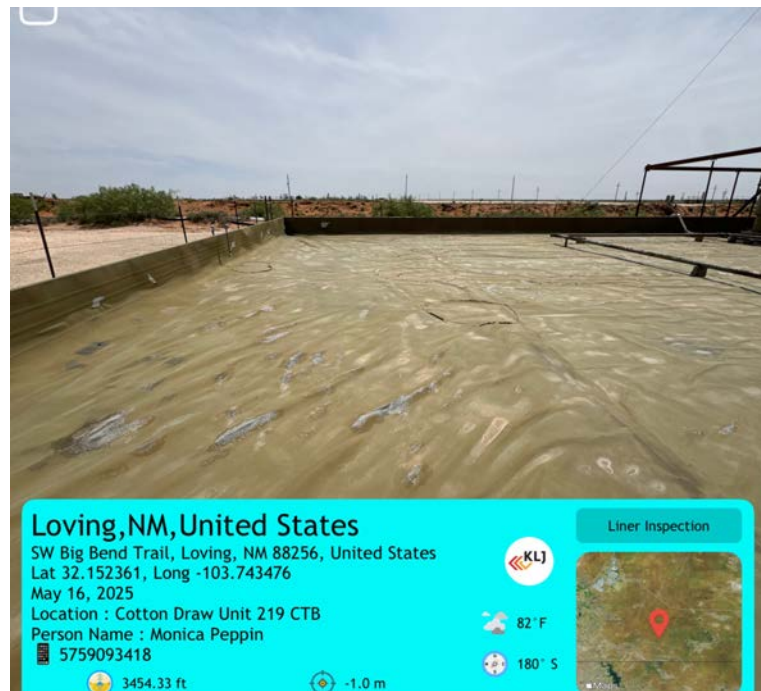
Facing south viewing liner on east side of containment.

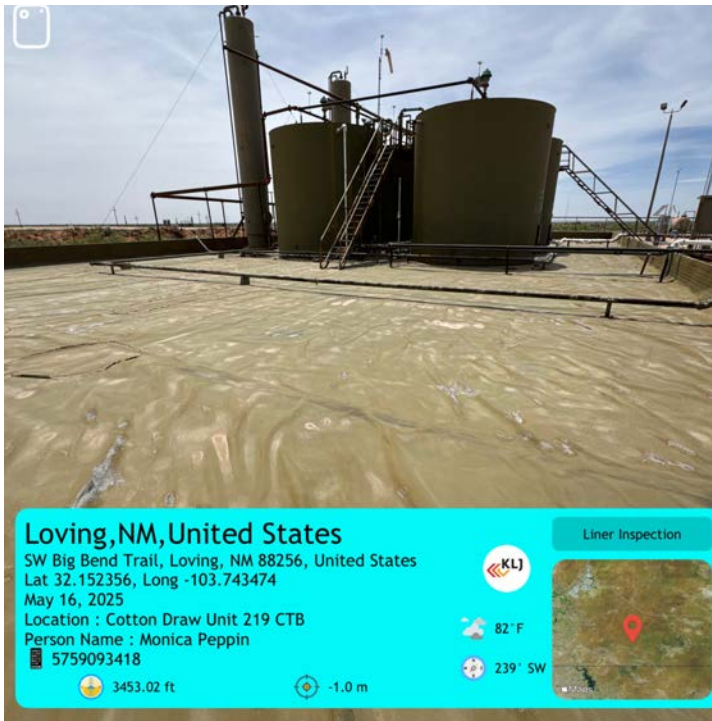
View from northeast corner looking towards tanks.

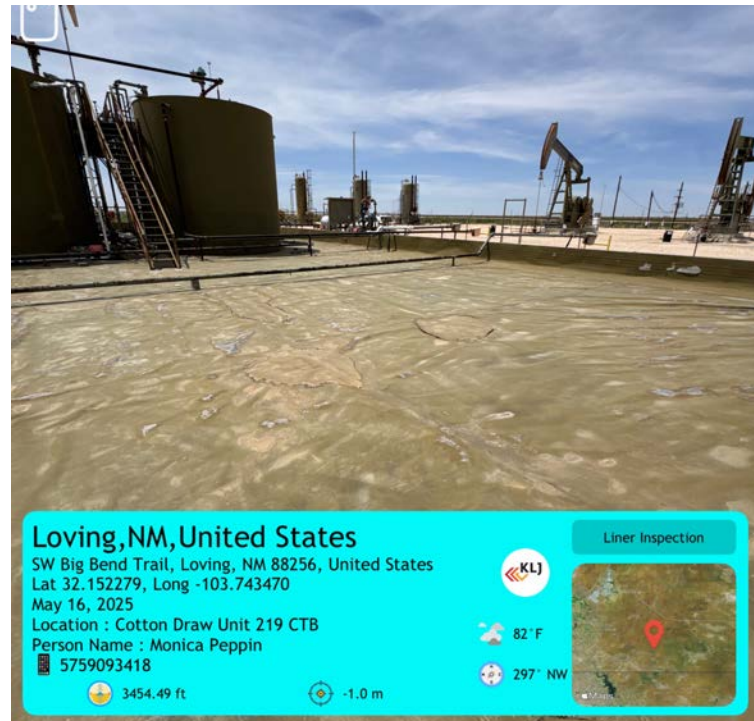
View from southeast corner towards tanks.

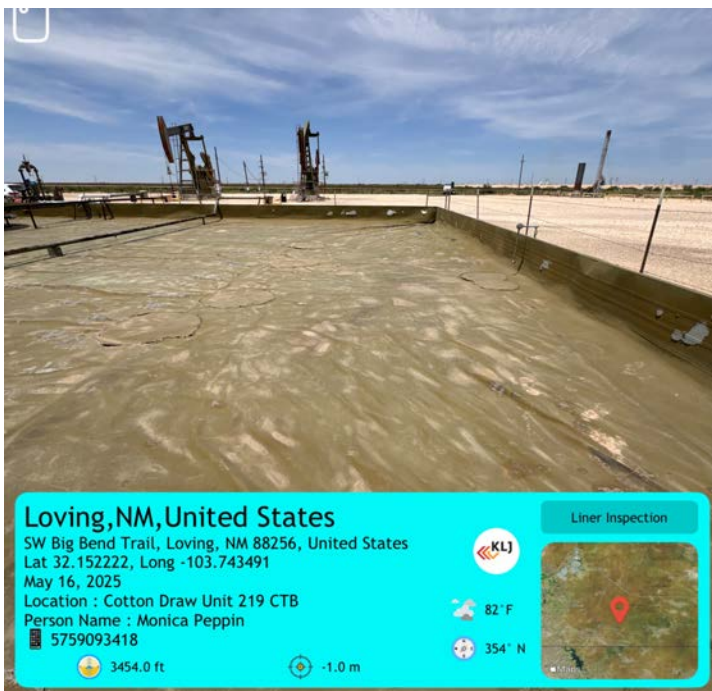
View of east wall facing north from south side of containment.

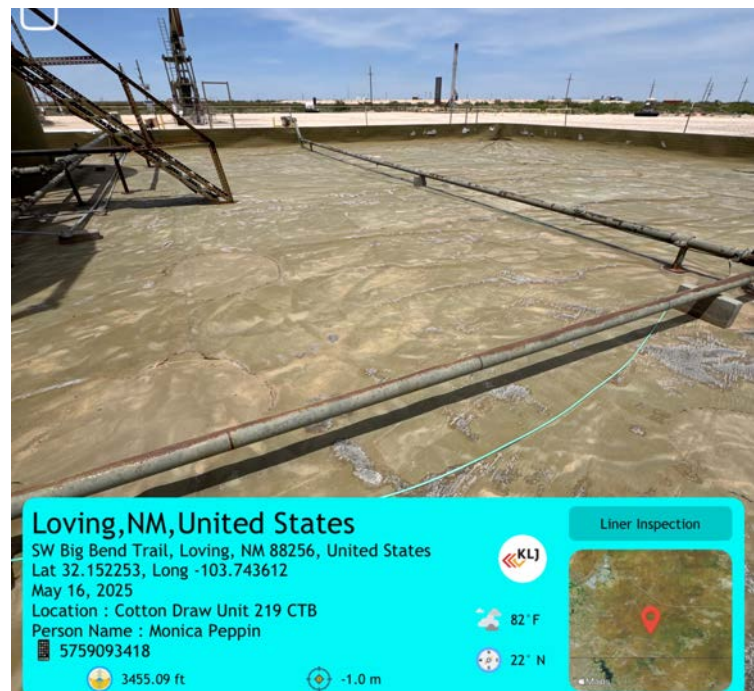
Facing northeast viewing liner on east end of containment.

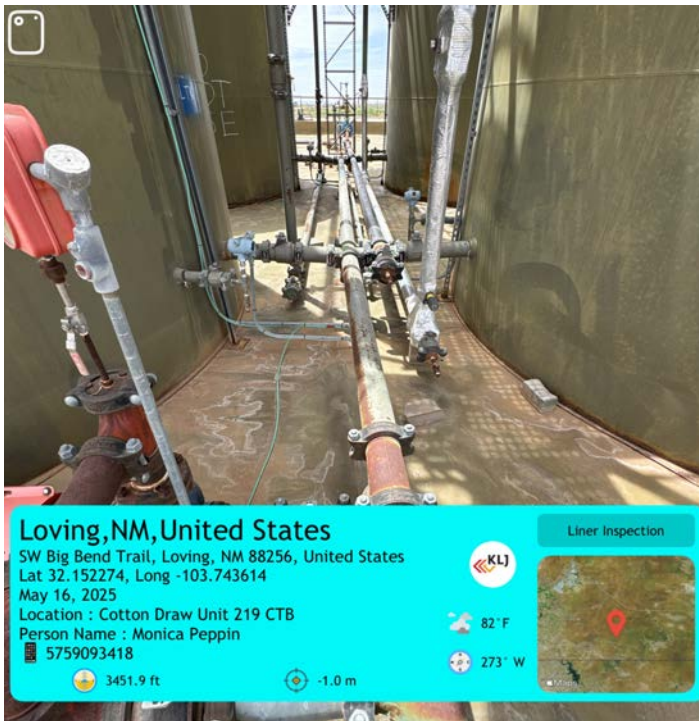
Liner between tanks facing west from east side of containment.

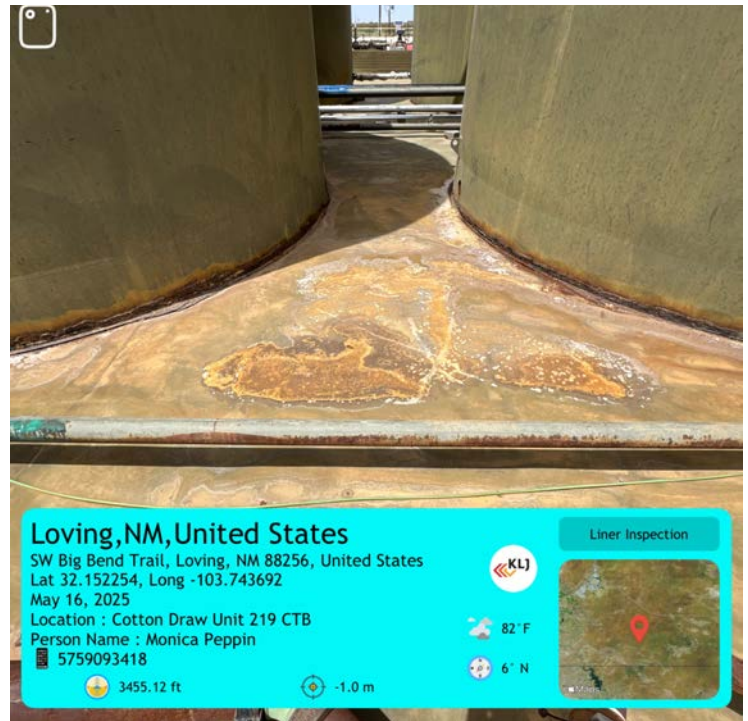
Liner between tanks facing south from north side.

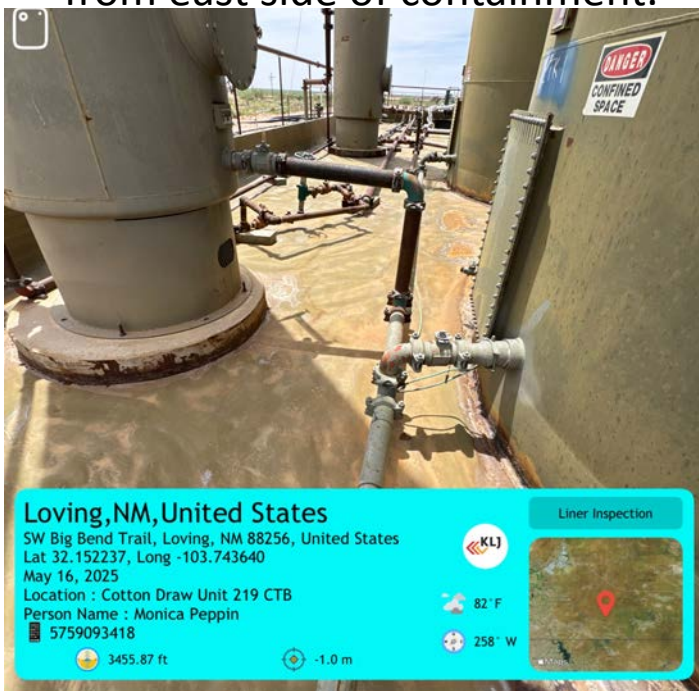
East wall of containment from south corner facing north.

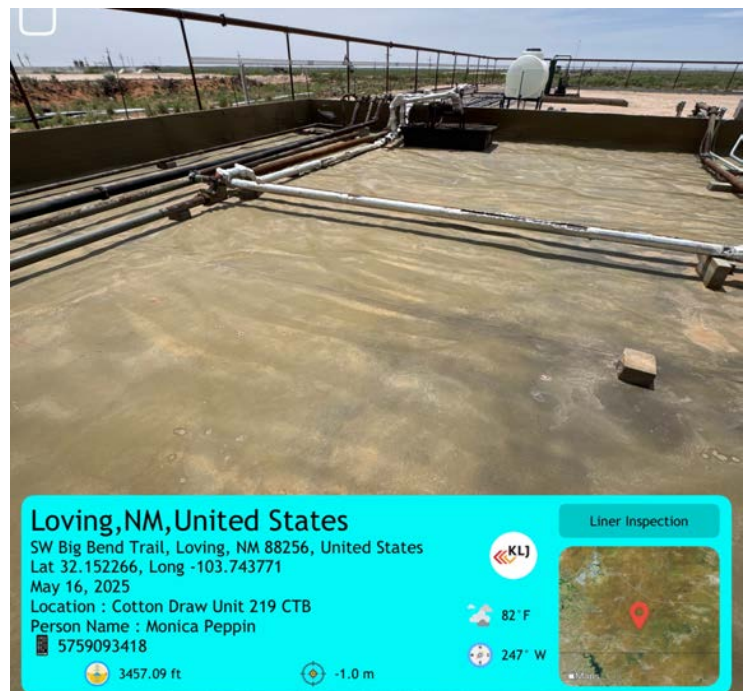
Liner area in southwest corner of containment view taken near tank.

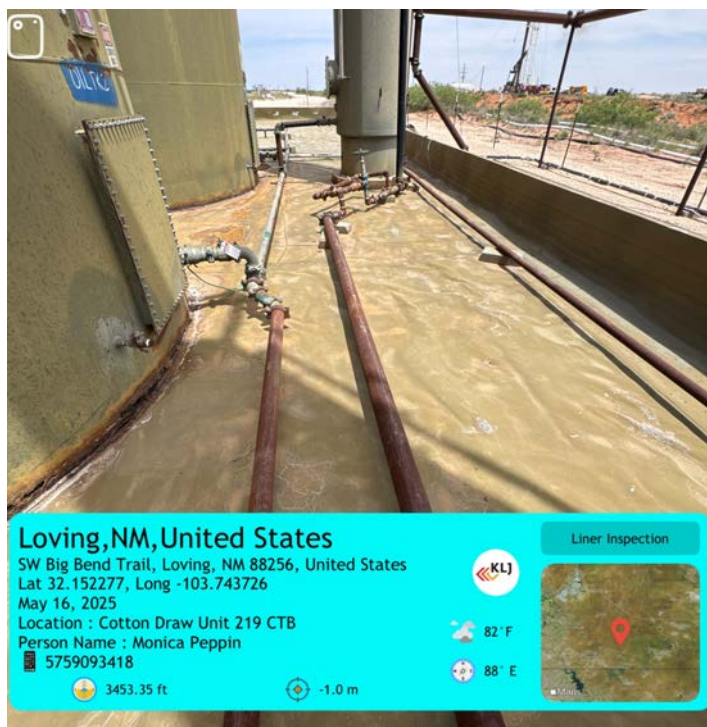
View of liner on south end from west wall facing east.

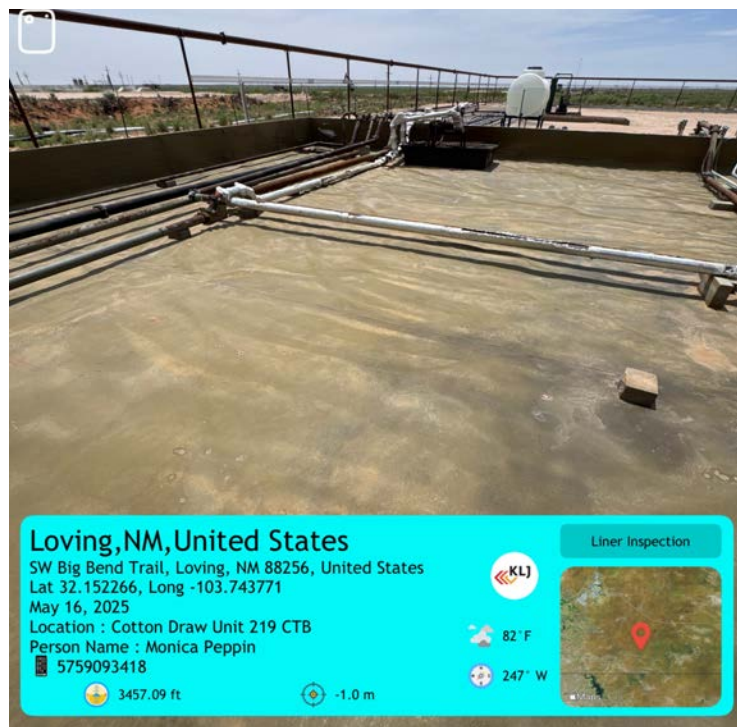
View of liner near pumps and west wall facing north.

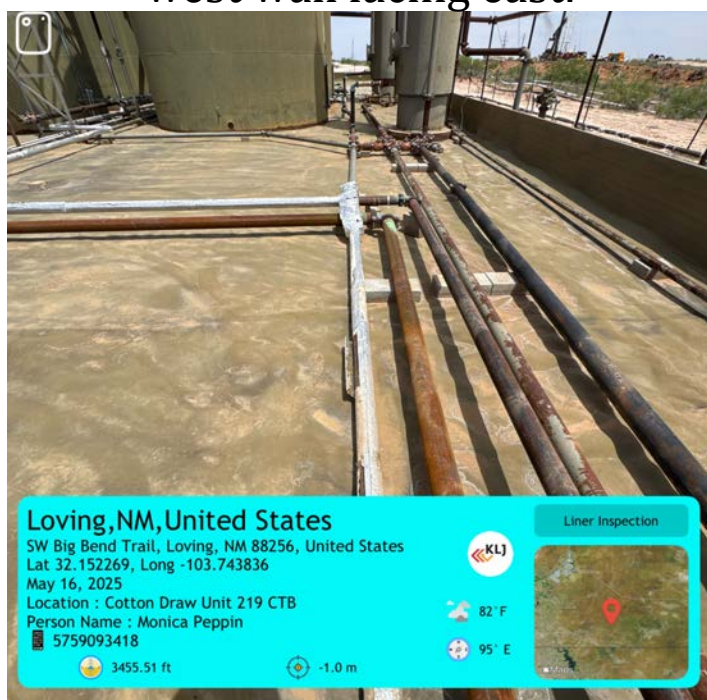
View of liner under piping and near equipment from southwest corner.

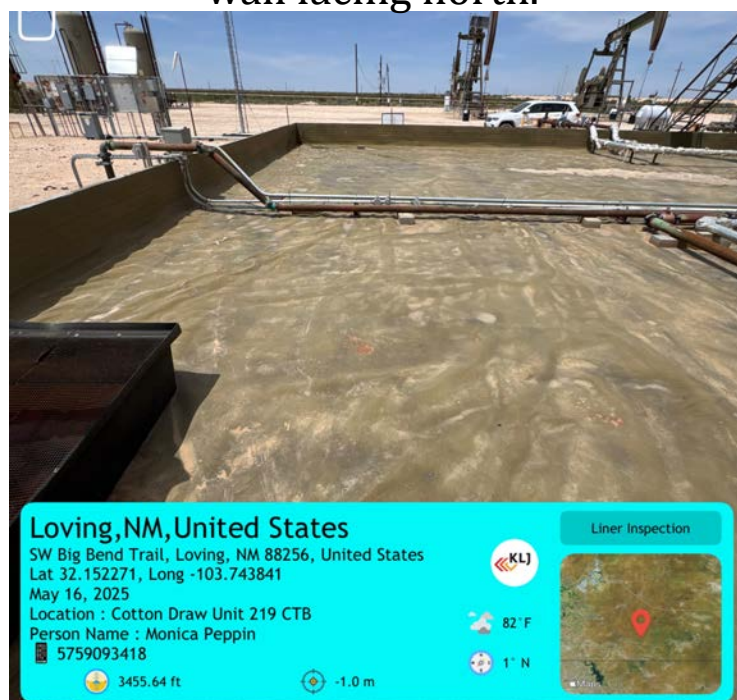
West side of containment viewing southwest corner of liner.

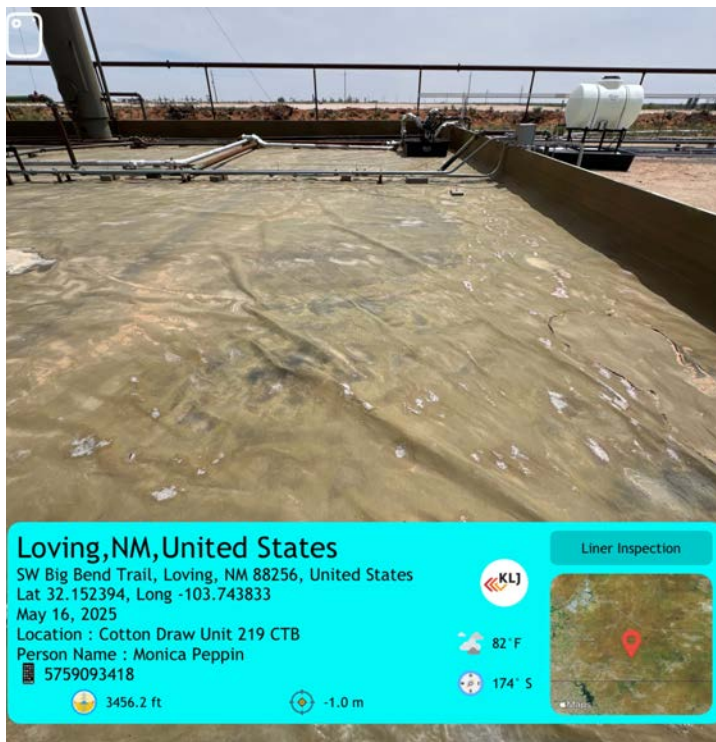
West wall view from north side facing south.

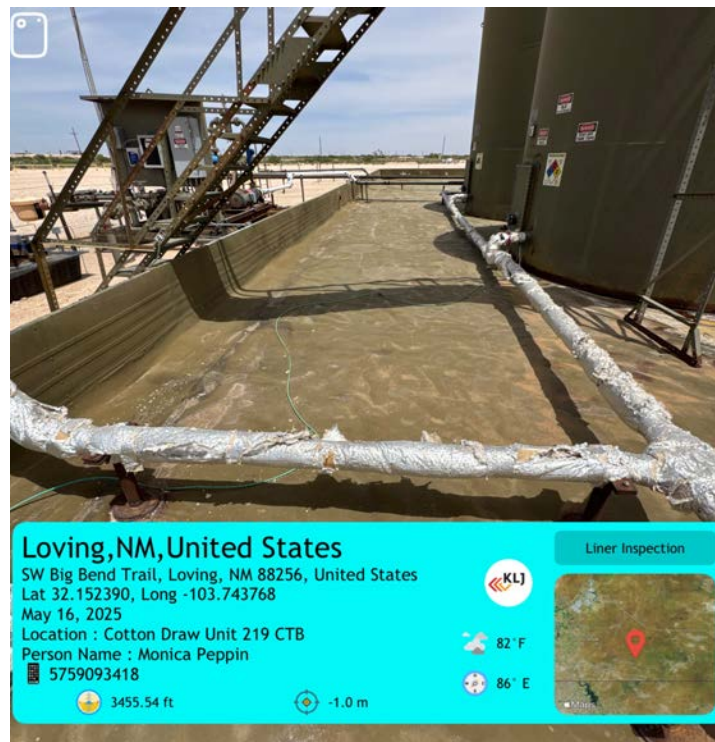
View from west wall of north side of containment.

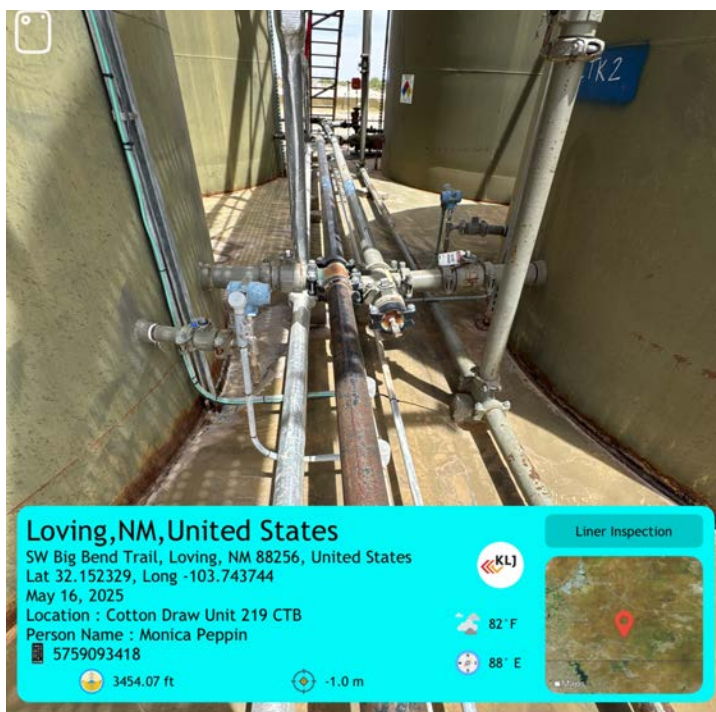
View of liner between tanks facing east from west side.

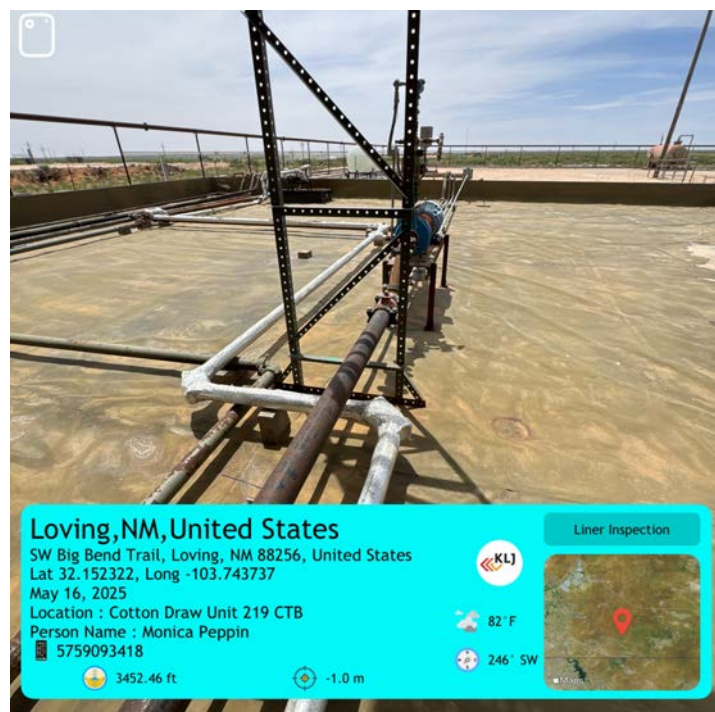
View of west end from between tanks facing west.

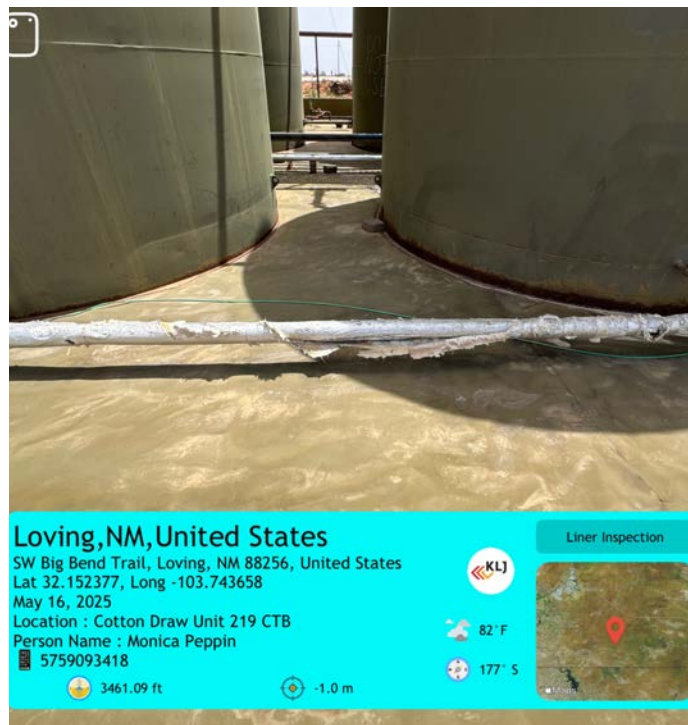
View of liner between tanks from west side facing east.

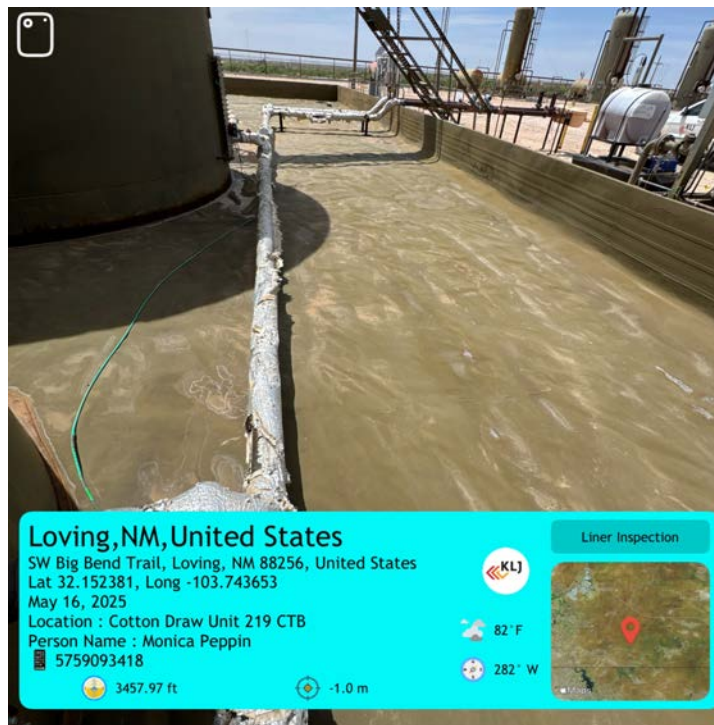
View of liner near equipment of north end facing west.
