# *Liner Inspection Closure Report*

## **Mimosa 18 CTB 1**

**Site Name:** Mimosa 18 CTB 1  
**Incident ID:** nAPP2511828007  
**Facility ID:** fAPP2405030777

SUBJECT: Liner Inspection and Closure Report for Mimosa 18 CTB 1 – May 21, 2025 Site Visit

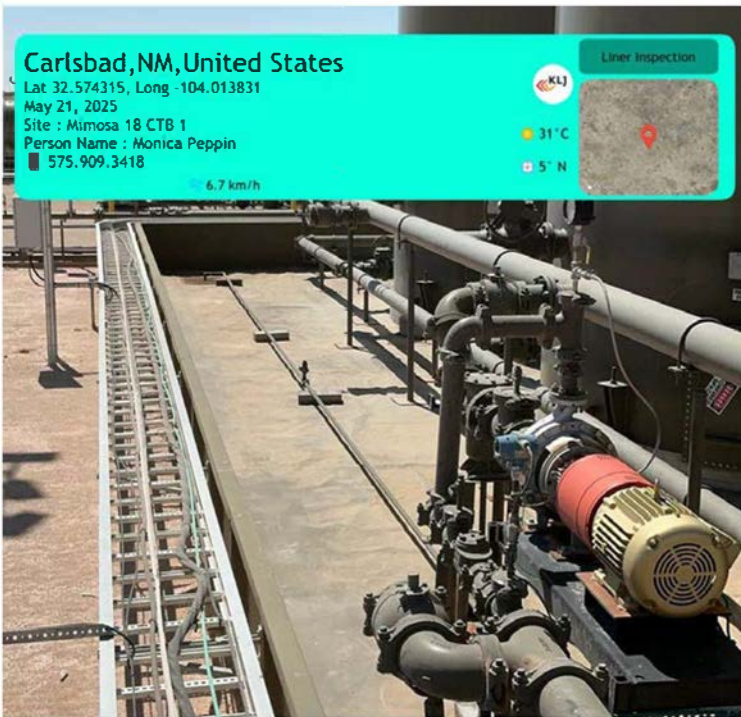
West view of liner on south wall.

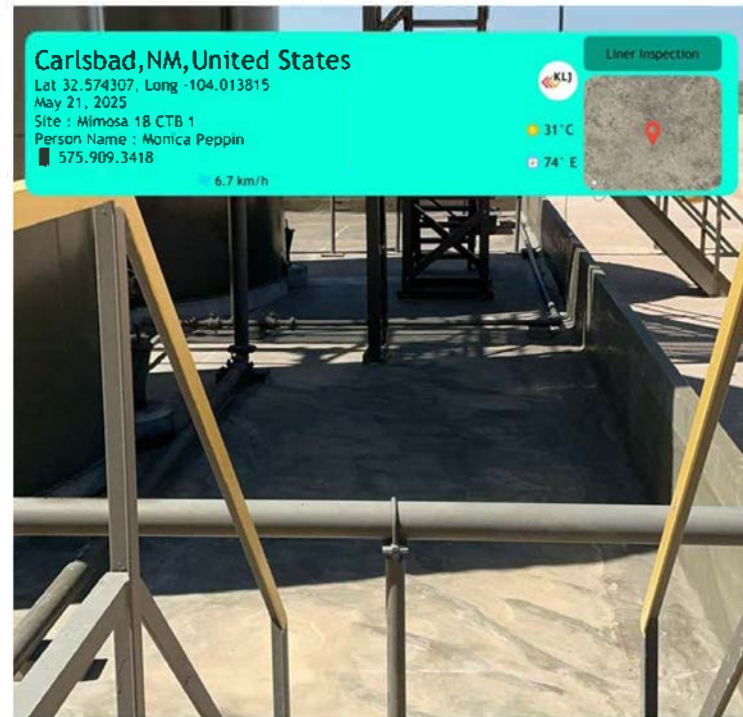
Looking north viewing east side of containment.

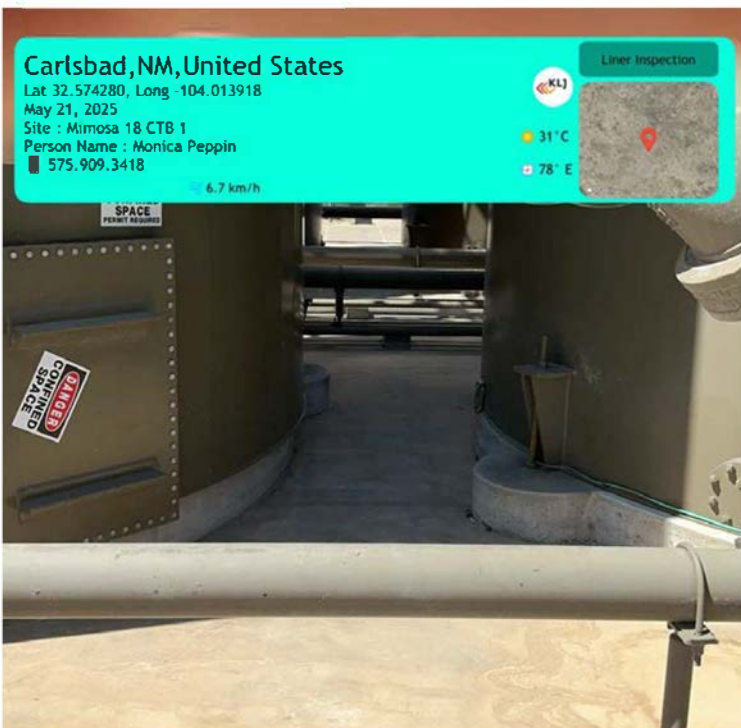
Liner between tanks on southeast side.

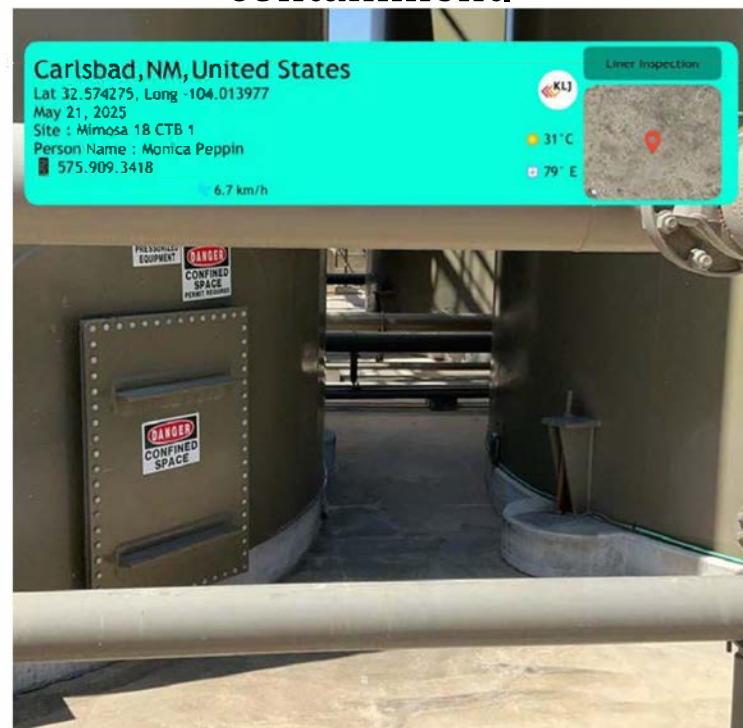
Middle area of liner between tanks.

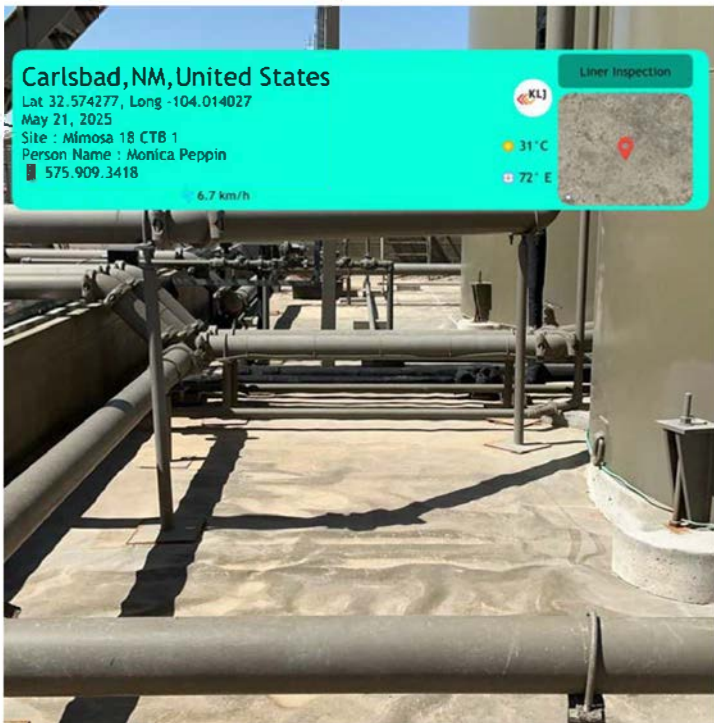
View of liner facing east from west wall.

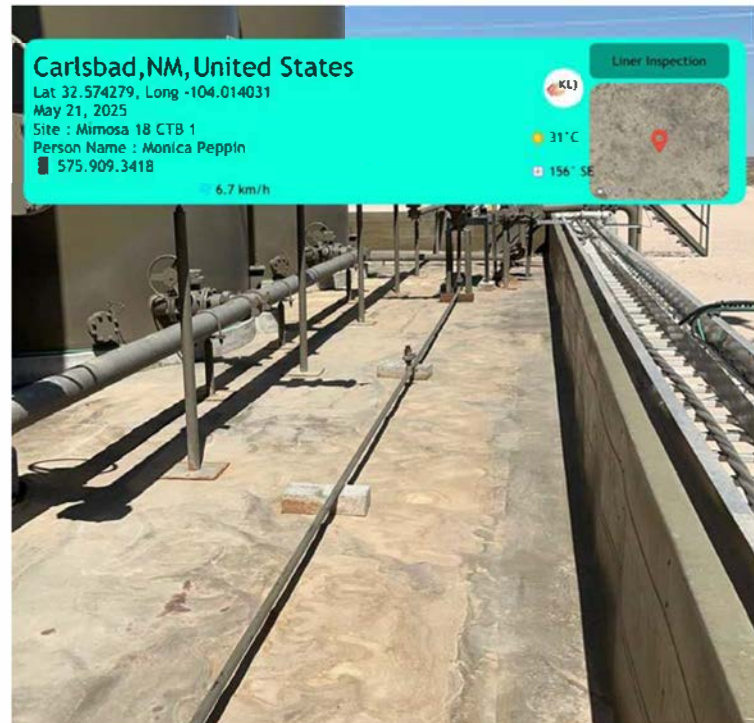
View of south wall facing east.

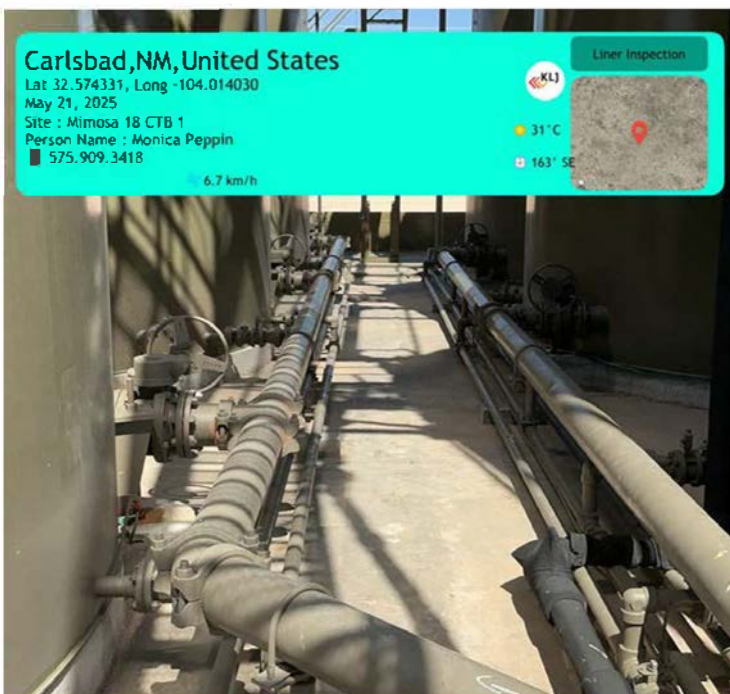
Liner between tanks facing east from west side.

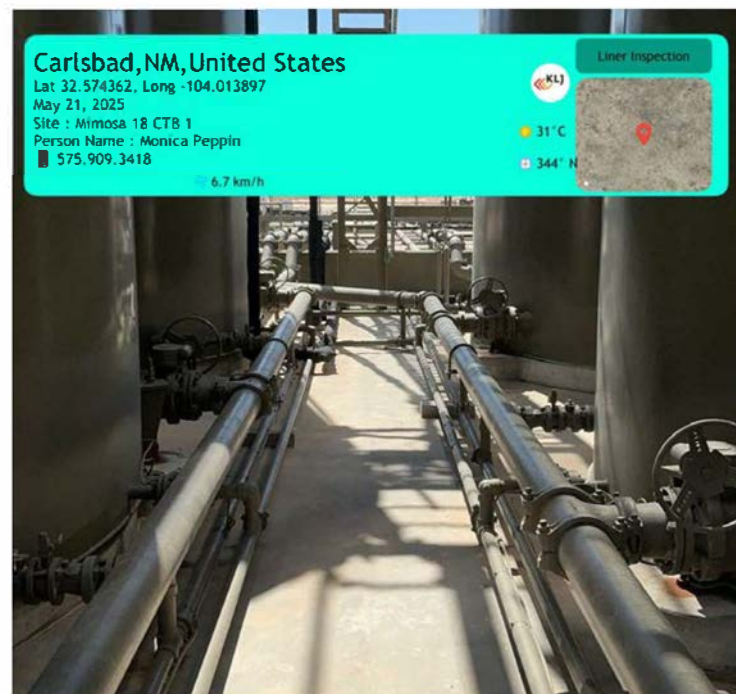
Liner between tanks facing west from east side.

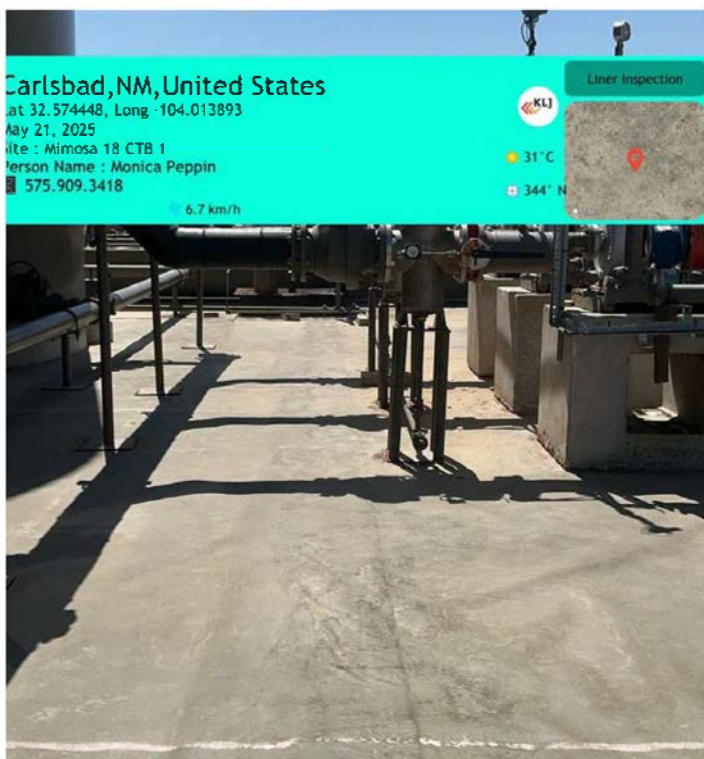
North side of containment facing west near transfer pumps.

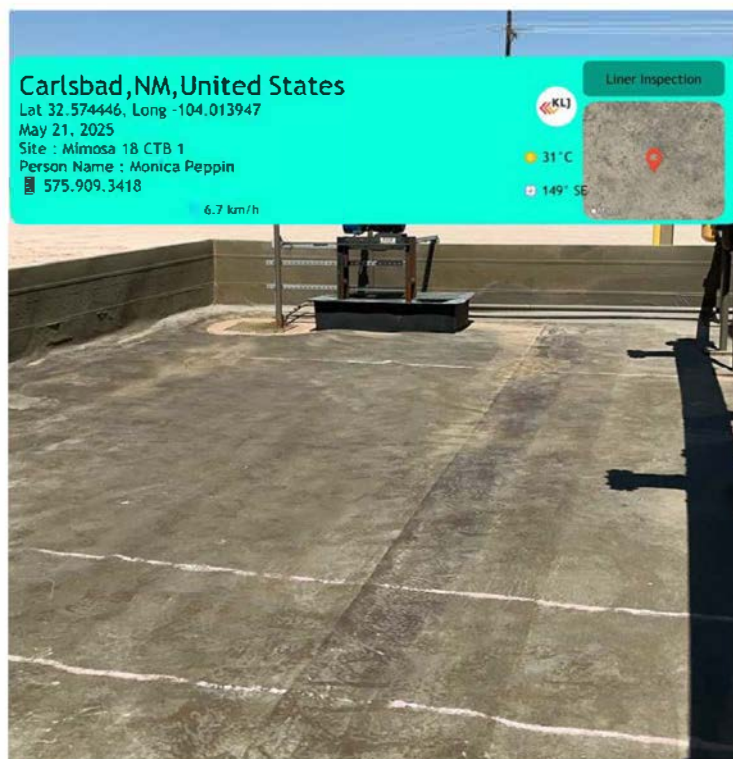
Northeast corner of containment view.

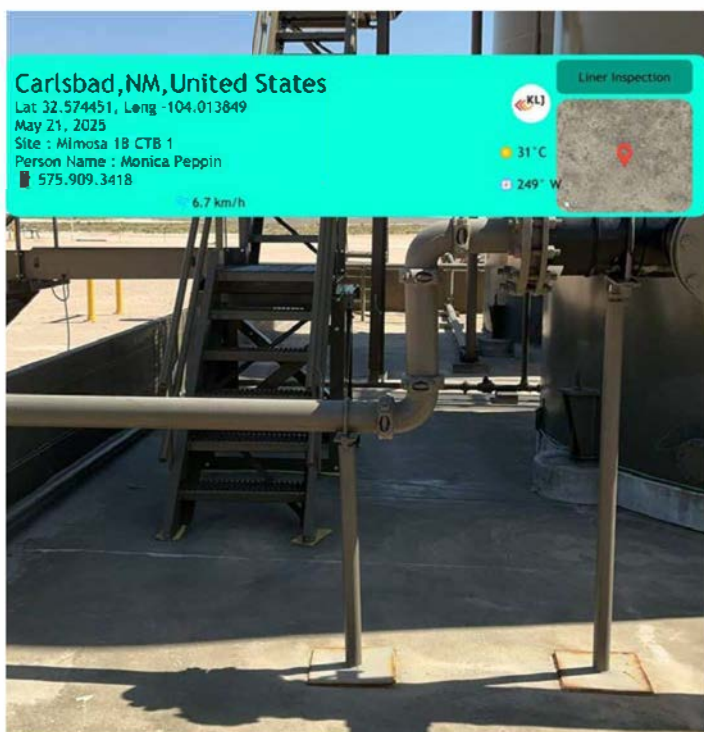
Liner between tanks from south end facing north.

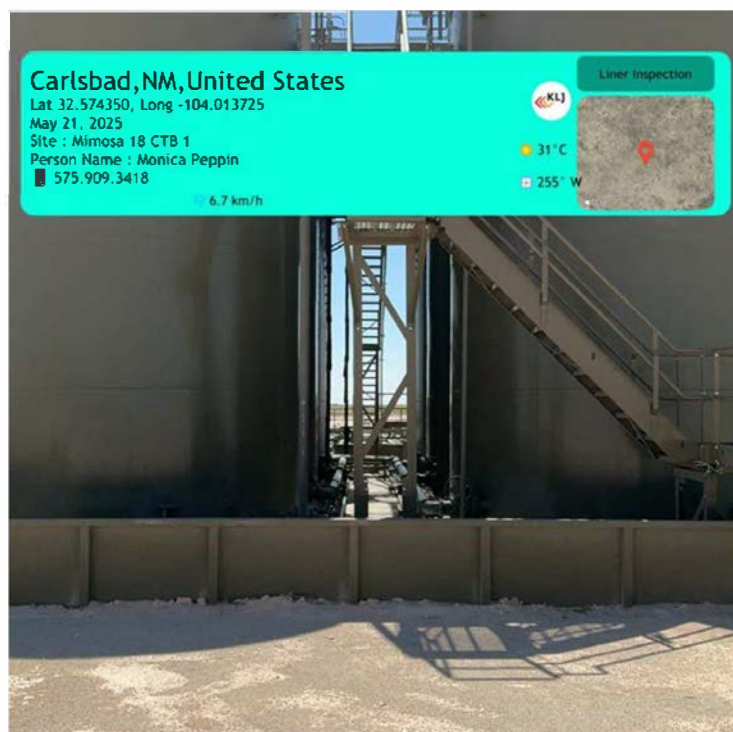
Liner from outside containment facing north.
