SUBJECT: Liner Inspection and Closure Report for Shetland 11 CTB 1– May 27, 2025 Site Visit

Incident ID: nAPP2511829379  
Facility ID (Name): fAPP2123649550 (SHETLAND 11 CTB 1)  
Facility Location: Unit D of Section 11, Township 26 South, Range 31 East, New Mexico  
Facility GPS Coordinates: 32.052915, -103.749751  
Eddy County, New Mexico

# Environmental Liner Inspection Field Notes & Photolog Report

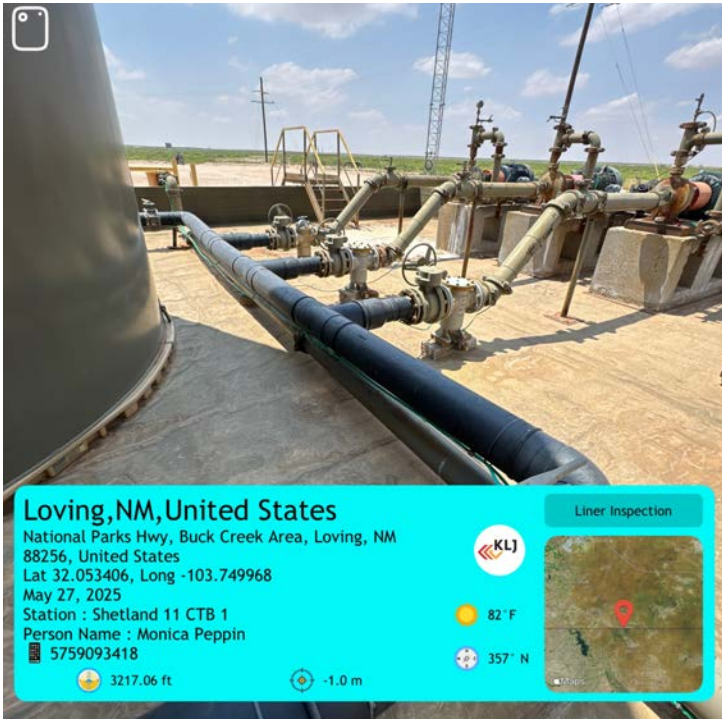
Northwest view of liner from mid-area of containment.

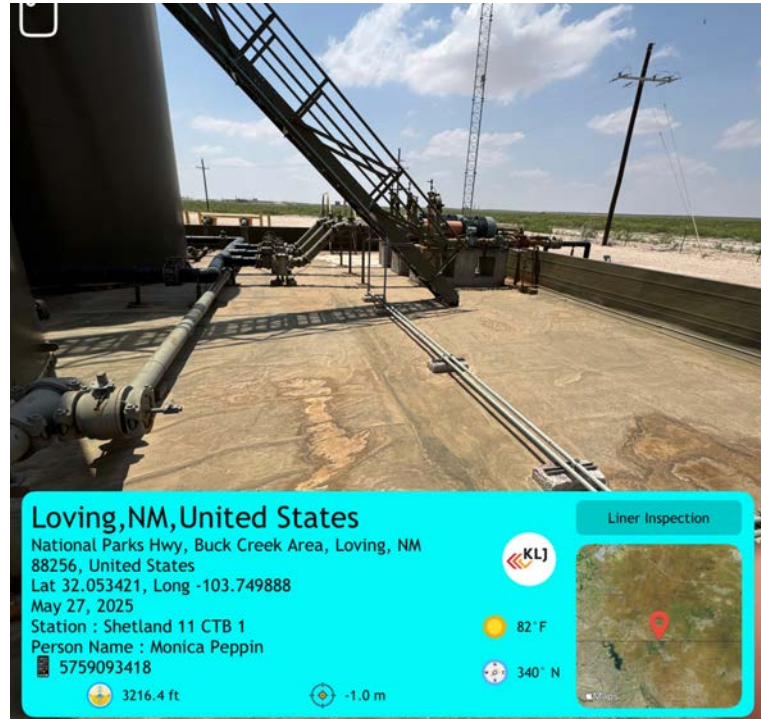
Northwest view of open area from east wall.

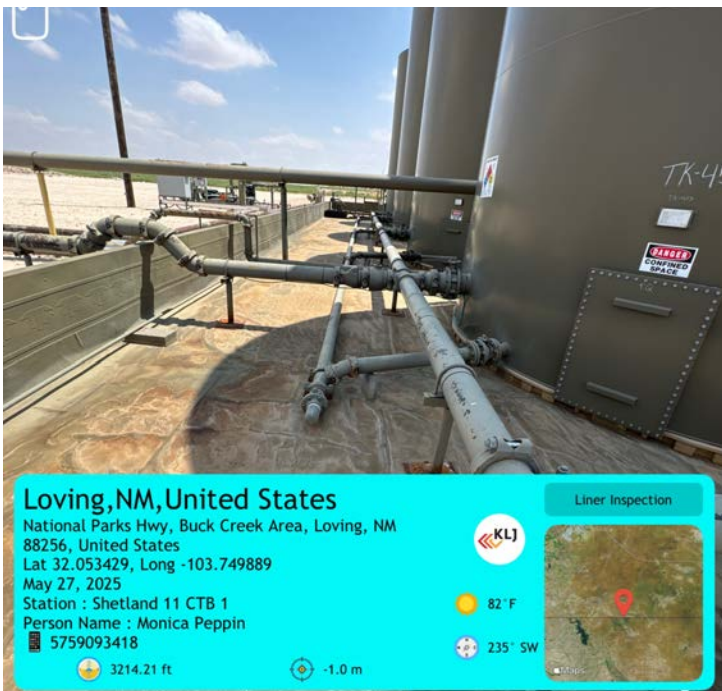
South view of east wall of containment.

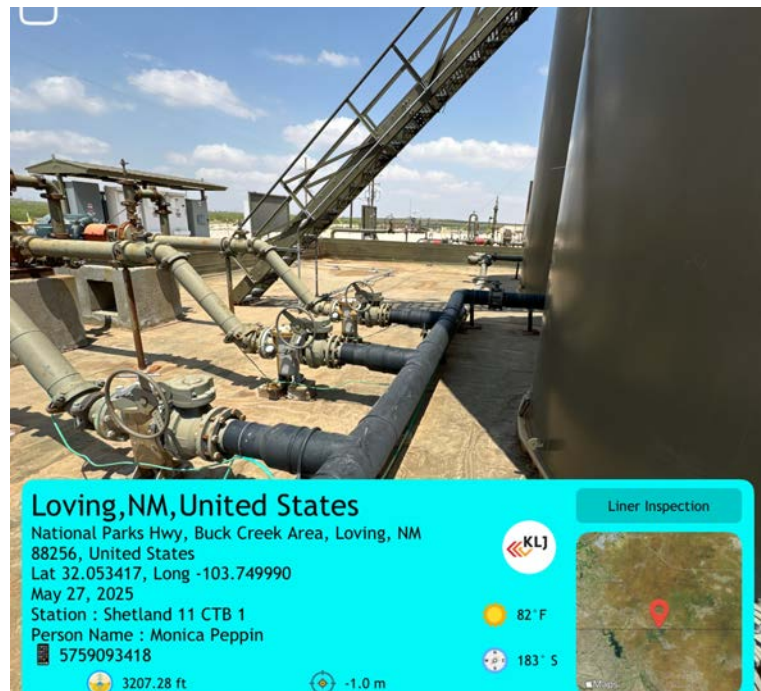
Facing east viewing liner of north end of containment.

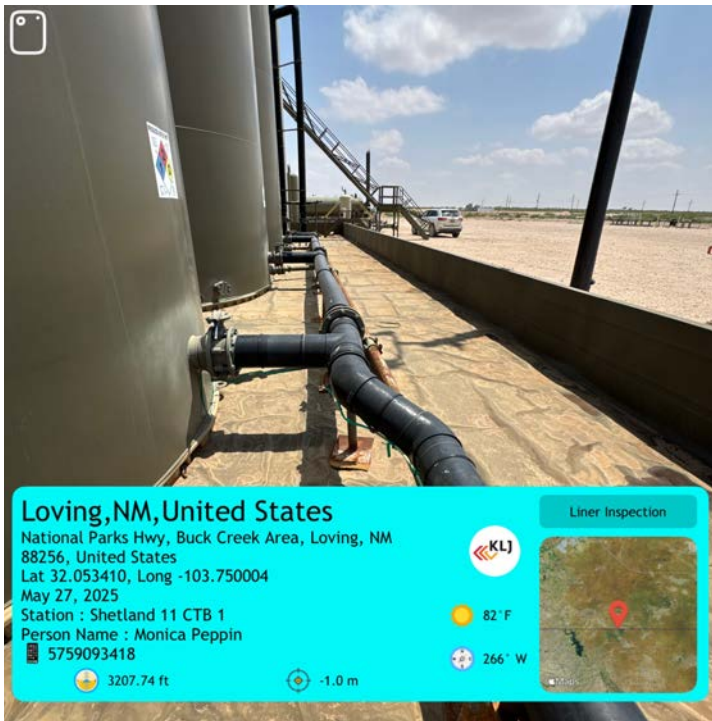
View of west wall of from north end of containment.

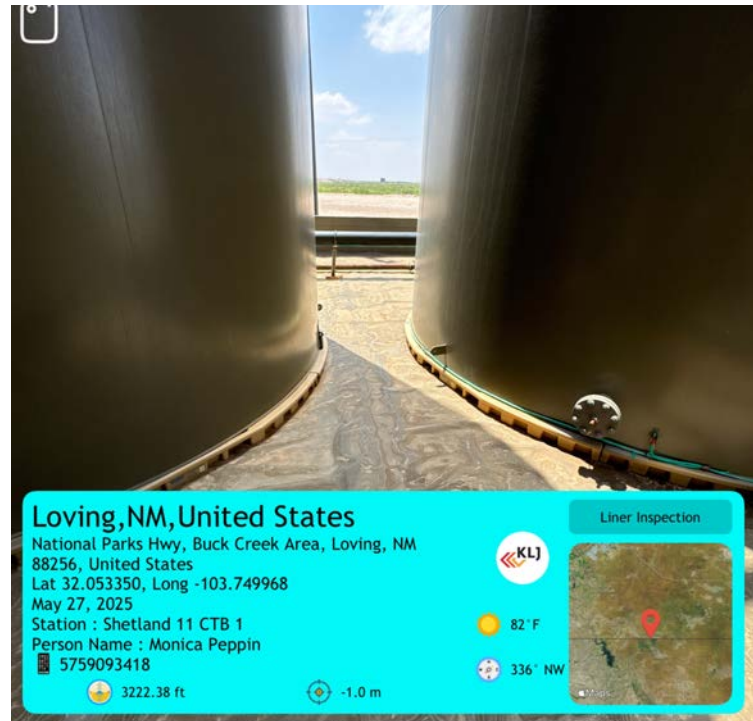
Liner between tanks on south end of containment.

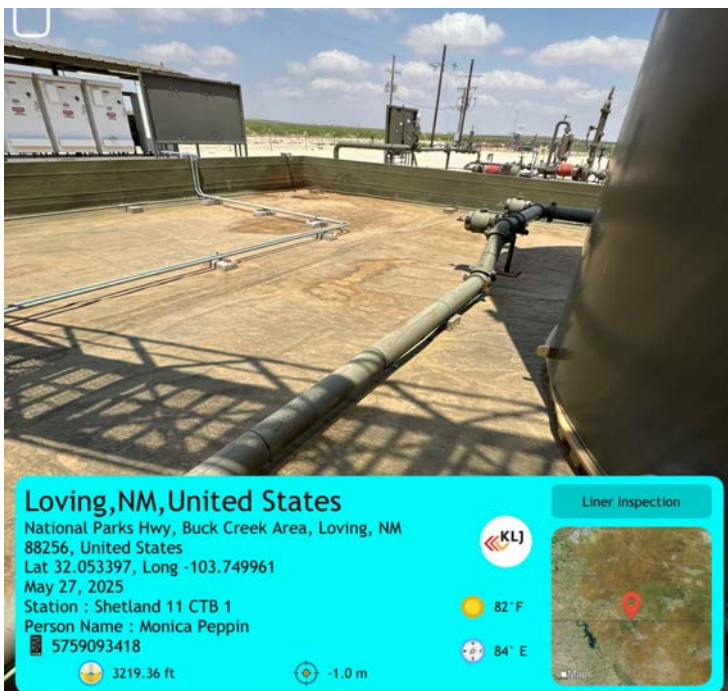
View of north end of containment facing northeast.

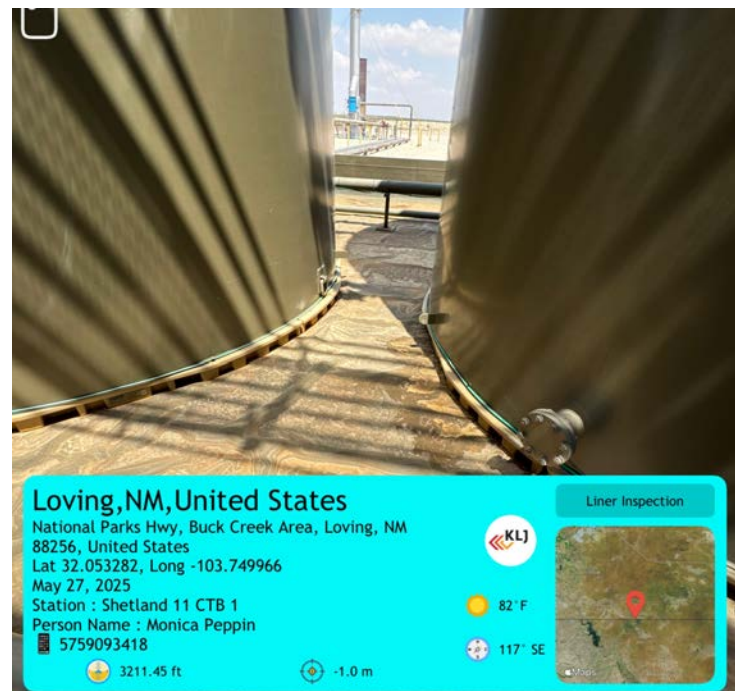
Facing northeast viewing liner between middle tanks.

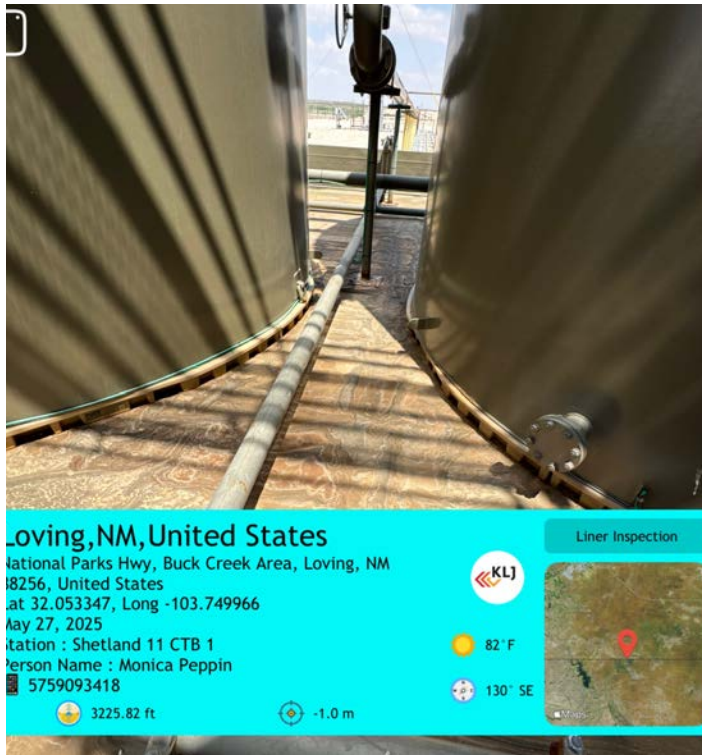
Liner between tanks facing west from east side of containment.

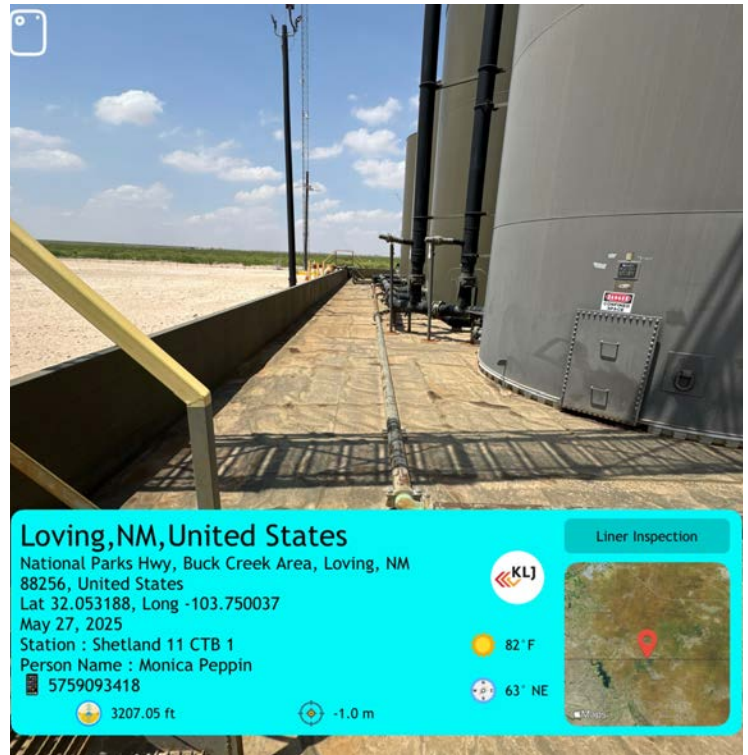
Liner on west wall of containment facing north.

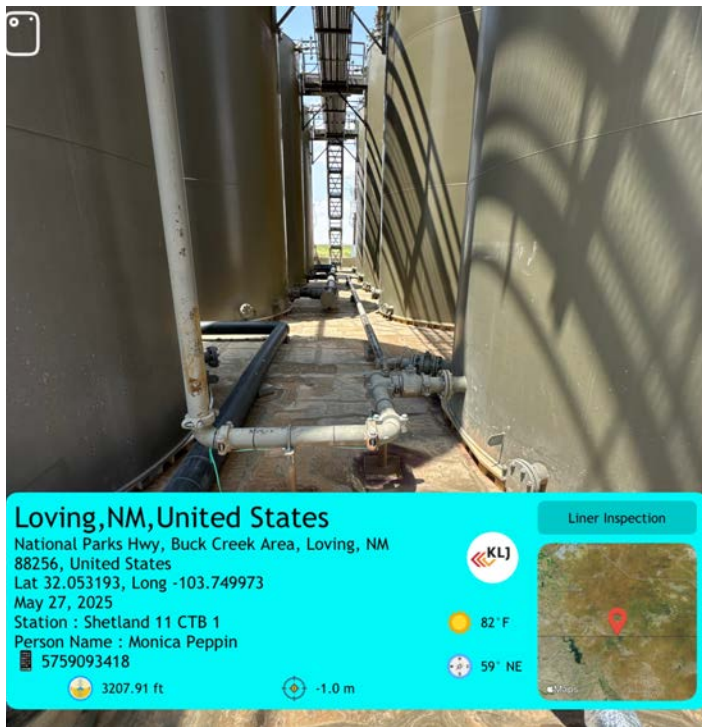
Liner between tanks from south end facing north.

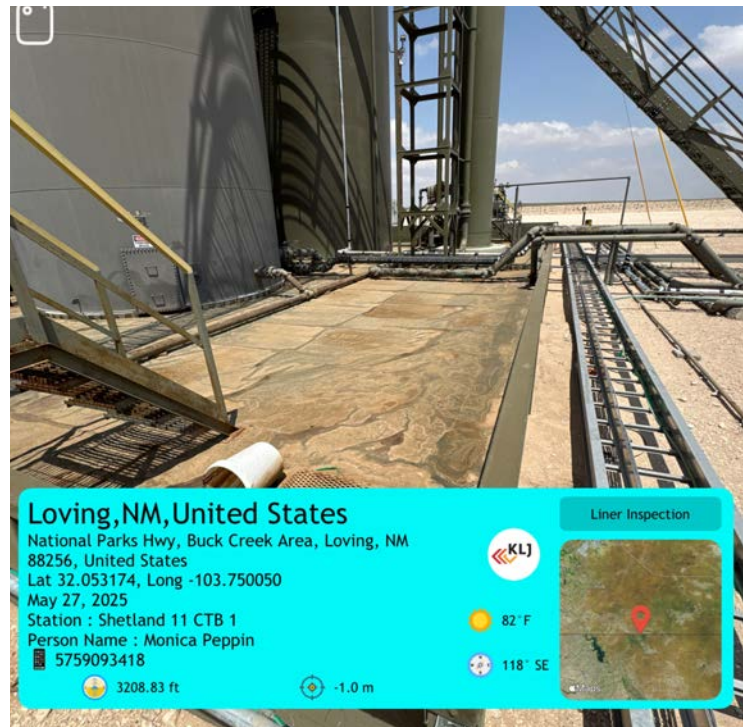
Liner area from southwest corner of containment facing east.

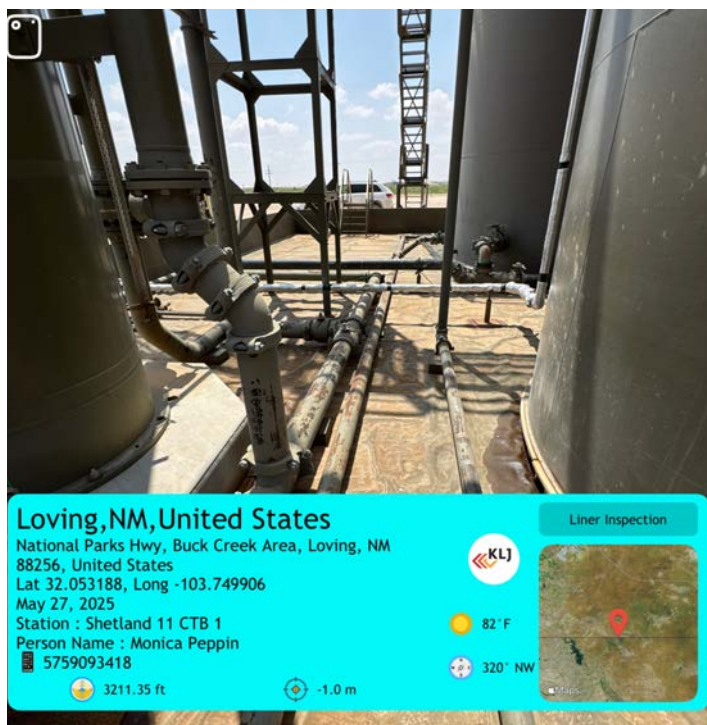
View of liner facing west from east side on south area of containment.

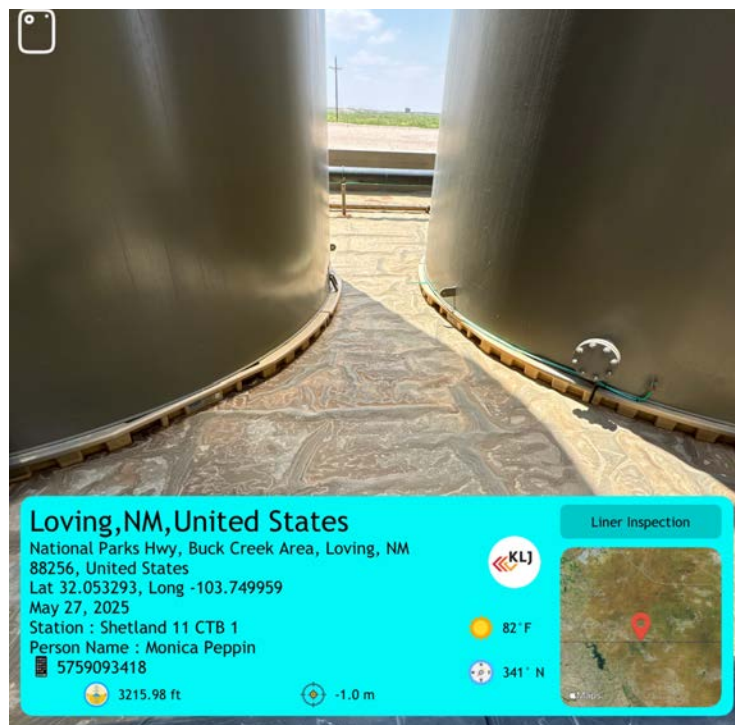
View of liner between tanks on north end of containment.

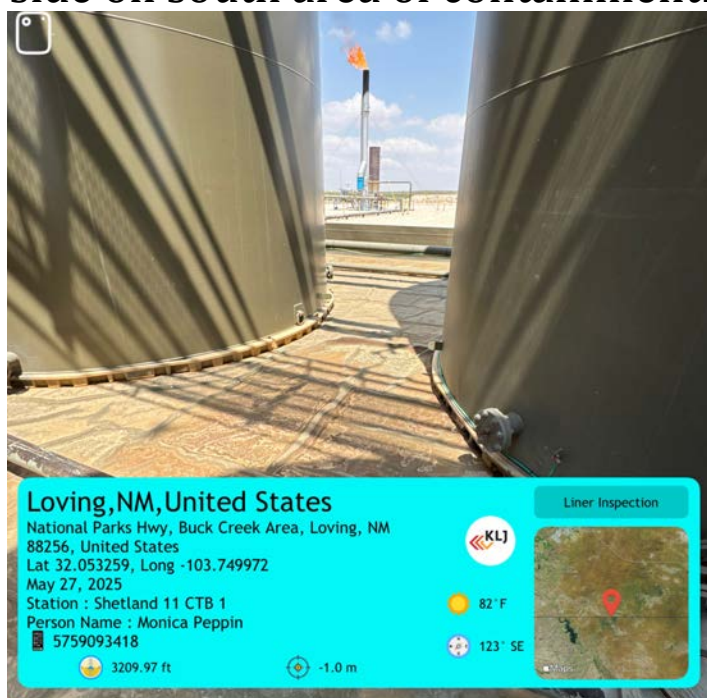
View of liner between tanks facing northeast from west side.

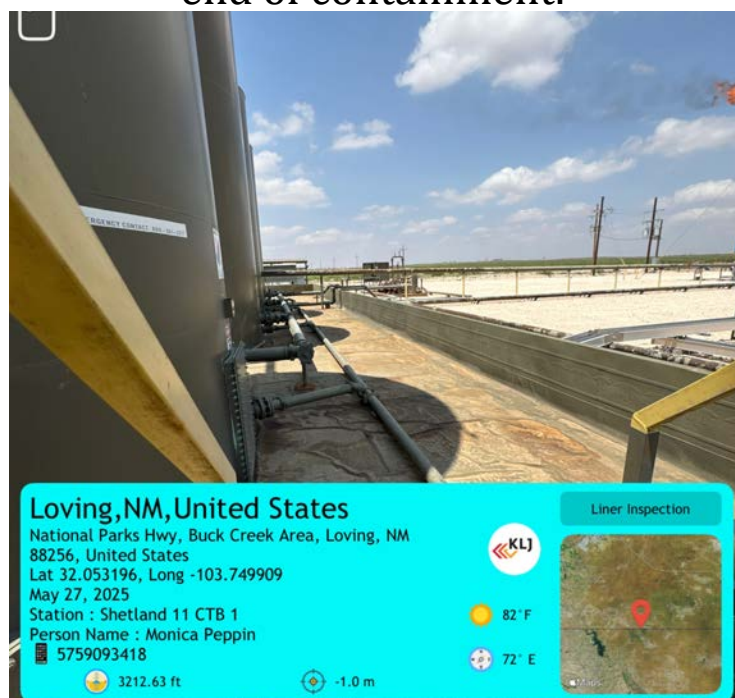
East wall of containment facing north.
