Incident Number: nAPP2325637510

Liner Inspection Closure Report

Ann SWD #1

Liner Inspection Closure Report
May 2025

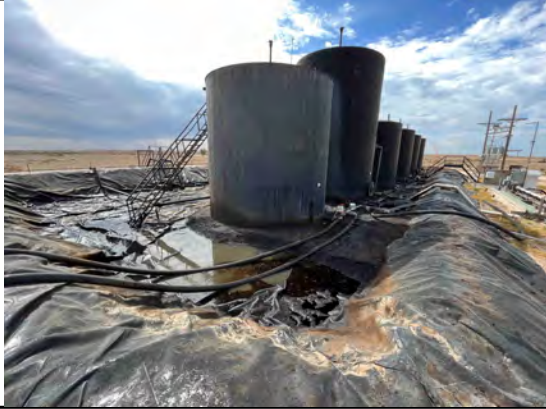
Northwest corner of lined containment

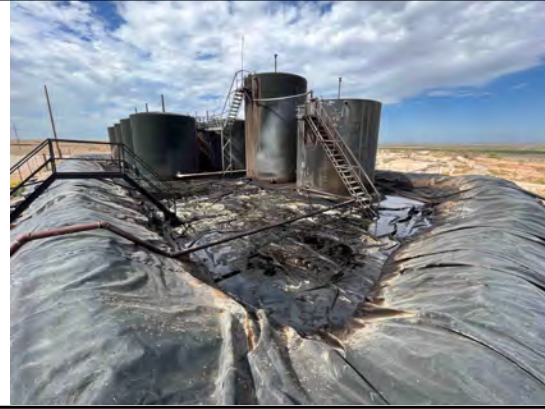
Northeast corner of lined containment

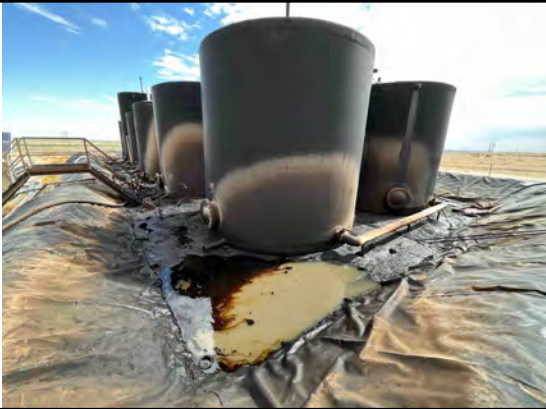
Southwest corner of lined containment

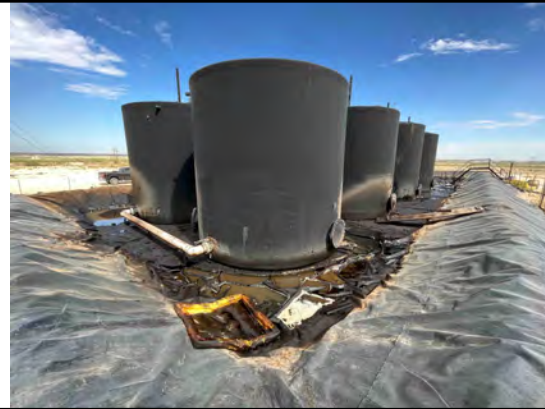
Southeast corner of lined containment

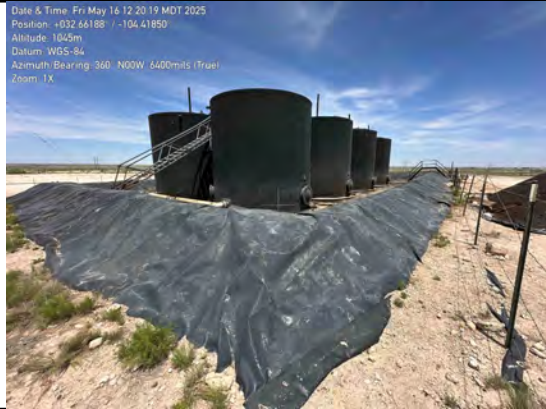
Outer walls of lined containment (south wall)

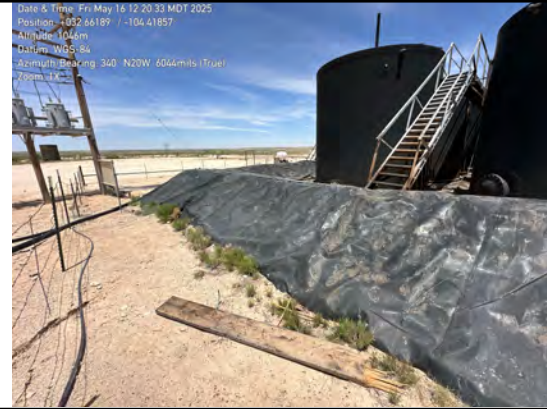
Outer walls of lined containment (south wall)

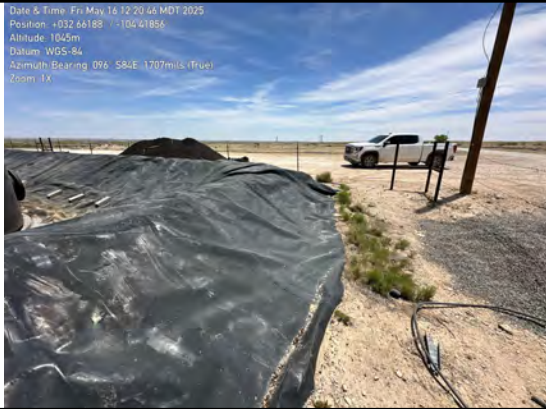
Outer walls of lined containment (south wall)

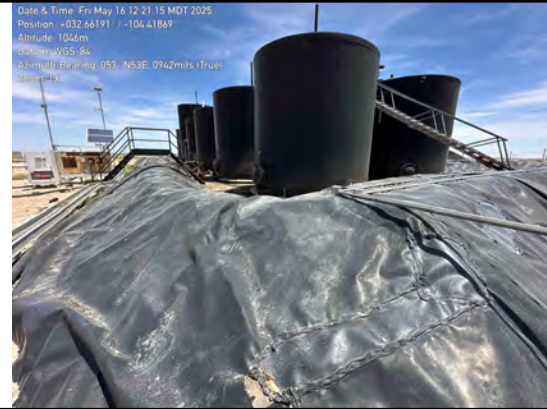
Southwest corner of lined containment

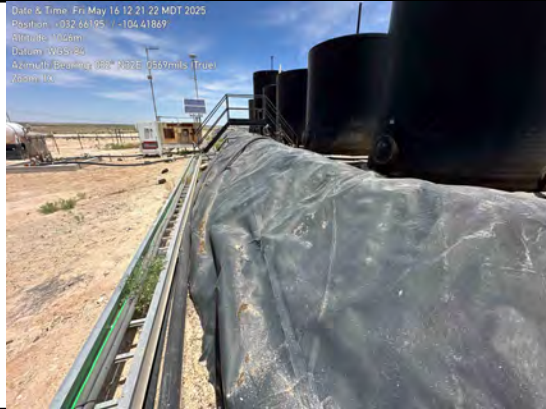
Outer walls of lined containment (west wall)

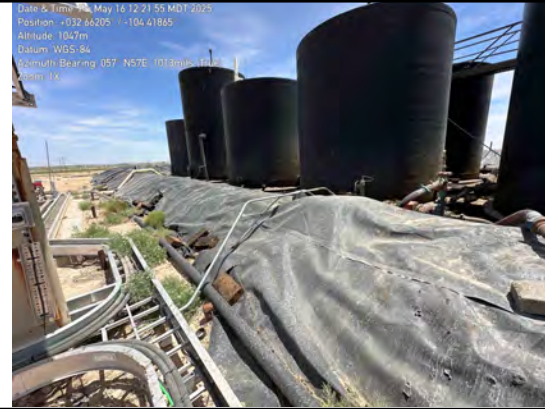
Outer walls of lined containment (west wall)

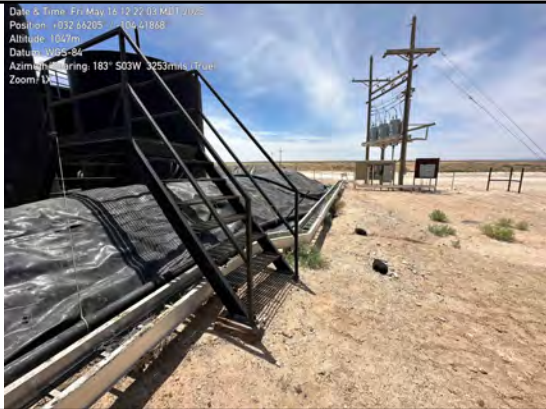
Outer walls of lined containment (west wall)

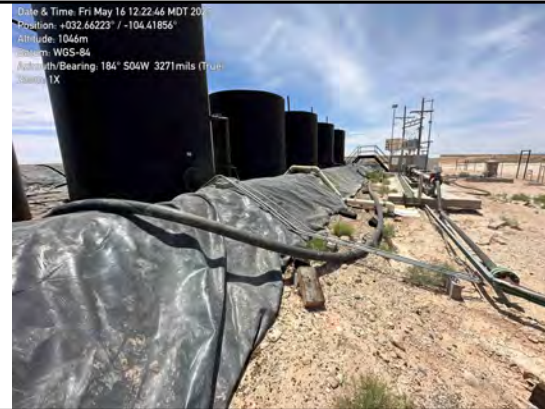
Outer walls of lined containment (west wall)

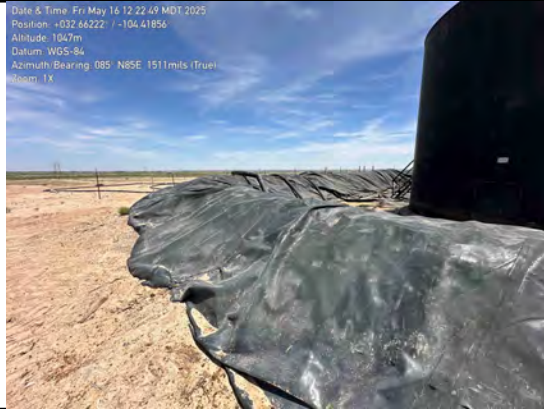
Northwest corner of lined containment

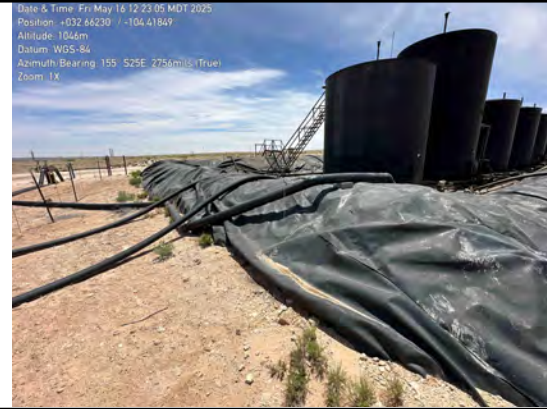
Outer walls of lined containment (north wall)

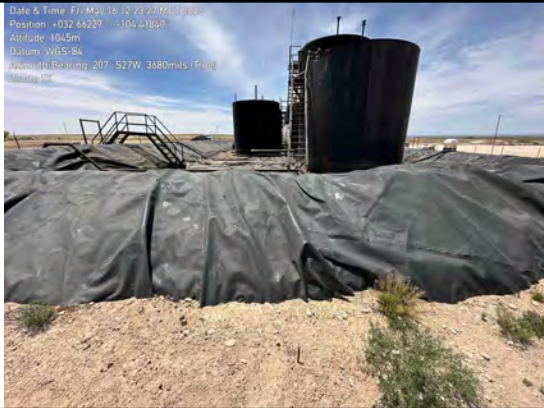
Outer walls of lined containment (north wall)

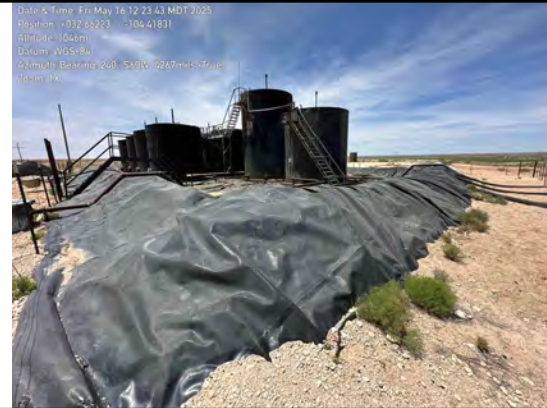
Outer walls of lined containment (north wall)

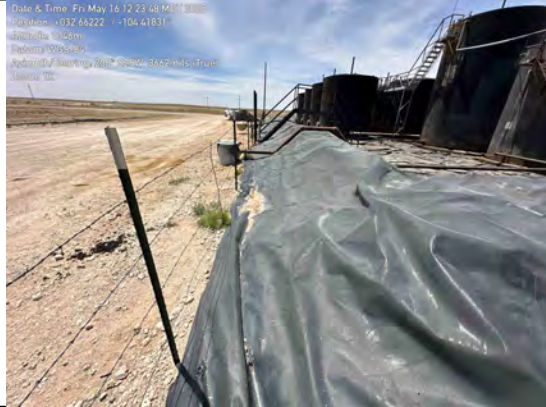
Outer walls of lined containment (east wall)

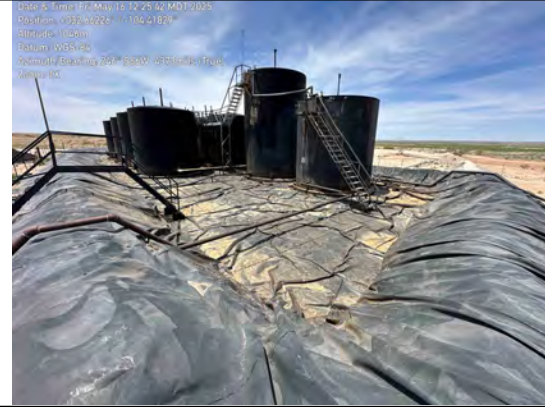
Northeast corner of lined containment

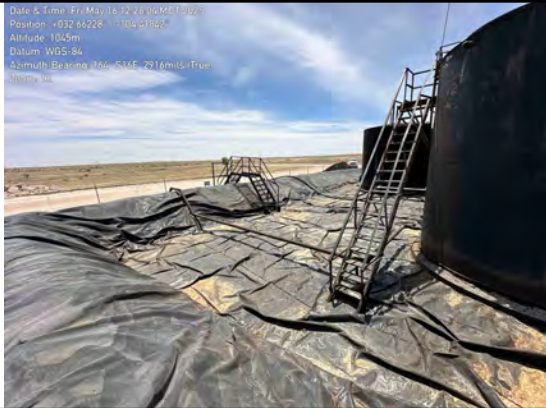
Northwest areas of lined containment

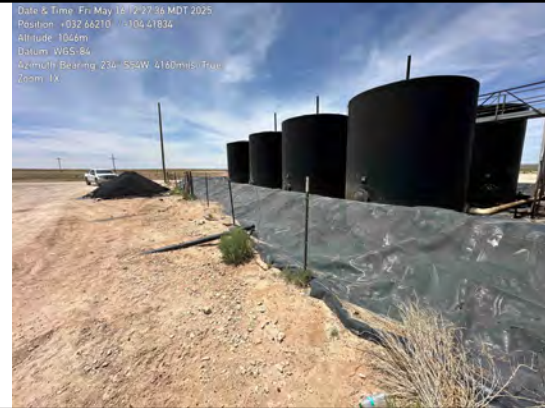
Outer walls of lined containment (east wall)

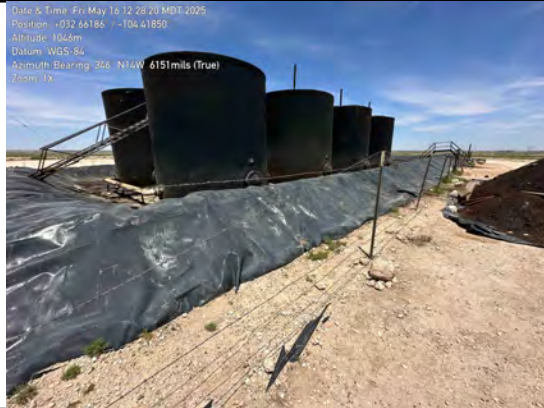
Outer walls of lined containment (east wall)

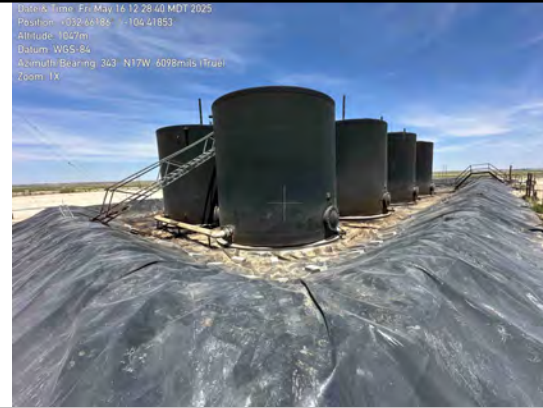
Southeast corner of lined containment

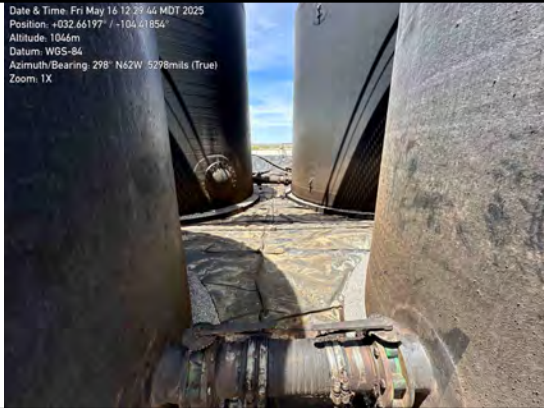
Containment areas between tanks

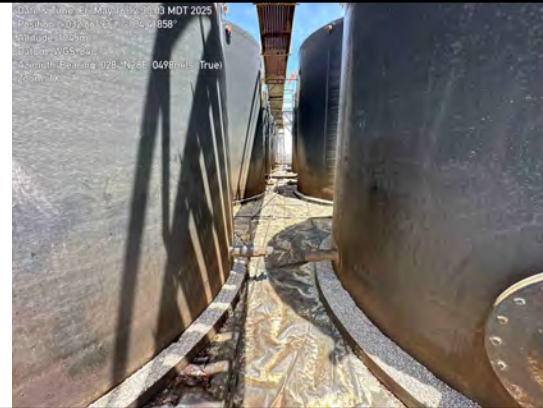
Containment areas between tanks

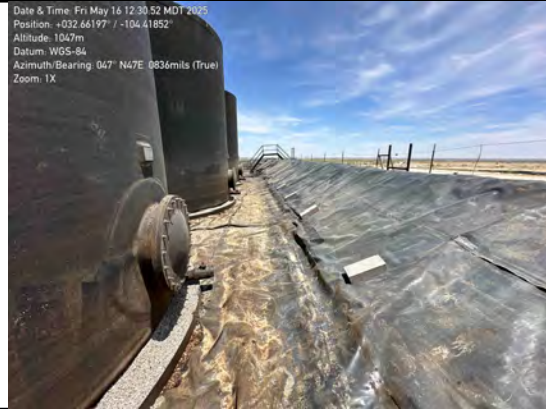
Inside walls of lined containment

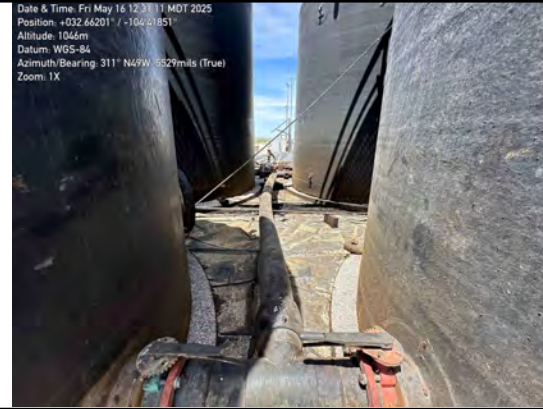
Containment areas between tanks

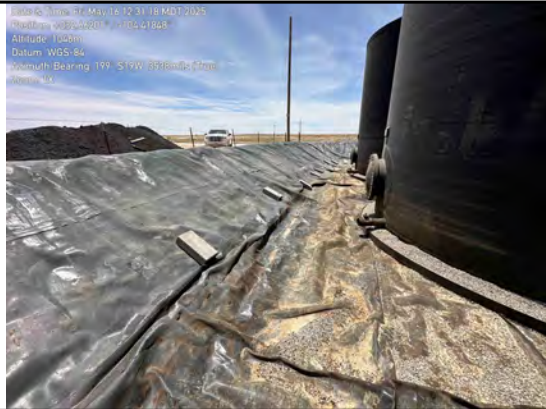
Inside walls of lined containment

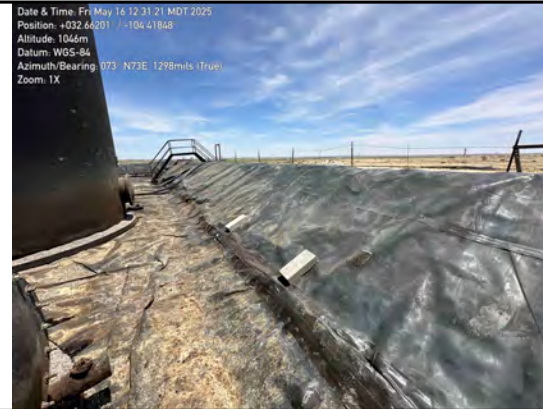
Inside walls of lined containment

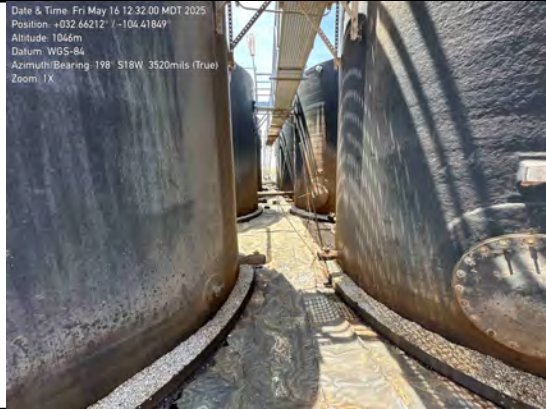
Containment areas between tanks

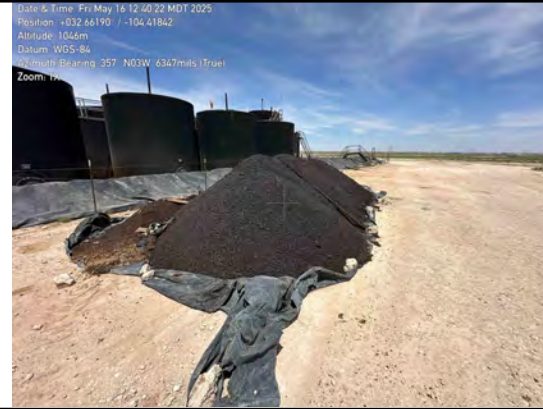
Gravel removed and hauled to disposal

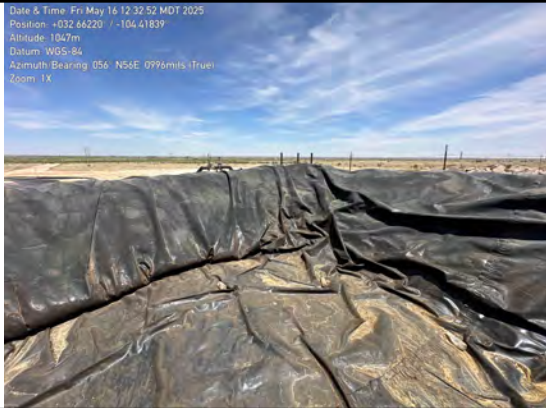
Inside walls of lined containment

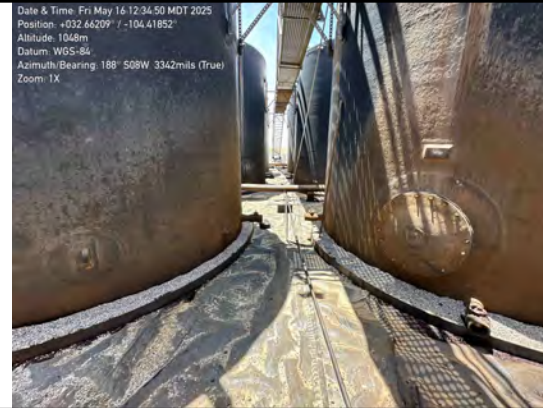
Containment areas between tanks
