Subject: Liner Inspection Report for Nageezi Unit H33

MPLX submits this Liner Inspection Report for the Nageezi Unit H33 release (nAPP2514851289) which describes the release, corrective actions, and the results of the liner inspection at the site.

Liner Inspection Report
Nageezi Unit H33 Release (nAPP2514851289)

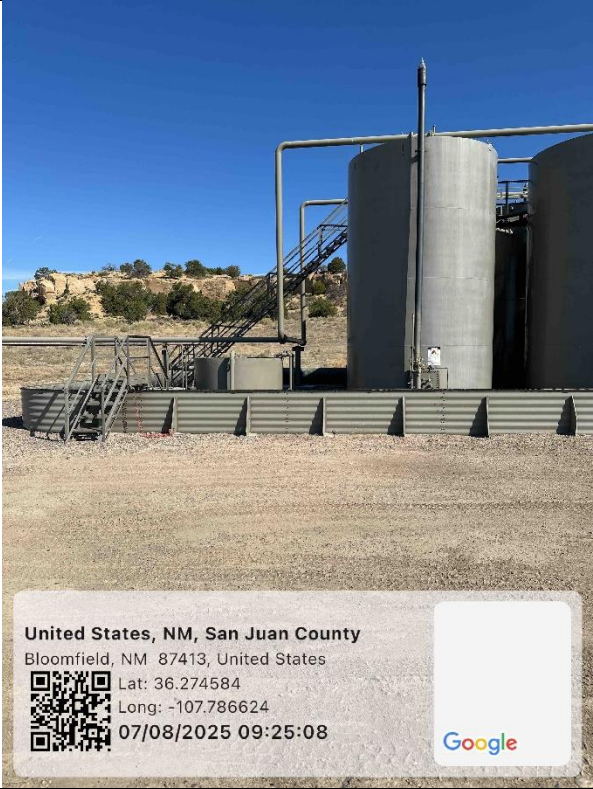
Description: Facing northwest, view of area outside containment demonstrating no observable stained or wet soils on the southwest side.
Incident: nAPP2514851289		
GPS: 36.27432, -107.78736		
Date of Photo: 8/7/2025		
Taken by: Heather Woods

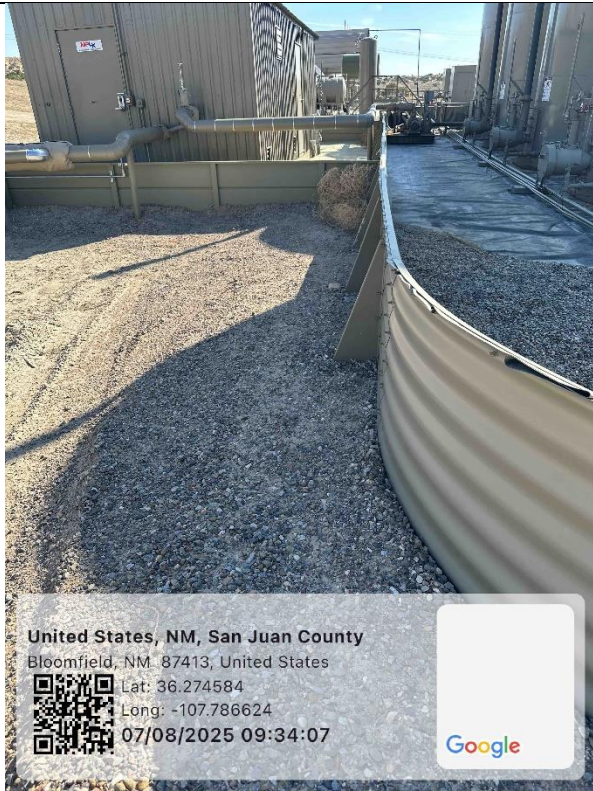
Incident: nAPP2514851289	
GPS: 36.27432, -107.78736	
Date of Photo: 8/7/2025	
Taken by: Heather Woods	
Description: Facing northeast, view of area outside containment demonstrating no observable stained or wet soils on the northwest side.

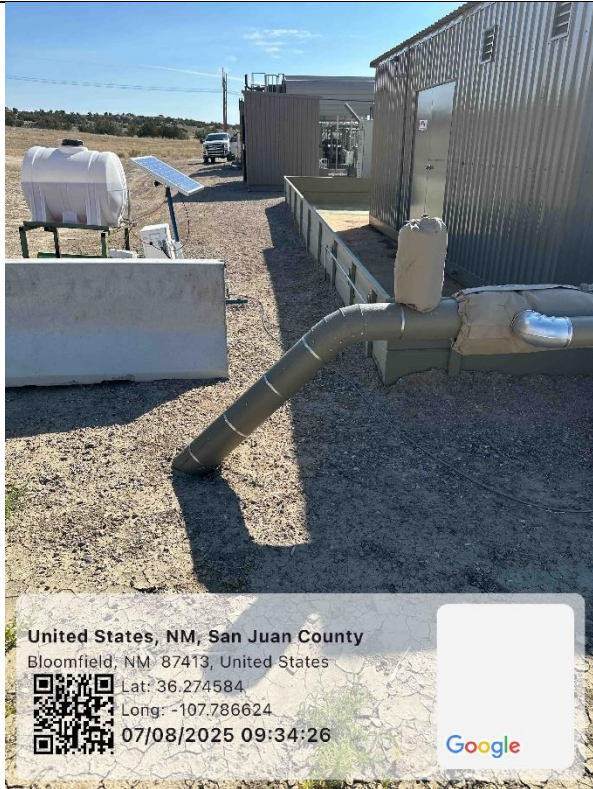
Incident: nAPP2514851289	
GPS: 36.27432, -107.78736	
Date of Photo: 8/7/2025	
Taken by: Heather Woods	
Description: Facing northeast, view of area outside containment demonstrating no observable stained or wet soils on the north side.

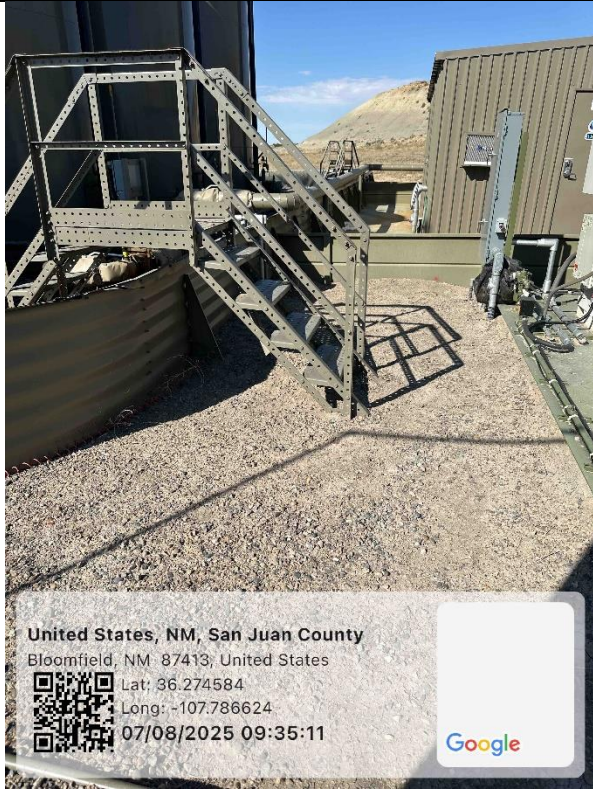
Incident: nAPP2514851289	
GPS: 36.27432, -107.78736	
Date of Photo: 8/7/2025	
Taken by: Heather Woods	
Description: Facing southwest, view of area outside containment demonstrating no observable stained or wet soils on the northeast.

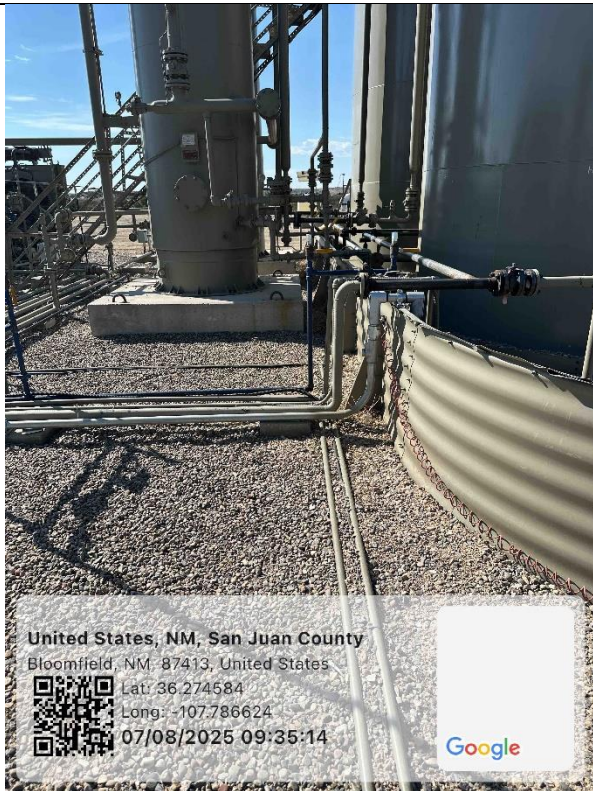
Incident: nAPP2514851289	
GPS: 36.27432, -107.78736	
Date of Photo: 8/7/2025	
Taken by: Heather Woods	
Description: Facing southeast, view of area outside containment demonstrating no observable stained or wet soils on the east side.

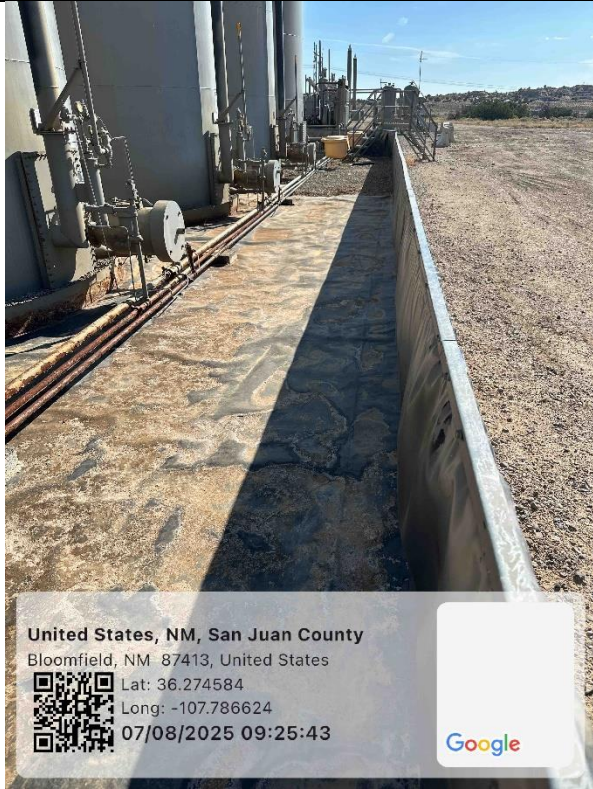
Incident: nAPP2514851289	
GPS: 36.27432, -107.78736	
Date of Photo: 8/7/2025	
Taken by: Heather Woods	
Description: Facing northeast, view of area inside containment in south portion demonstrating liner is intact.

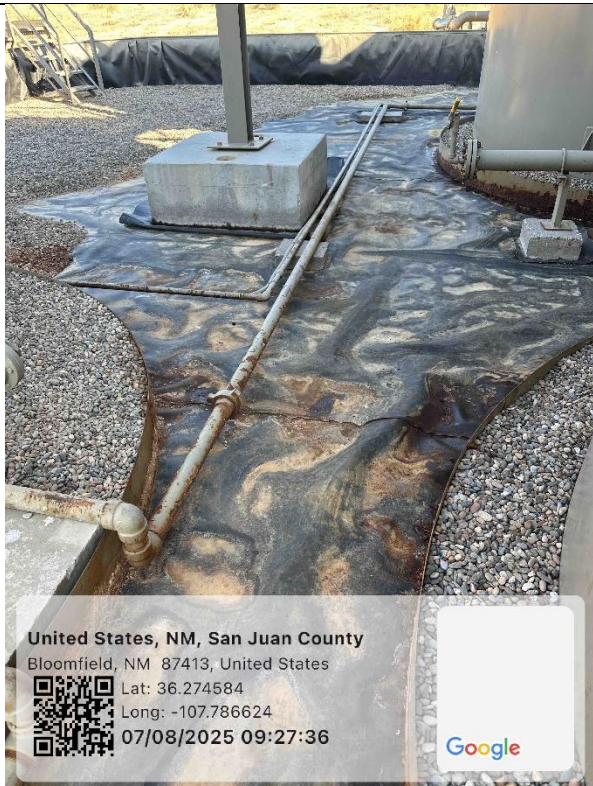
Incident: nAPP2514851289	
GPS: 36.27432, -107.78736	
Date of Photo: 8/7/2025	
Taken by: Heather Woods	
Description: Facing northwest, view of area inside containment in west portion demonstrating liner is intact.

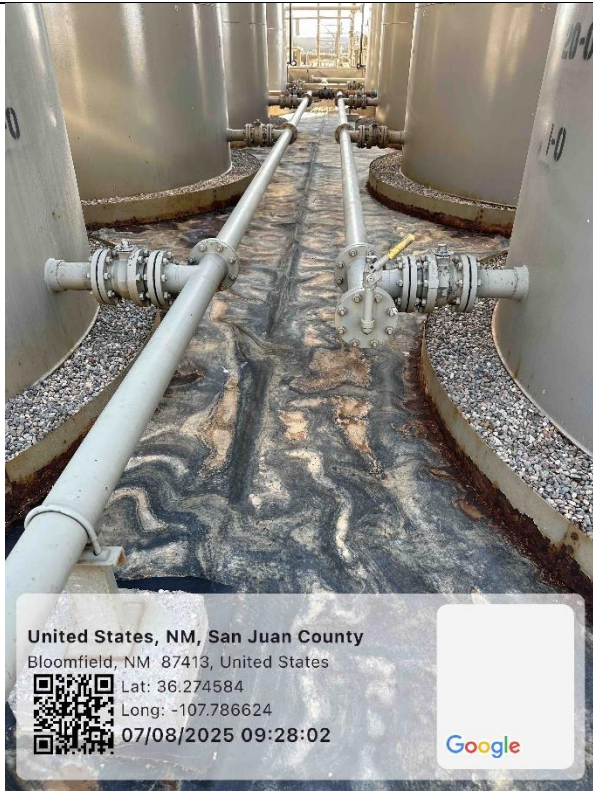
Incident: nAPP2514851289	
GPS: 36.27432, -107.78736	
Date of Photo: 8/7/2025	
Taken by: Heather Woods	
Description: Facing northeast, view of area inside containment in central portion demonstrating liner is intact.

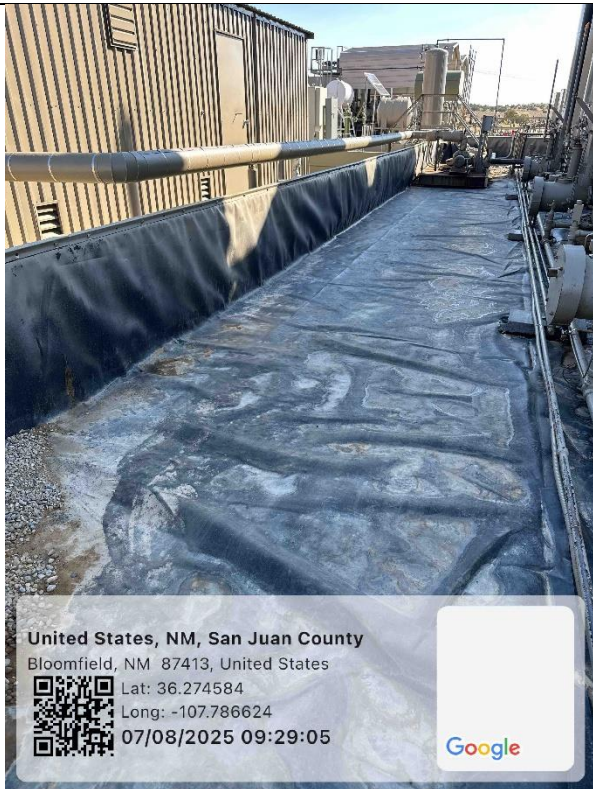
Incident: nAPP2514851289	
GPS: 36.27432, -107.78736	
Date of Photo: 8/7/2025	
Taken by: Heather Woods	
Description: Facing northeast, view of area inside containment in north portion demonstrating liner is intact.

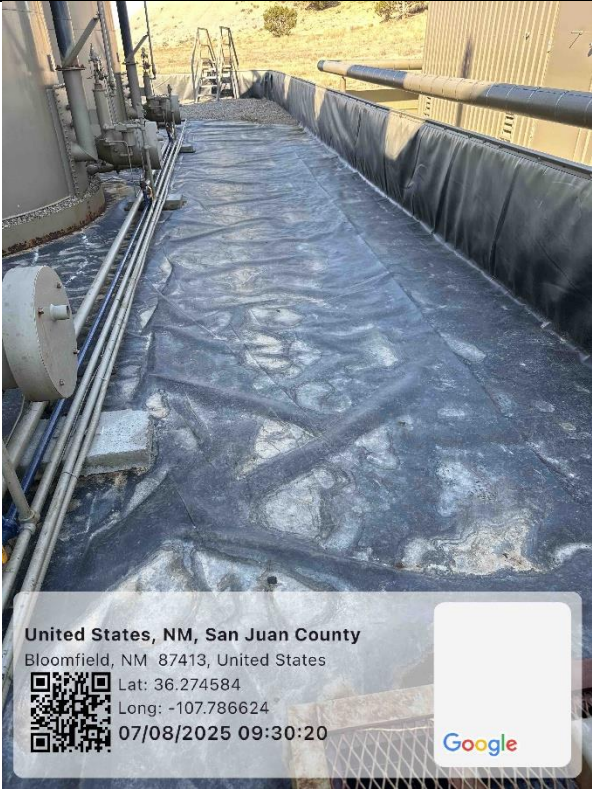
Incident: nAPP2514851289	
GPS: 36.27432, -107.78736	
Date of Photo: 8/7/2025	
Taken by: Heather Woods	
Description: Facing southwest, view of area inside containment in north portion demonstrating liner is intact.

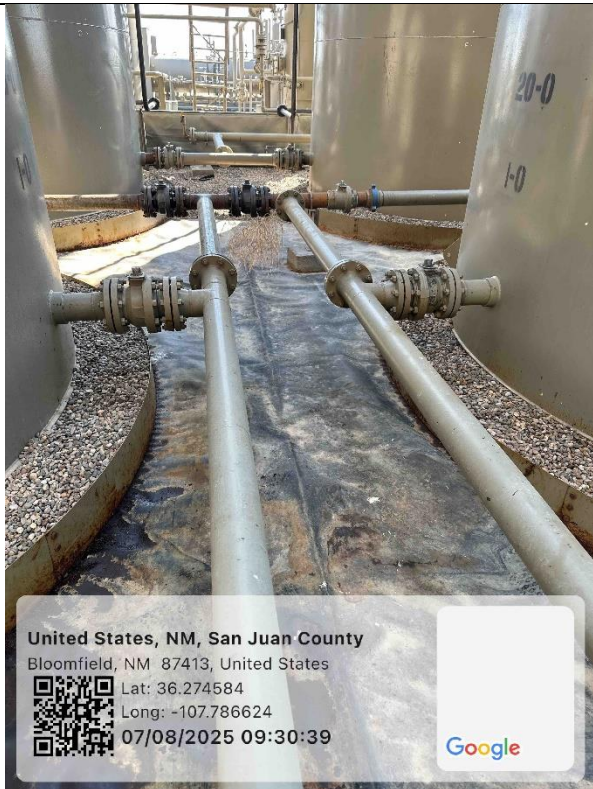
Description: Facing northeast, view of area inside containment in central portion demonstrating liner is intact.

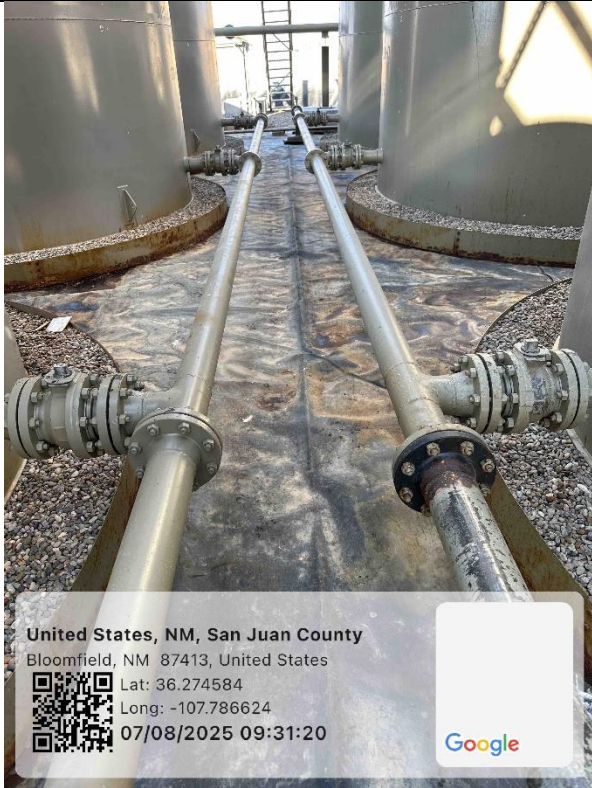
<p>The photograph shows a view of industrial equipment, including large cylindrical tanks and a network of pipes. A Google Earth overlay is present in the bottom right of the image, displaying the following information: United States, NM, San Juan County; Bloomfield, NM 87413, United States; Lat: 36.274584; Long: -107.786624; 07/08/2025 09:31:20. The Google logo is also visible.</p>
Incident: nAPP2514851289	
GPS: 36.27432, -107.78736	
Date of Photo: 8/7/2025	
Taken by: Heather Woods	
Description: Facing northeast, view of area inside containment in central portion demonstrating liner is intact.

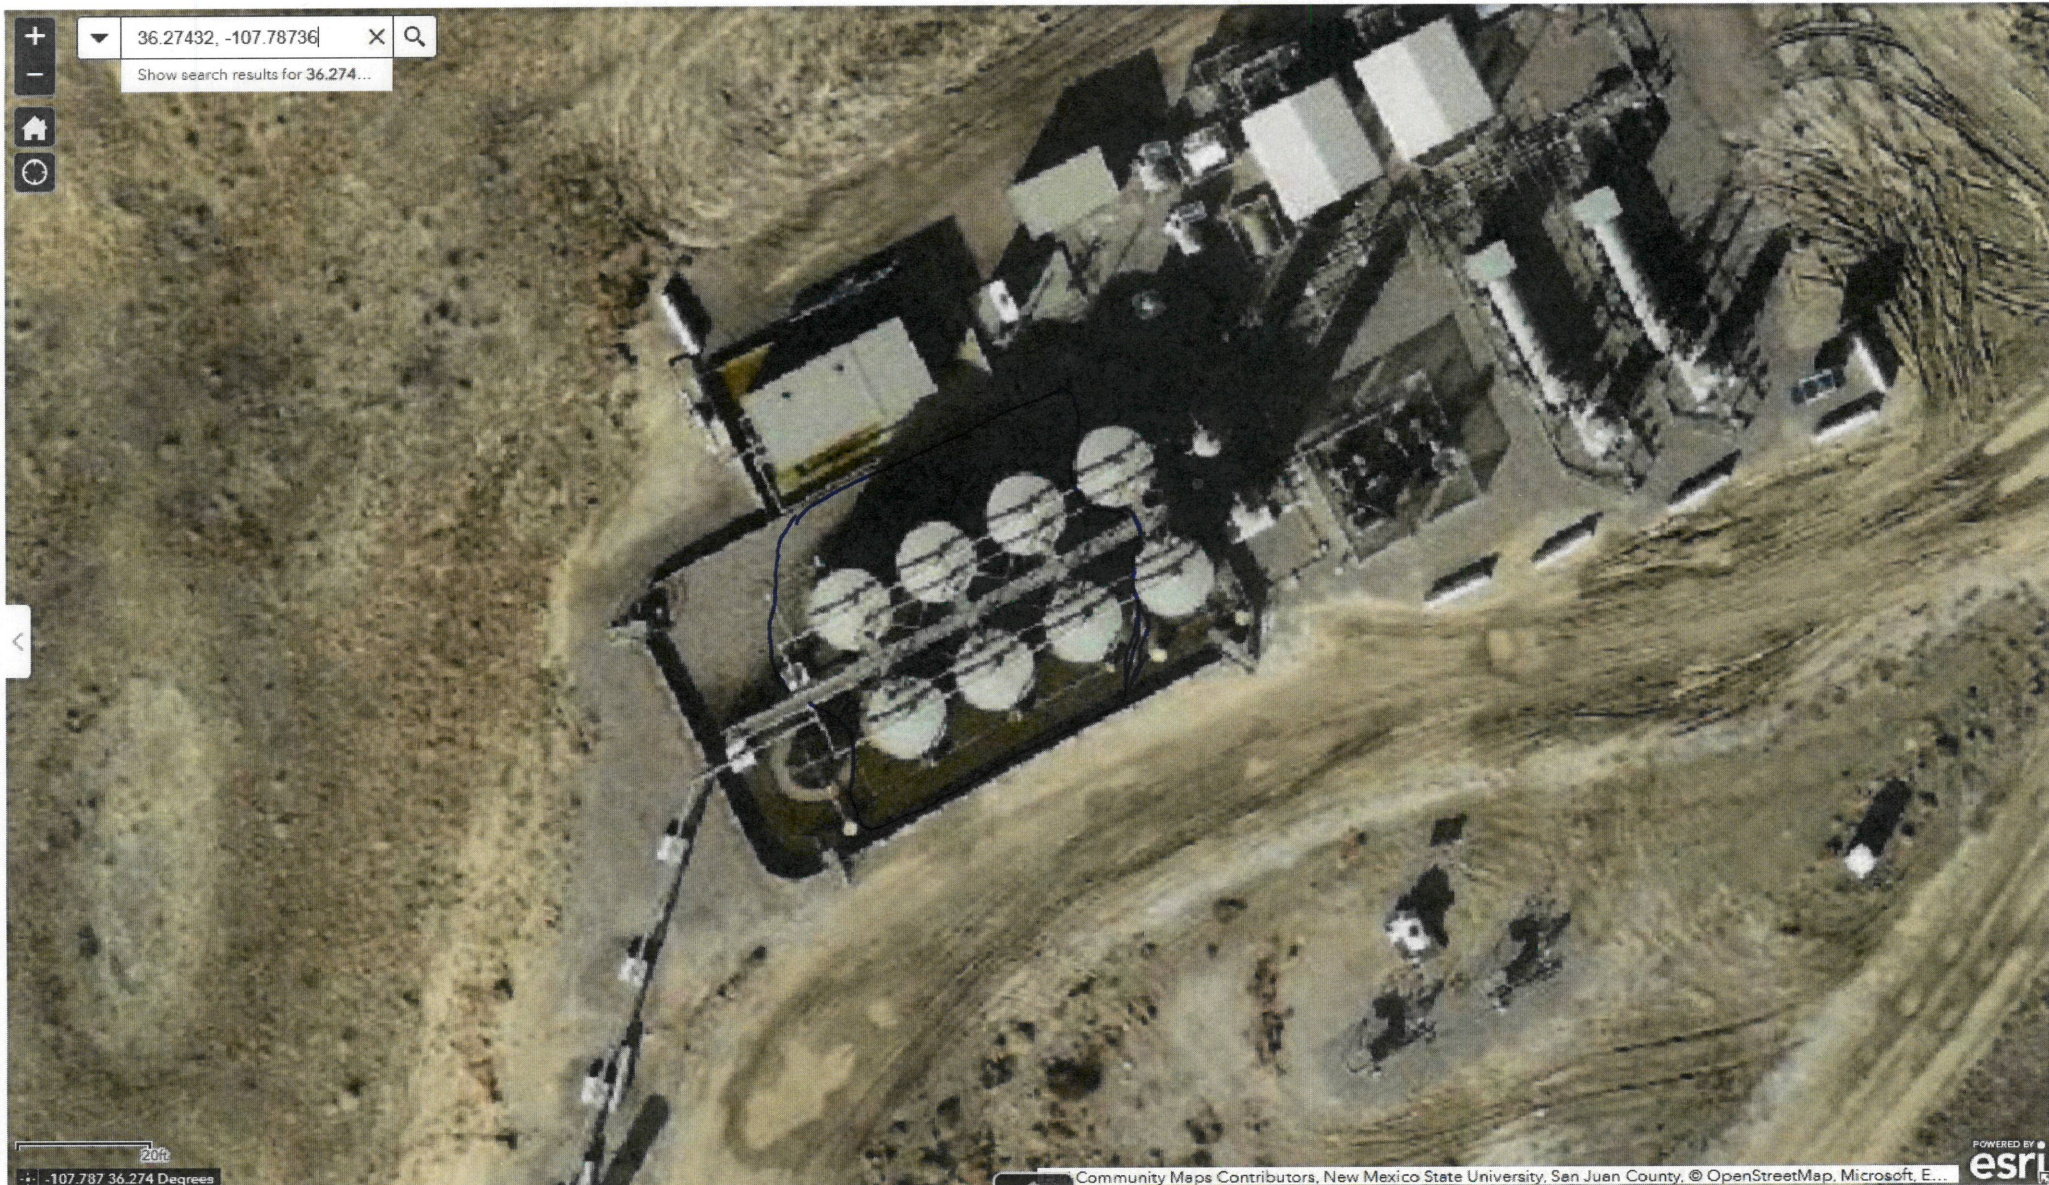
Nageezi Unit H33 Liner Inspection

*Black poly liner in steel containment (rounded rectangular).
Gravel and fluids have been removed from impacted areas.
No tears, holes, or other compromising defects observed.
Liner appears intact.*

— Approx. Extents of
Impacted Liner
