SUBJECT: Liner Inspection and Closure Report for Purrito 18 CTB 1 – July 16, 2025 Site Visit

Incident ID: nAPP2512472736
Facility ID (Name): fAPP2408639251 (PURRITO 18 CTB 1)
Facility Location: Unit A of Section 18, Township 23 South, Range 32 East, New Mexico
Facility GPS Coordinates: 32.308038, -103.7206141
Lea County, New Mexico

Environmental Liner Inspection

Field Notes & Photolog Report

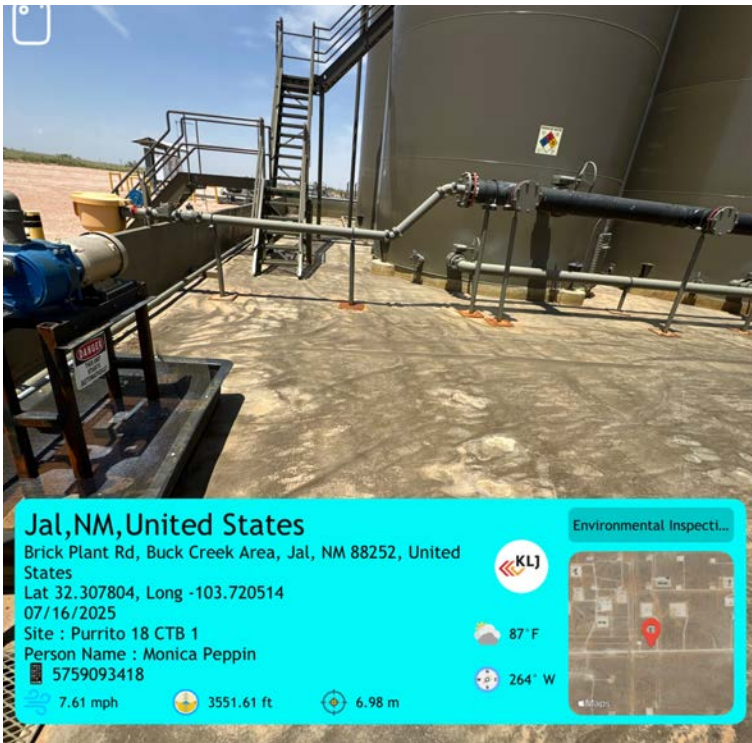
North end view from east corner facing west.

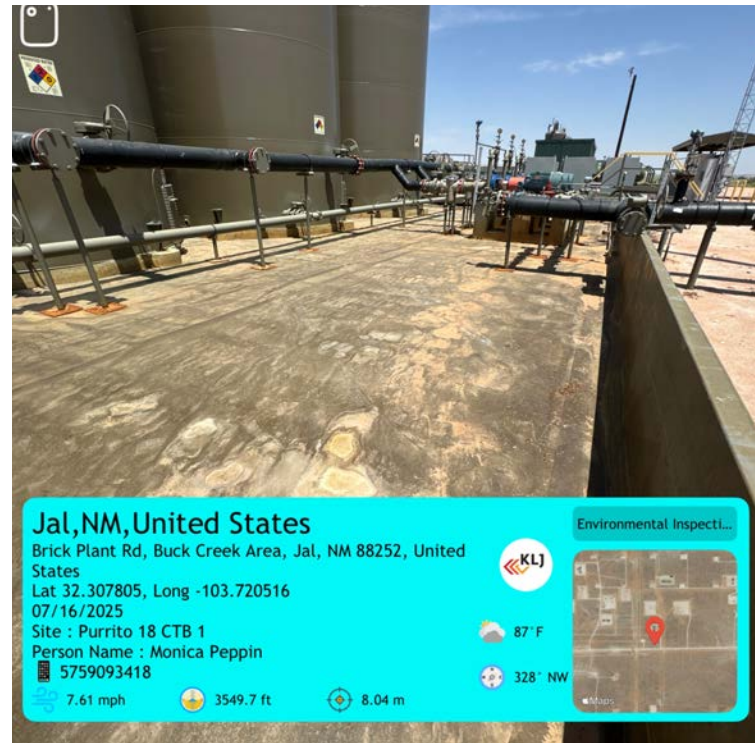
Facing northwest viewing liner near pumps and tanks.

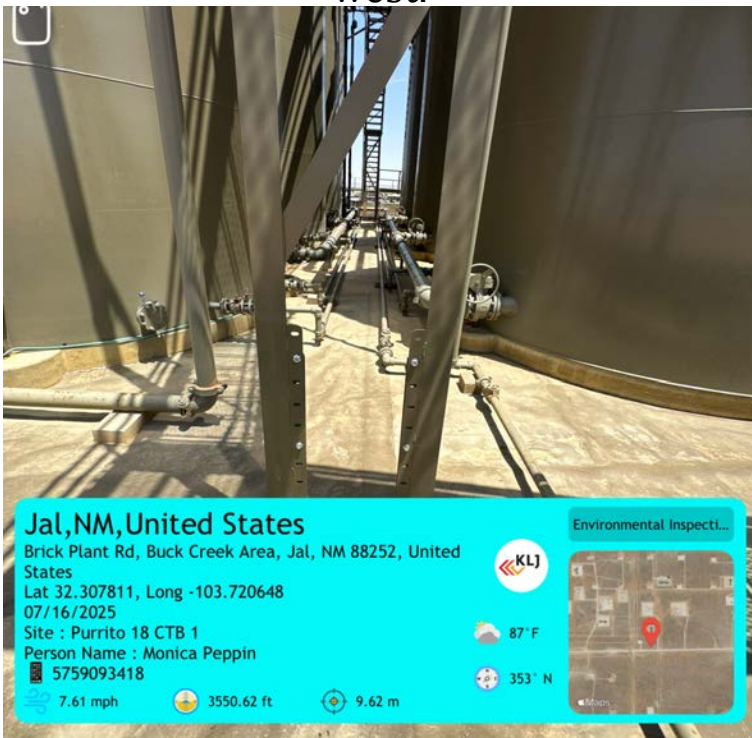
Liner between tanks from south end facing north.

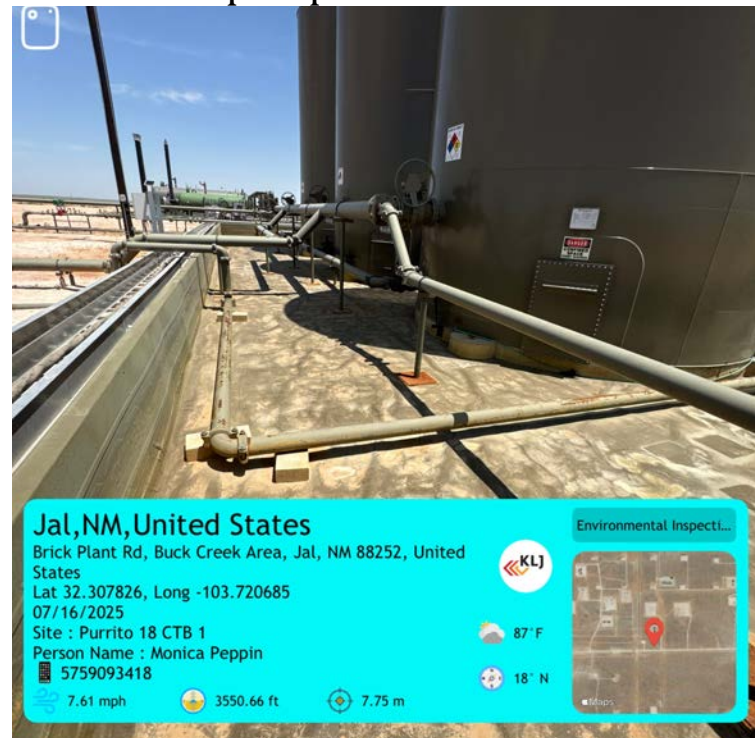
Facing north from southwest corner.

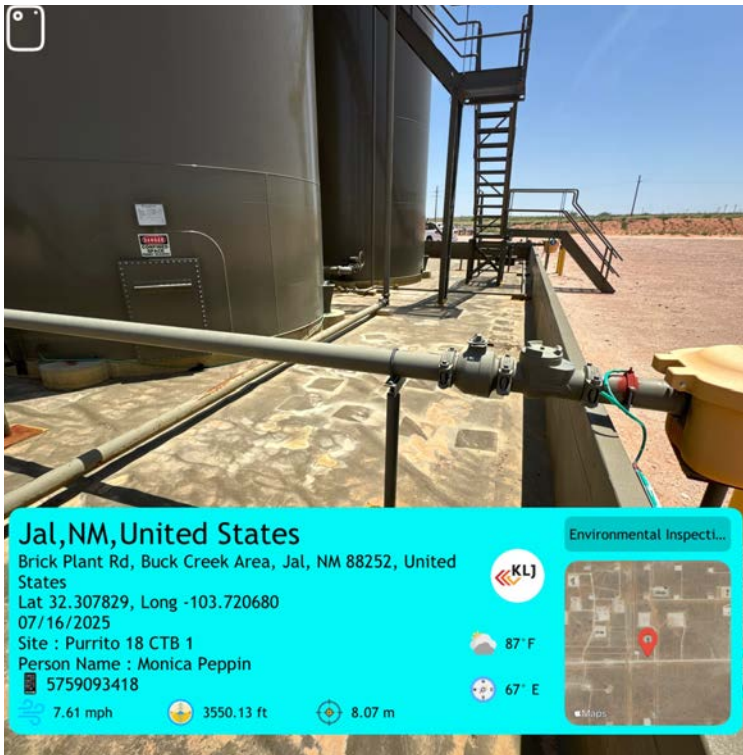
View of liner from southwest corner facing east.

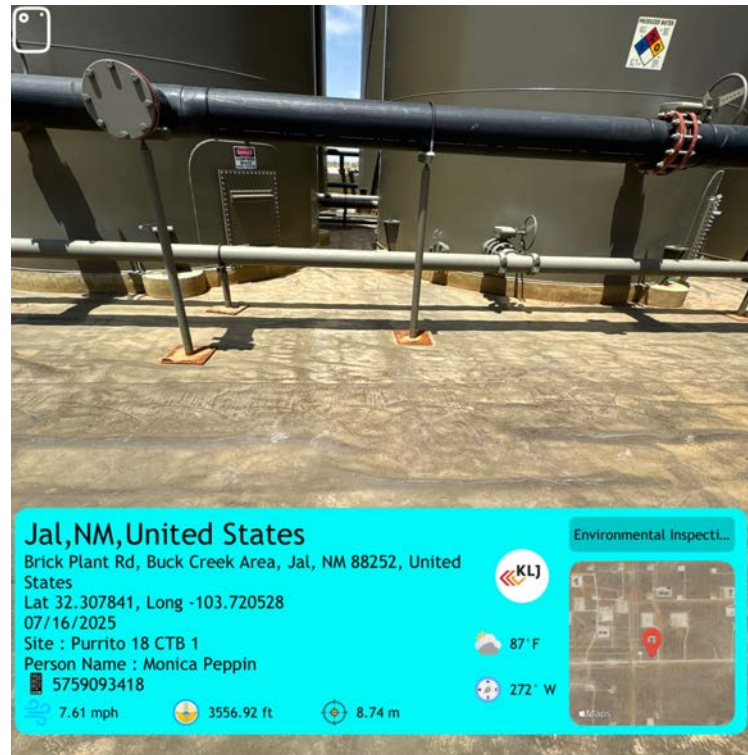
Liner between tanks on northern end facing west.

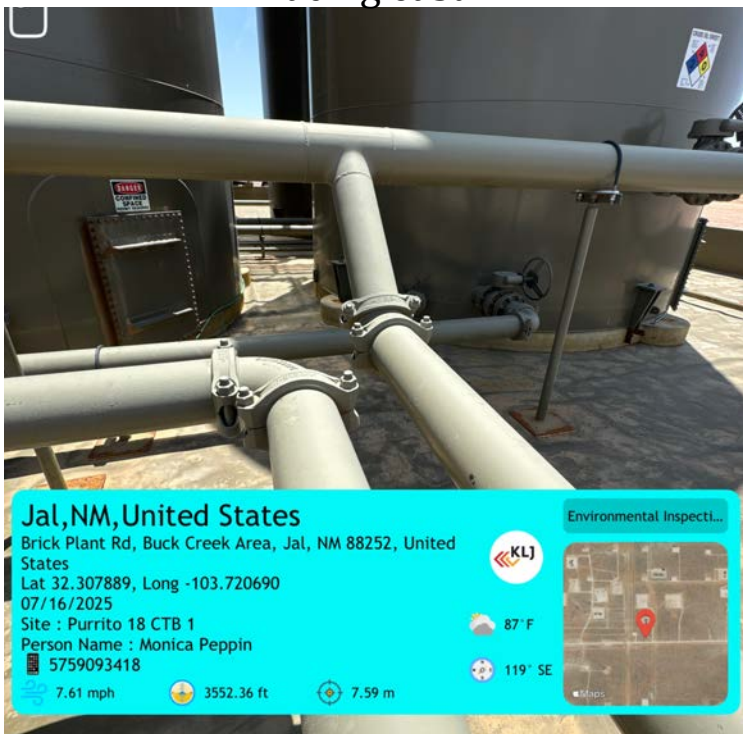
Liner between tanks on south end facing east .

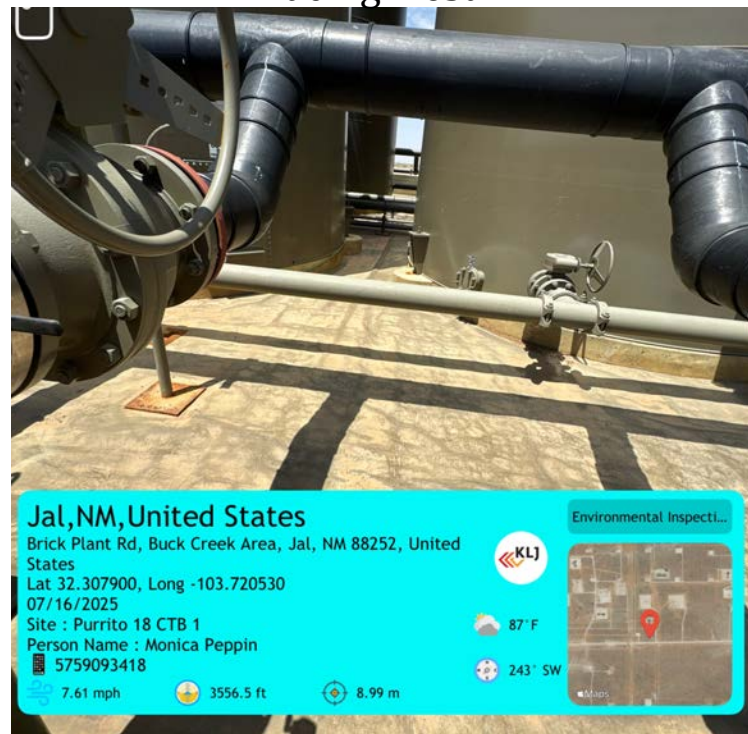
Liner between tanks facing west from east side.

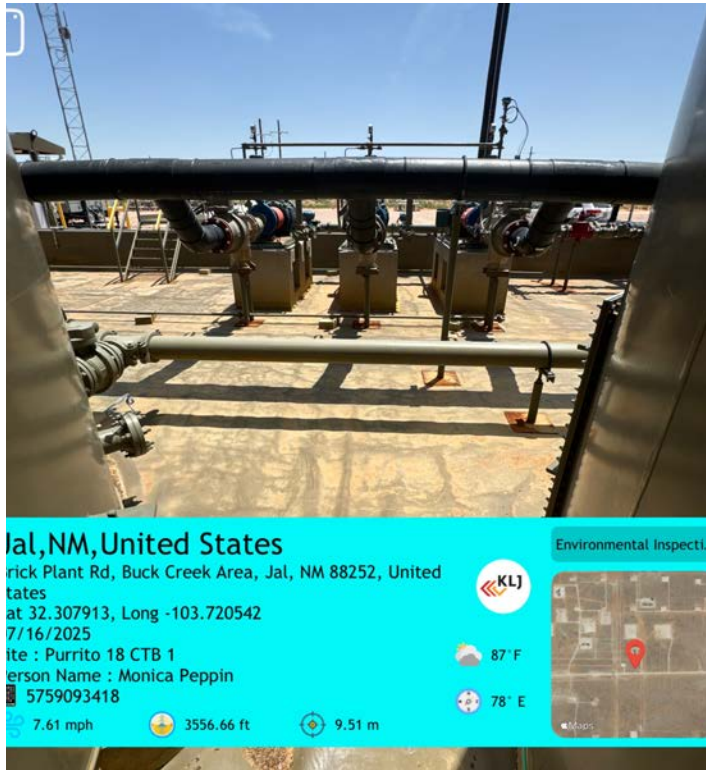
Facing east between tanks of liner under transfer pumps.

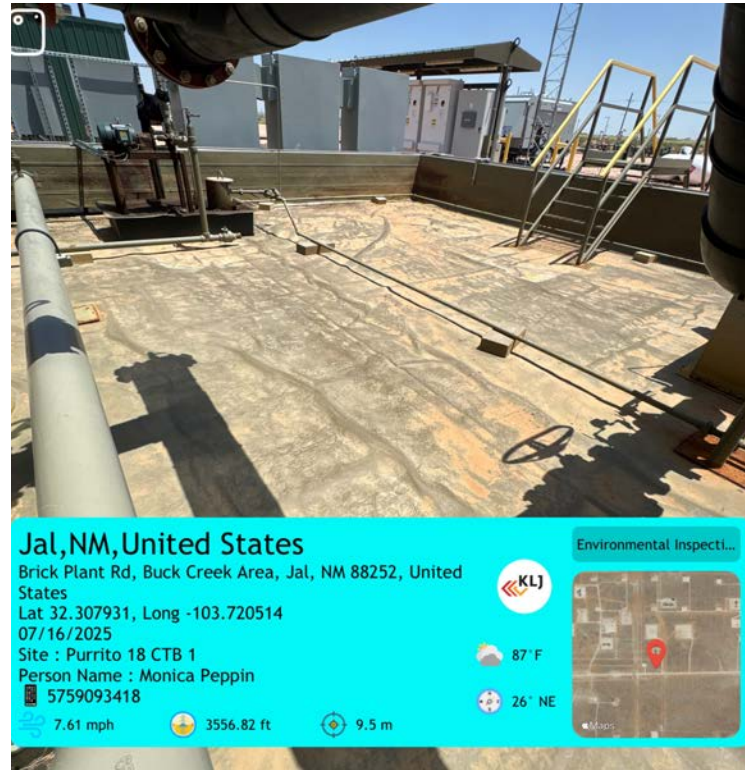
Viewing liner of northeast corner from near tanks.

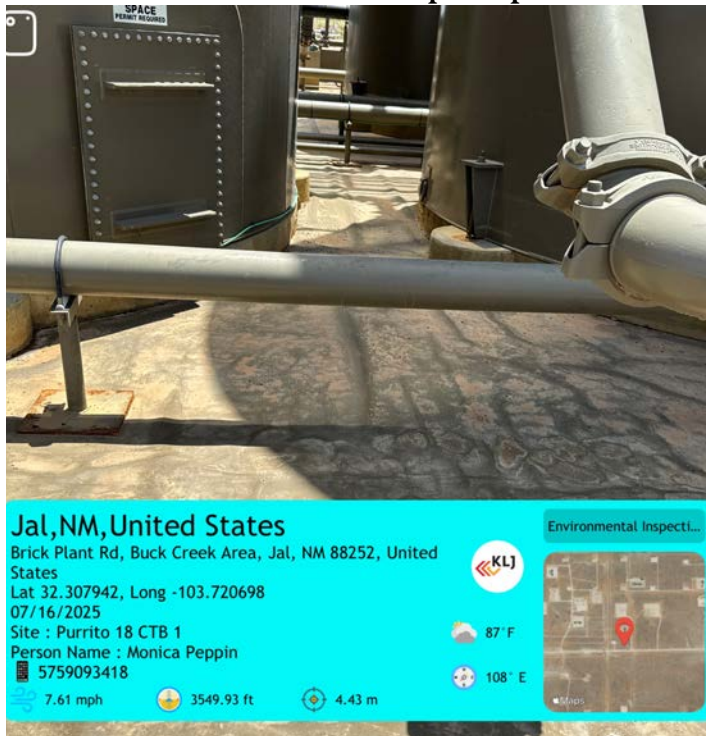
Liner between tanks from west side facing east.

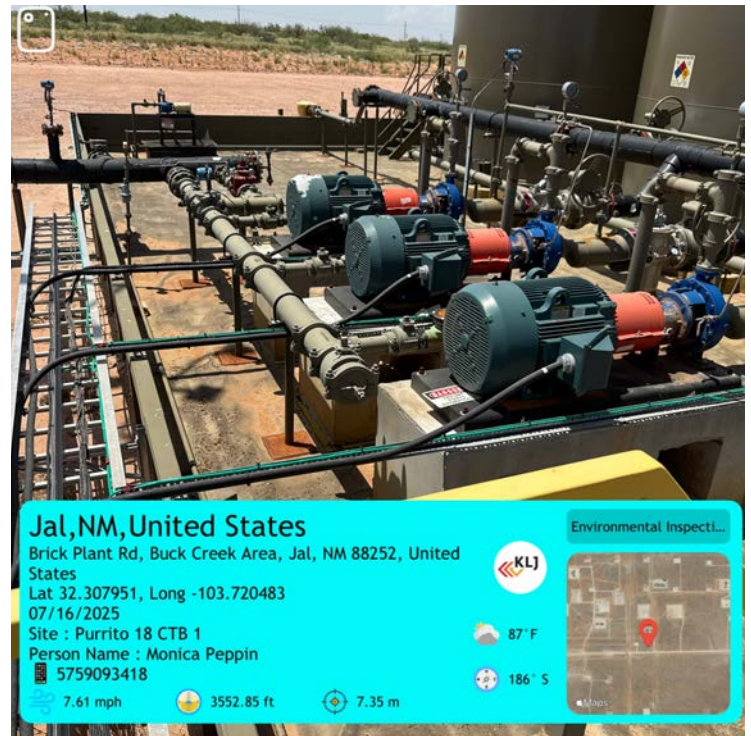
Liner view under transfer pumps facing south from northeast corner.

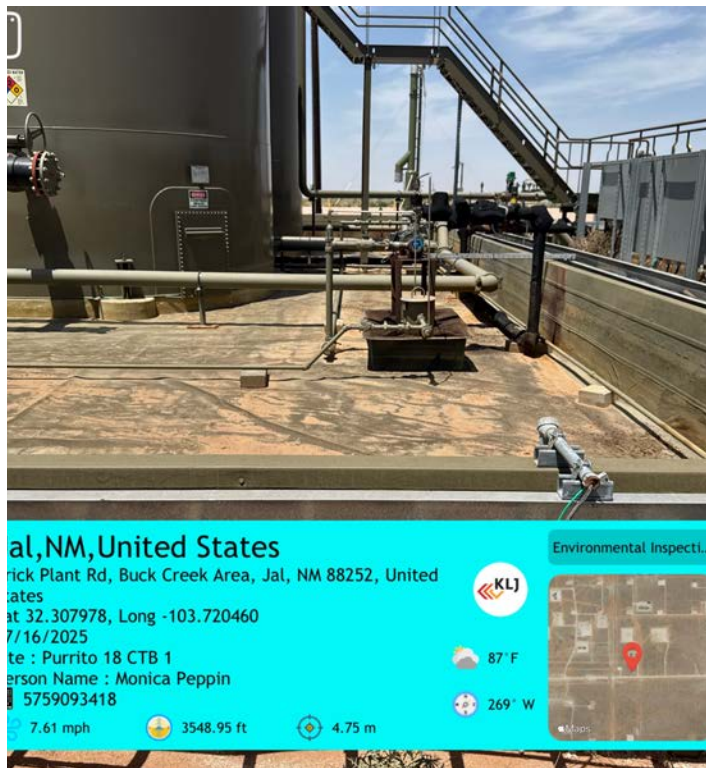
Facing west from east side viewing liner on north end.

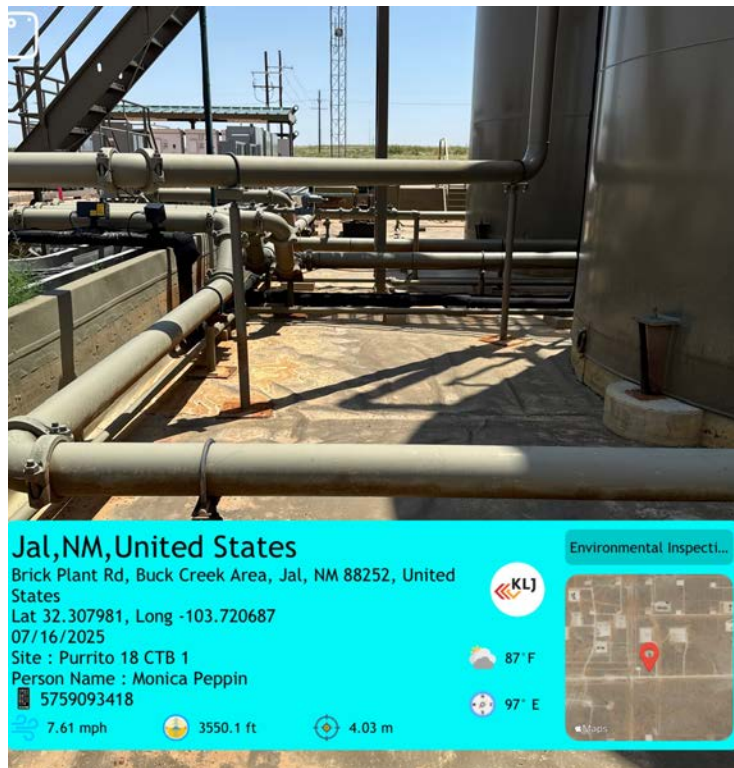
North view from west side facing east.

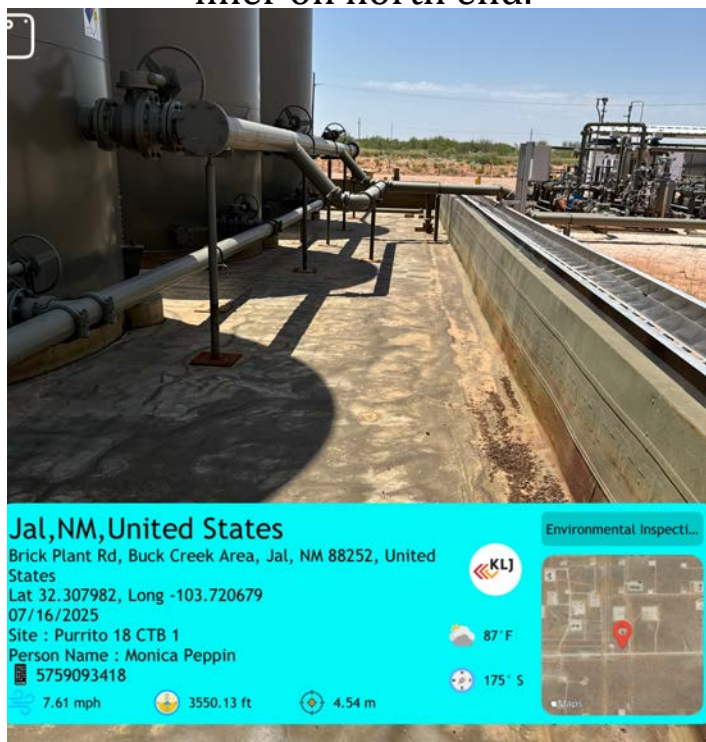
West side view facing south from north end.

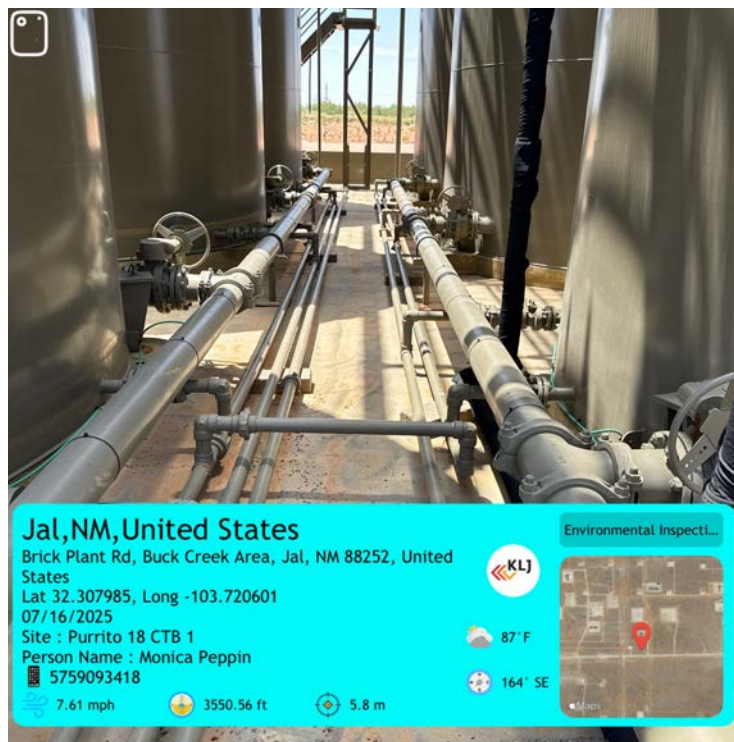
Liner between tanks facing south from north end.
