RE: Leak #150 – Soil Remediation Progress Summary  
NMOCD Incident No. nAPP2335641154

**Figure 1 – Excavation Overview  
Aerial Drone Photographs**

Targa Resources Corp.  
Leak #150 - nAPP2335641154  
UL "I", Sec. 19, T19S, R37E  
Lea County, New Mexico

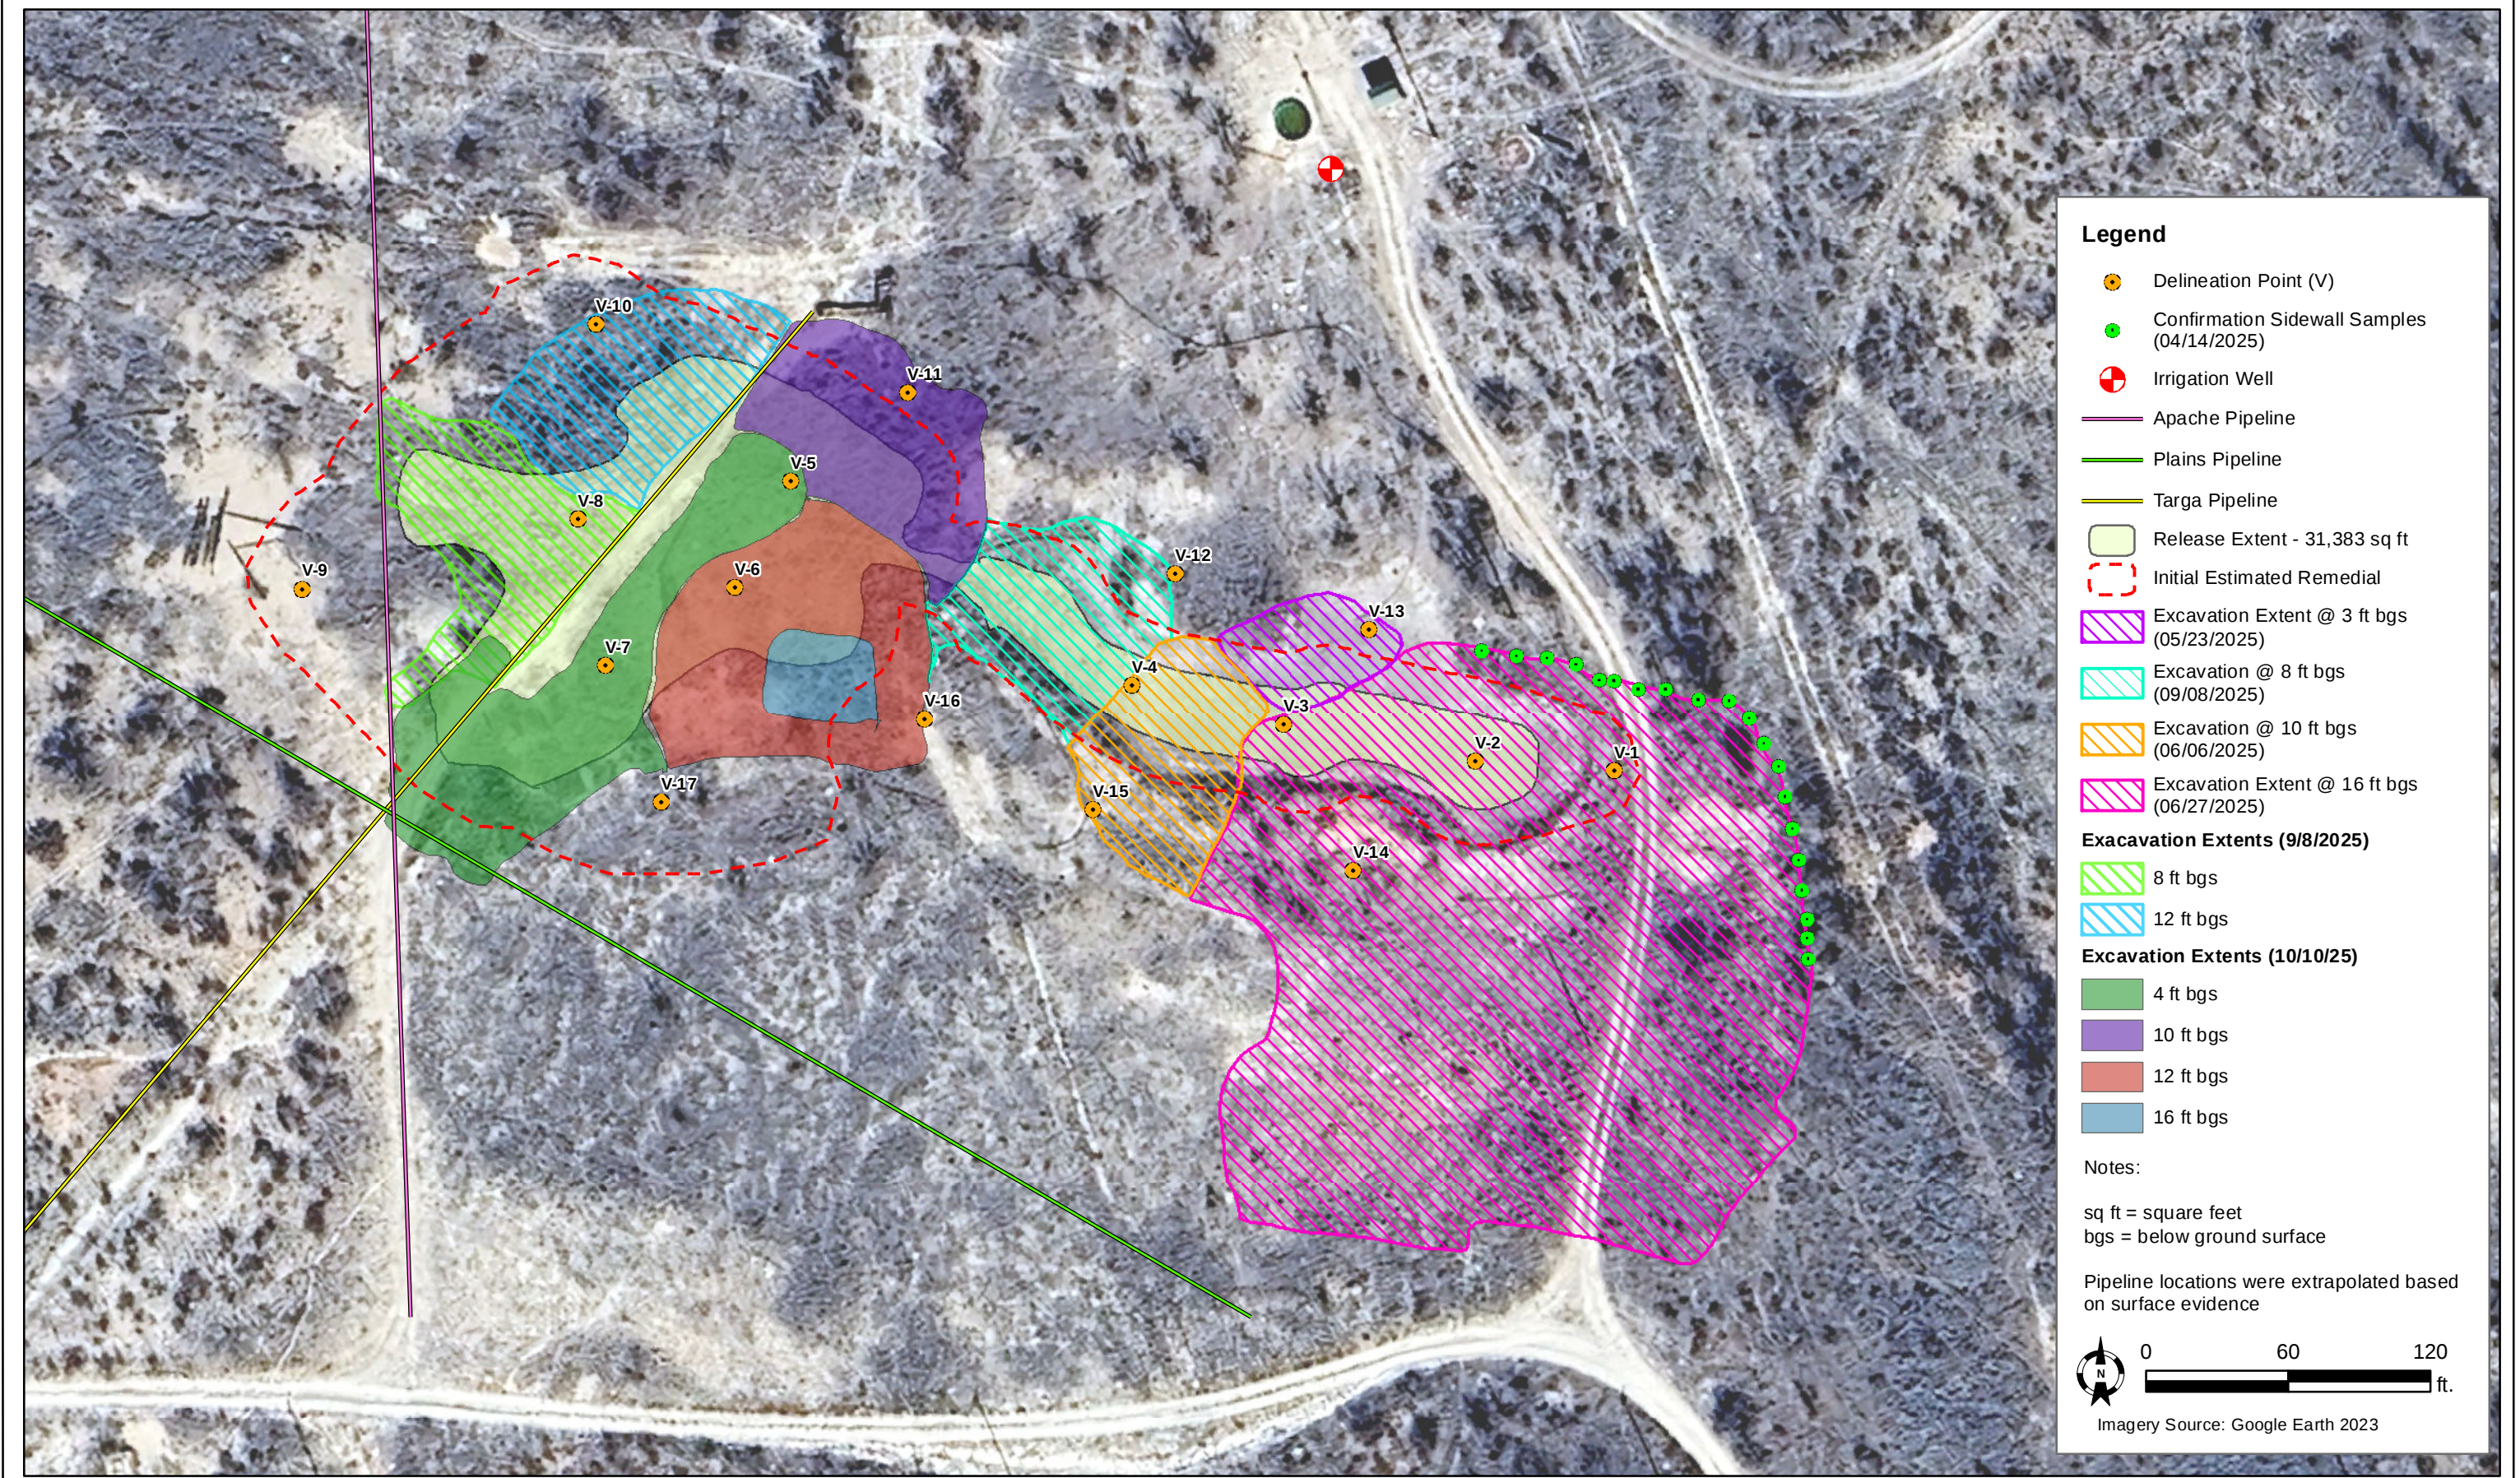
Figure  
1

The attached figure shows the current excavation extents at the site. Aerial photographs of the excavation collected on September 2<sup>nd</sup> are also attached for reference. To date water levels persist within the stock tank area, but have receded to an extent from the south wall.

Excavation Overview  
(October 10, 2025)
