State S-19 Yeso TB

Incident ID nAPP2526942456

PREPARED BY:
PIMA ENVIRONMENTAL SERVICES, LLC

Liner Inspection and Closure Report

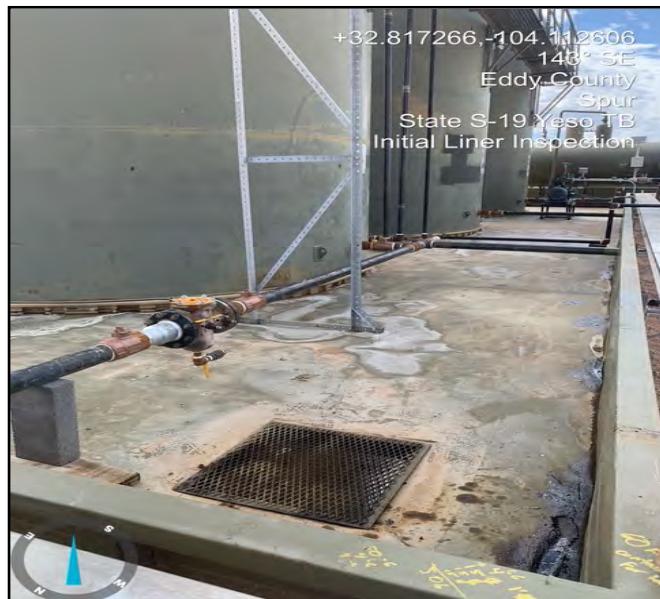
Photo of liner taken during initial liner inspection facing southeast.

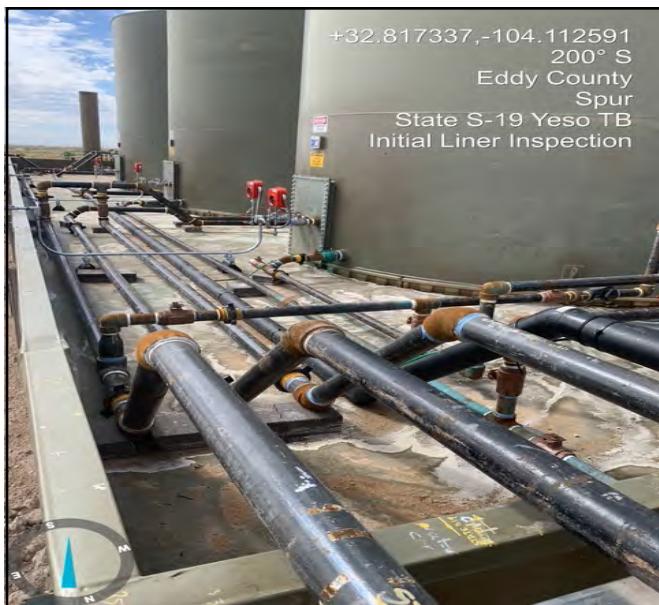
Photo of liner taken during initial liner inspection facing south.

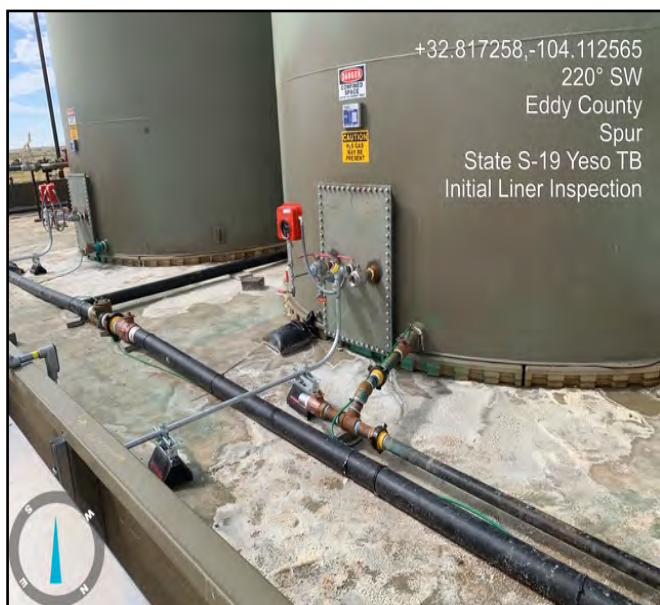
Photo of liner taken during initial liner inspection facing southwest.

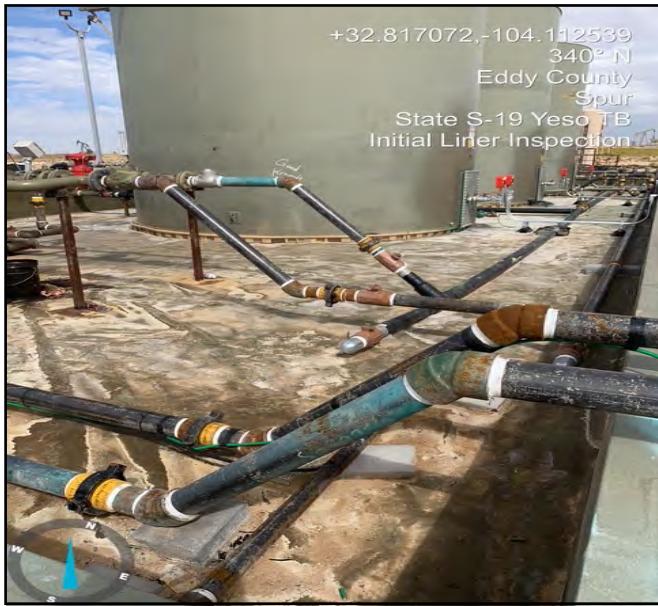
Photo of liner taken during initial liner inspection facing north.

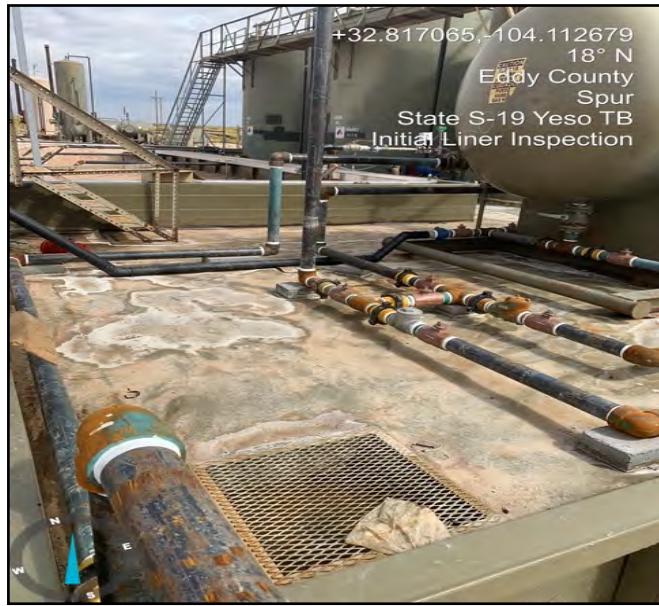
Photo of liner taken during initial liner inspection facing north.

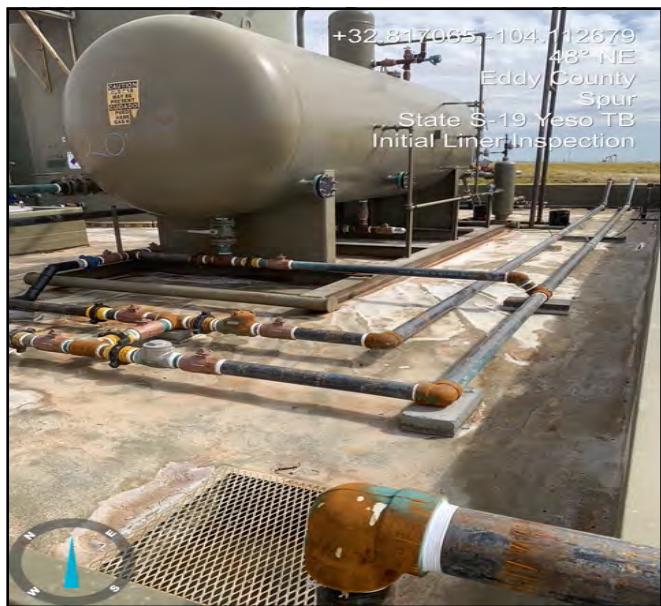
Photo of liner taken during initial liner inspection facing northeast.

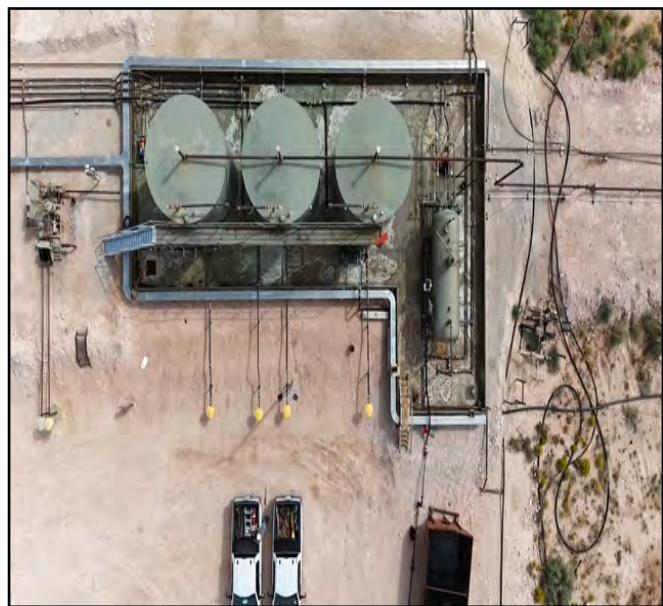
Aerial photo of liner taken during initial liner inspection.

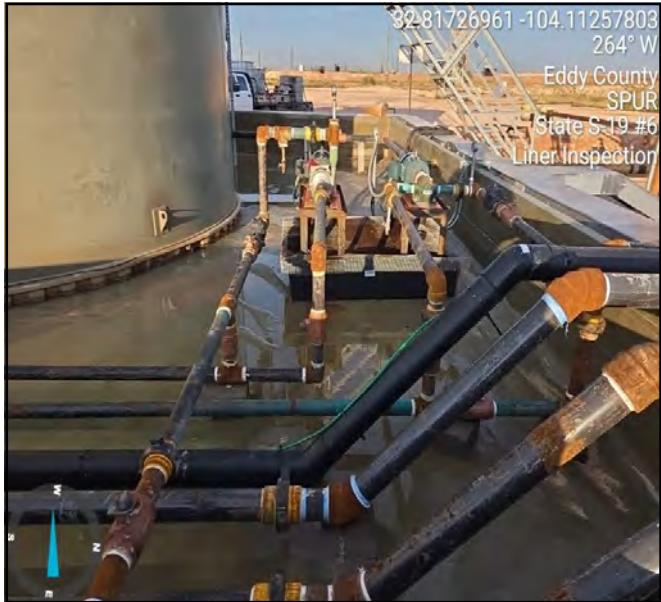
Photo of location taken during Liner Inspection facing west.

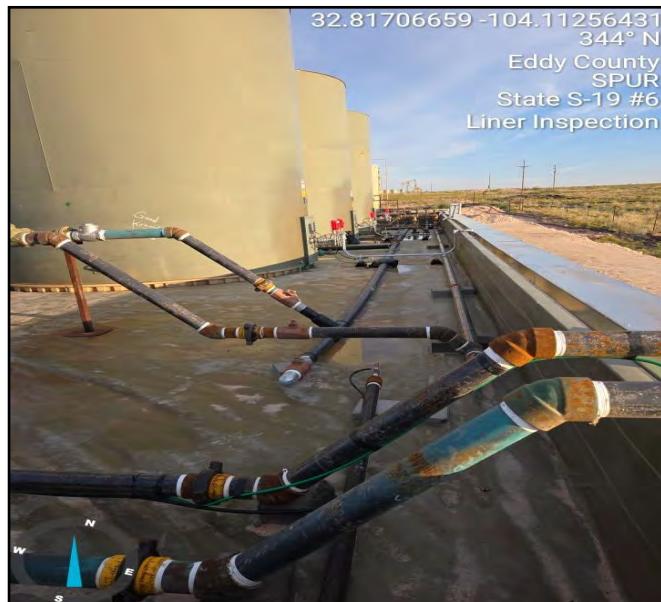
Photo of location taken during Liner Inspection facing north.

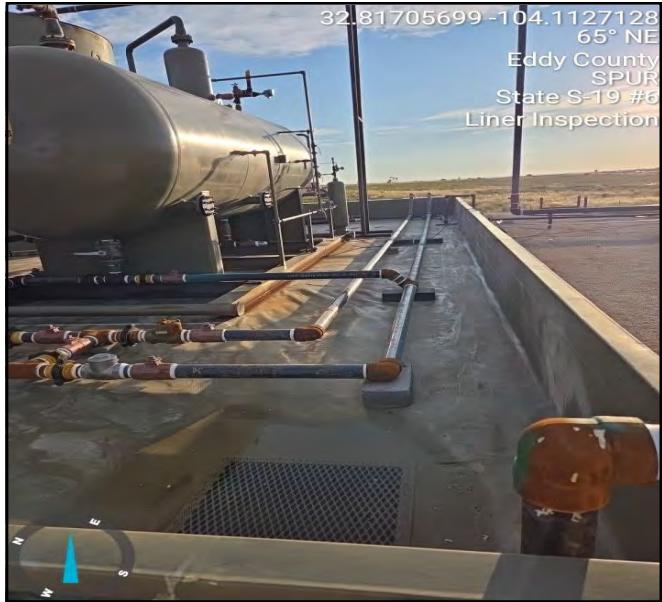
Photo of location taken during Liner Inspection facing northeast.

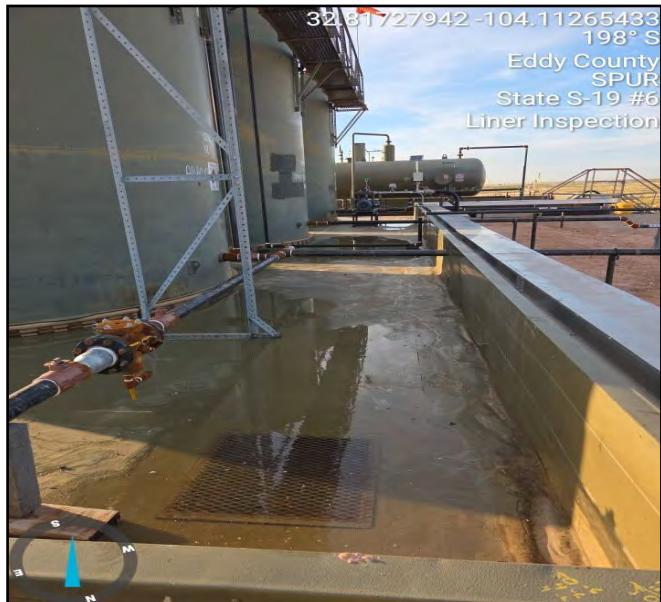
Photo of location taken during Liner Inspection facing south.
