Our Ref.: 12679377 – NMOCD – 1

December 4, 2025

Closure Report  
Devon Energy Production Company, LP  
Exmoor 15 CTB 2  
Unit Letter A, Section 15, TS25, R31E  
GPS: 32.134225, -103.757538  
Eddy County, New Mexico

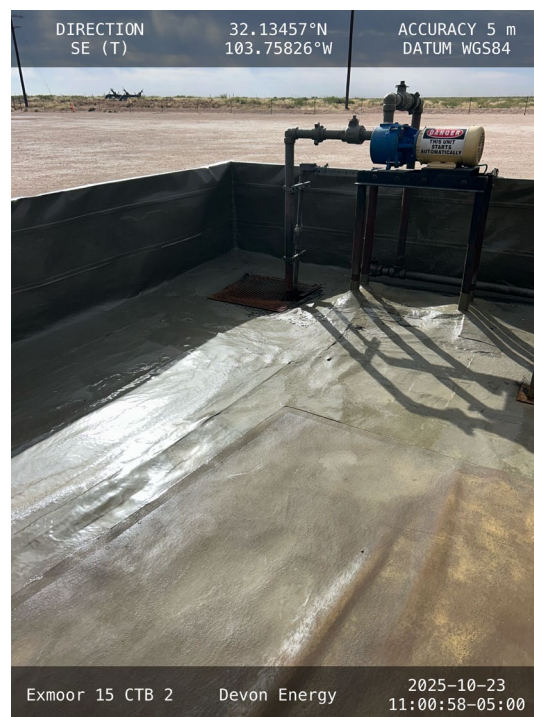
The liner inspection notice was provided on October 20, 2025. A liner integrity inspection was performed on October 23, 2025. The liner was visually inspected and no rips, tears, holes, or damages in the liner was observed. The liner was determined to be intact with no integrity issues. Photographic documentation of the liner inspection is presented in **Attachment 3**.

Photo 2 View of southeast corner of containment.

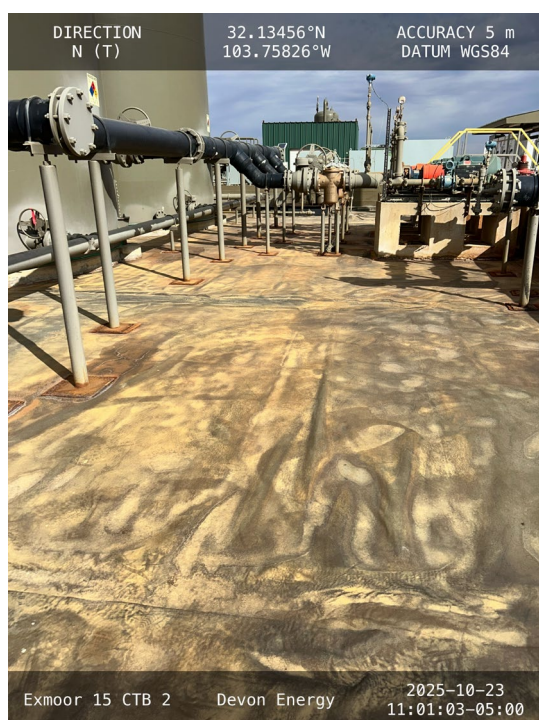
Photo 3 View of eastern portion of secondary containment facing north.

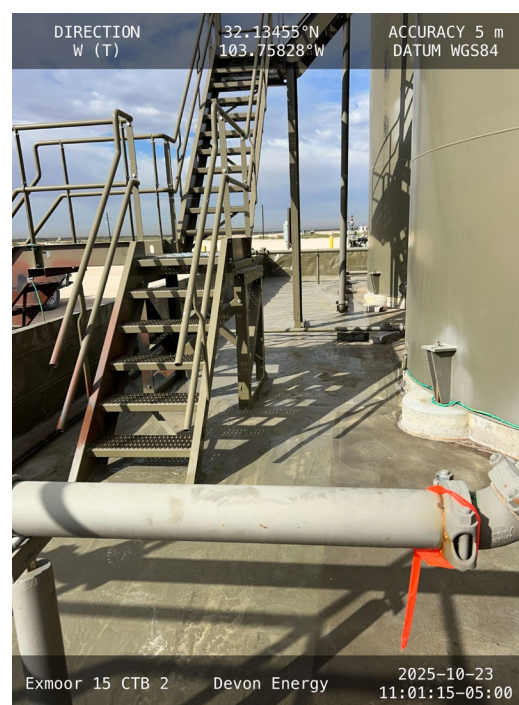
Photo 4 View of southern portion of secondary containment facing west.

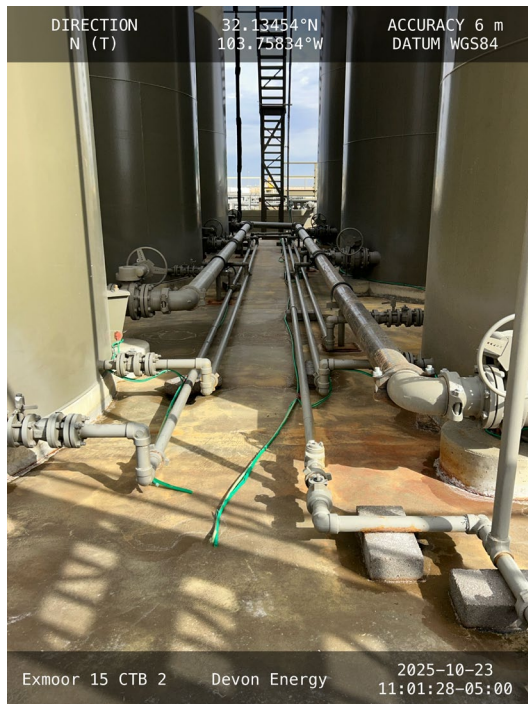
**Photo 5** View of central portion of secondary containment facing north.

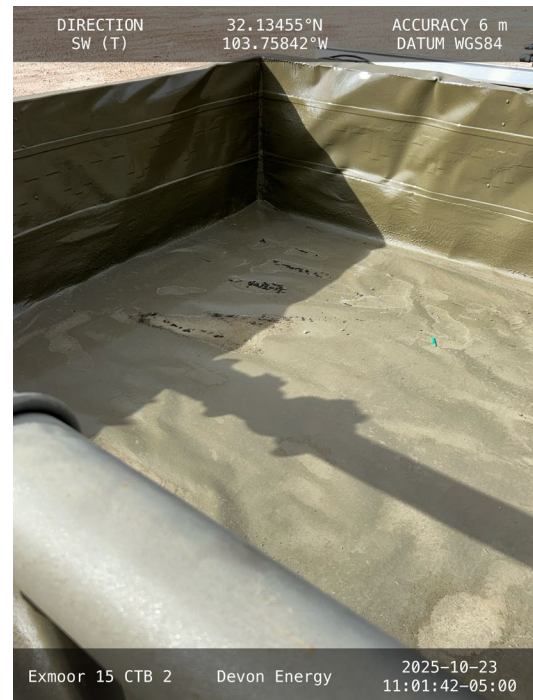
**Photo 6** View of southwest corner of secondary containment.

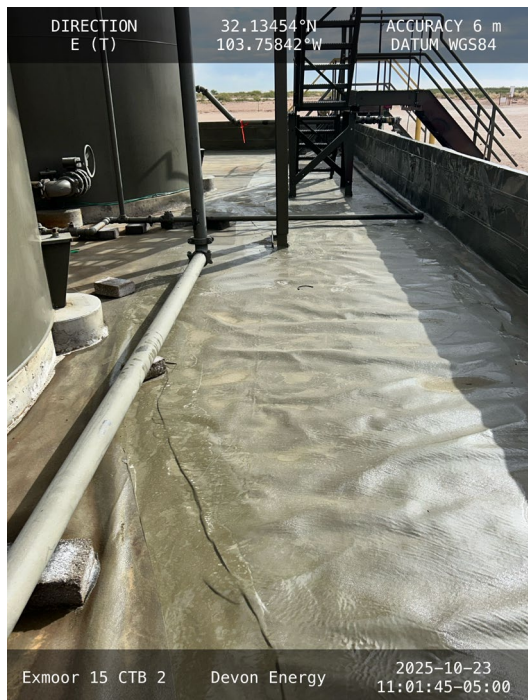
**Photo 7** View of southern portion of secondary containment facing east.

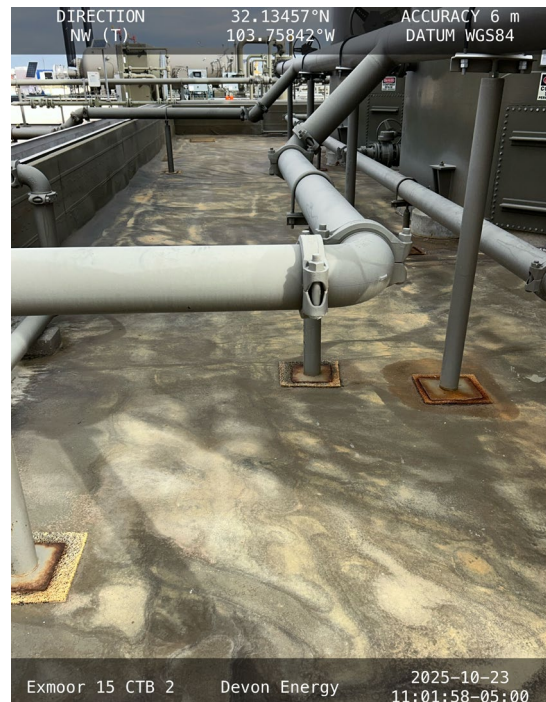
**Photo 8** View of western portion of secondary containment facing north.

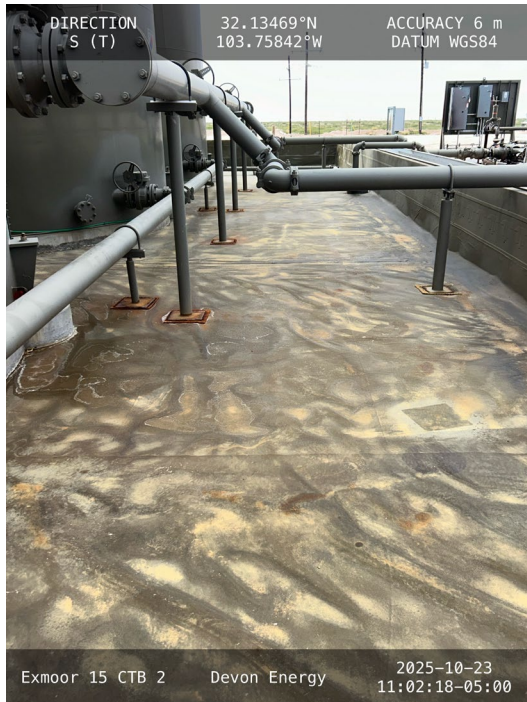
**Photo 9** View of western portion of secondary containment facing south.

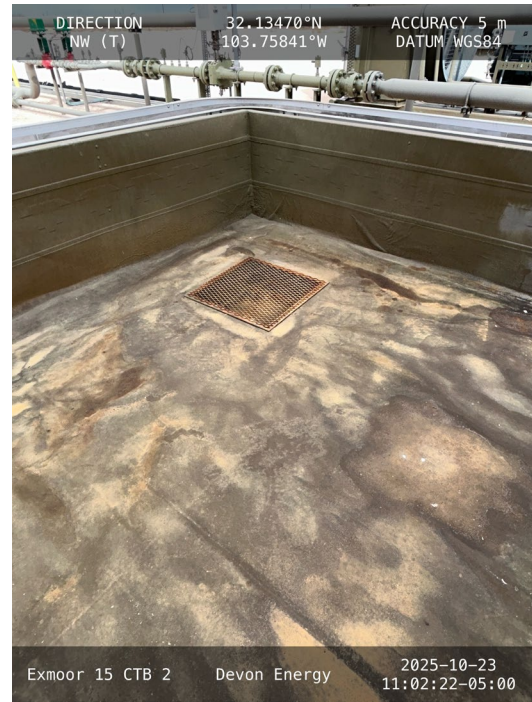
**Photo 10** View of northwest corner of secondary containment.

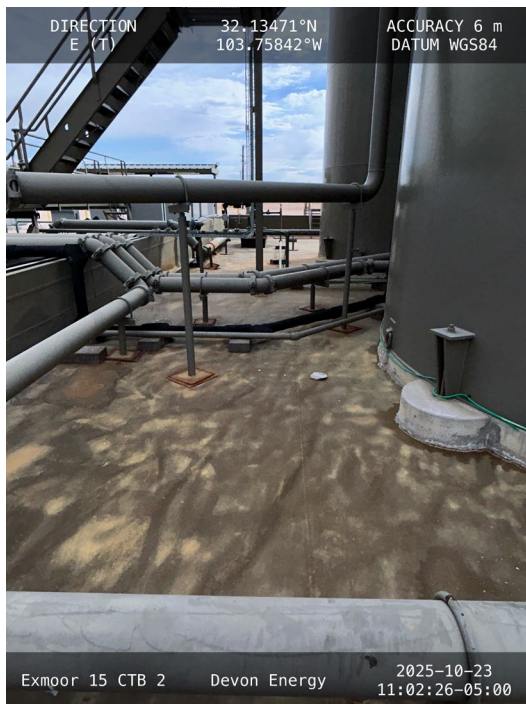
**Photo 11** View of northern portion of secondary containment facing east.

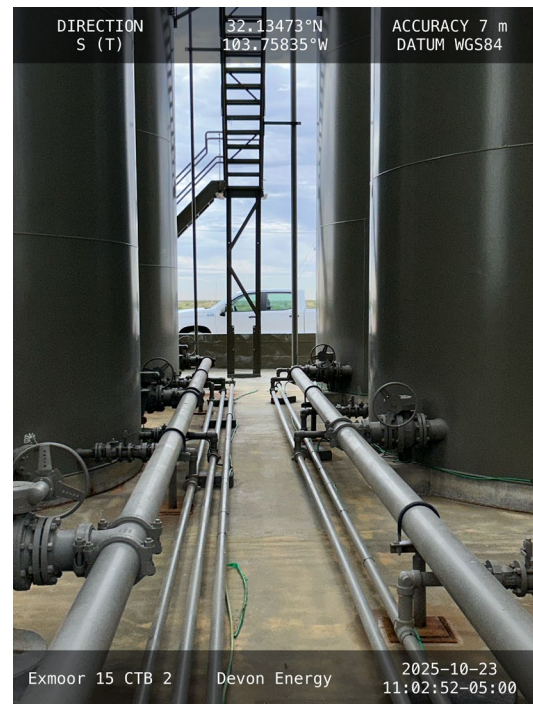
**Photo 12** View of central portion of secondary containment facing south.

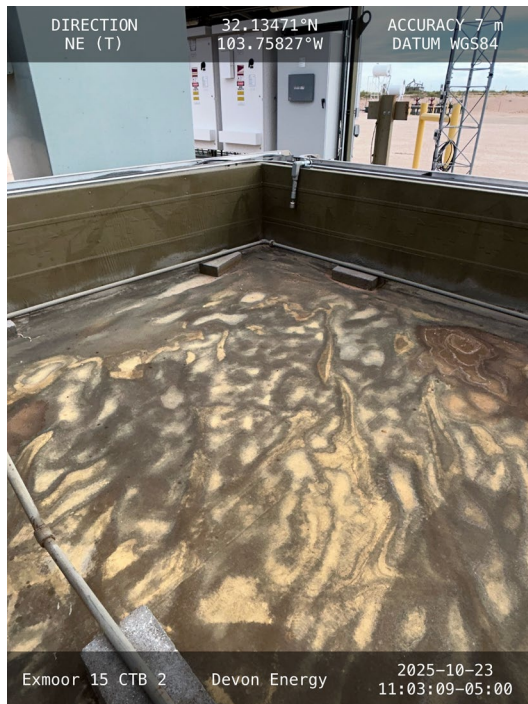
**Photo 13** View of northeast corner of secondary containment.

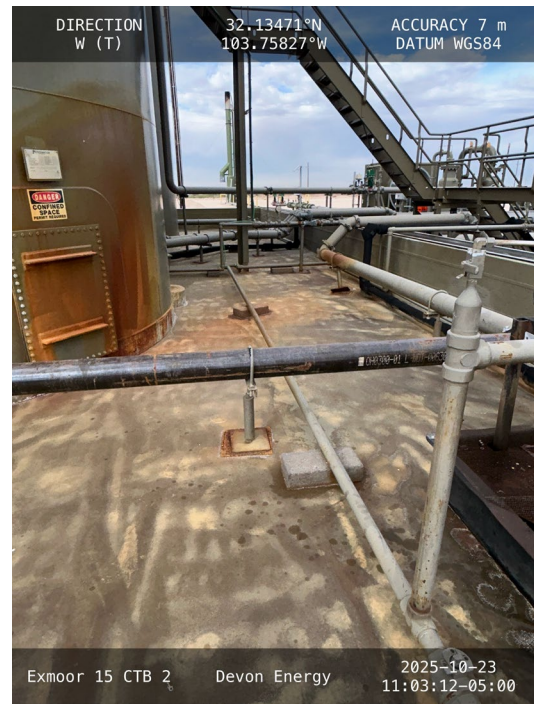
**Photo 14** View of northern portion of secondary containment facing west.
