RE: **Exotic Cat 5 CTB 2 - Closure Request Report**

Incident Number: nAPP2523322705

ESRR Project No. 7086

Earth Systems Response and Restoration (ESRR), presents the following Closure Request Report (CRR) to document the findings during a recent liner inspection conducted at Exotic Cat 5 CTB 2 (Site) following an inadvertent release of produced water within a lined secondary containment (LSC). Based on initial release response and liner inspection activities, Devon Energy (Devon) is requesting No Further Action (NFA) at the Site.

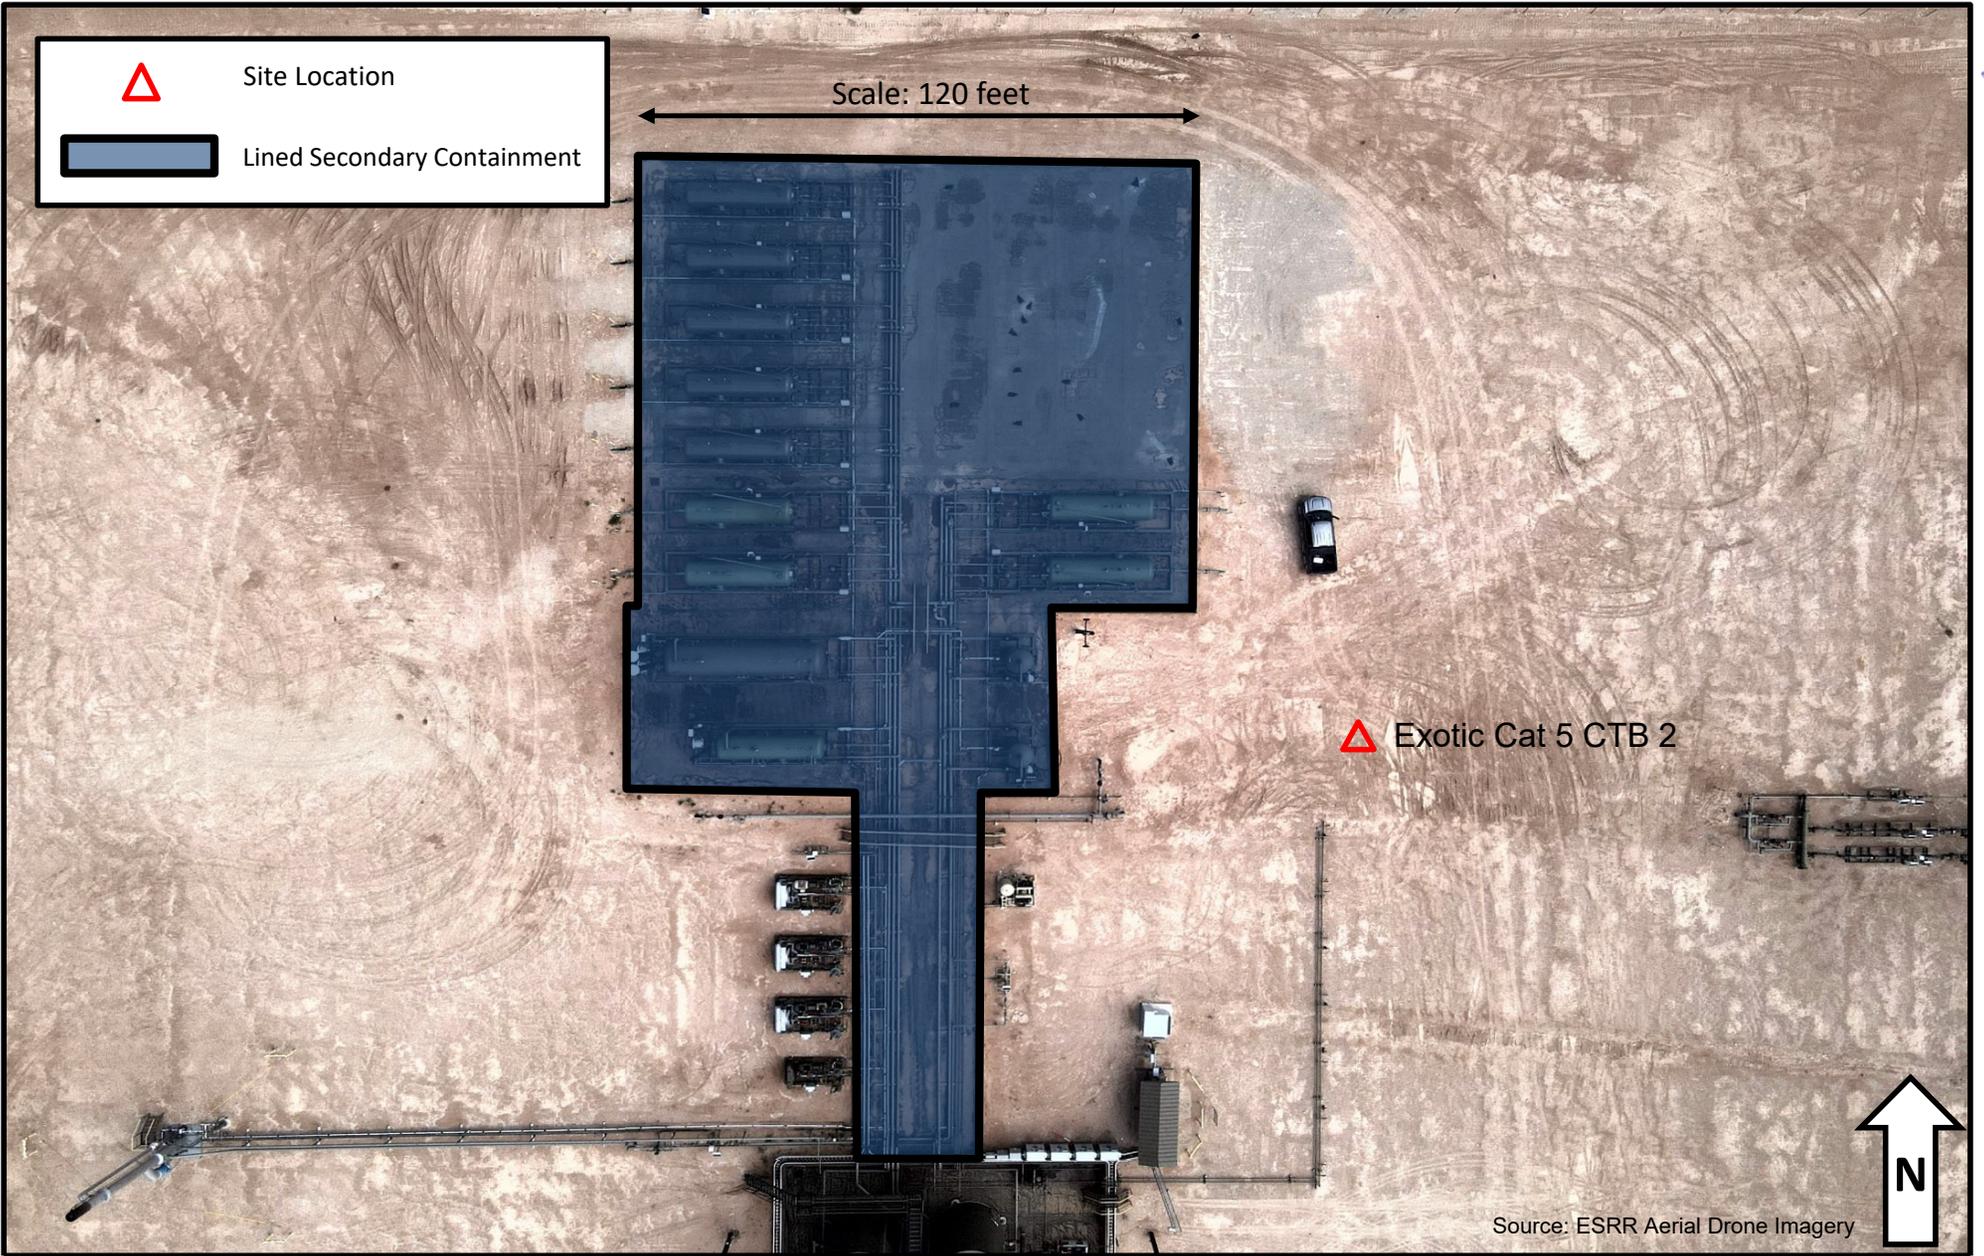
Figure 2 – Release Extent

On August 20, 2025, a pinhole leak developed on a dump valve, releasing approximately 261 barrels (bbls) of produced water within a LSC (**Figure 2**). The release was fully contained within the LSC with no fluids escaping to the production pad or adjacent native soils. A vacuum truck was immediately dispatched to the Site recovering the 261 bbls of produced water.

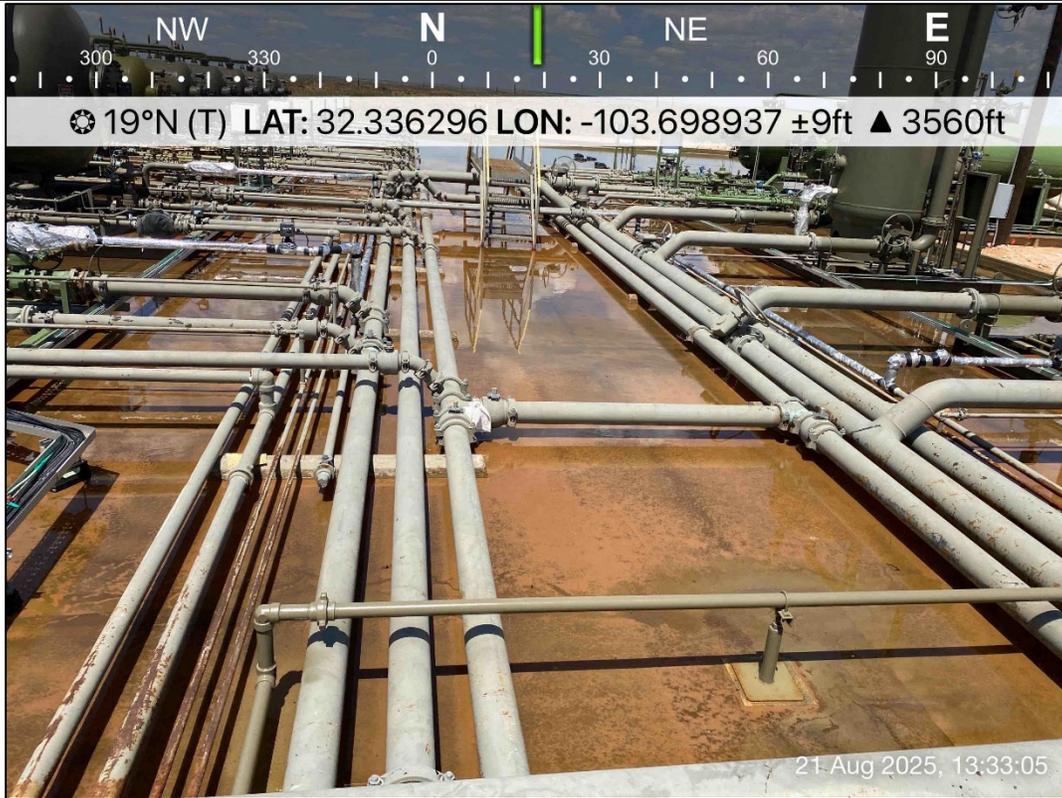
PHOTO 1: Northeastern view during initial site assessment activities. 8/21/2025

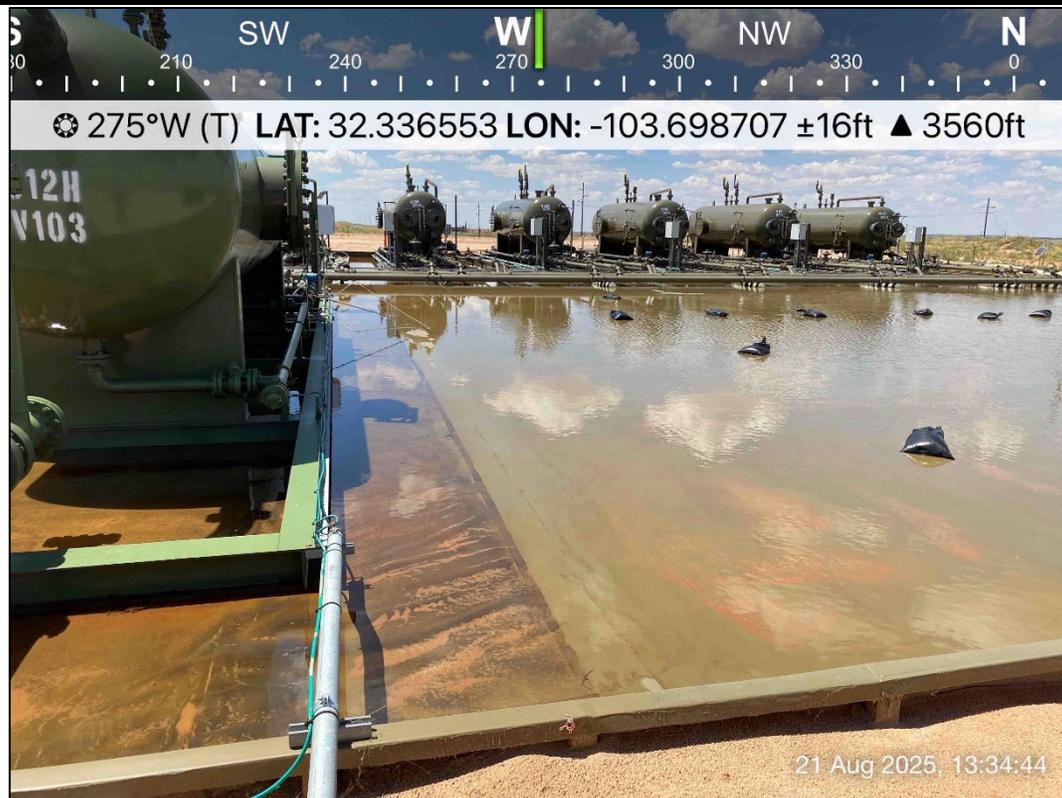
PHOTO 2: Northeastern view during initial site assessment activities. 8/21/2025

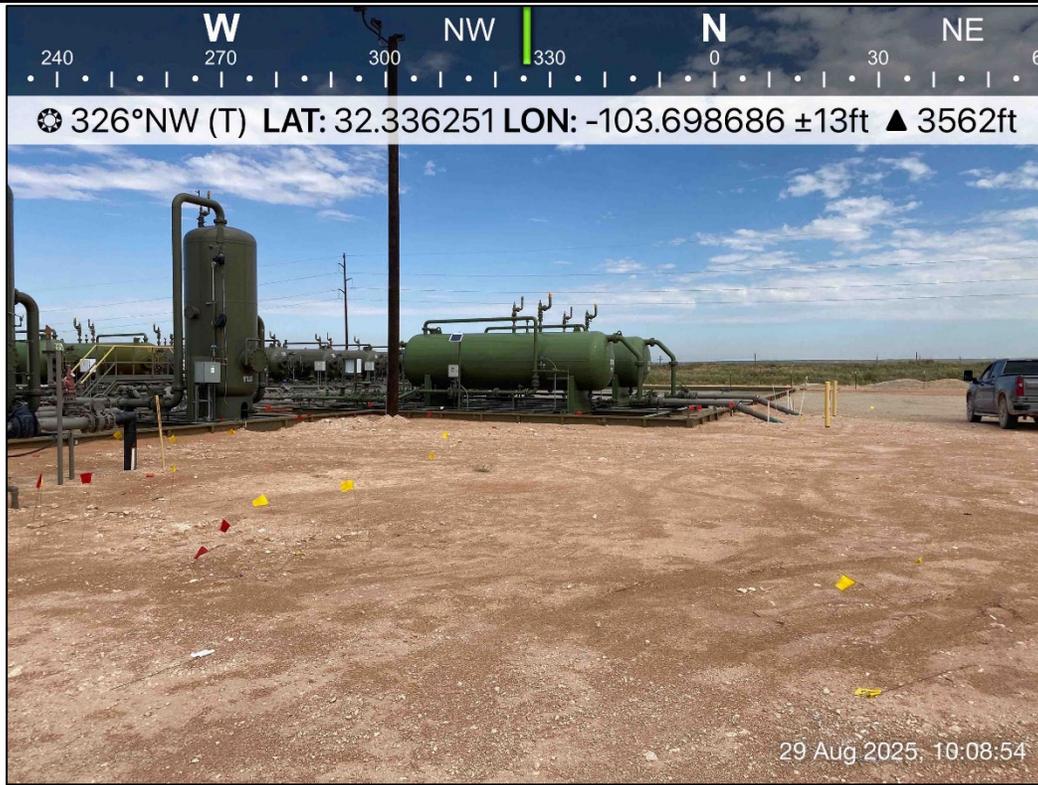
PHOTO 3: Northwestern view outside of containment during liner inspection activities. 8/29/2025

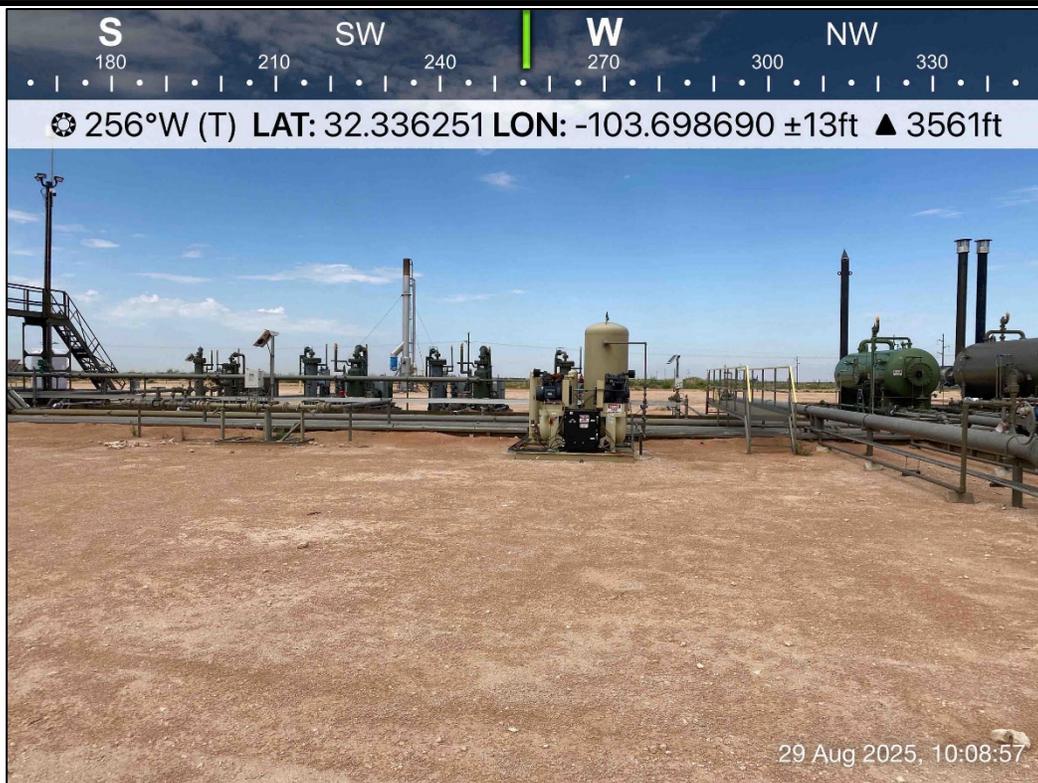
PHOTO 4: Southwestern view outside of containment during liner inspection activities. 8/29/2025

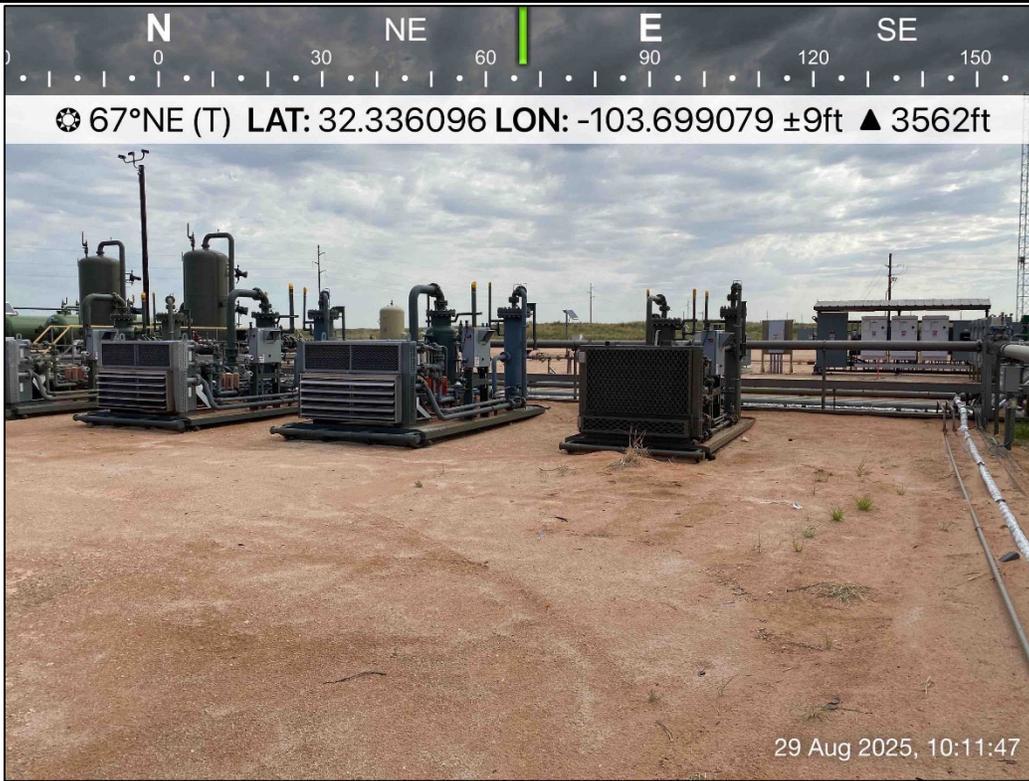
PHOTO 5: Northeastern view outside of containment during liner inspection activities. 8/29/2025

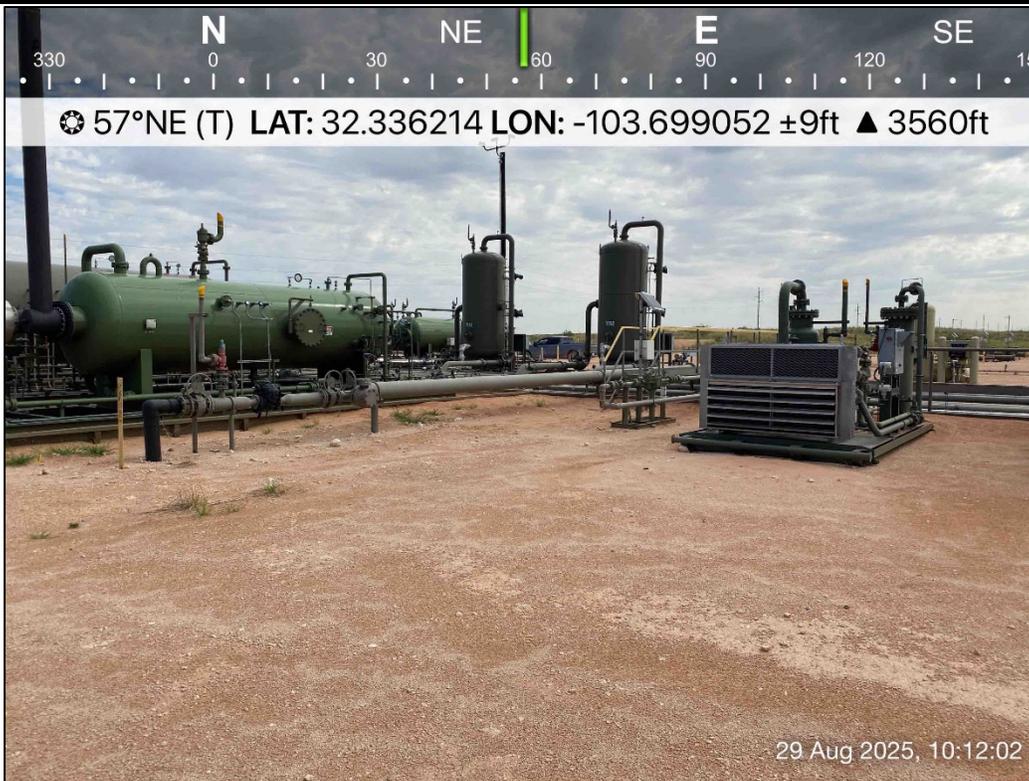
PHOTO 6: Northeastern view outside of containment during liner inspection activities. 8/29/2025

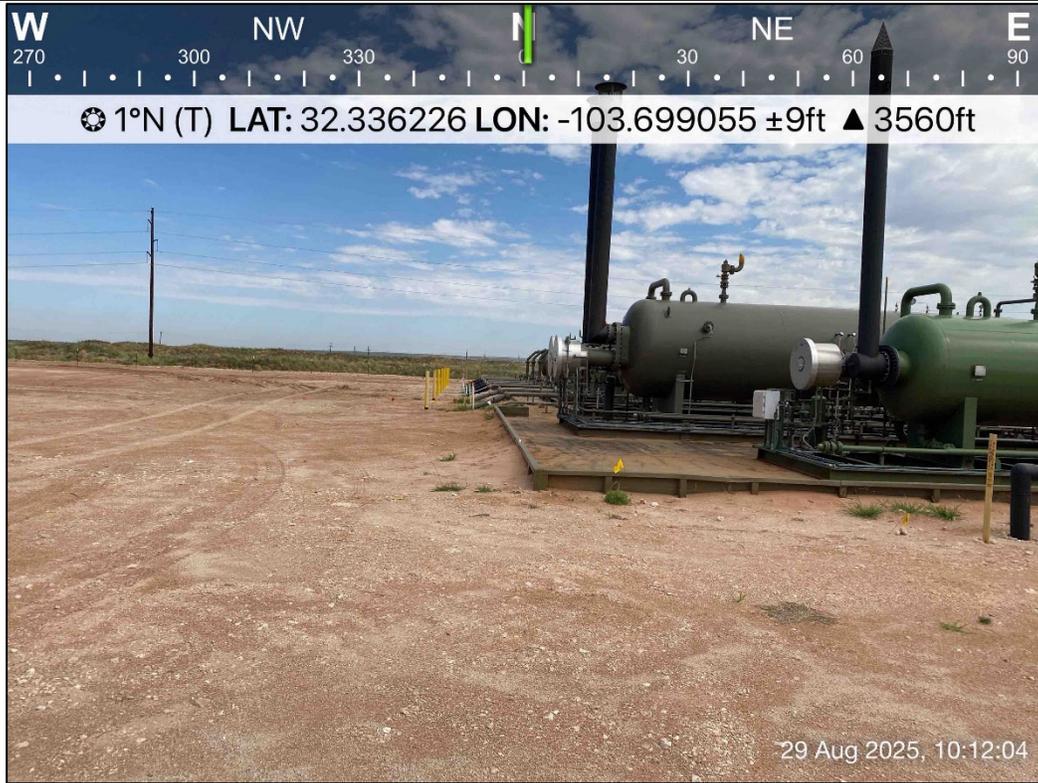
PHOTO 7: Northern view outside of containment during liner inspection activities. 8/29/2025

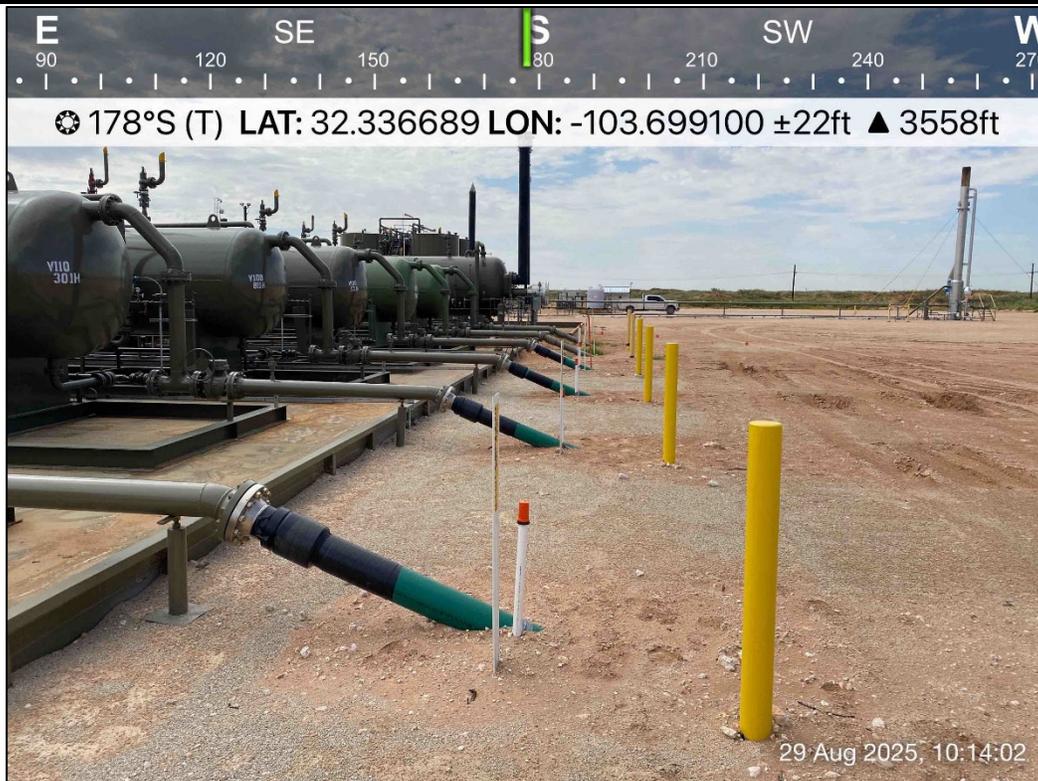
PHOTO 8: Southwestern view outside of containment during liner inspection activities. 8/29/2025

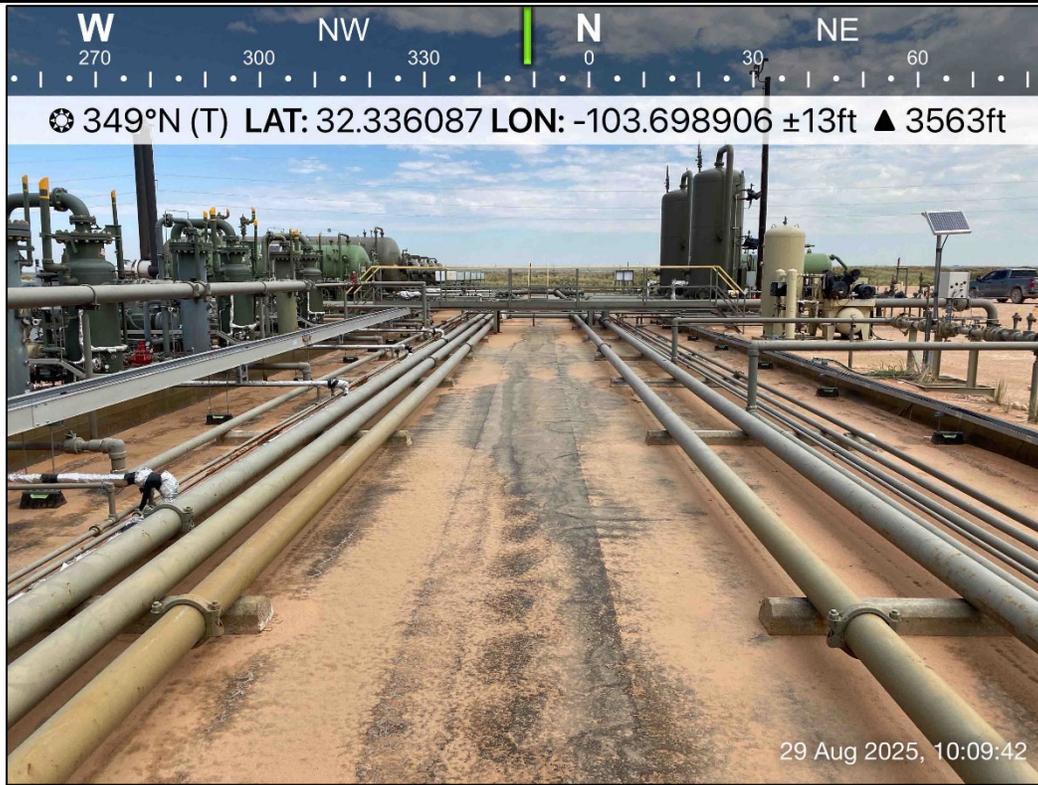
On August 29, 2025, ESRR conducted a thorough visual inspection of the LSC and found no tears, cracks, cuts, breaks, or other signs of damage, confirming no evidence of a breach to the LSC. The liner appears to be in good condition and is performing as designed. **Photographic Documentation** of liner inspection activities is attached.

PHOTO 9: Northwestern view during liner inspection activities. 8/29/2025

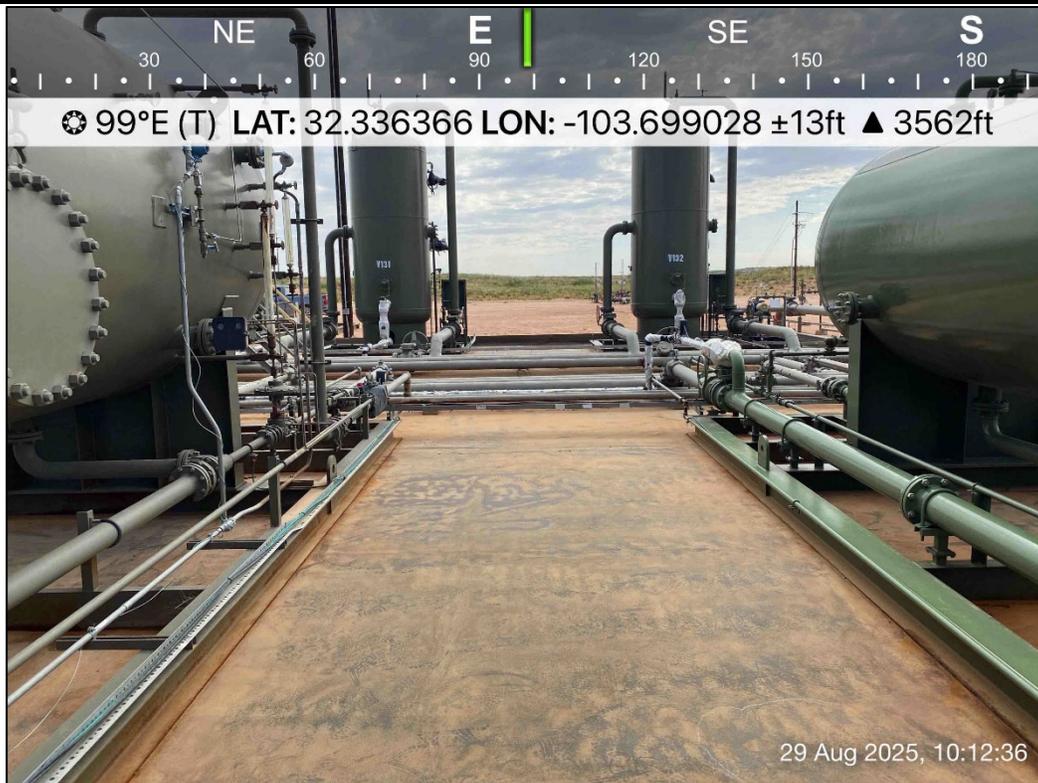
PHOTO 10: Southeastern view during liner inspection activities. 8/29/2025

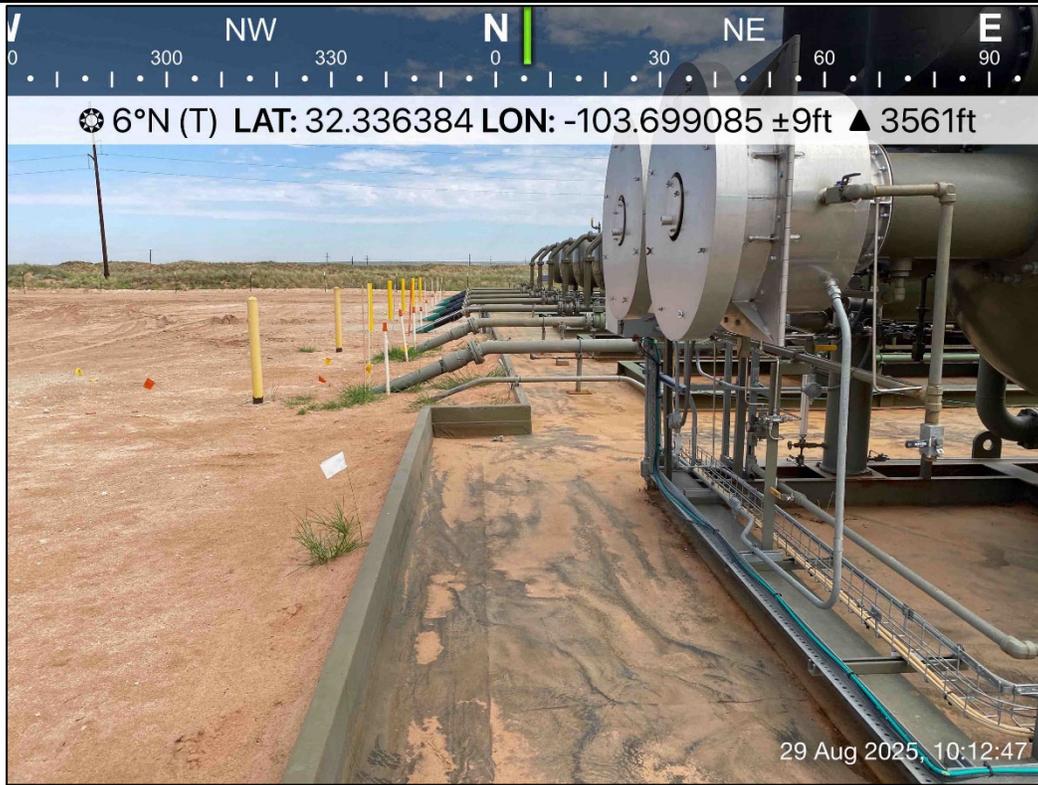
PHOTO 11: Northeastern view during liner inspection activities. 8/29/2025

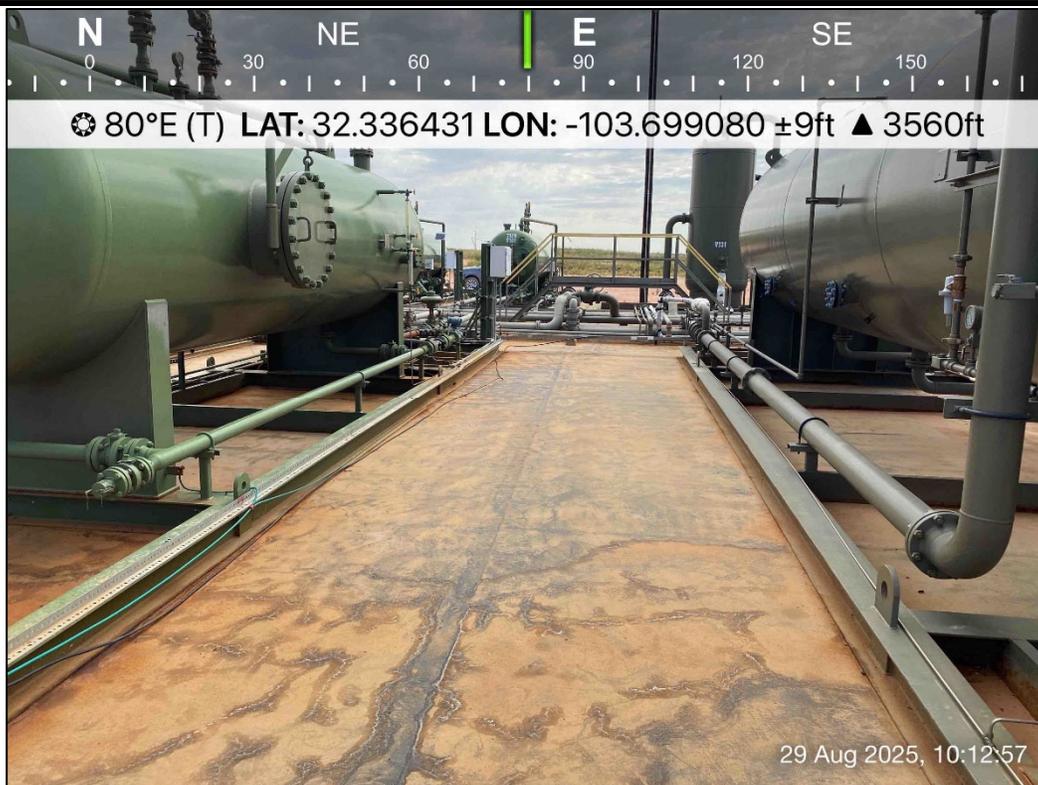
PHOTO 12: Northeastern view during liner inspection activities. 8/29/2025

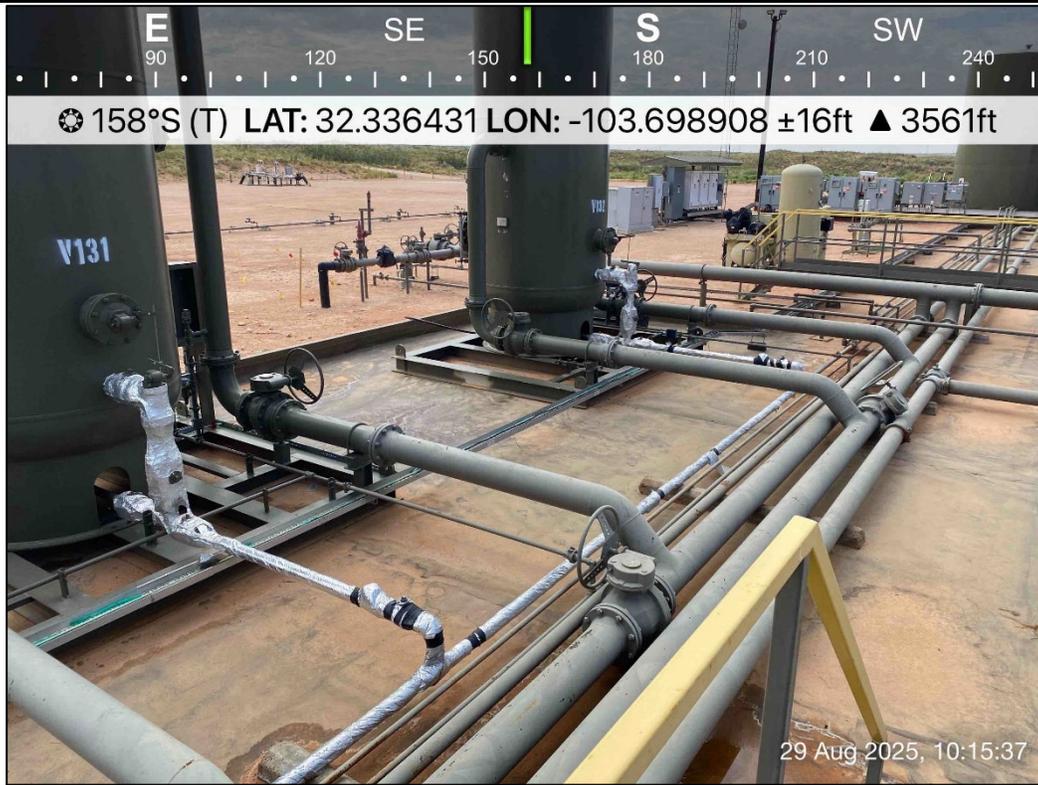
PHOTO 13: Southeastern view during liner inspection activities. 8/29/2025

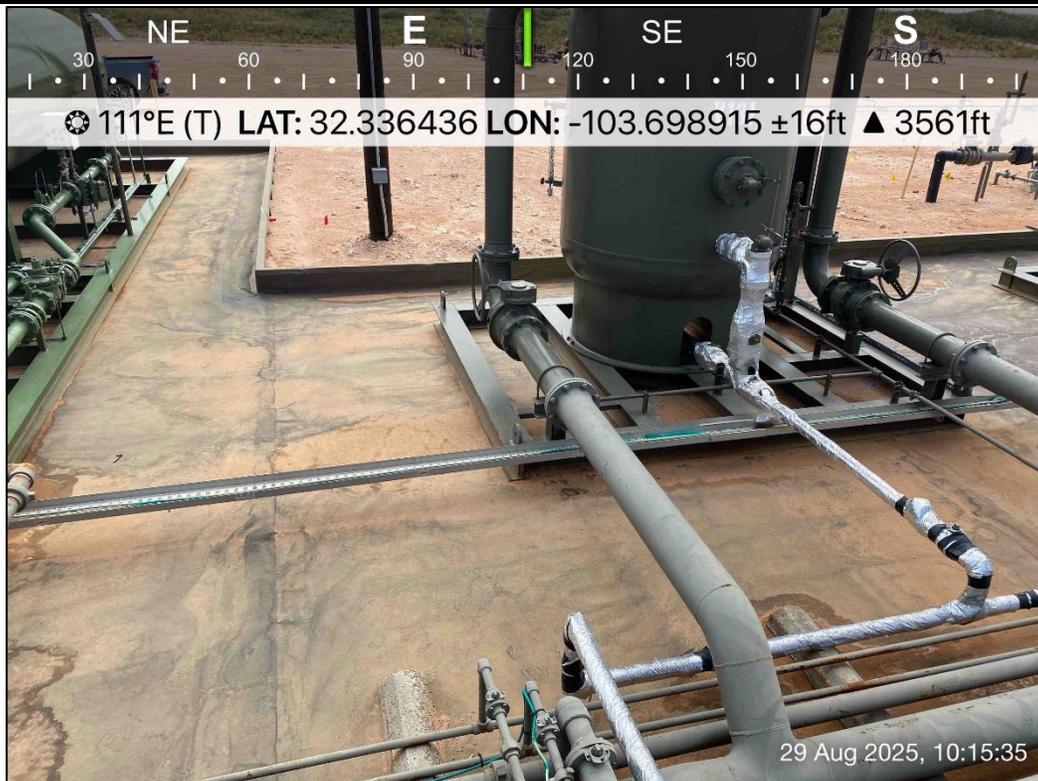
PHOTO 14: Southeastern view during liner inspection activities. 8/29/2025

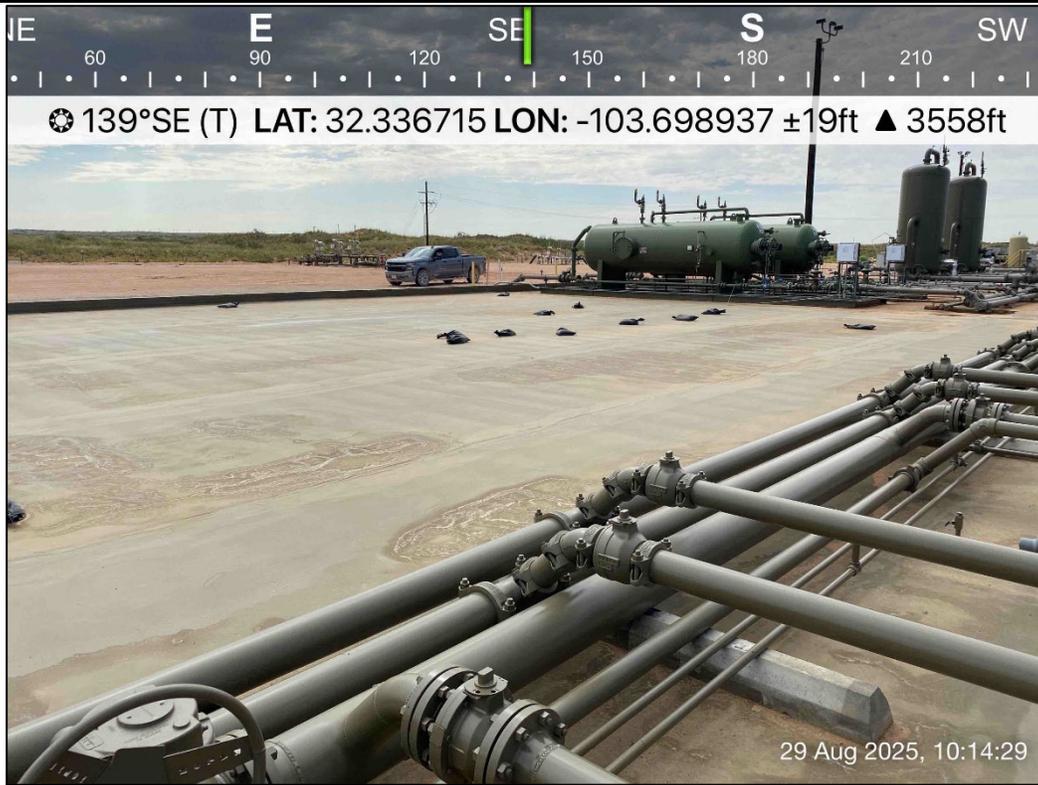
PHOTO 15: Southeastern view during liner inspection activities. 8/29/2025

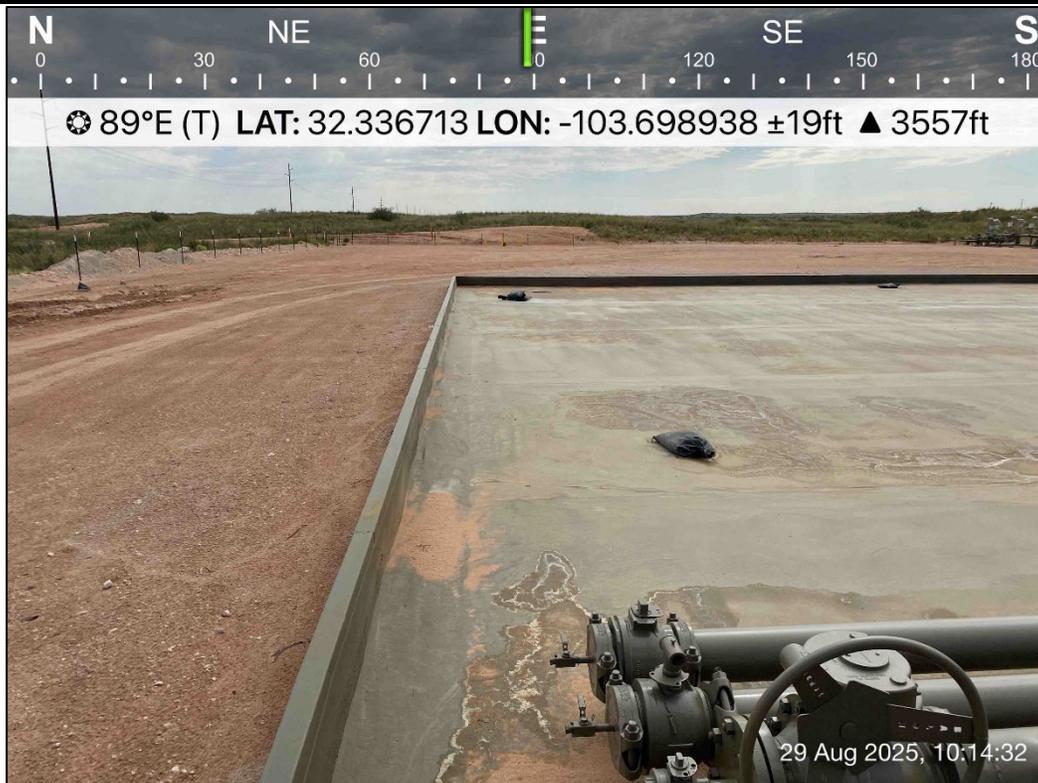
PHOTO 16: Eastern view during liner inspection activities. 8/29/2025

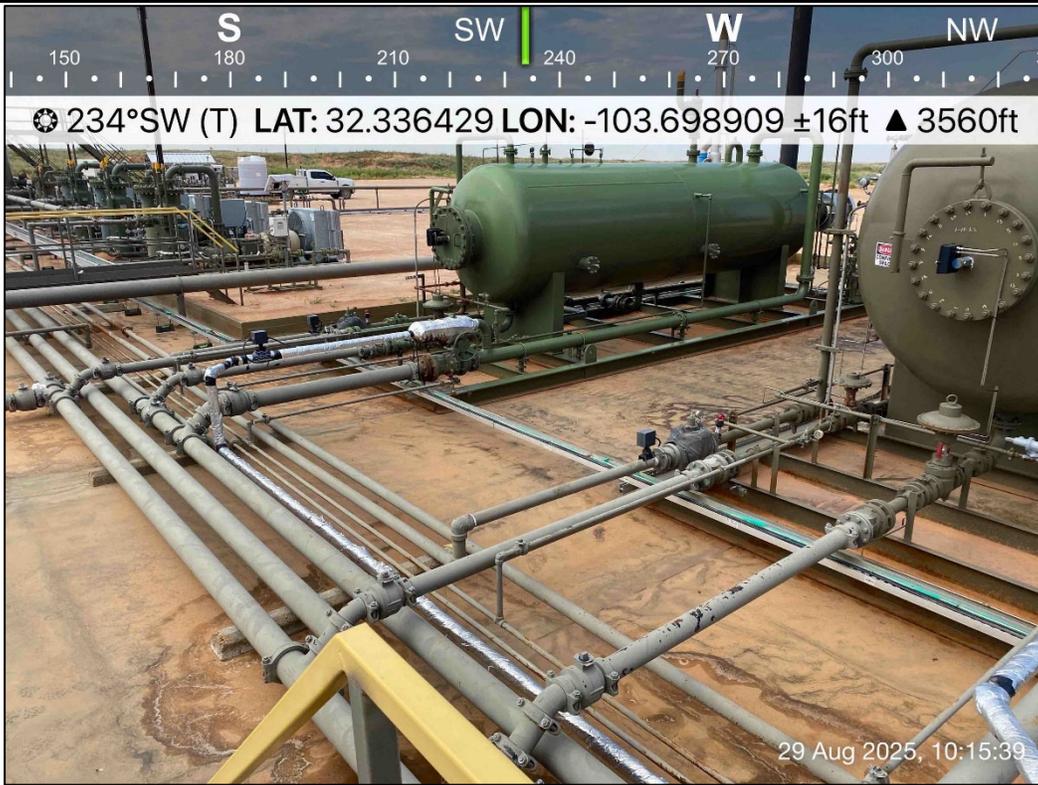
PHOTO 17: Southwestern view during liner inspection activities. 8/29/2025

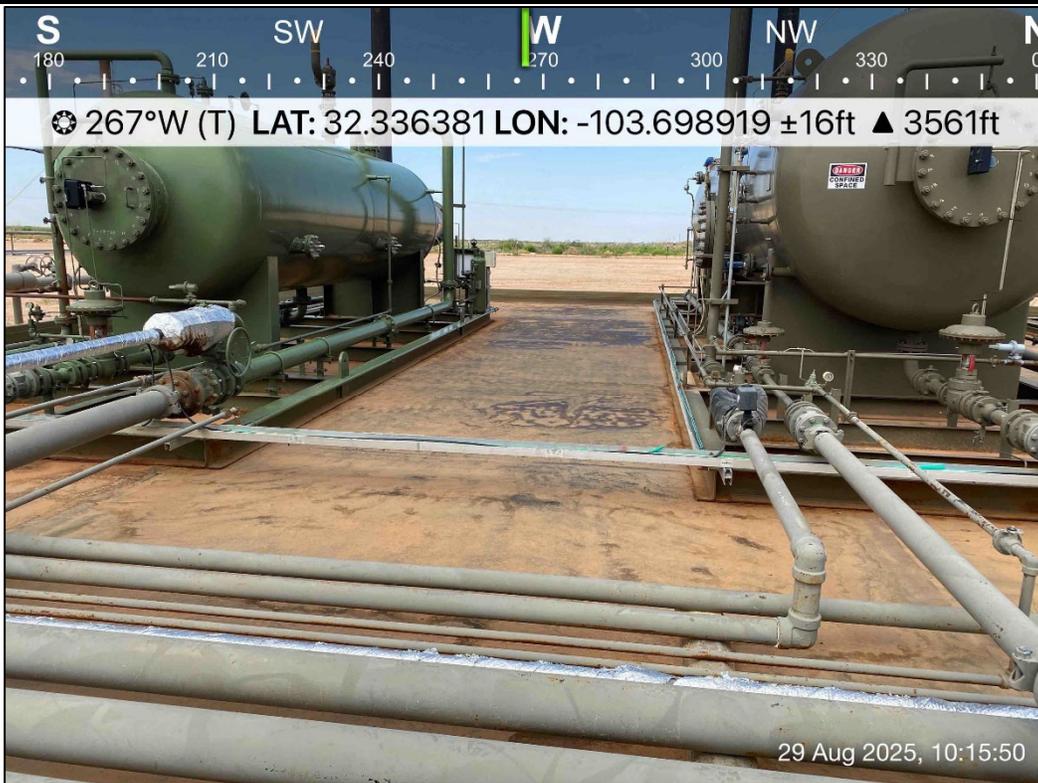
PHOTO 18: Western view during liner inspection activities. 8/29/2025

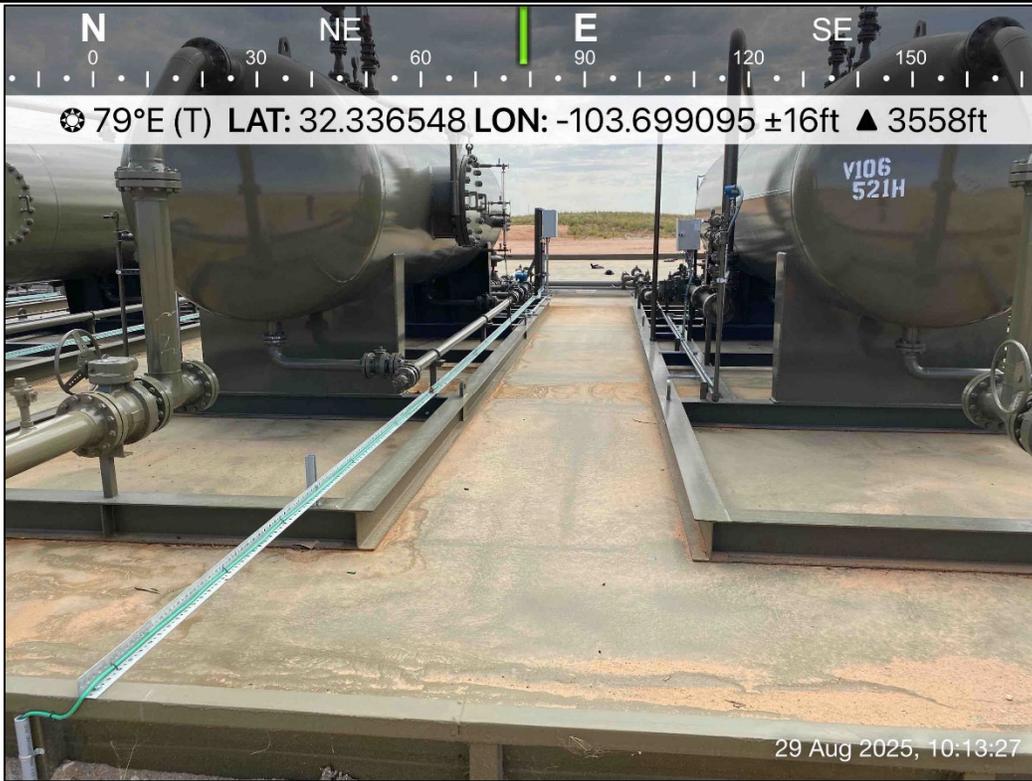
PHOTO 19: Northeastern view during liner inspection activities. 8/29/2025
