## **Liner Inspection and Closure Request**

**Devon Energy Production Company, LP  
Red Bull 29 Federal 1H  
Lea County, New Mexico**

**Unit Letter "D", Section 29, Township 23 South, Range 35 East  
Latitude 32.281725 North, Longitude 103.396853 West  
NMOCD Incident # NAPP2526021459**

**January 2026**

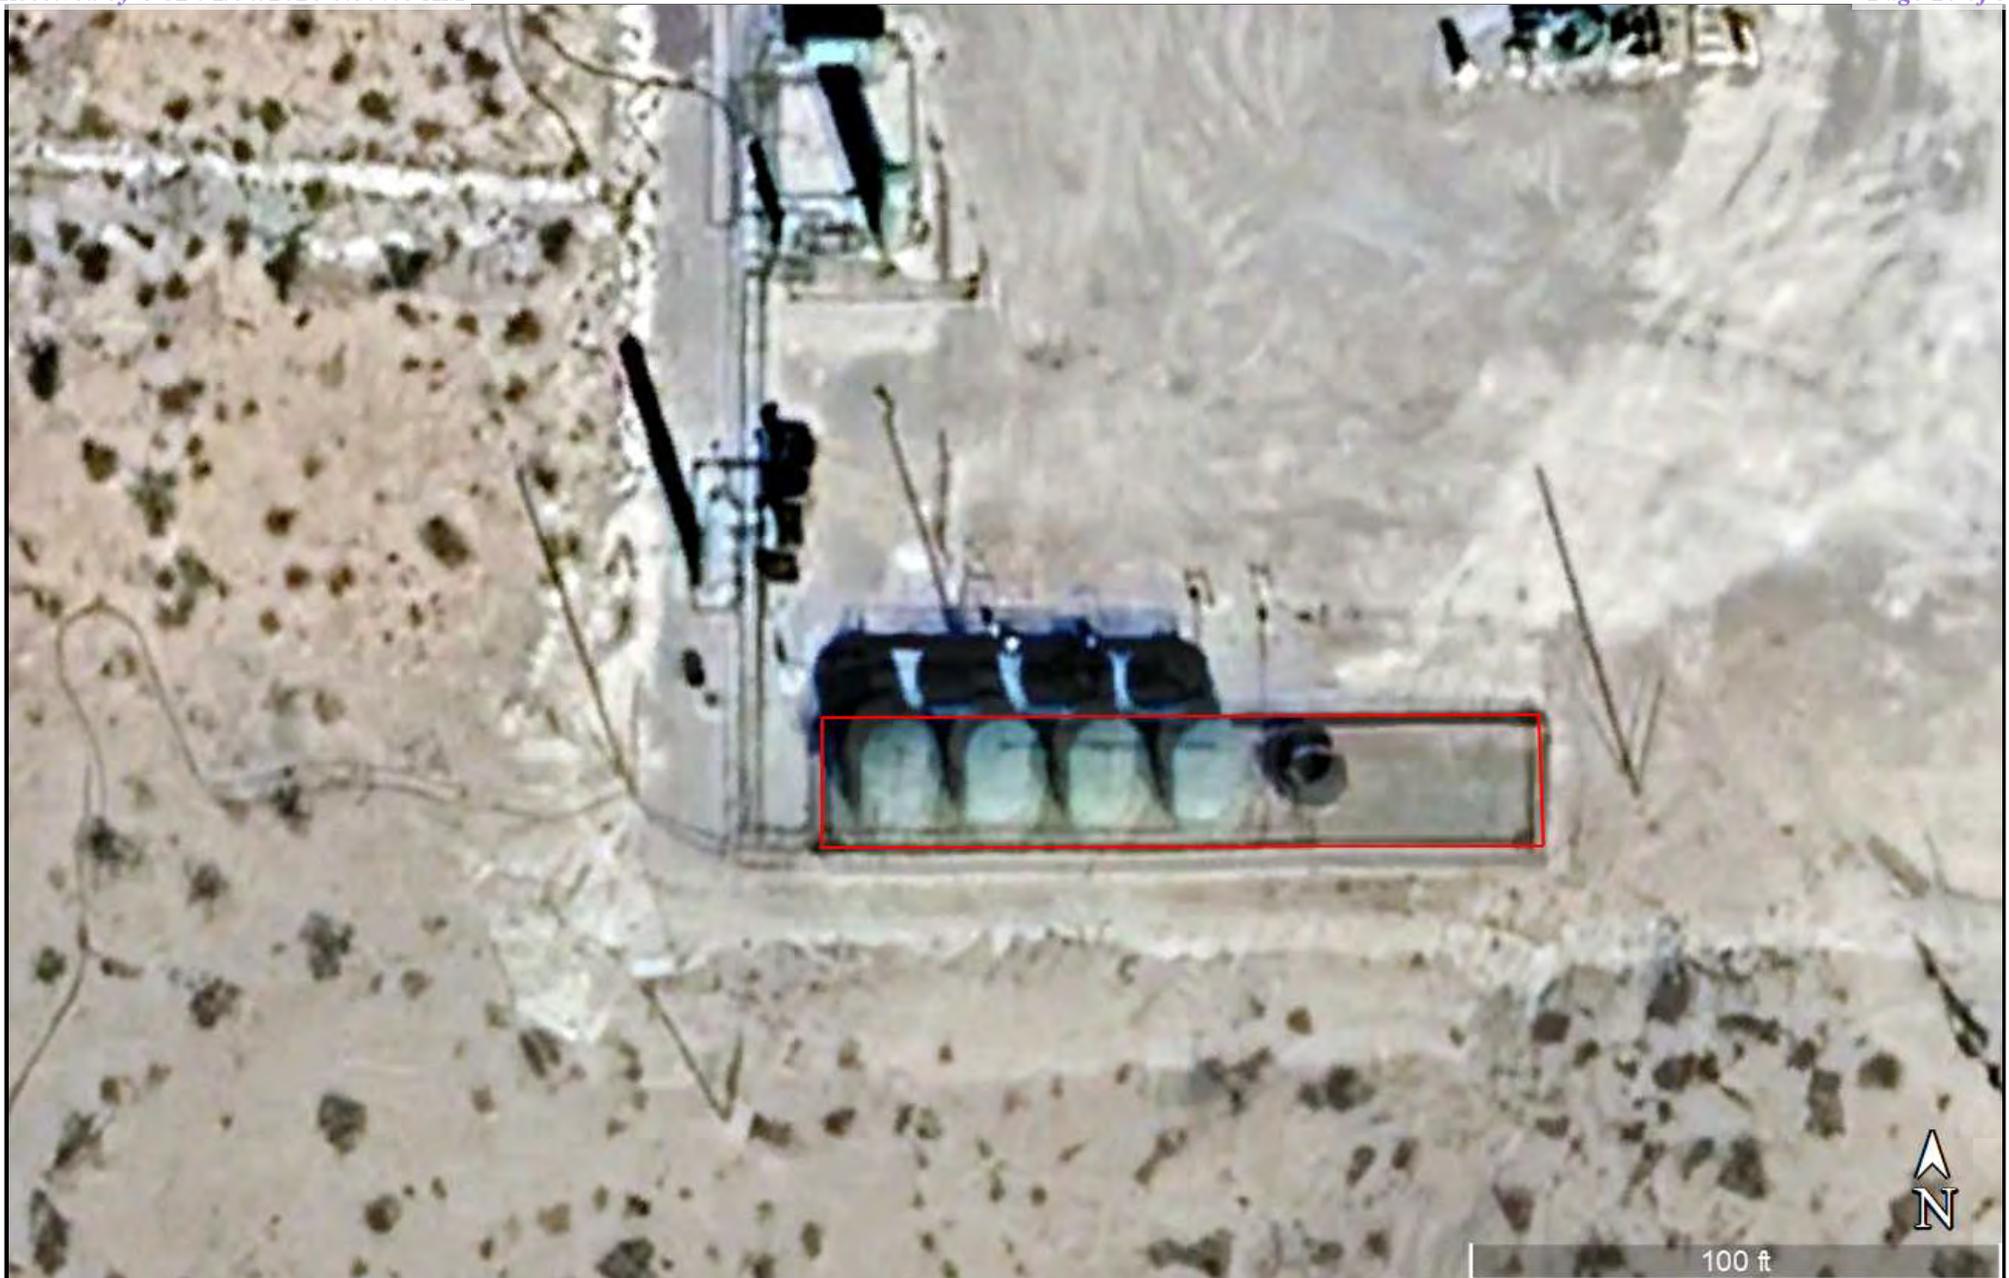
**Figure 4**

On January 16, 2026, Hungry Horse personnel arrived on location to inspect the liner. The liner and metal containment were thoroughly inspected form edge to edge, as well as around the tanks and process equipment installed on the liner itself. Site Photographs are provided as Attachment III. The liner was found to be in place, intact, with no visible breaks or tears. There was no evidence of the release escaping the metal containment area. A completed Liner Inspection Form is attached as Attachment V.

Liner Inspection Map  
Devon Energy Production Company, LP  
Red Bull 29 Fed 1H  
GPS: 32.281725, -103.396853  
Lea County

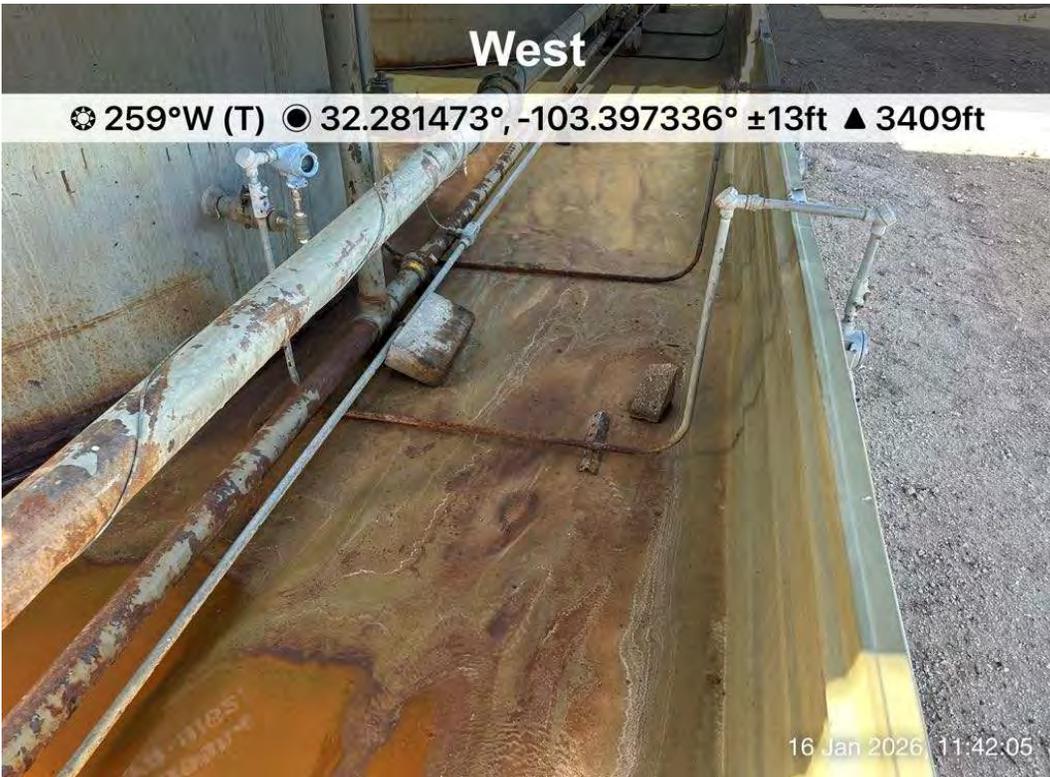
Photo: 3	Description: Liner Inspection
<p style="text-align: center;"><b>West</b></p> <p style="text-align: center;">☉ 259°W (T) ● 32.281473°, -103.397336° ±13ft ▲ 3409ft</p>

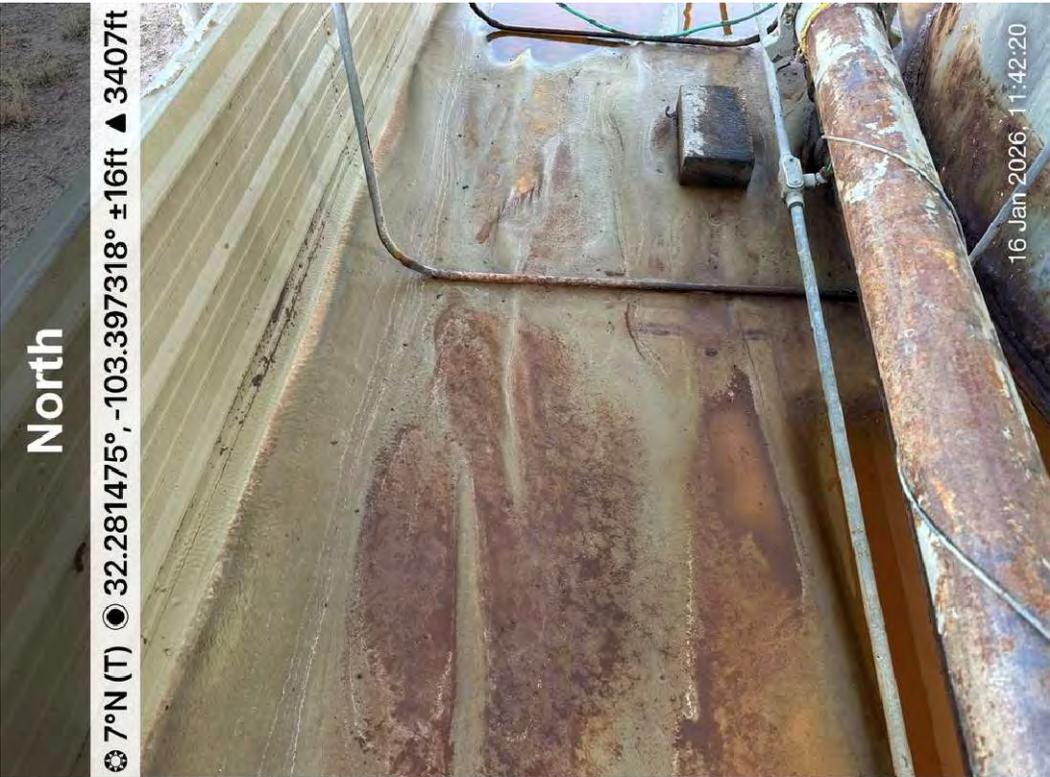
Photo: 4	Description: Liner Inspection
<p style="writing-mode: vertical-rl; transform: rotate(180deg);"><b>North</b></p> <p style="writing-mode: vertical-rl; transform: rotate(180deg);">☉ 7°N (T) ● 32.281475°, -103.397318° ±16ft ▲ 3407ft</p>

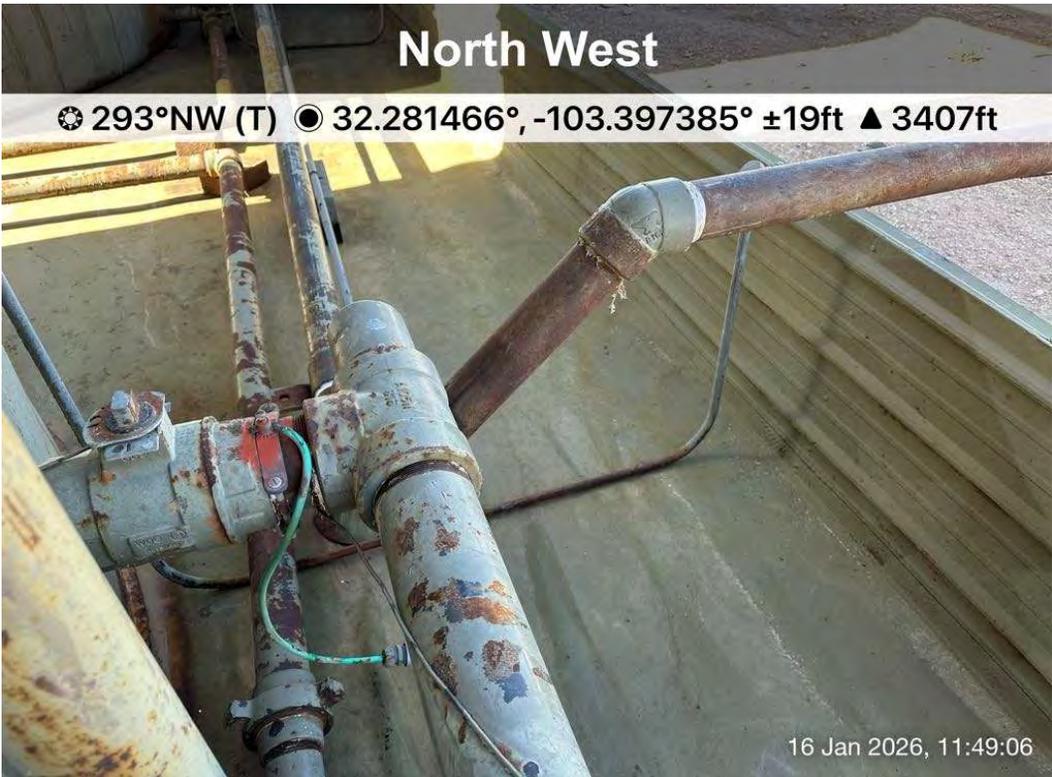
<b>Photo:</b>	<b>13</b>	<b>Description:</b> Liner Inspection
---------------	-----------	--------------------------------------

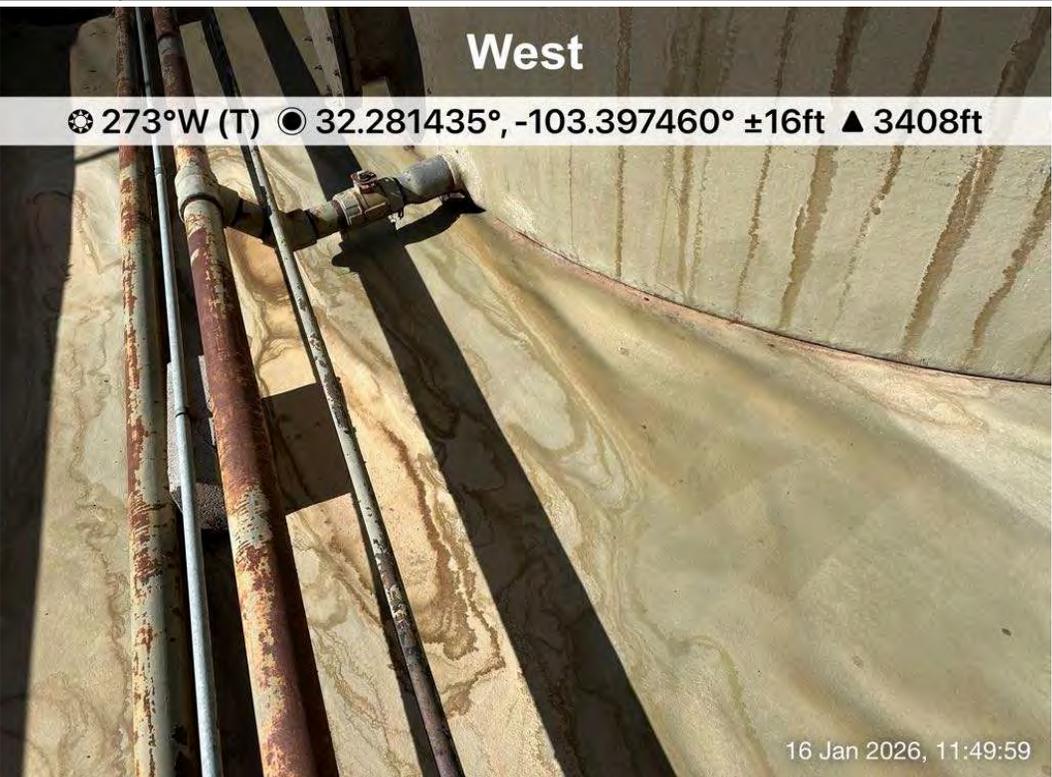
<b>Photo:</b>	<b>14</b>	<b>Description:</b> Liner Inspection
---------------	-----------	--------------------------------------
