RE: **ROSS DRAW UNIT #044H - Closure Request Report**

Incident Number: nAPP2529330869

ESRR Project No. VP-7643

**Environmental Karst Study Report  
Devon Ross Draw Unit No. 044H  
Eddy County, New Mexico**

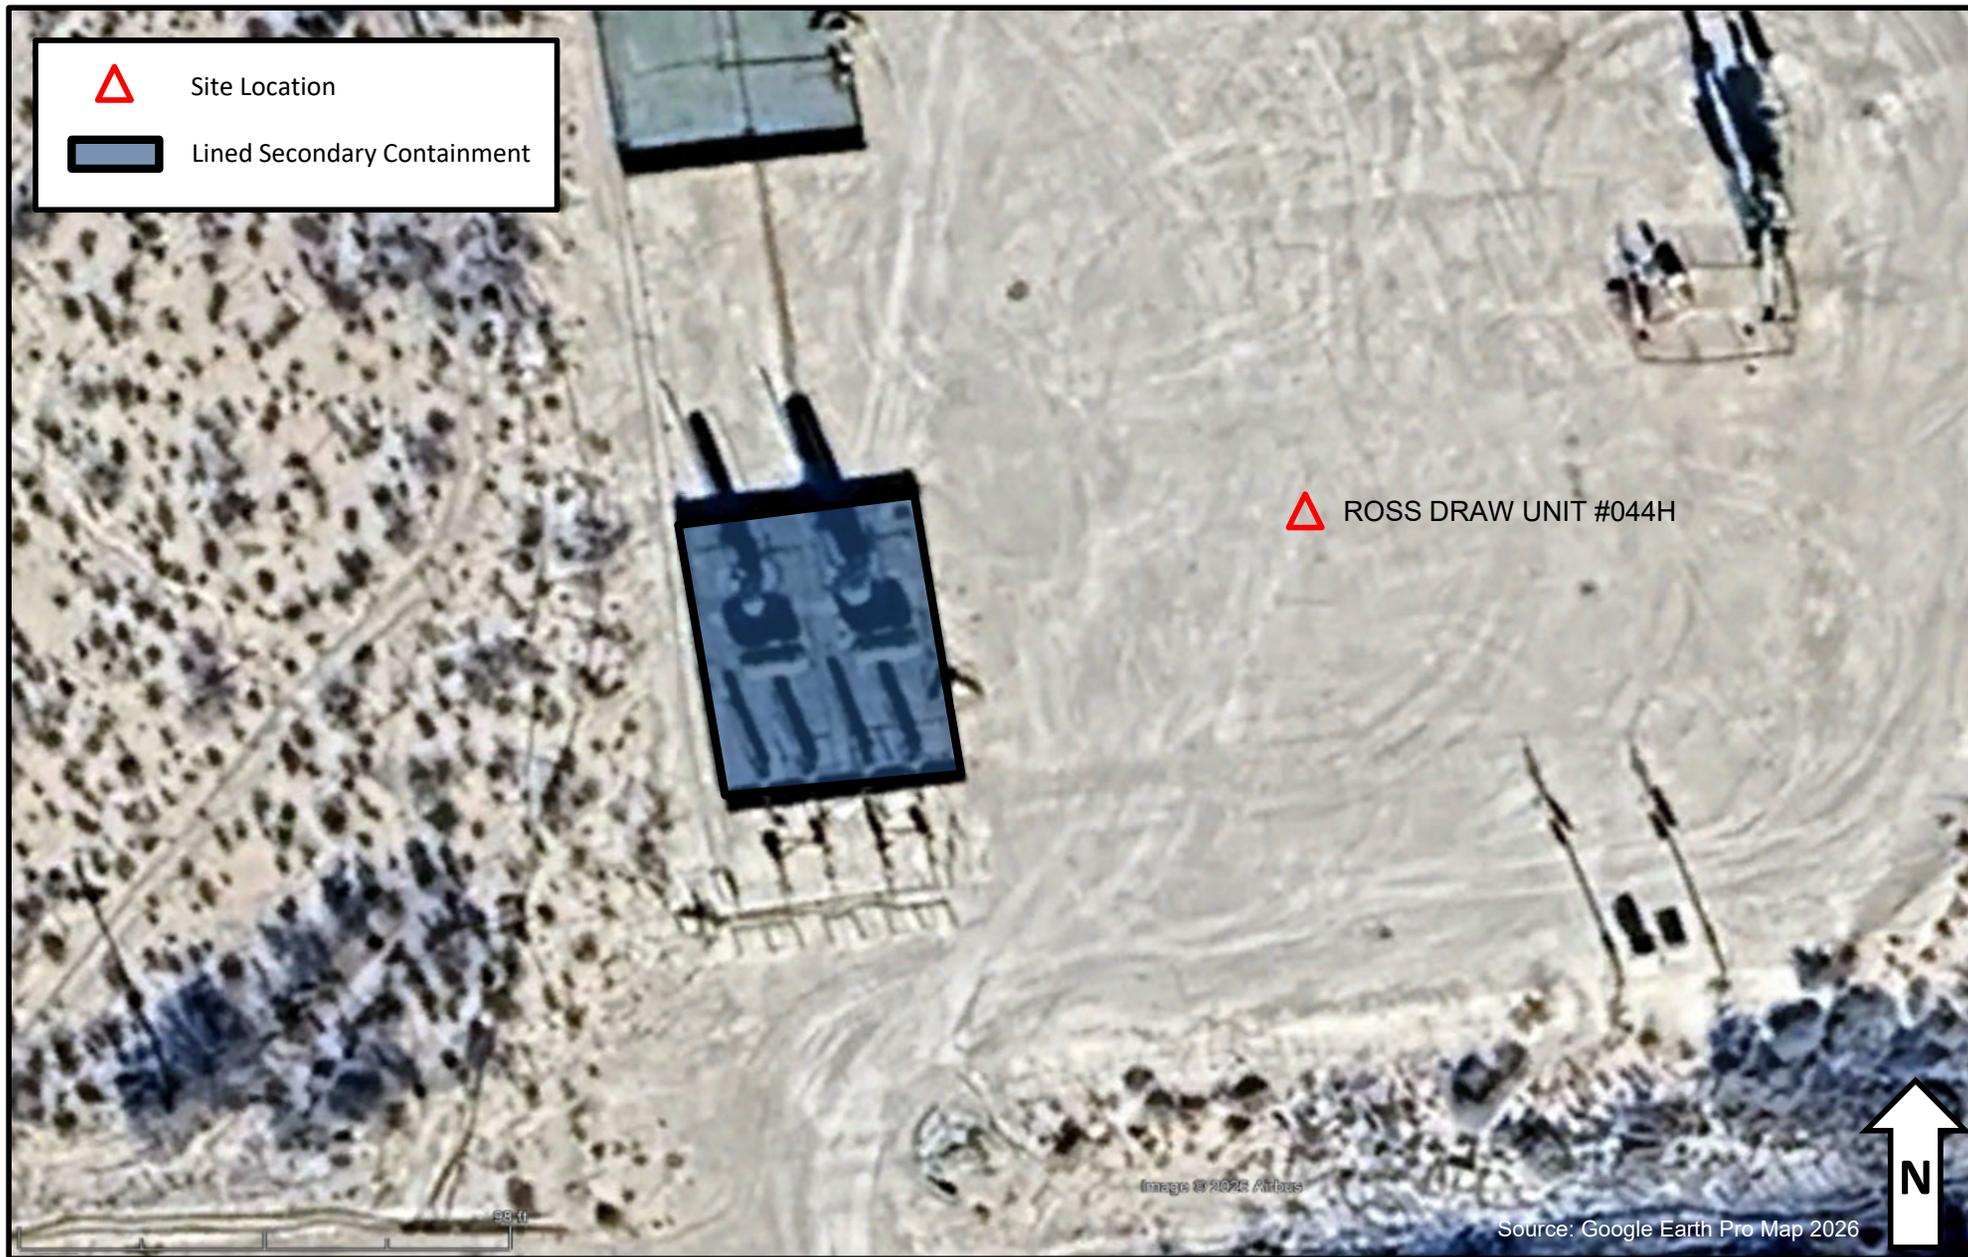
**Figure 2 – Release Extent**

On October 17, 2025, a surface flow line failed due to corrosion, releasing approximately 5 barrels (bbls) of produced water and 1 bbl of crude oil within a LSC (**Figure 2**). The release was fully contained within the LSC with no fluids escaping to the production pad or adjacent native soils. A vacuum truck was immediately dispatched to the Site recovering all fluids.

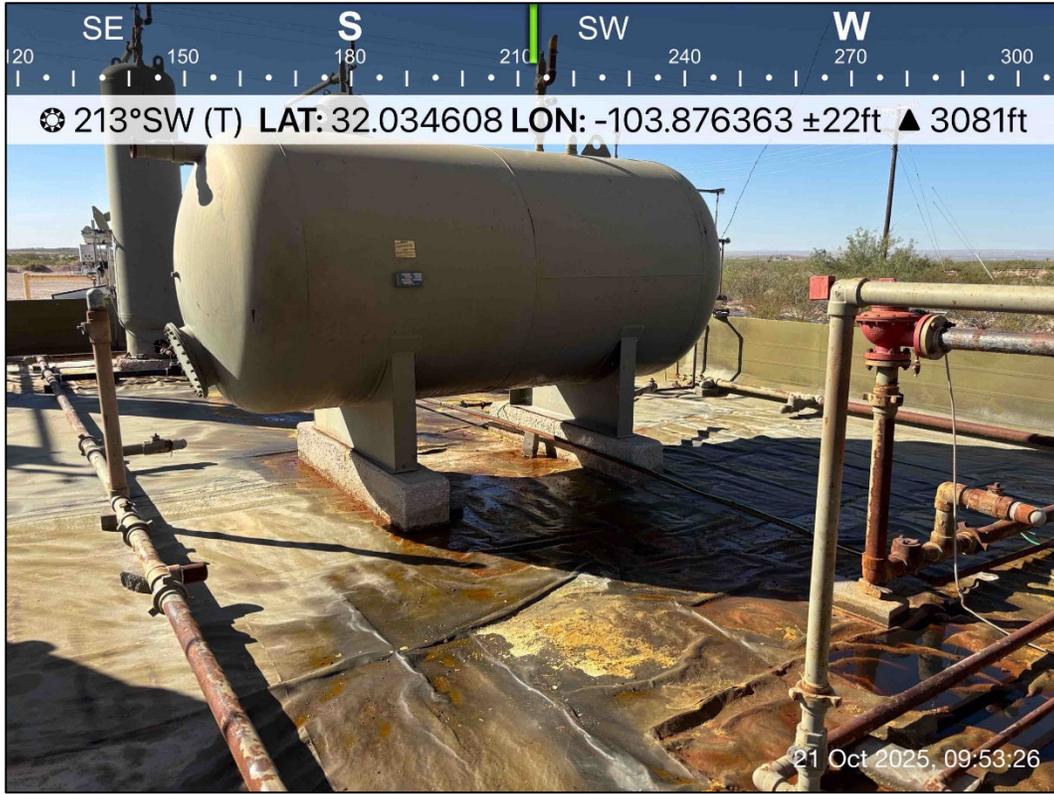
**PHOTO 1:** Southwestern view during initial site assessment. 10/21/2025

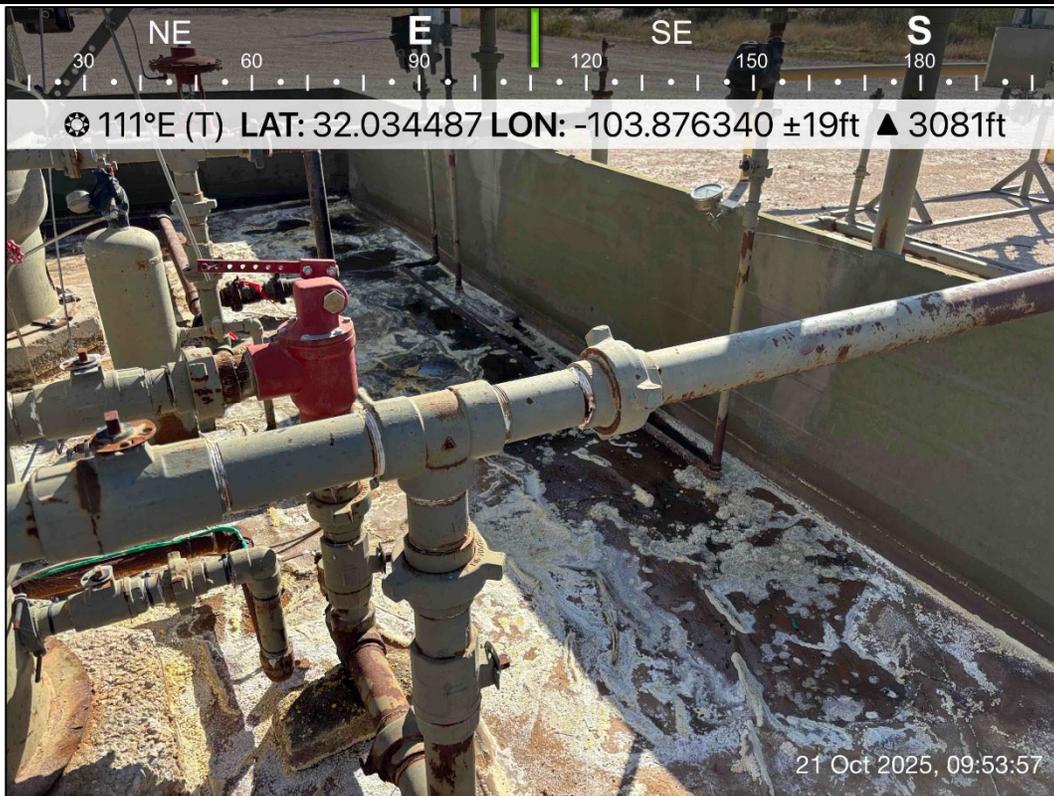
**PHOTO 2:** Southeastern view during initial site assessment. 10/21/2025

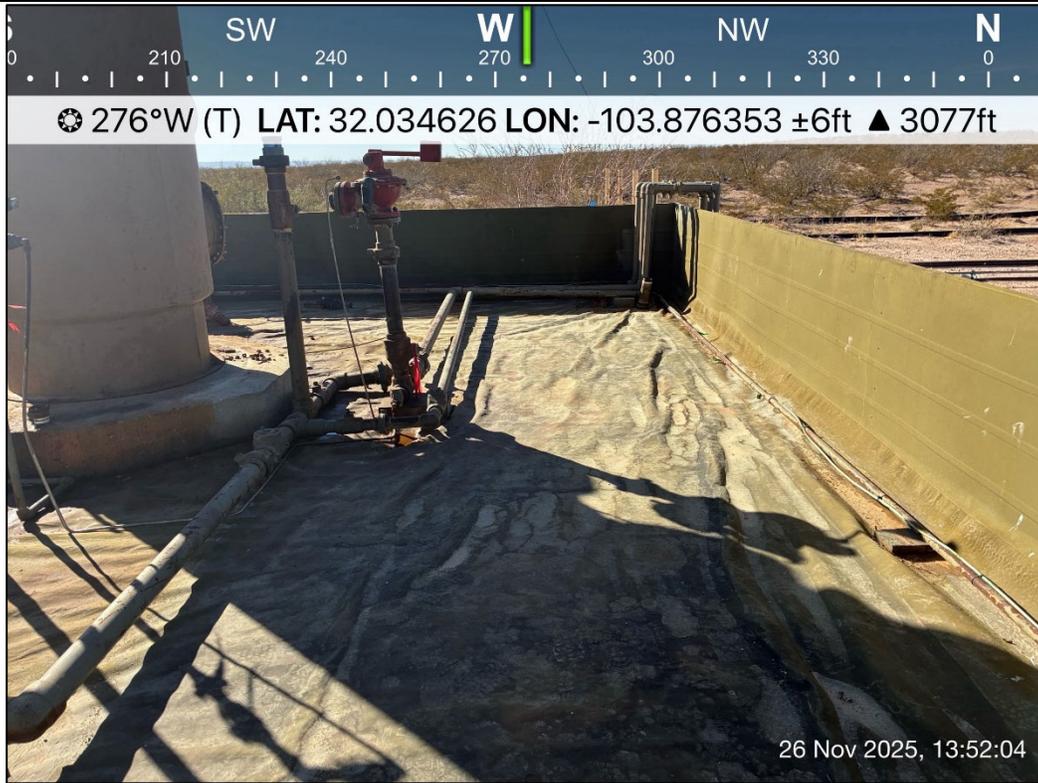
On November 26, 2025, ESRR conducted a thorough visual inspection of the LSC and found no tears, cracks, cuts, breaks, or other signs of damage, confirming no evidence of a breach to the LSC. The liner appeared to be in good condition and is performing as designed. **Photographic Documentation** of liner inspection activities is attached.

PHOTO 7: Western view during liner inspection activities. 11/26/2025

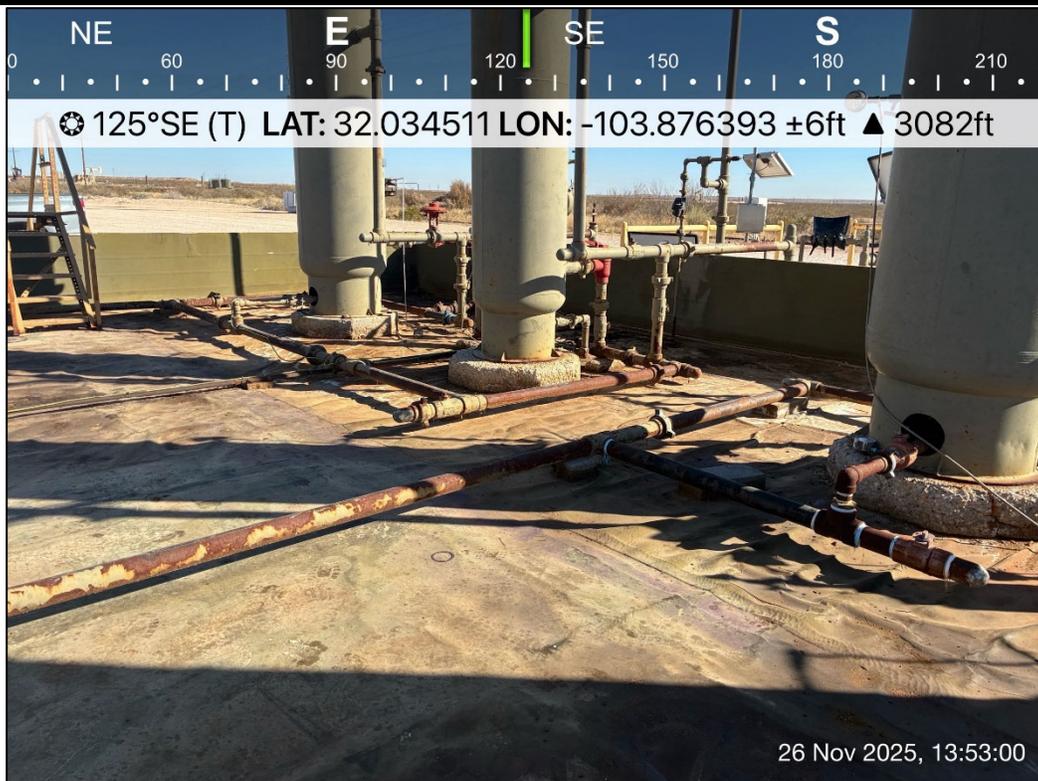
PHOTO 8: Southeastern view during liner inspection activities. 11/26/2025

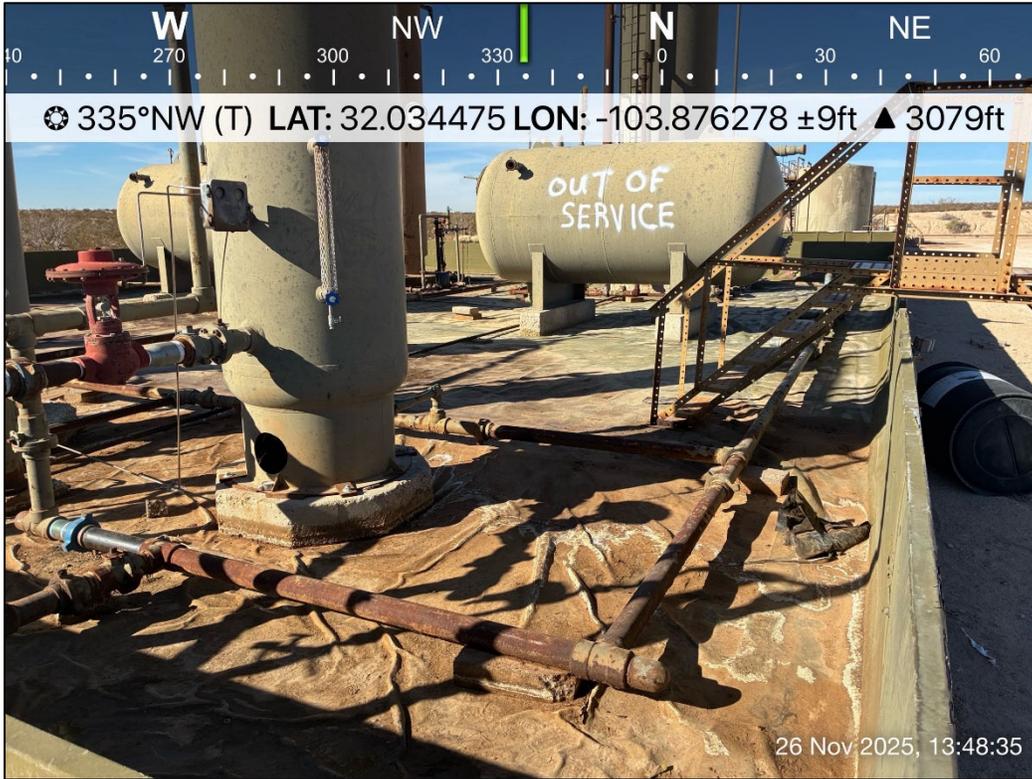
PHOTO 9: Northwestern view during liner inspection activities. 11/26/2025

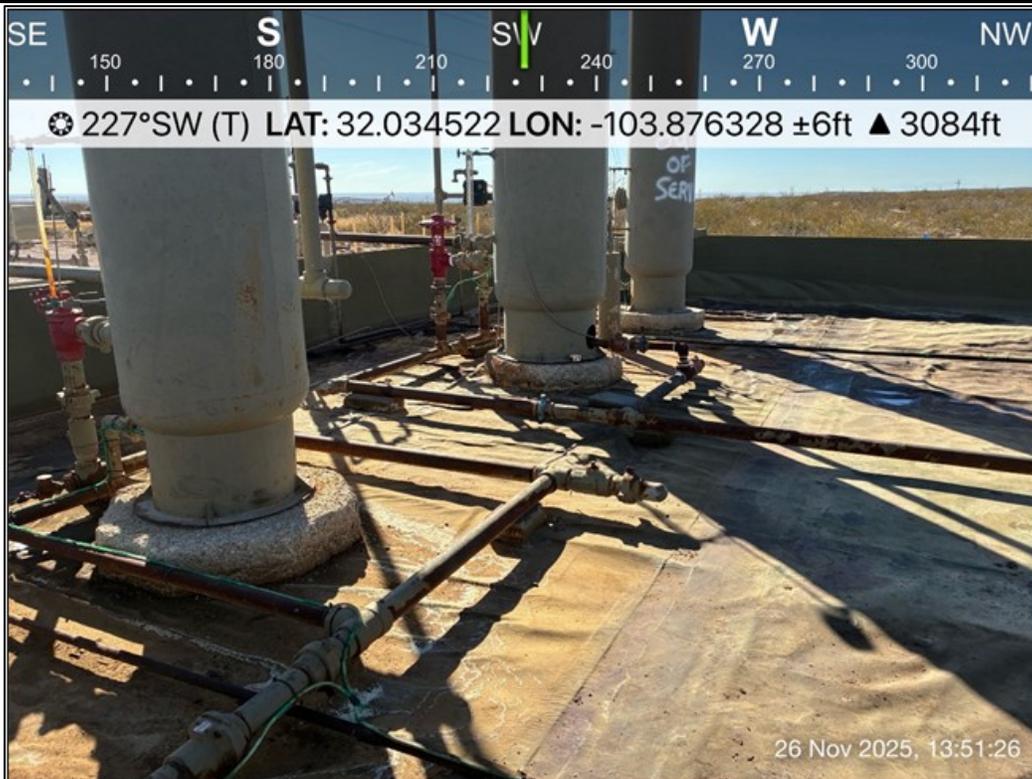
PHOTO 10: Southwestern view during liner inspection activities. 11/26/2025

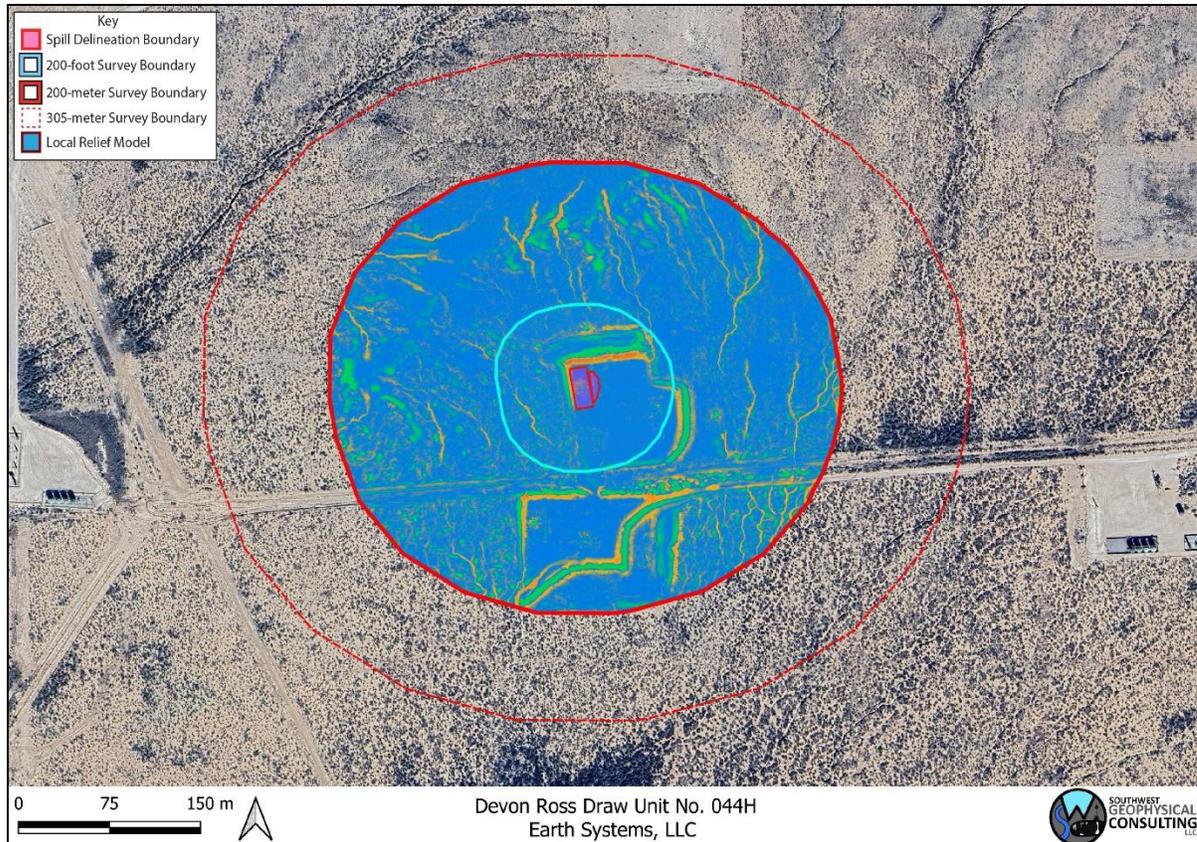
Figure 6: Surface karst survey results. Background image credit: Google Earth. Image date: March 20, 2023. Image datum: WGS-84.

The desk study and surface karst survey showed no surface karst features located within the 200-meter (656-foot)<sup>[1]</sup> survey area surrounding the spill delineation boundary (Figure 6).

No springs exist within the 305-meter (1,000-foot)<sup>[1]</sup> survey boundary (Figure 6).

Caution should be exercised while operating in or around all karst-related features due to the possibility of near-surface voids. Employing a BLM-CFO-approved karst monitor on site during these activities should be considered.

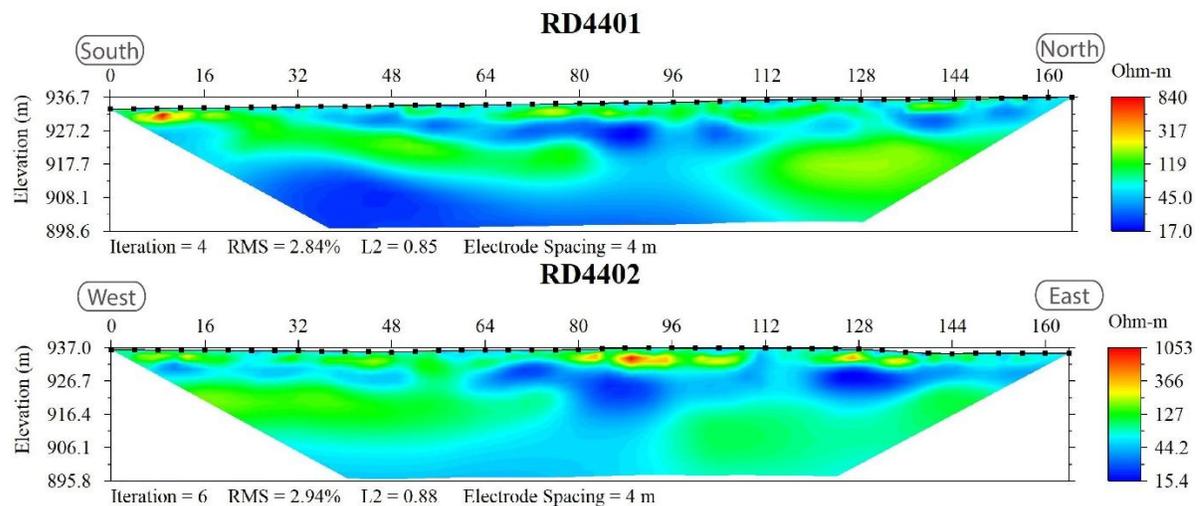
The results of this study indicate a moderately well-layered geologic system with low resistivities between 15 and 1053 Ohm-m (**Figure 7**). Please keep in mind when viewing the 2D inverted resistivity sections that color maps can be widely different for each view. Always check the color map located on the right side of the image when viewing the 2D images to ensure you understand the range of resistivities presented. Distances along the top and depths along the left side are in meters. The color map along the right side is in Ohm-m. Due to the nature of the survey, shallower zones have higher resolution between electrodes than deeper zones; therefore, small features at depth will not be visible.

**Figure 7: 2D inverted resistivity sections RD4401 and RD4402. Reds and oranges indicate higher resistivity values. Yellows and greens are medium-resistivity values. Blues are low-resistivity values. Please note that the color scale is relative.**

No anomalies consistent with air-filled subsurface voids are found within the RD44 survey area. Small solutionally enlarged voids or fractures at or near the resolution limit of the survey (2.0 – 2.5 meters) may be present. Areas of high-resistivity (reds and oranges) near the surface are interpreted as dry gypsite soils and gypsum or dolomite bedrock of the Rustler Formation<sup>[17]</sup> (**Figure 7** and **Figure 8**). Low-resistivity areas between 15 – 20 Ohm-m may either represent fluid from the brine release, surface-to-subsurface hydrologic pathways, or a layer of either clays and halite lenses or moist or saturated layers within the Rustler Formation (**Figure 7**).
