**BRADLEY 8 FEE 2H TB**

PREPARED BY:  
PIMA ENVIRONMENTAL SERVICES, LLC

PREPARED FOR:  
Spur Energy

## Liner Inspection and Closure Report

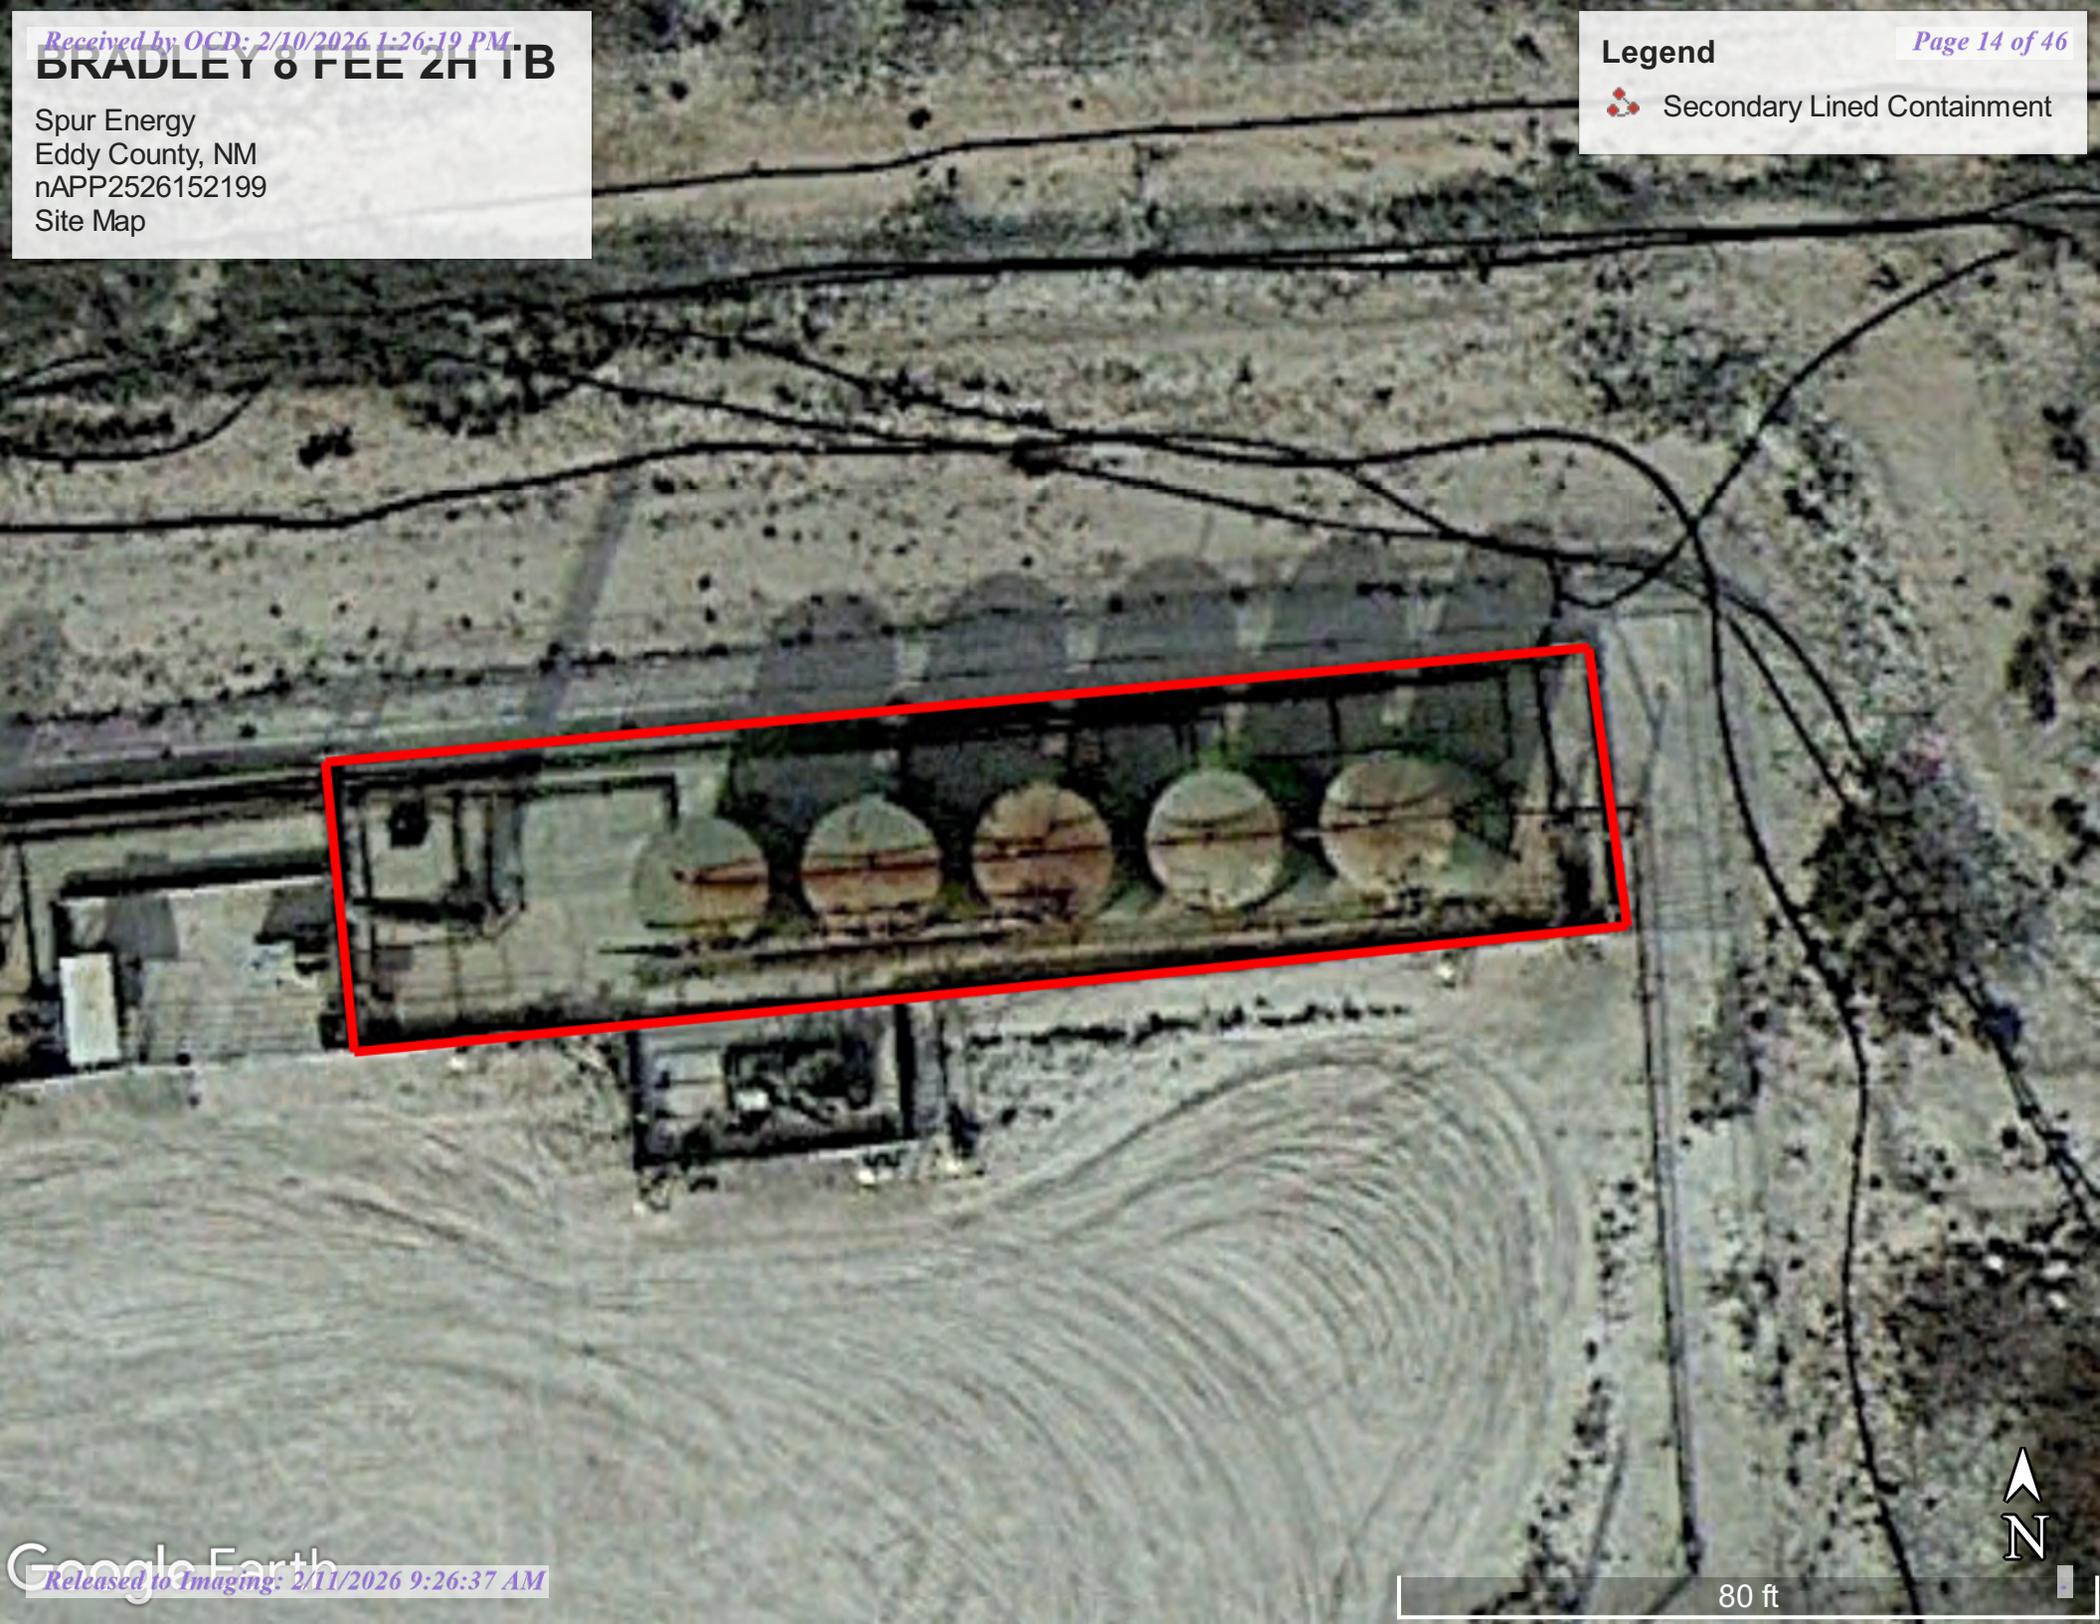
Figure 4- Site Map

**nAPP2526152199:** On September 18, 2025, an equipment failure caused the tanks to overflow, releasing approximately 721 barrels of produced water into the lined secondary containment. Spur personnel promptly responded by deploying a vacuum truck and successfully recovered the entire released volume. All fluids were fully contained within the engineered secondary containment, with no impacts observed outside the lined area. A site map is provided in Figure 4 for reference.

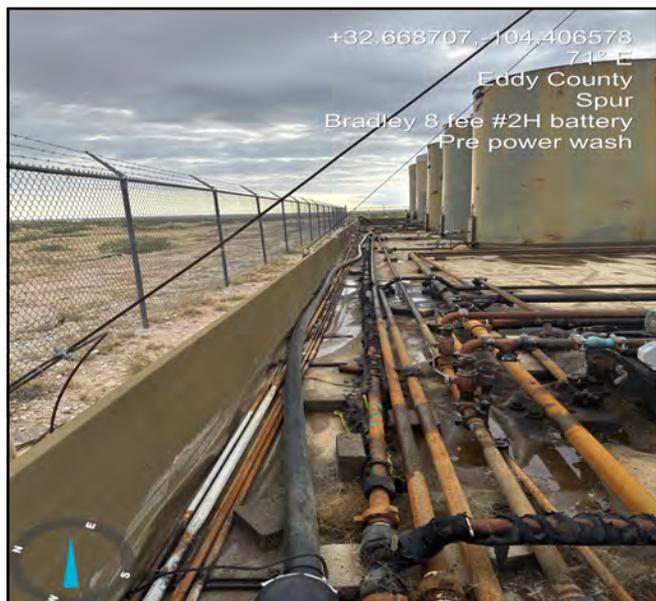
Photo of liner taken during initial liner inspection facing east.

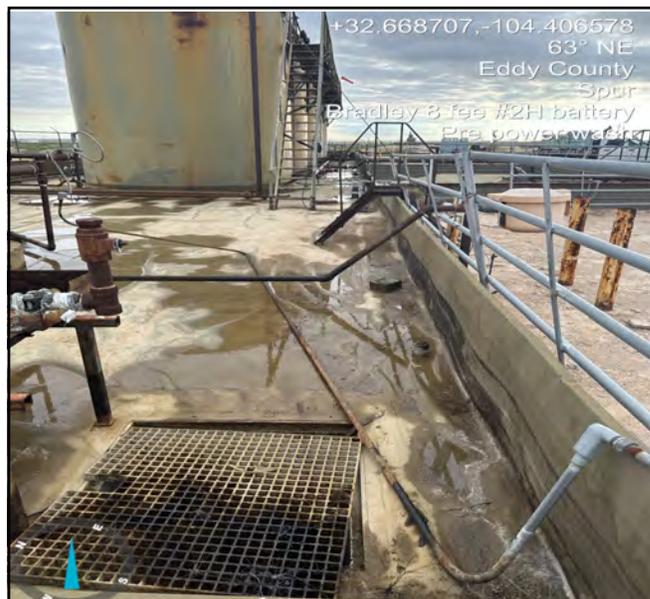
Photo of liner taken during initial liner inspection facing northeast.

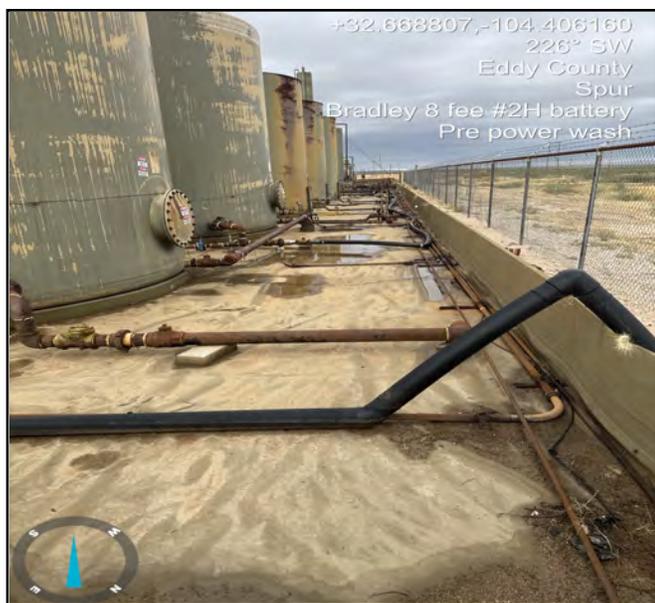
Photo of liner taken during initial liner inspection facing southwest.

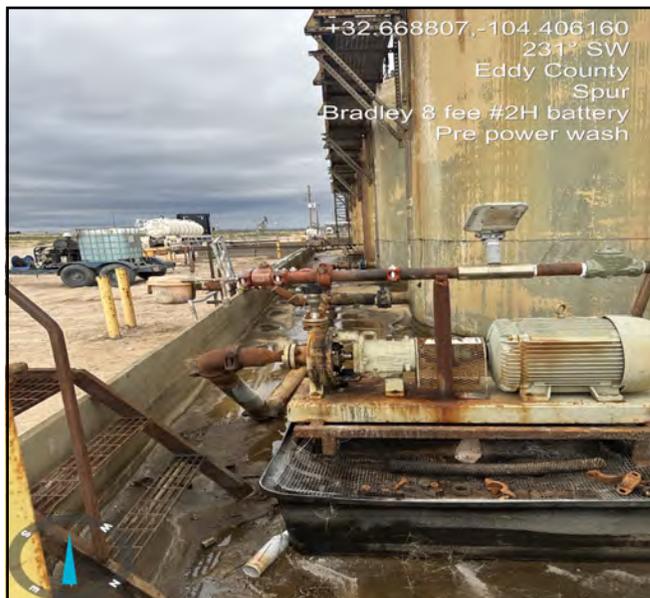
Photo of liner taken during initial liner inspection facing southwest.

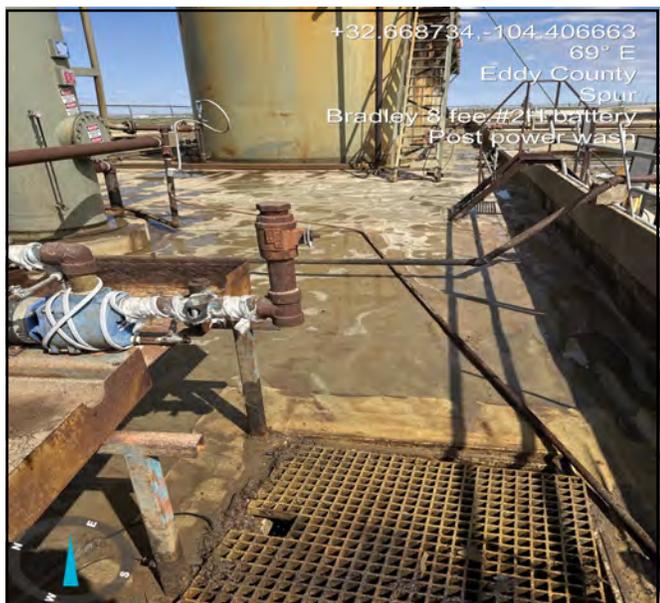
Photo of location taken post power wash facing east.

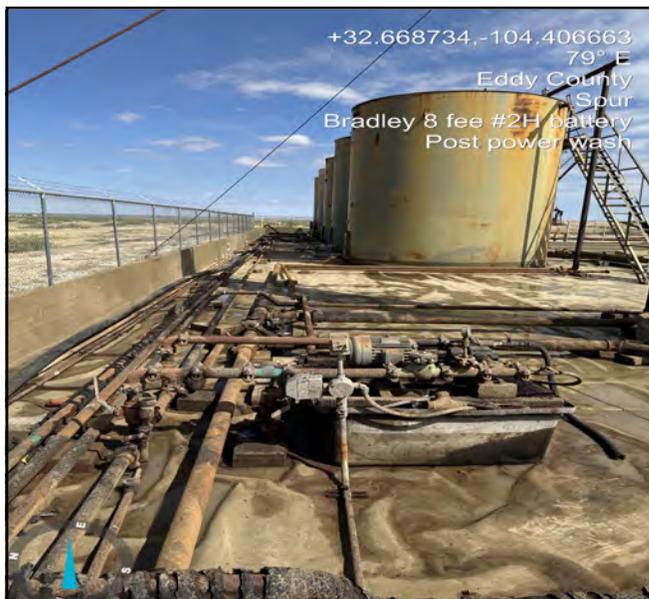
Photo of location taken post power wash facing east.

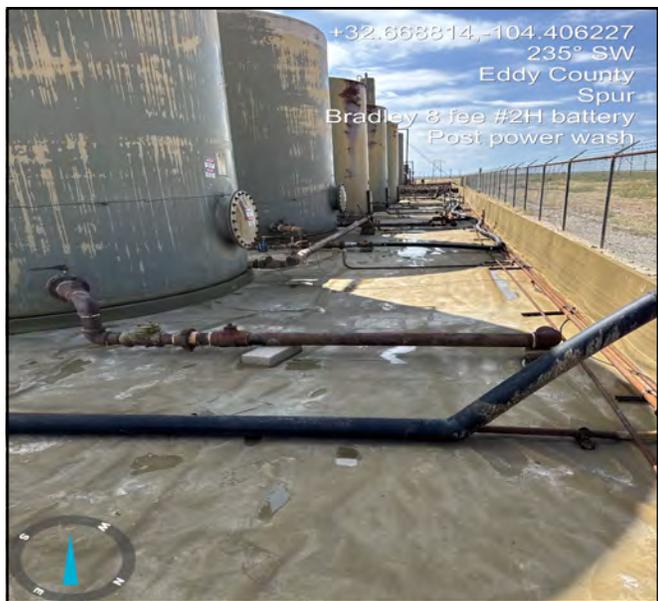
Photo of location taken post power wash facing southwest.
