Our ref.: 12684335-NMOCD-1

January 30, 2026

Closure Report
Devon Energy Production Company, LP
Tomb Raider 12 CTB 3
Unit Letter J, Section 12, TS23, R31E
GPS: 32.31546867, -103.7313752
Eddy County, New Mexico

DEVON ENERGY PRODUCTION COMPANY, LP
EDDY COUNTY, NEW MEXICO
TOMB RAIDER 12 CTB 3
INCIDENT NAPP2522453144

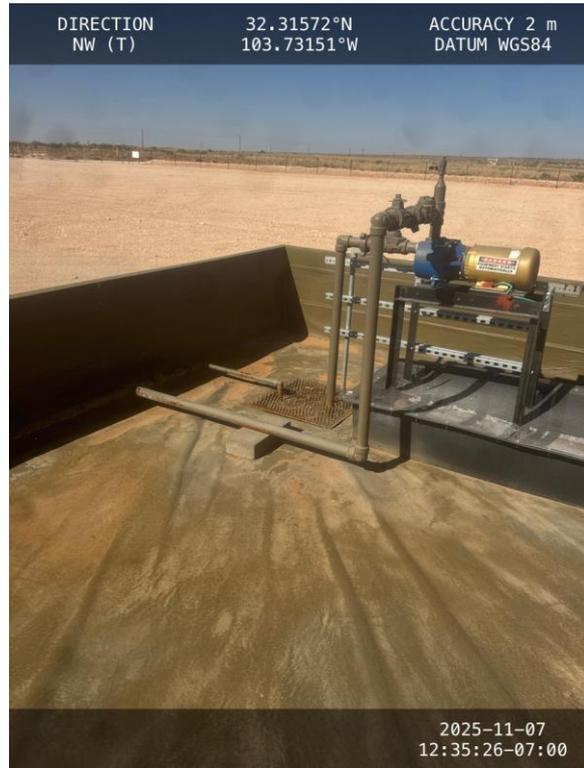
Photo 2 View of northwest corner of containment.

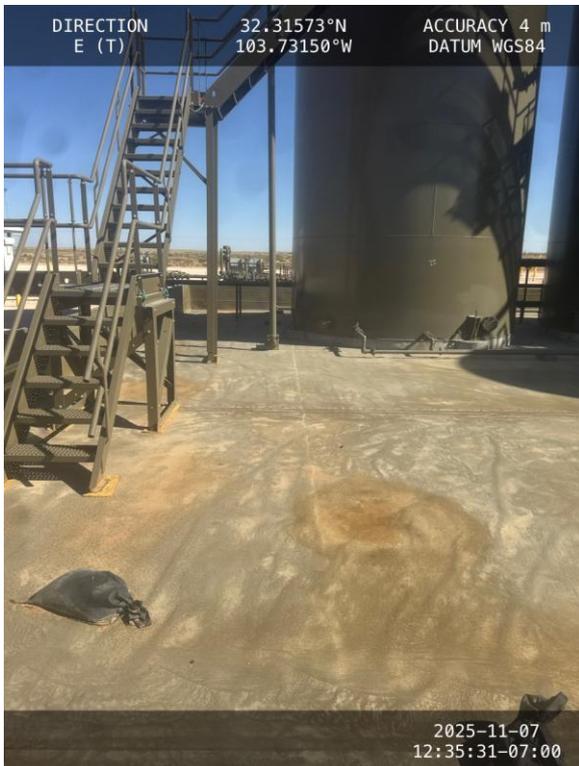
Photo 3 View of containment facing east.

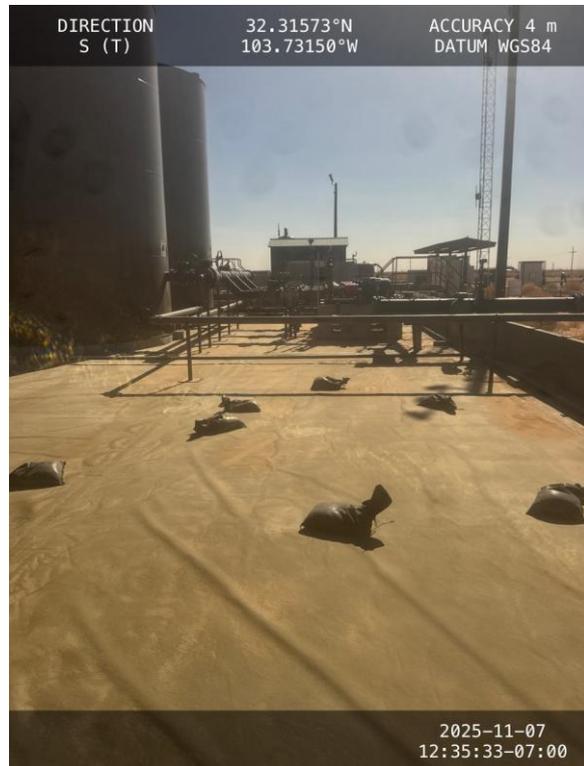
Photo 4 View of containment facing south.

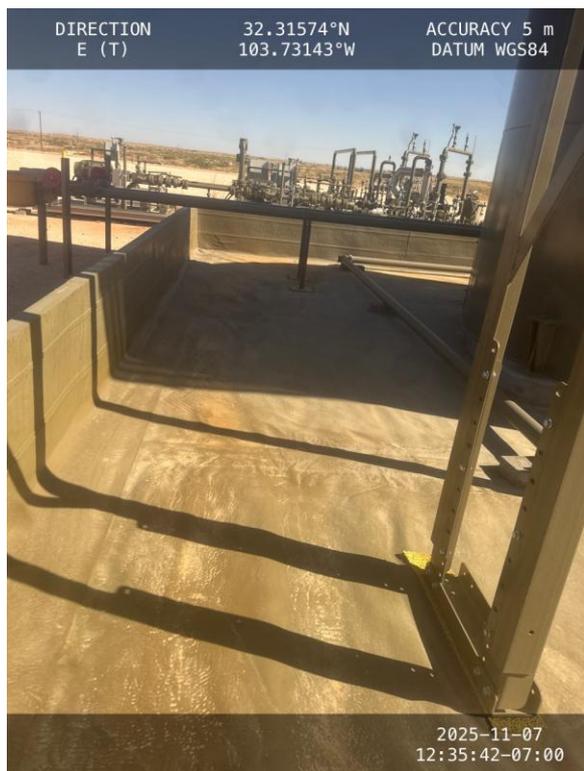
Photo 5 View of containment facing east.

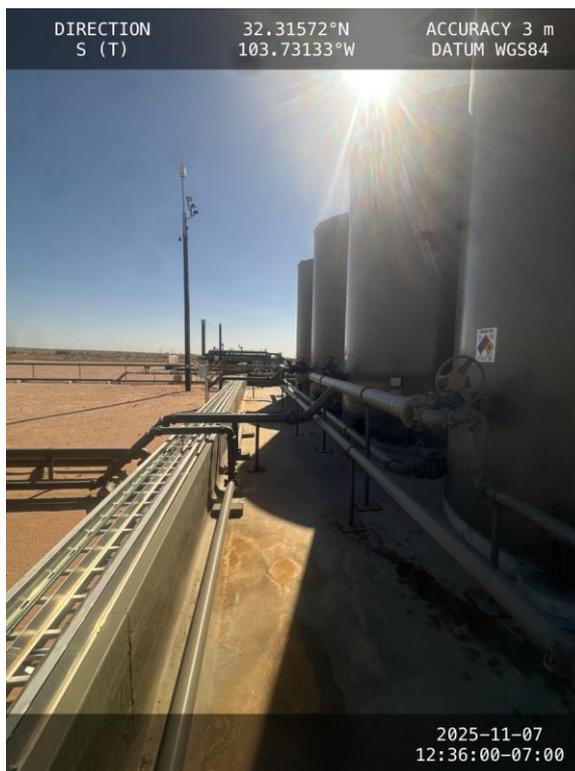
Photo 6 View of containment facing south.

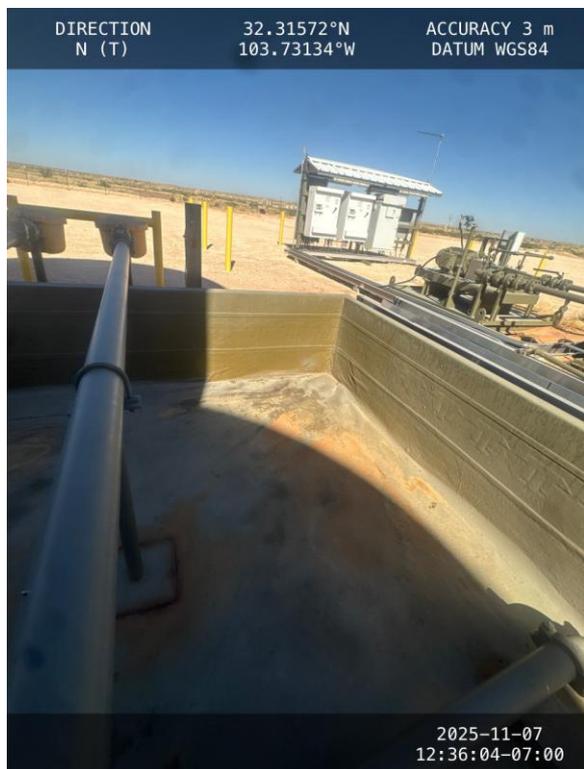
Photo 7 View of containment facing north.

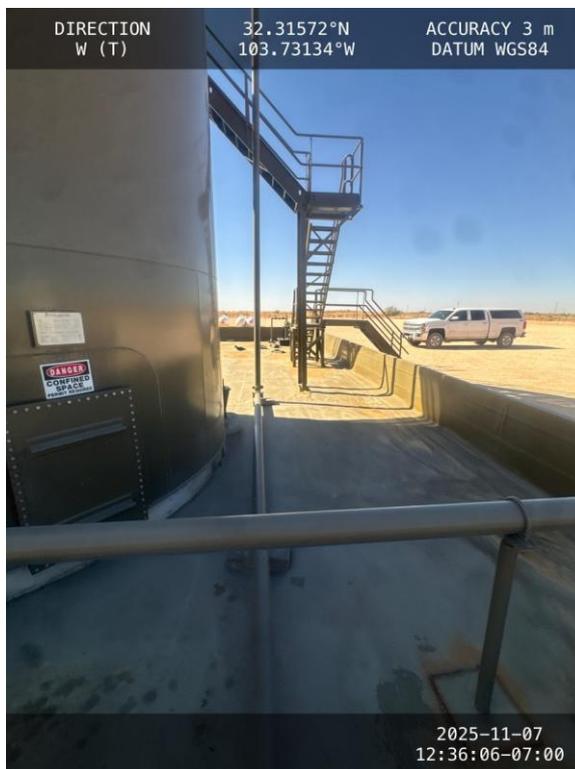
Photo 8 View of containment facing west.

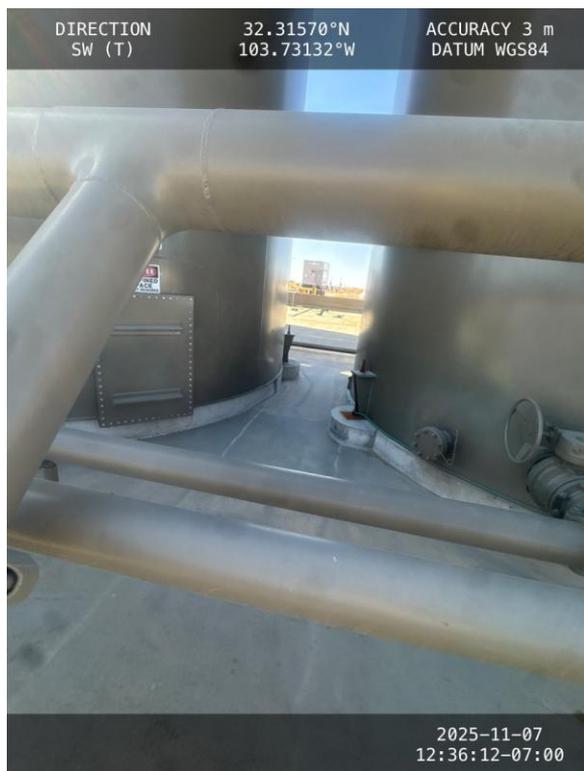
Photo 9 View of central portion of containment facing southwest.

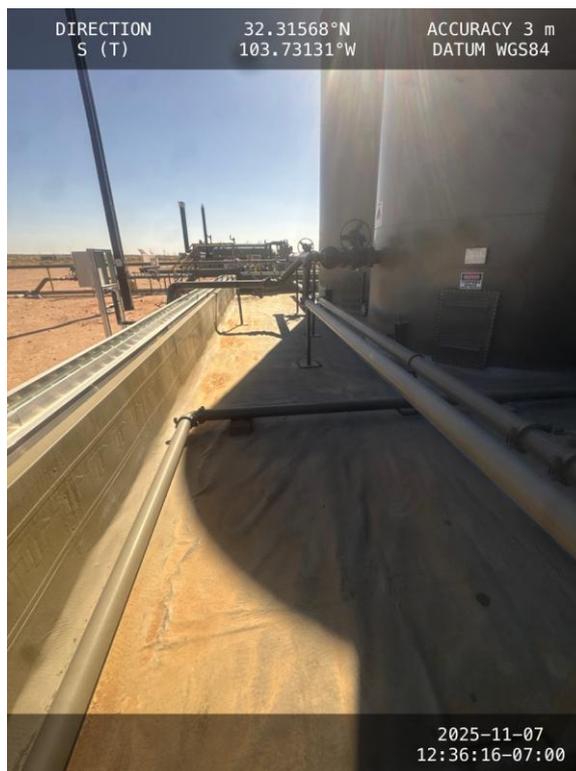
Photo 10 View of containment facing south.

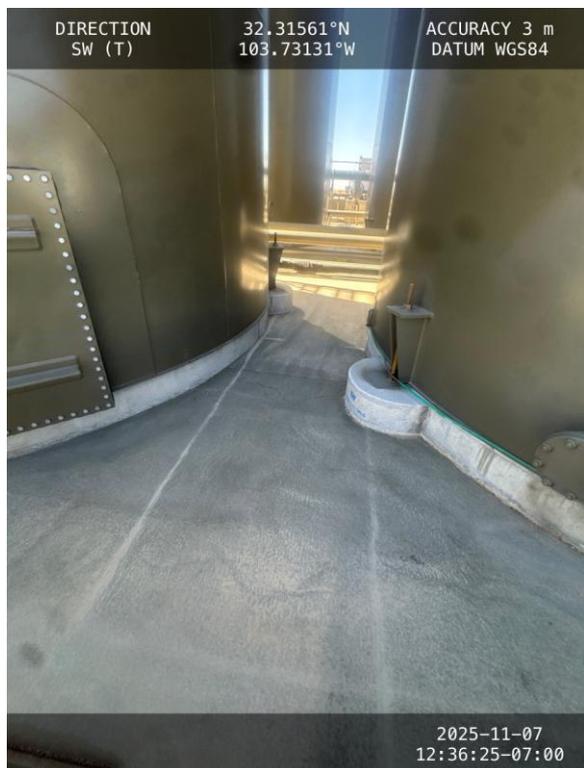
Photo 11 View of central portion of containment facing southwest.

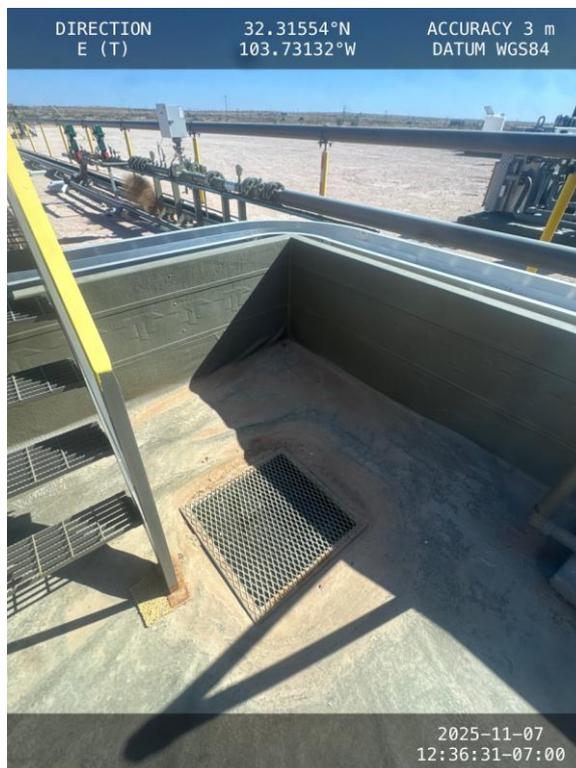
Photo 12 View of northeastern corner of containment.

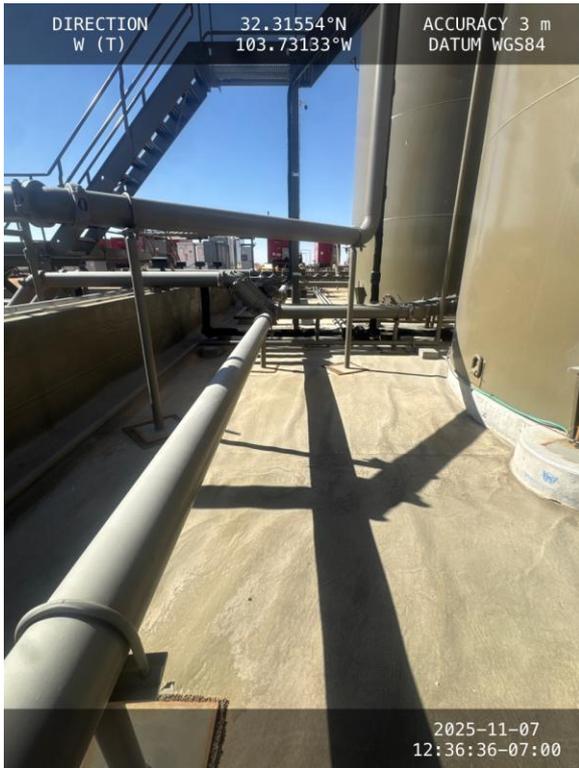
Photo 13 View of containment facing west.

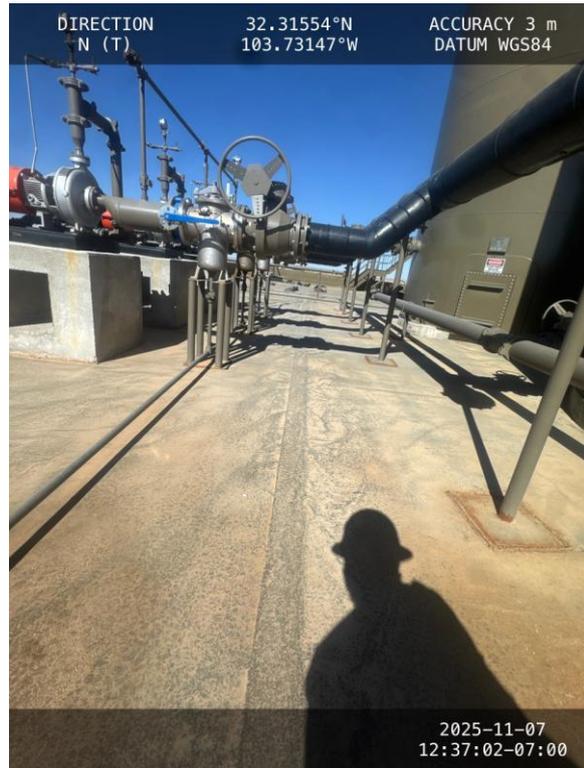
Photo 14 View of containment facing north.
