**RE: Heaton LS #005
2025 Annual Monitoring Report**

Cottonwood Consulting LLC (Cottonwood) is pleased to provide Simcoe LLC (Simcoe) with the results of the soil vapor extraction (SVE) monitoring conducted at the Heaton LS #005 well site (API 30-045-10251). Details regarding the methodology and associated results are summarized below.

Heaton LS 005

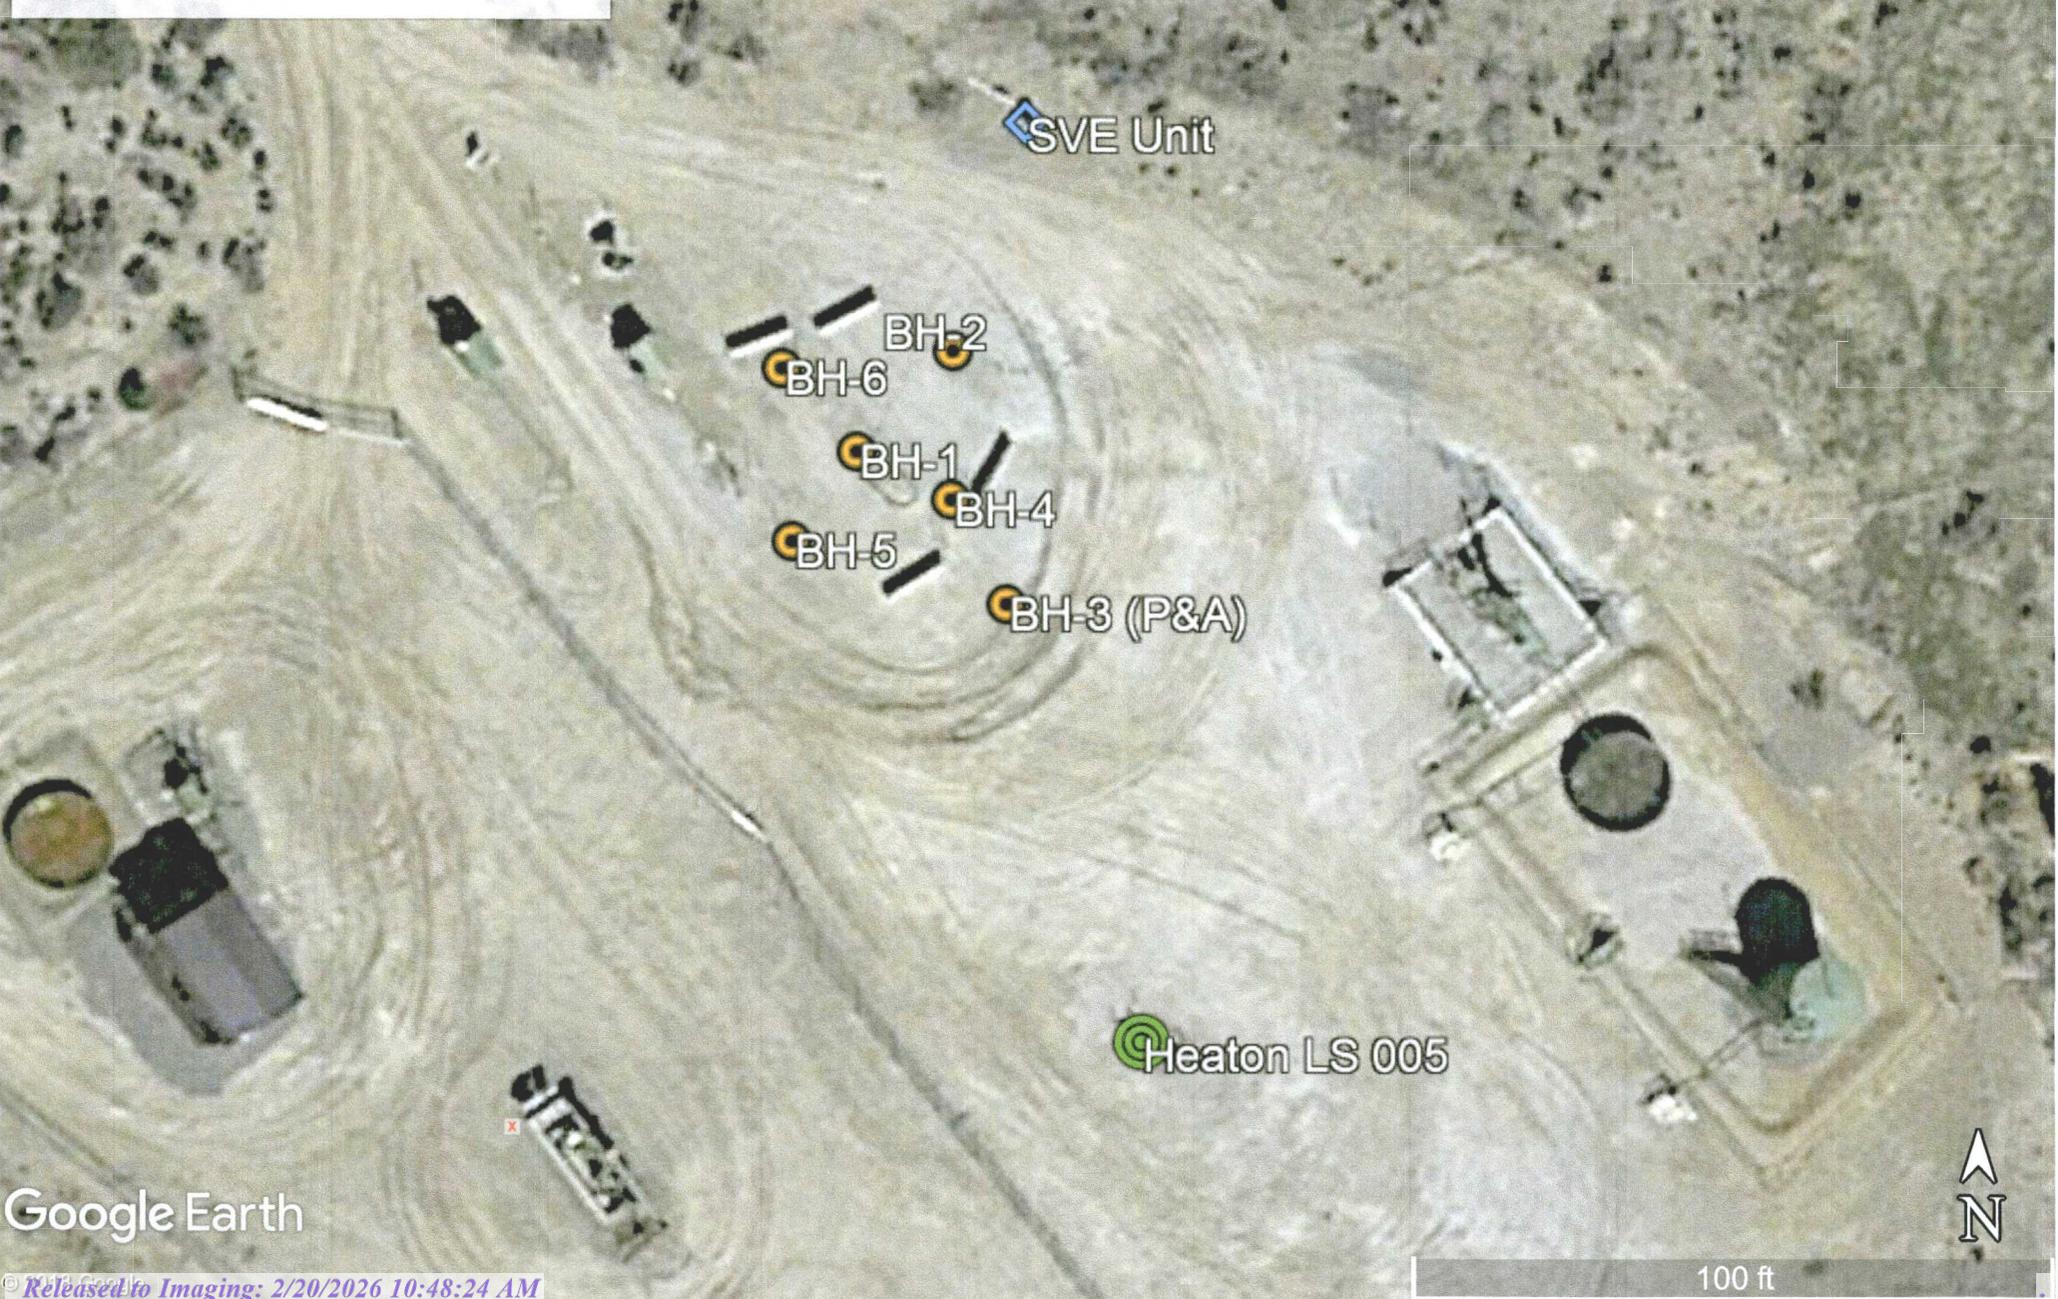
FIGURE 1

The SVE system was installed in response to a release of fluids at the Heaton LS #005 well site. The system was installed to perform in-situ remediation of impacted soils. The SVE system was installed in March 2015. In November 2017, the SVE unit was stolen. In August 2018, the system was replaced and restarted and regular monitoring has continued since then. See Figure 1 for a site map.

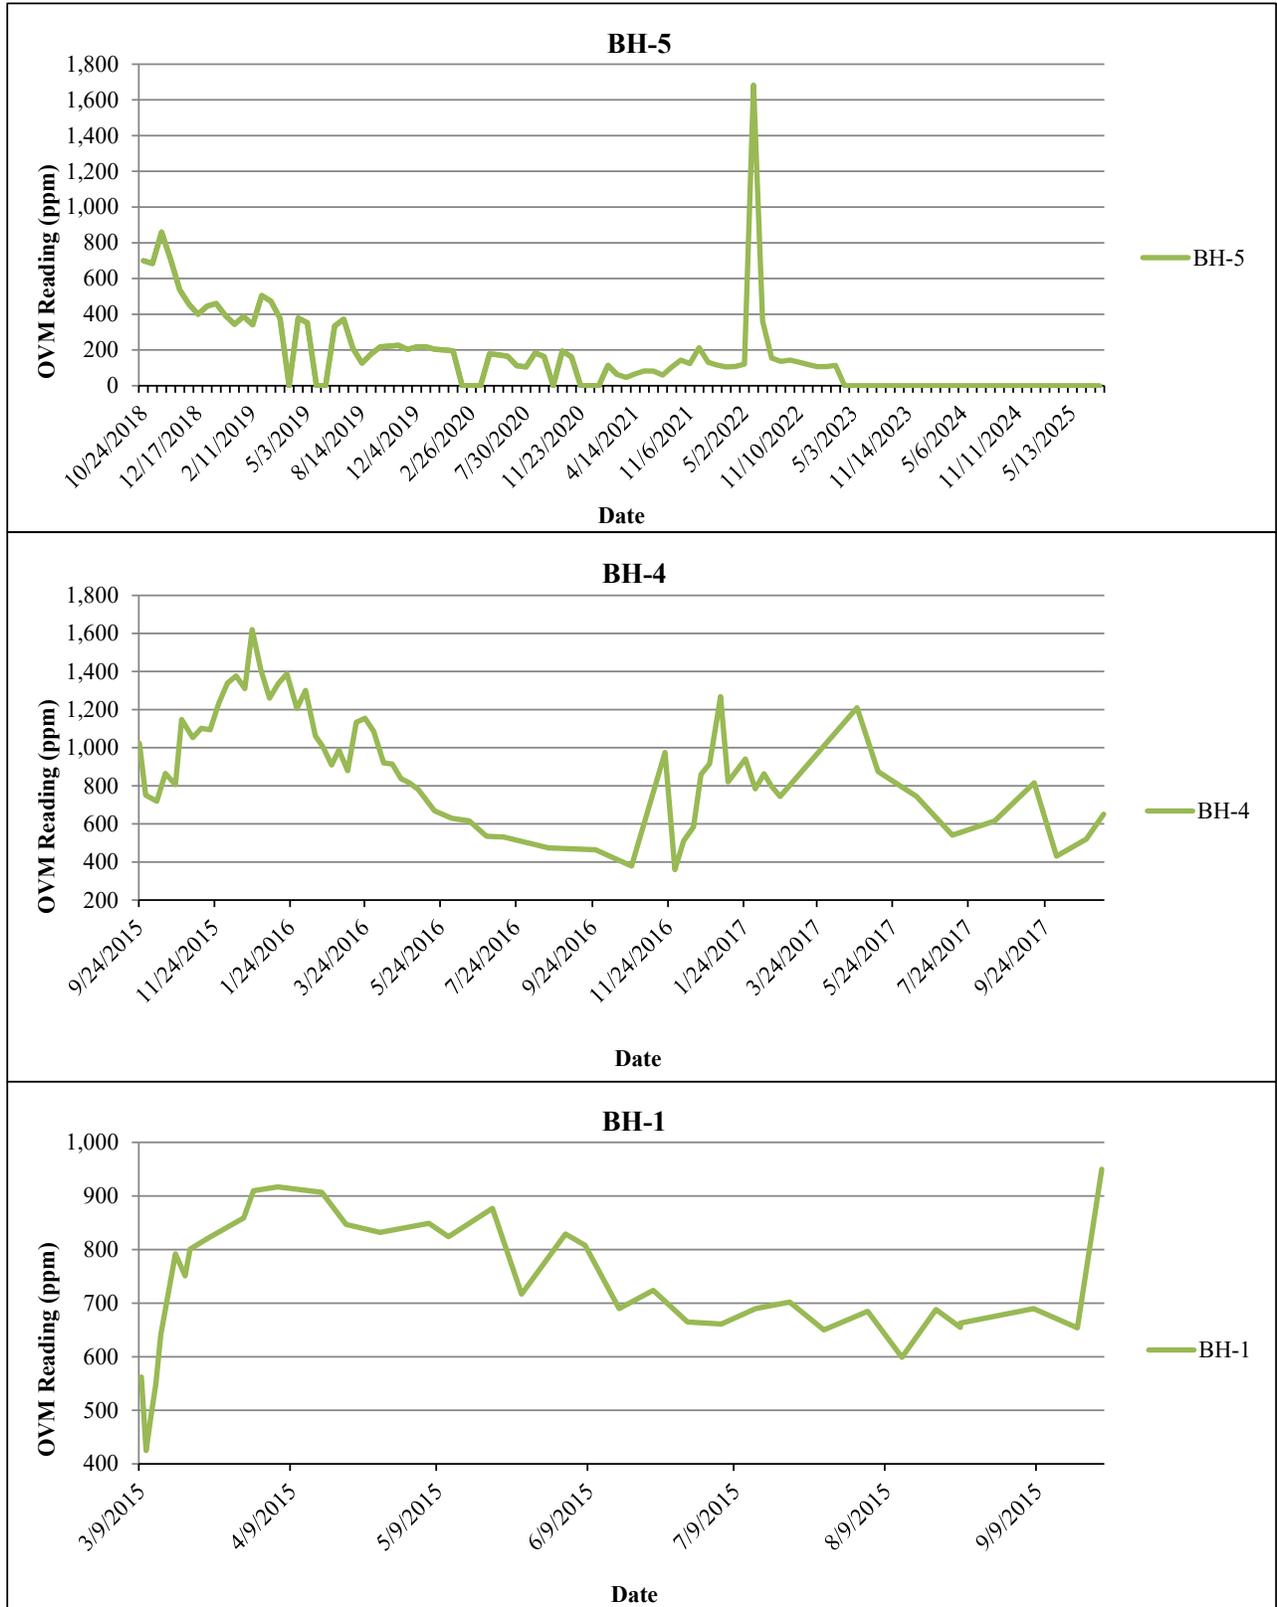
FIGURE 2

It appears that the SVE system reduced OVM readings in SVE points BH-1 and BH-4. OVM readings in SVE point BH-5 have been on a general downward trend, with the exception of a reading collected in June 2022. See Figure 2 for OVM reading results in BH-1, BH-4, and BH-5

OVM readings have trended downward since the system began extraction. Simcoe will continue to conduct regular monitoring at the Heaton LS #005 SVE system. In the future, Simcoe may advance subsurface soil borings to verify closure standards are met.
