GC FEDERAL 11 TB

Incident ID nAPP2528731446

Liner Inspection and Closure Report

February 2, 2026

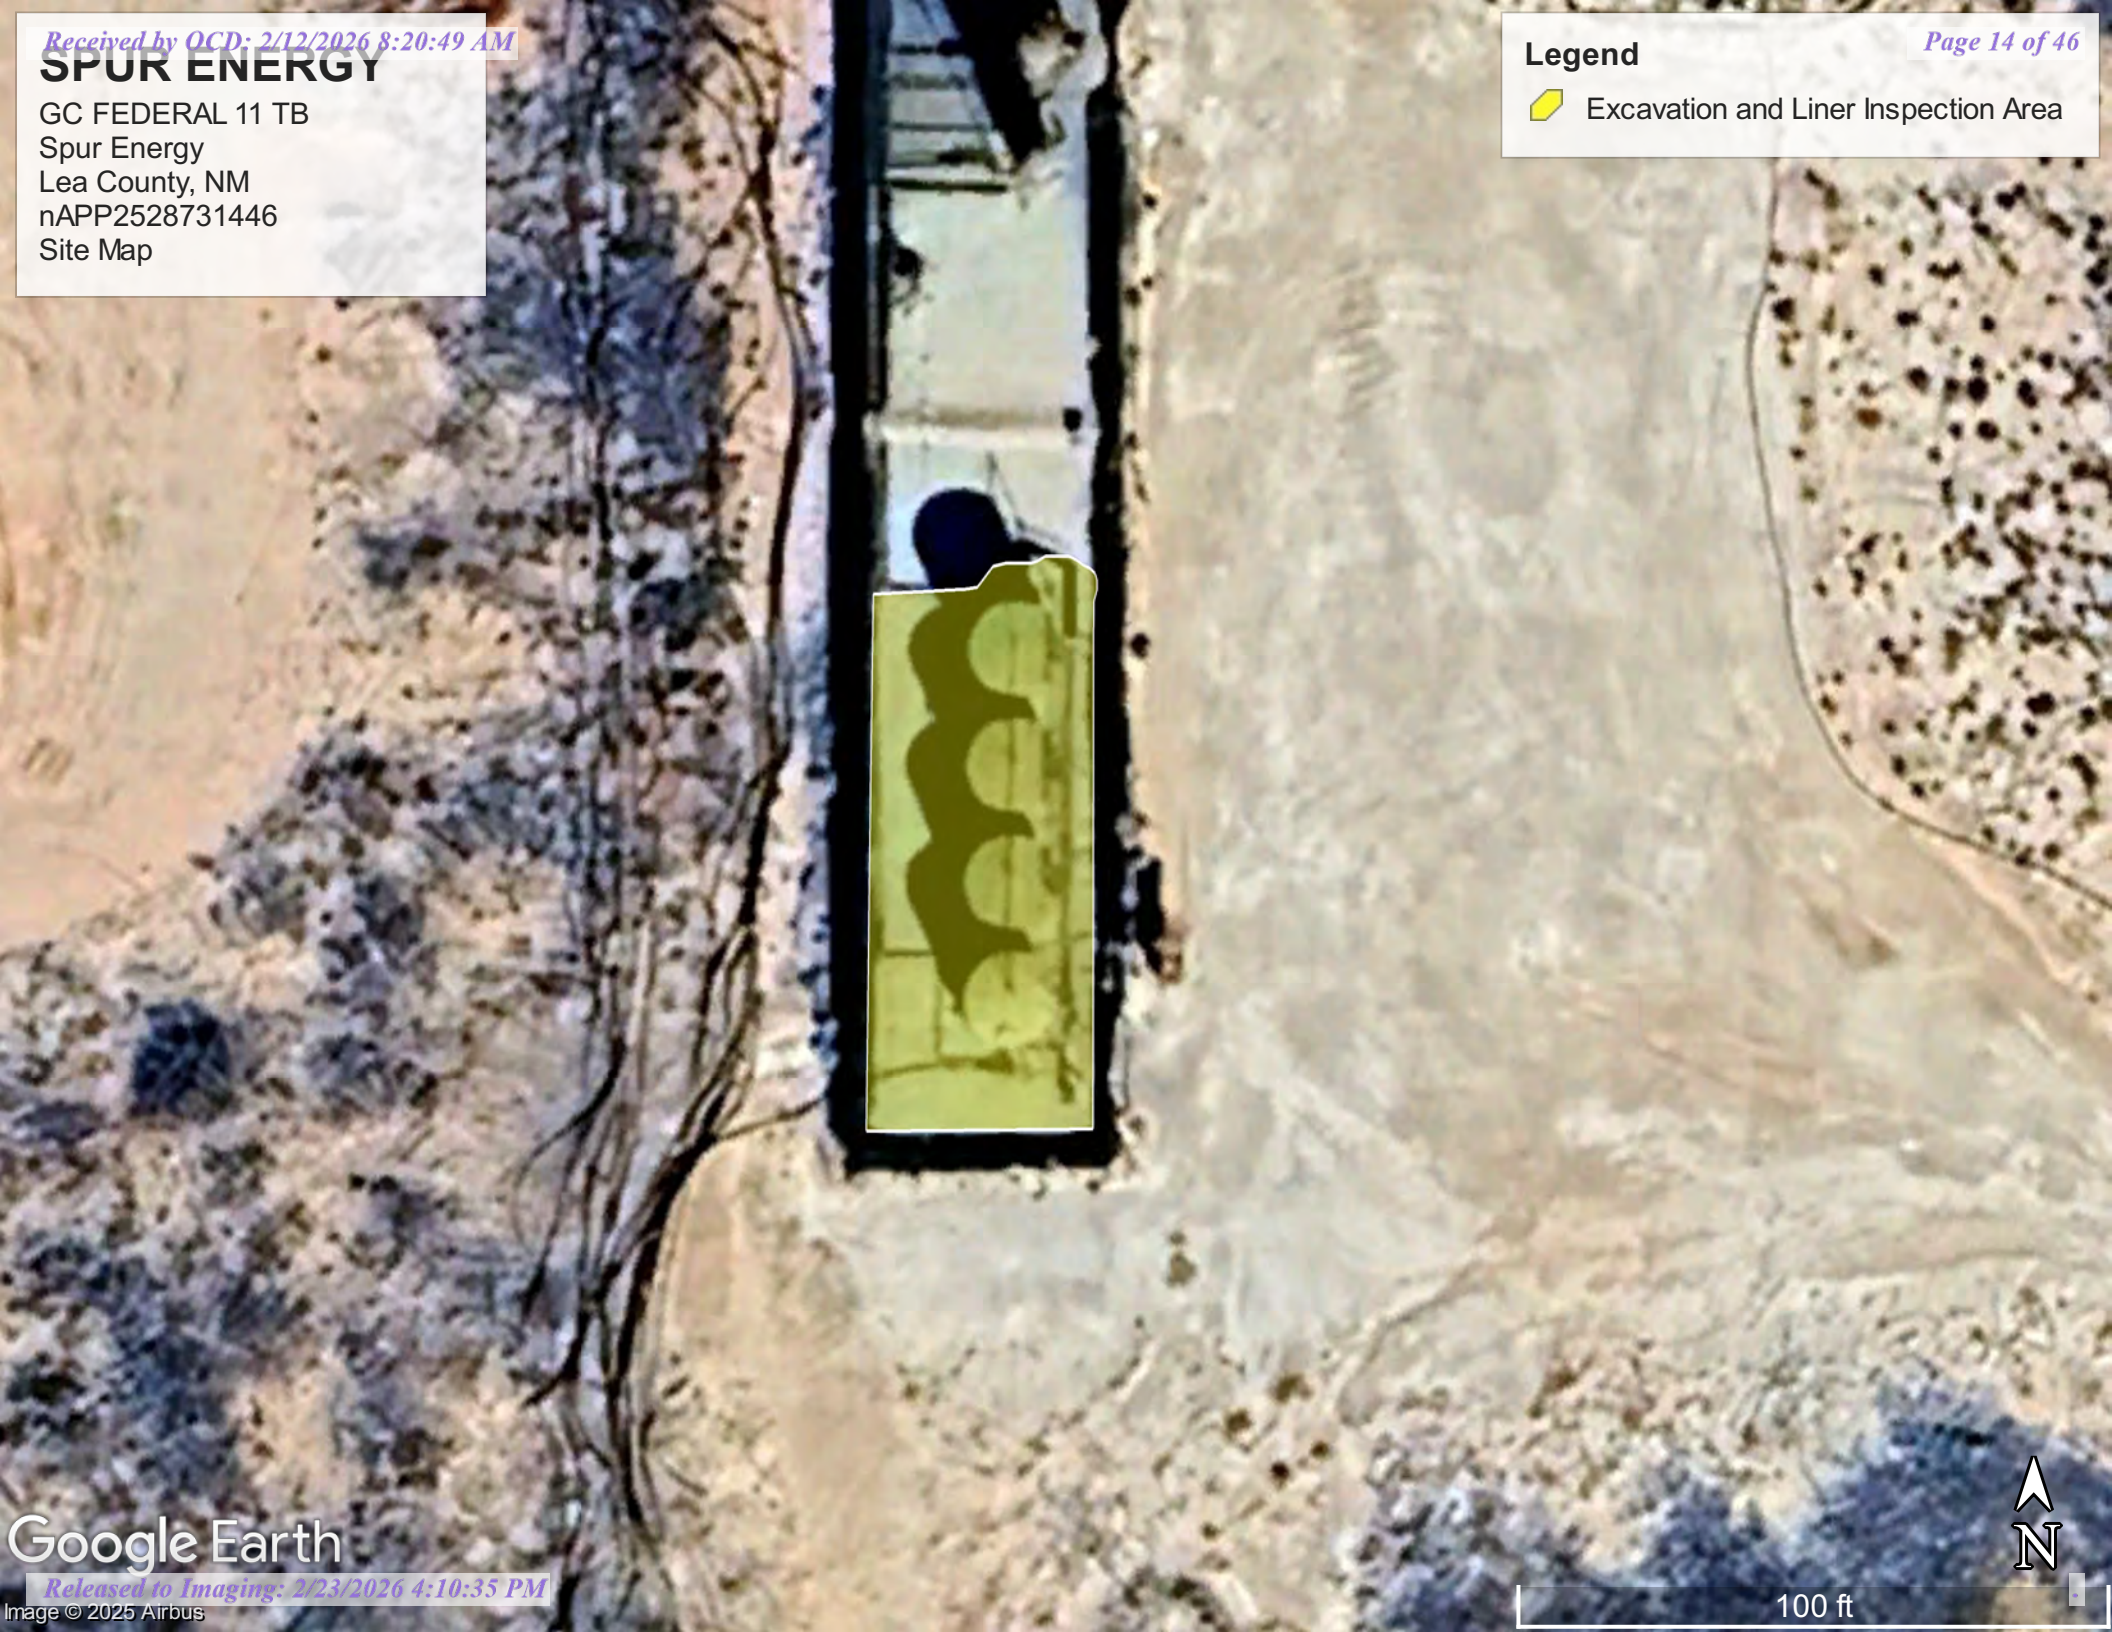
GC FEDERAL 11 TB
Spur Energy
Lea County, NM
nAPP2528731446
Site Map

nAPP2528731446: On October 11, 2025, a transfer motor failed, causing the storage tank to overflow and release approximately 5 barrels of crude oil and 127 barrels of produced water into the lined containment. Spur personnel immediately initiated recovery efforts and successfully recovered all fluids using a vacuum truck. No impact occurred outside of the lined containment. A site map is provided in Figure 4.

From October 20 through October 22, Pima Environmental personnel deployed a hand-shoveling crew at the GC location and removed approximately 20 cubic yards of contaminated gravel from an impacted area measuring approximately 3,400 square feet. All impacted gravel was carefully transported and properly disposed of at Lea Land, LLC, an NMOCD-approved landfill.

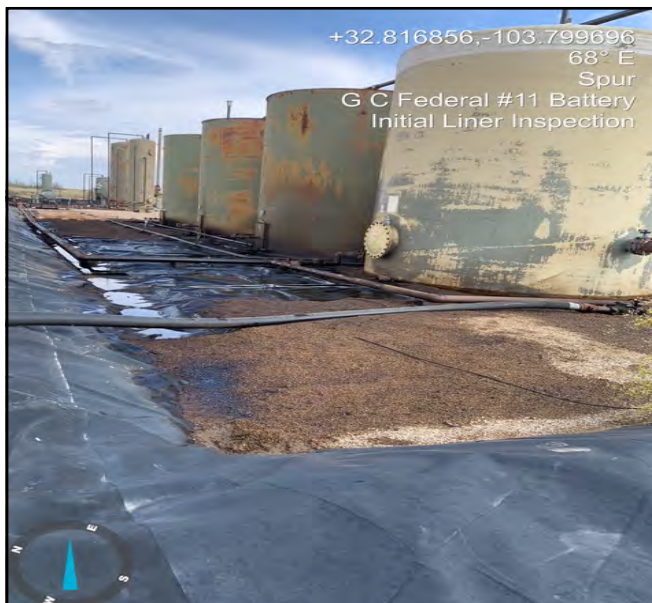
Photo of liner taken during initial liner inspection facing east.

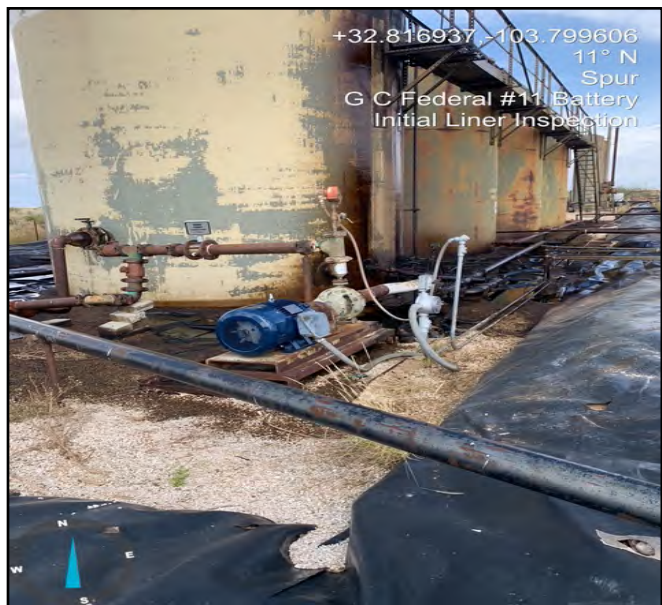
Photo of liner taken during initial liner inspection facing north.

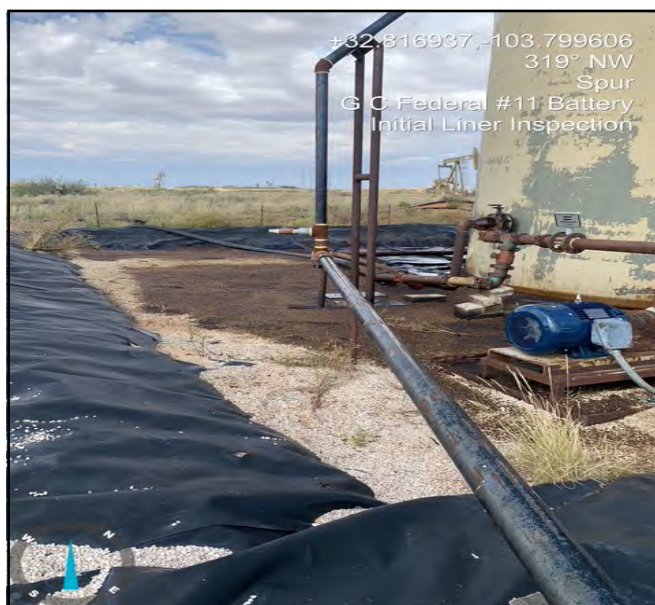
Photo of liner taken during initial liner inspection facing northwest.

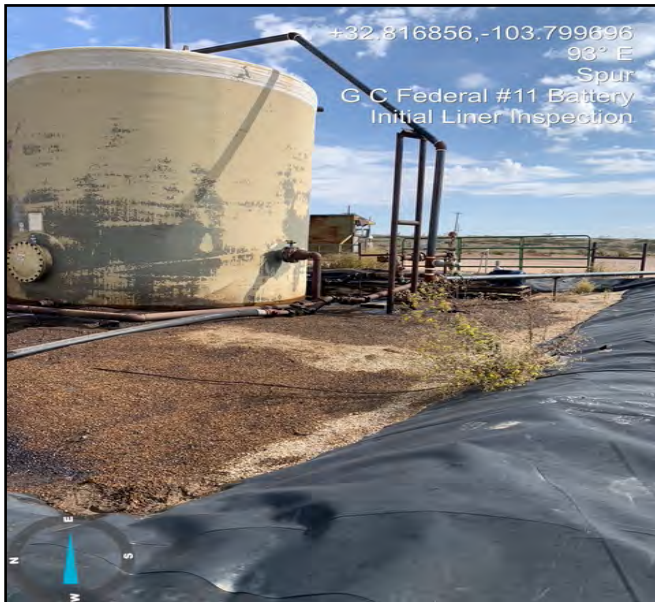
Photo of liner taken during initial liner inspection facing east.

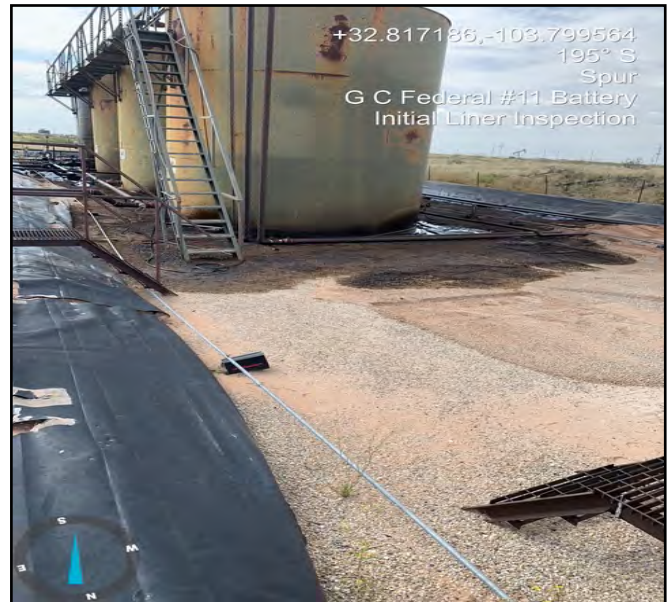
Photo of liner taken during initial liner inspection facing south.

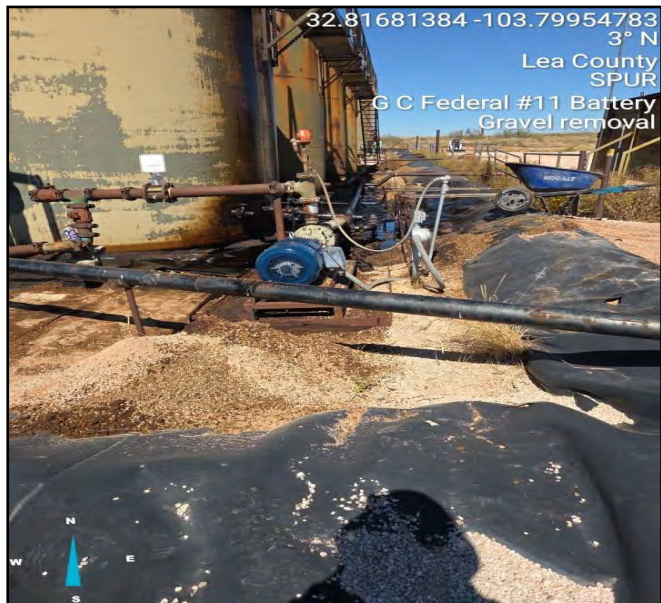
Photograph taken prior to gravel removal, facing north.

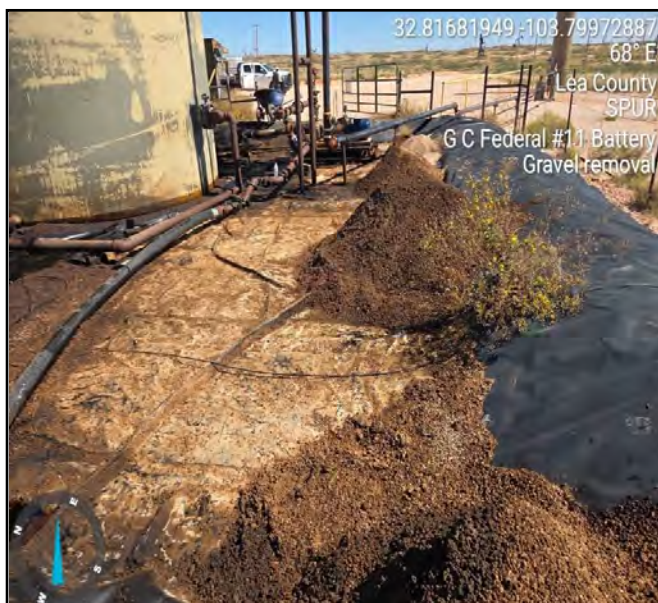
Photograph taken prior to gravel removal, facing east.

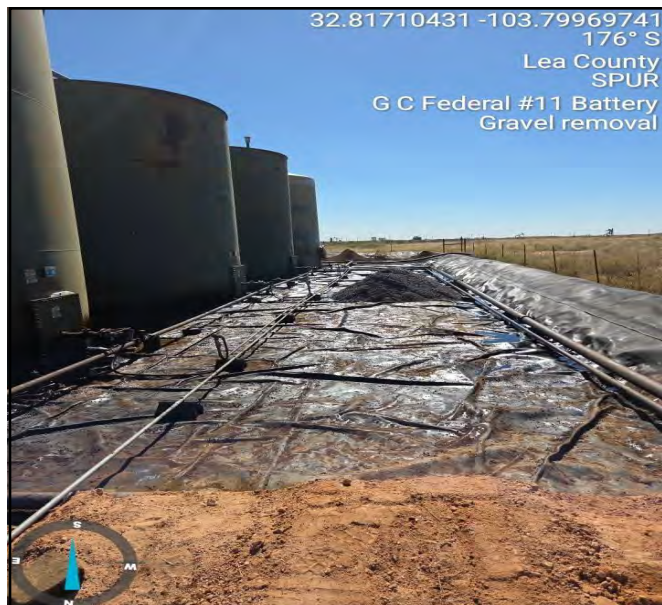
Photograph taken prior to gravel removal, facing south.

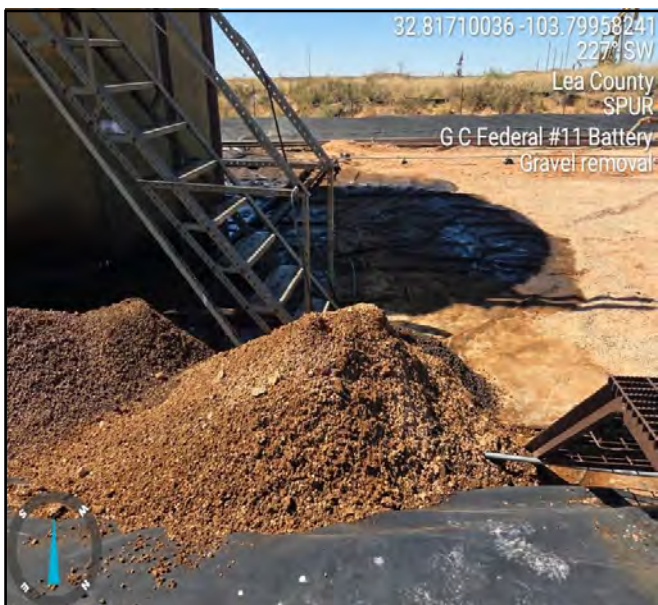
Photograph taken prior to gravel removal, facing southwest.

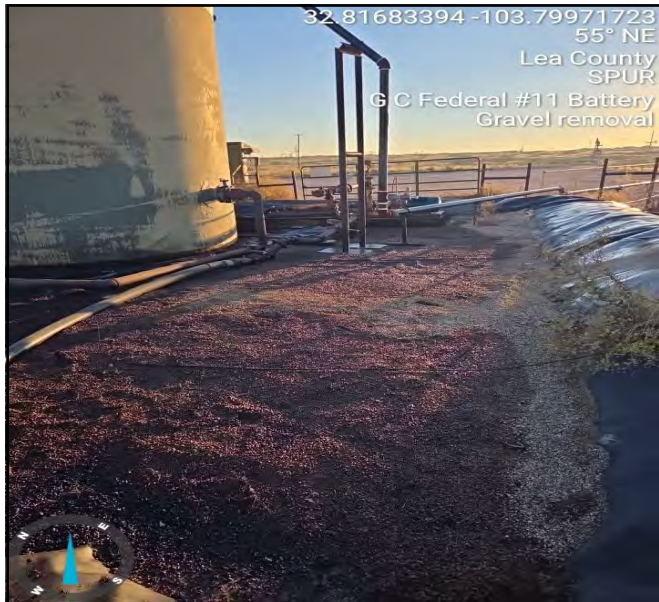
Photograph taken prior to gravel removal, facing northeast.

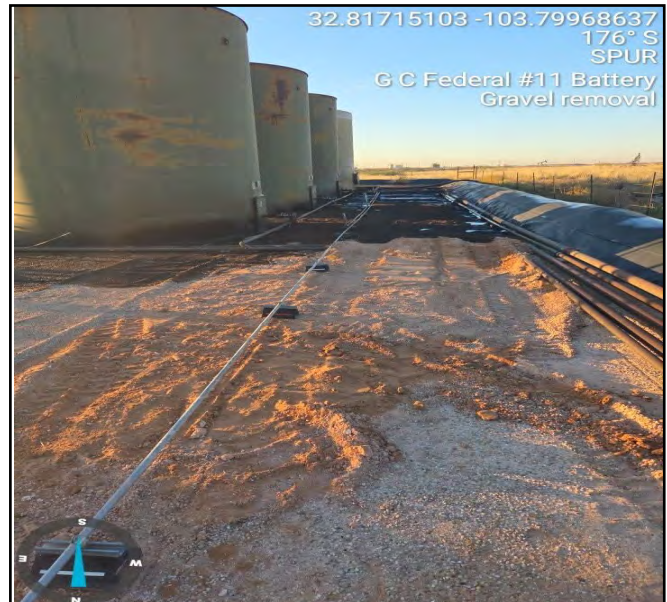
Photograph taken prior to gravel removal, facing south.

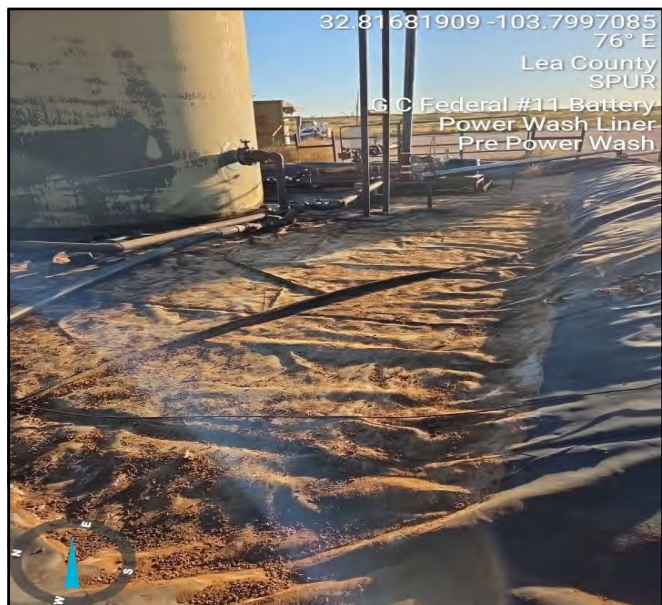
Photograph taken pre- powerwash process facing east.

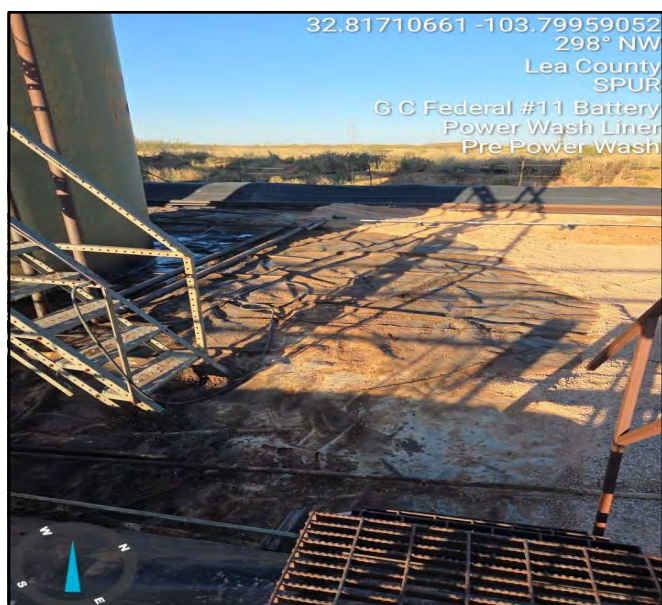
Photograph taken pre- powerwash process facing northwest.

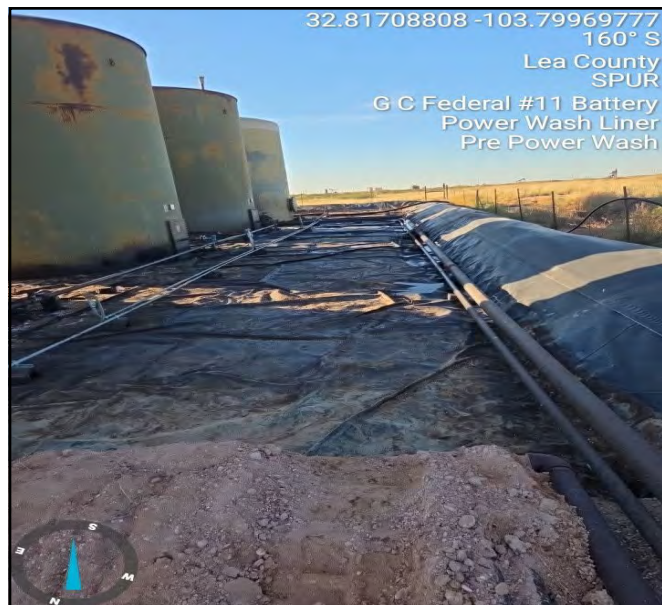
Photograph taken pre- powerwash process facing south.

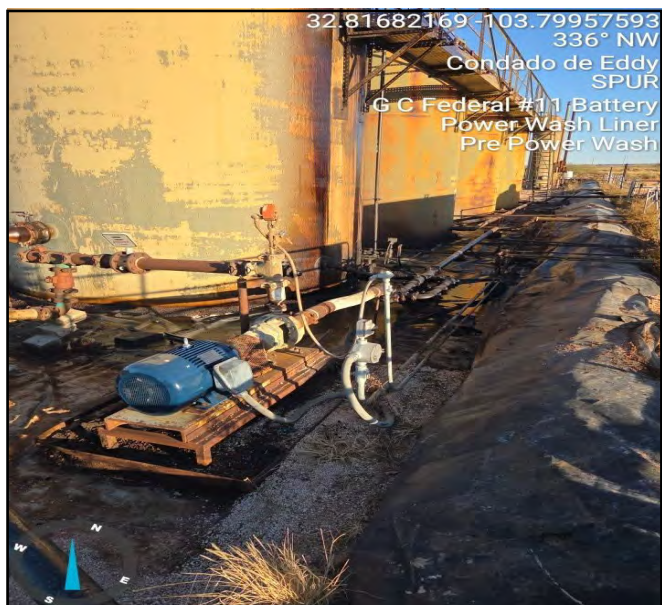
Photograph taken pre- powerwash process facing northwest.

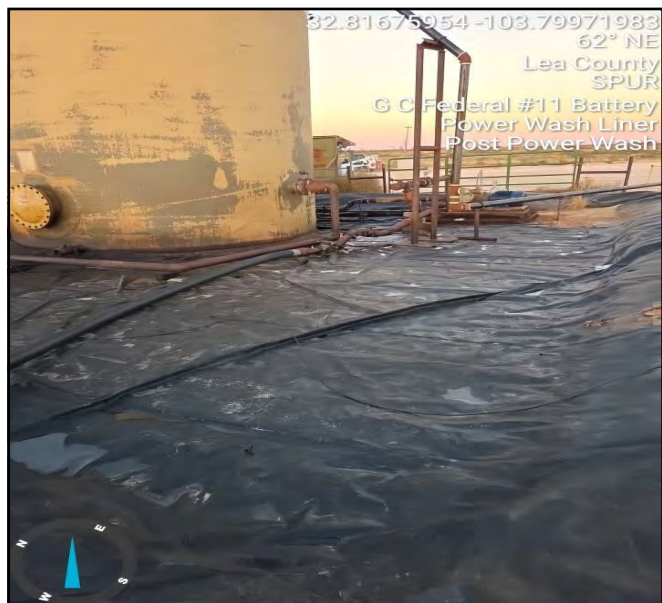
Visualization	Yes	No	Comments
Is there a tear in the liner?		X	
Are there holes in the liner?		X	
Is the liner retaining any fluids?	X		Standing fluid is visible inside the lined containment due to power washing efforts.
Does the liner have integrity to contain a leak?	X

Photo of location taken post power wash facing northeast.

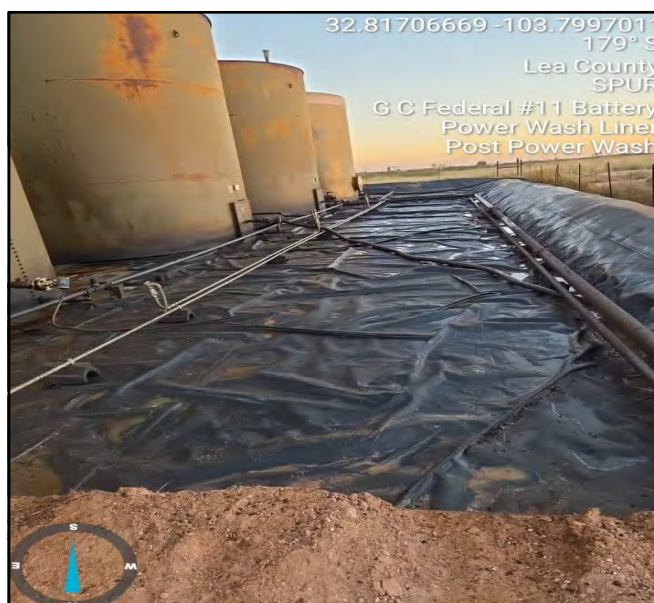
Photo of location taken post power wash facing south.

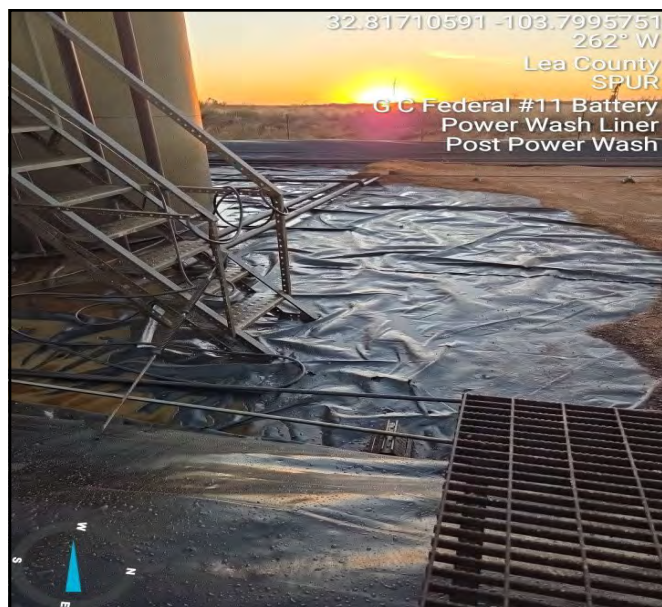
Photo of location taken post power wash facing west.

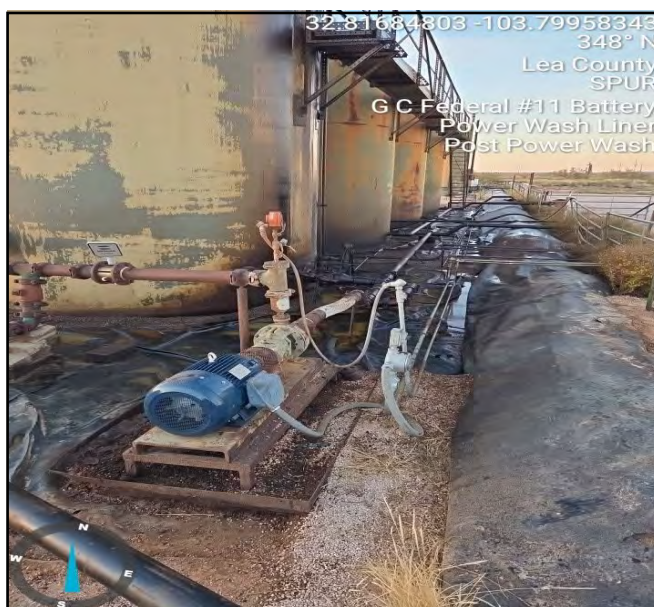
Photo of location taken post power wash facing north.
