RE: **Flagler 8 CTB 3 - Closure Request Report**

Incident Number: nAPP2534538169

ESRR Project No. VP-8277

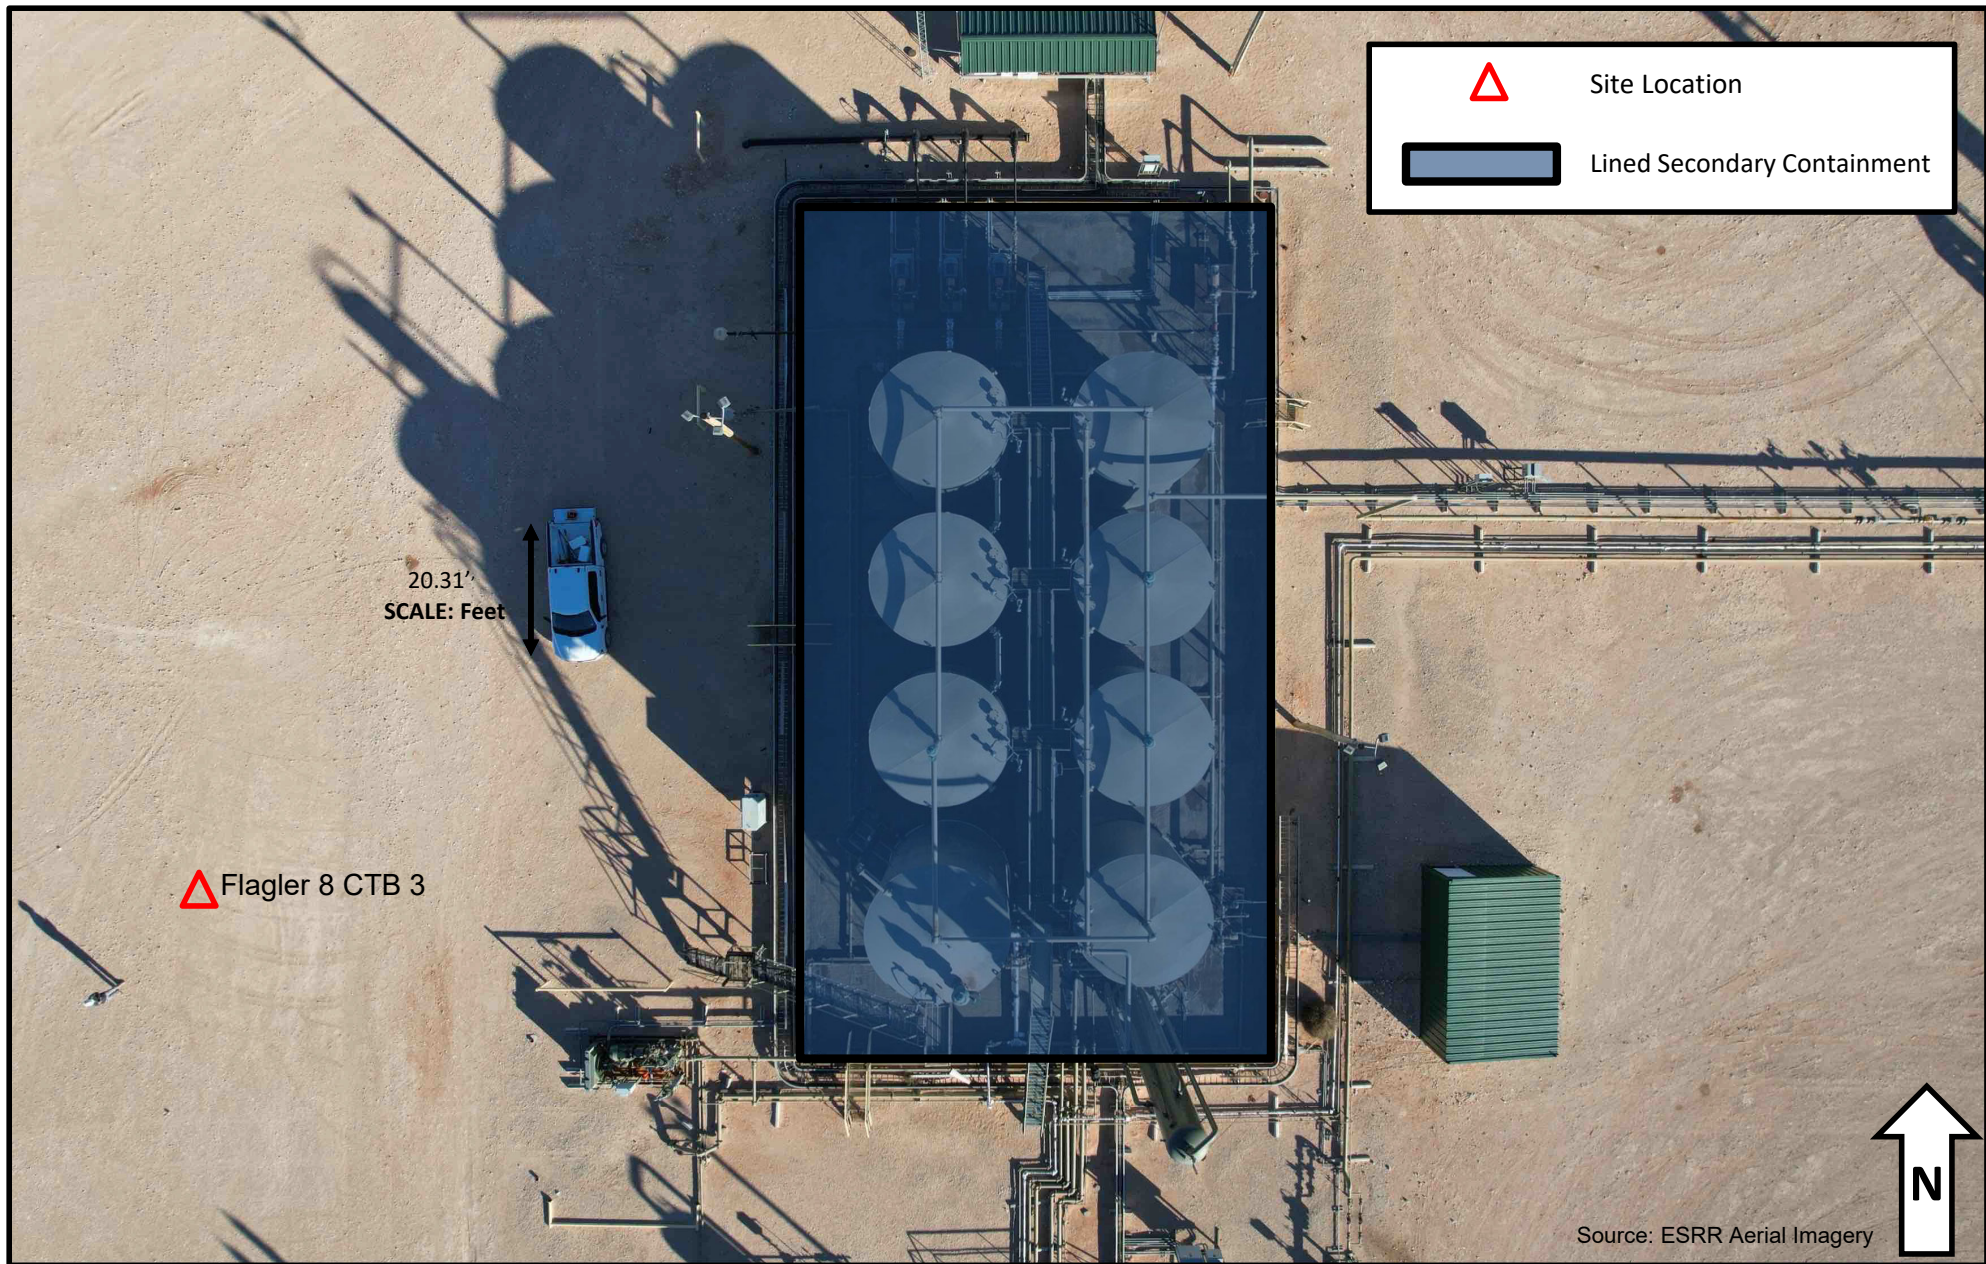
Figure 2 – Release Extent

On December 6, 2025, a pinhole leak developed on a check valve, releasing approximately 218 barrels (bbls) of produced water within a LSC (**Figure 2**). The release was fully contained within the LSC with no fluids escaping to the production pad or adjacent native soils. A vacuum truck was immediately dispatched to the Site recovering the 218 bbls of produced water.

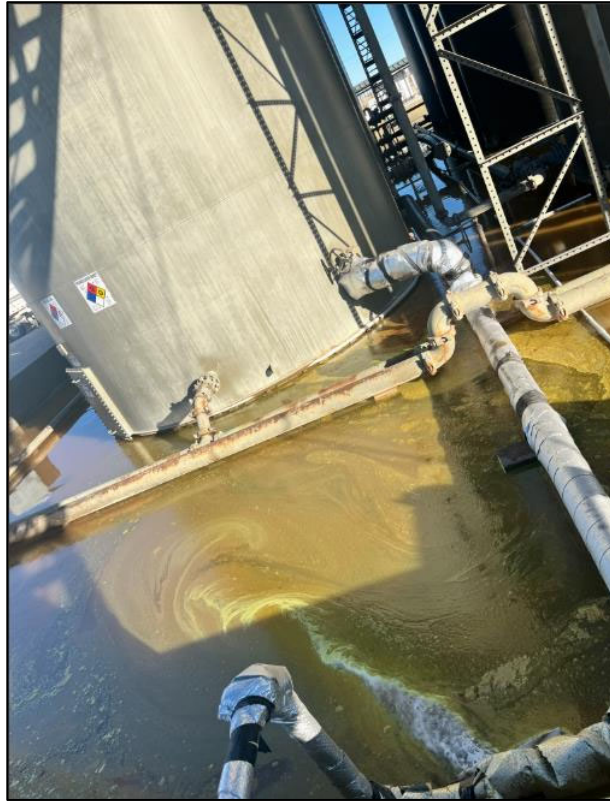
PHOTO 1: Northwestern view during discovery by Devon. 12/6/2025

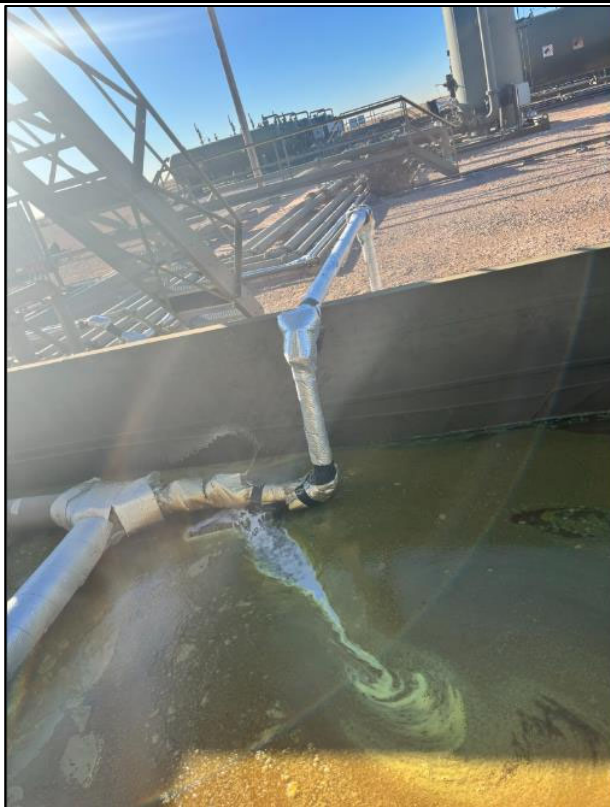
PHOTO 2: Southeastern view during discovery by Devon. 12/6/2025

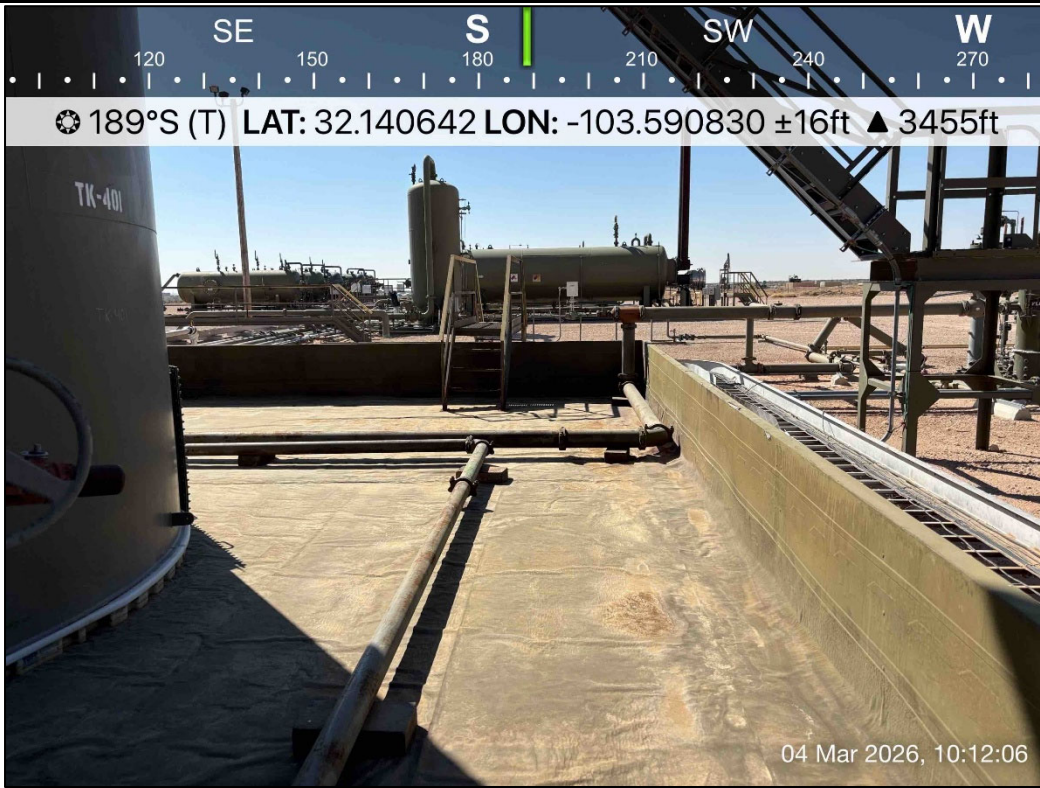
On March 4, 2026 ESRR conducted a thorough visual inspection of the LSC and found no tears, cracks, cuts, breaks, or other signs of damage, confirming no evidence of a breach to the LSC. The liner appeared to be in good condition and is performing as designed. **Photographic Documentation** of liner inspection activities is attached.

PHOTO 9: Southern view during liner inspection activities. 3/4/2026

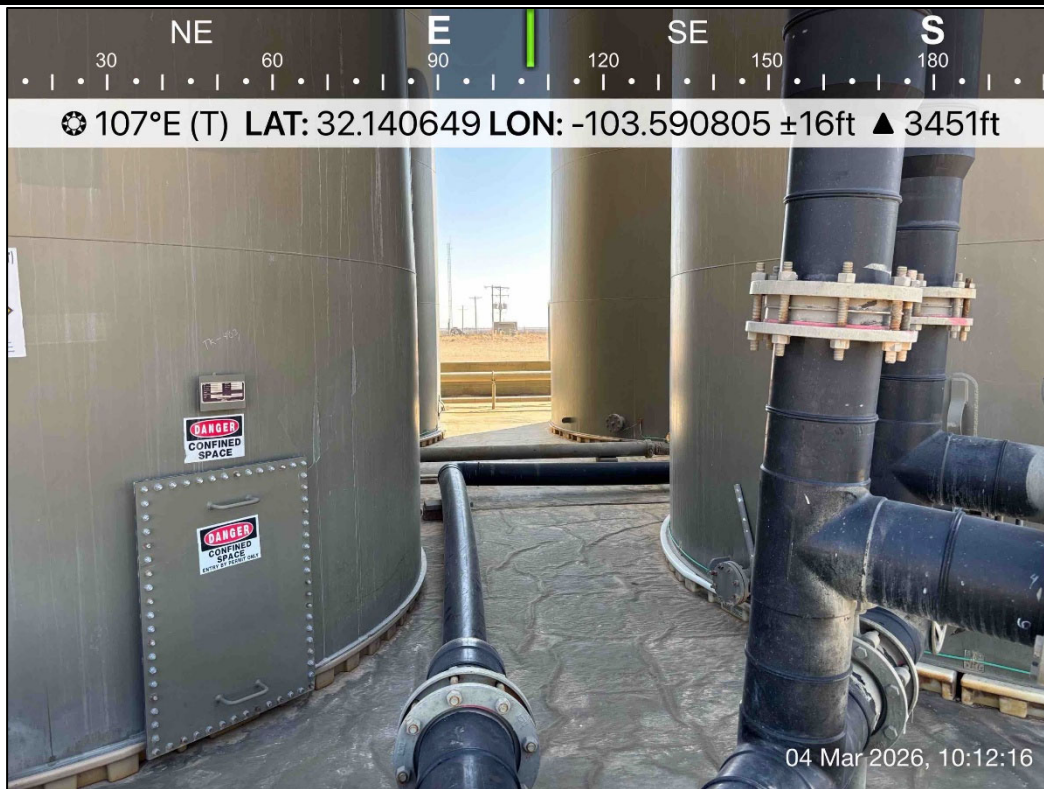
PHOTO 10: Southeastern view during liner inspection activities. 3/4/2026

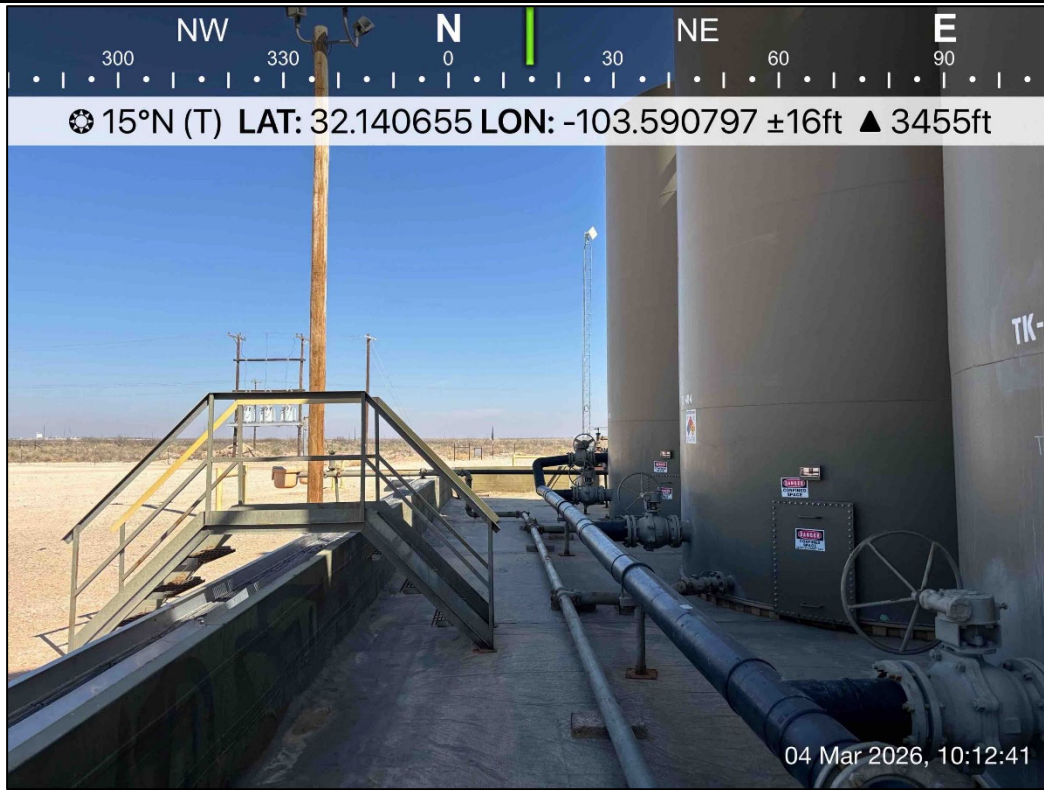
PHOTO 11: Northeastern view during liner inspection activities. 3/4/2026

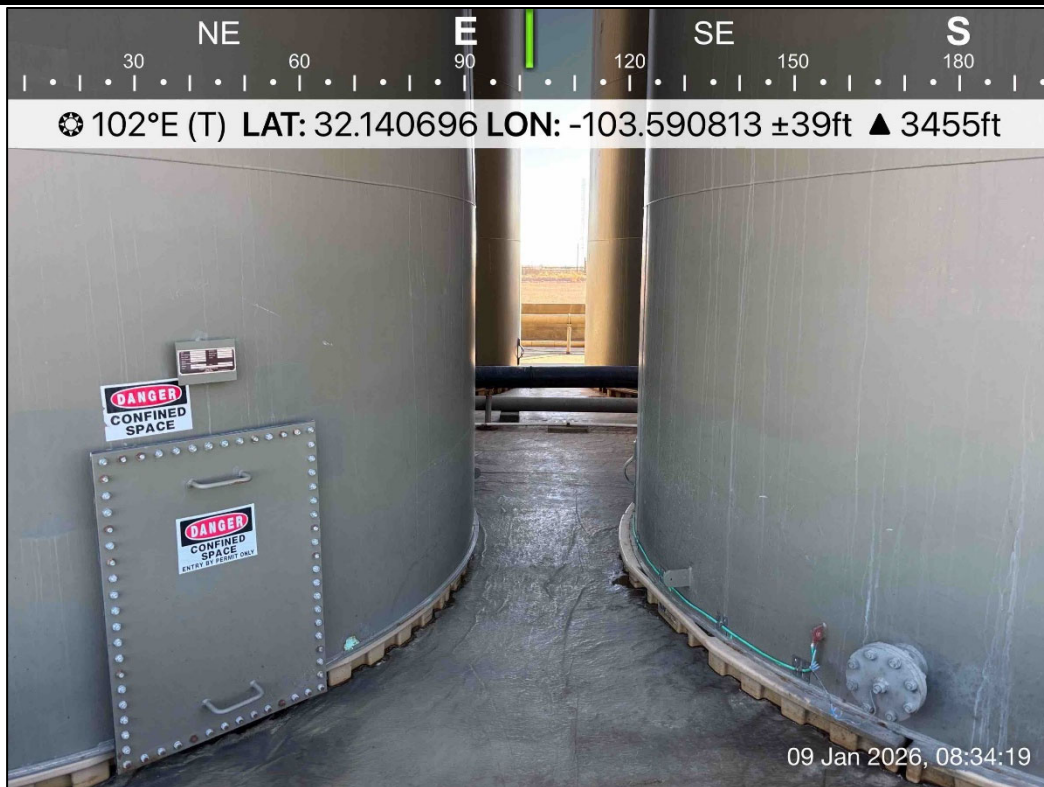
PHOTO 12: Southeastern view during liner inspection activities. 3/4/2026

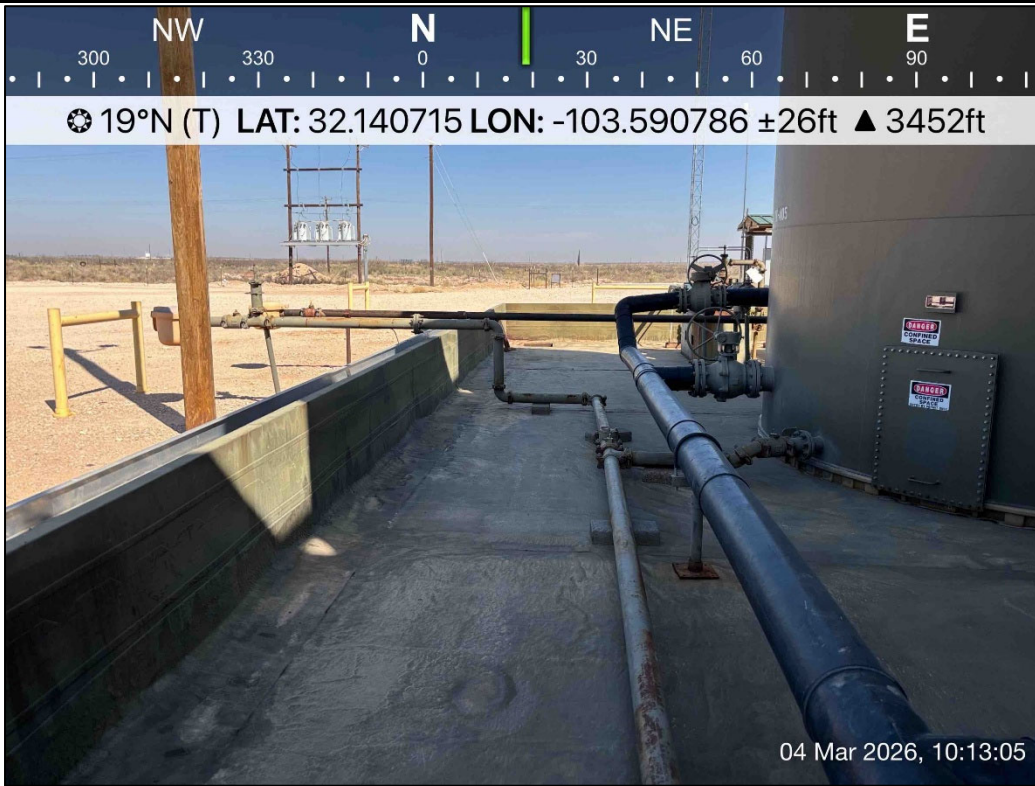
PHOTO 13: Northeastern view during liner inspection activities. 3/4/2026

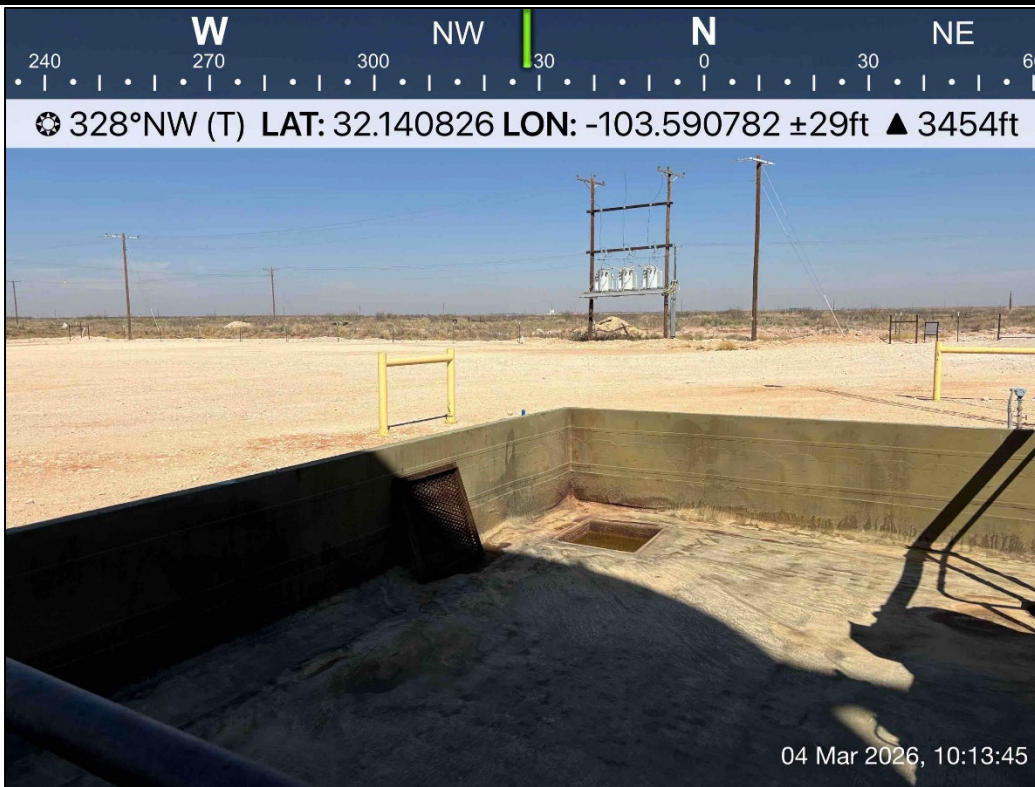
PHOTO 14: Northwestern view during liner inspection activities. 3/4/2026

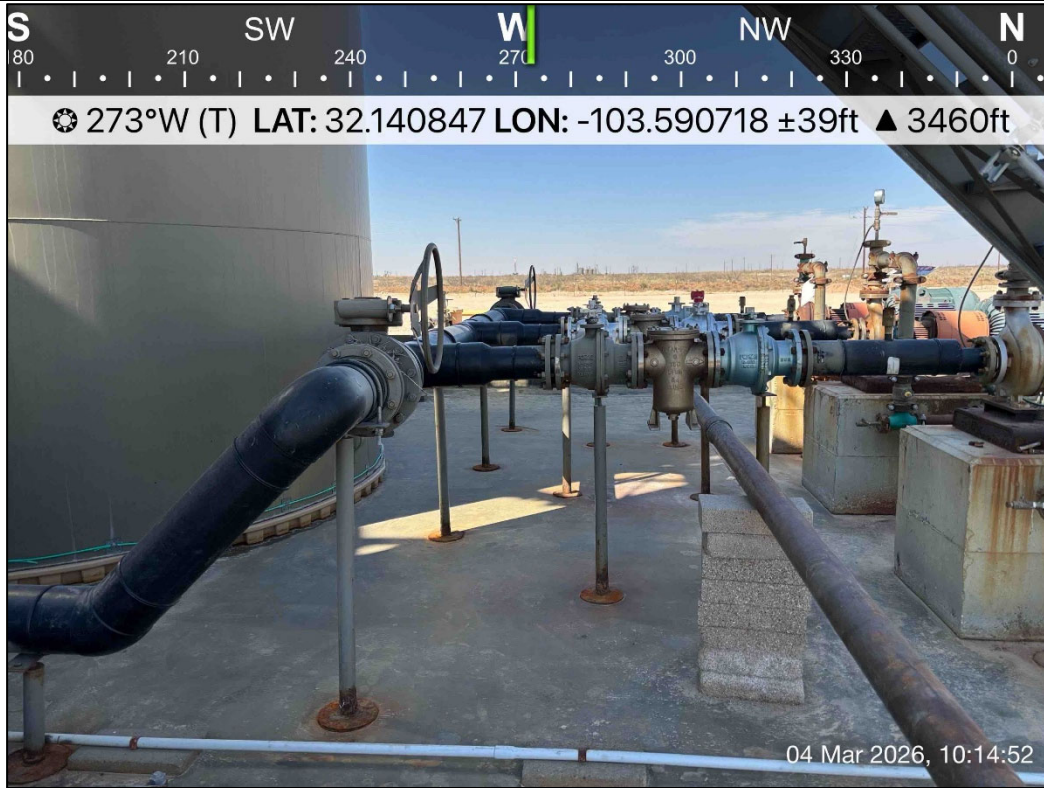
PHOTO 15: Western view during liner inspection activities. 3/4/2026

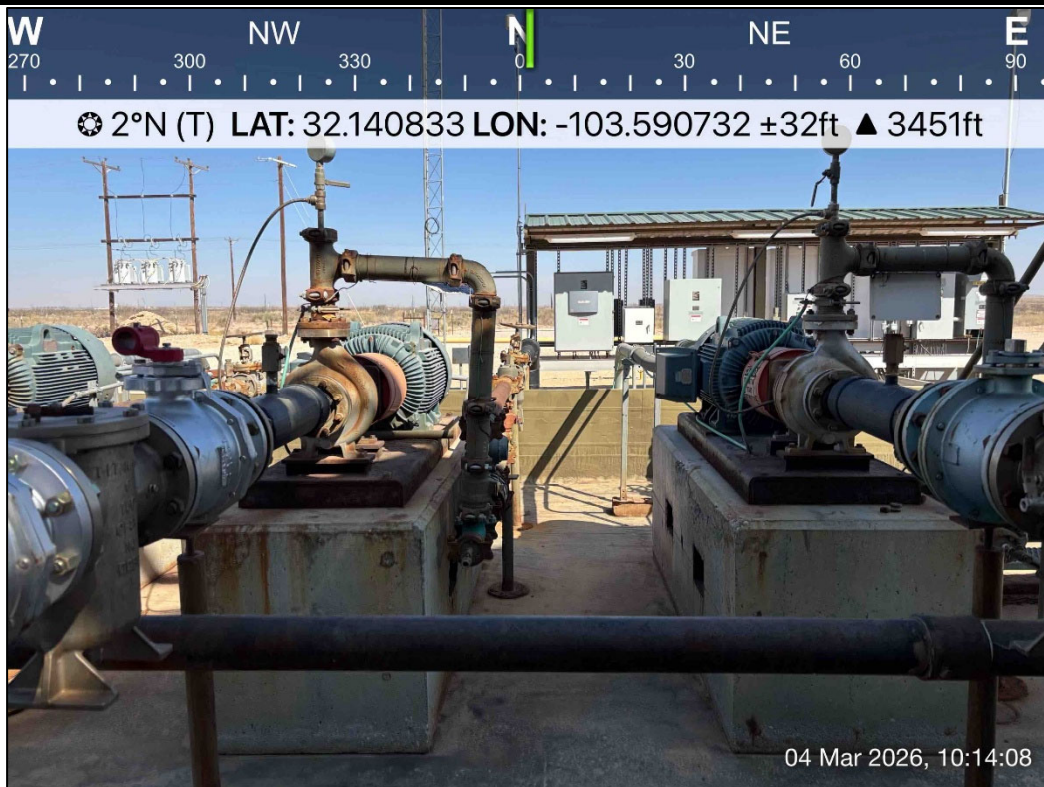
PHOTO 16: Northern view during liner inspection activities. 3/4/2026

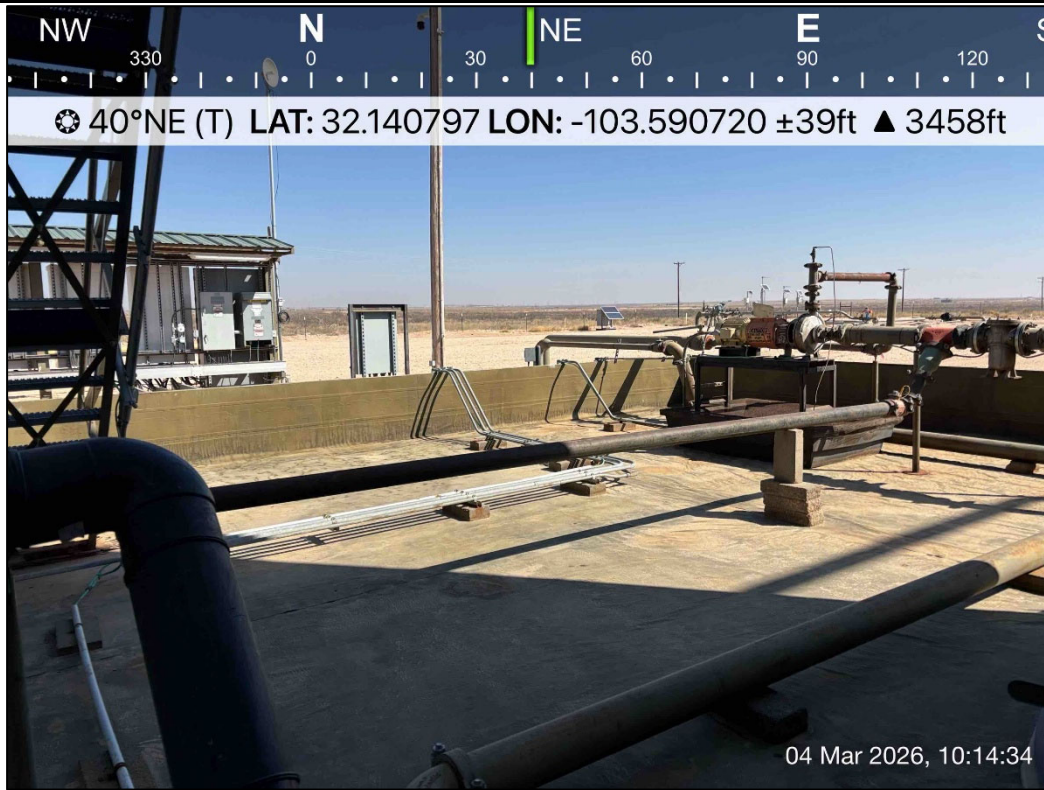
PHOTO 17: Northeastern view during liner inspection activities. 3/4/2026

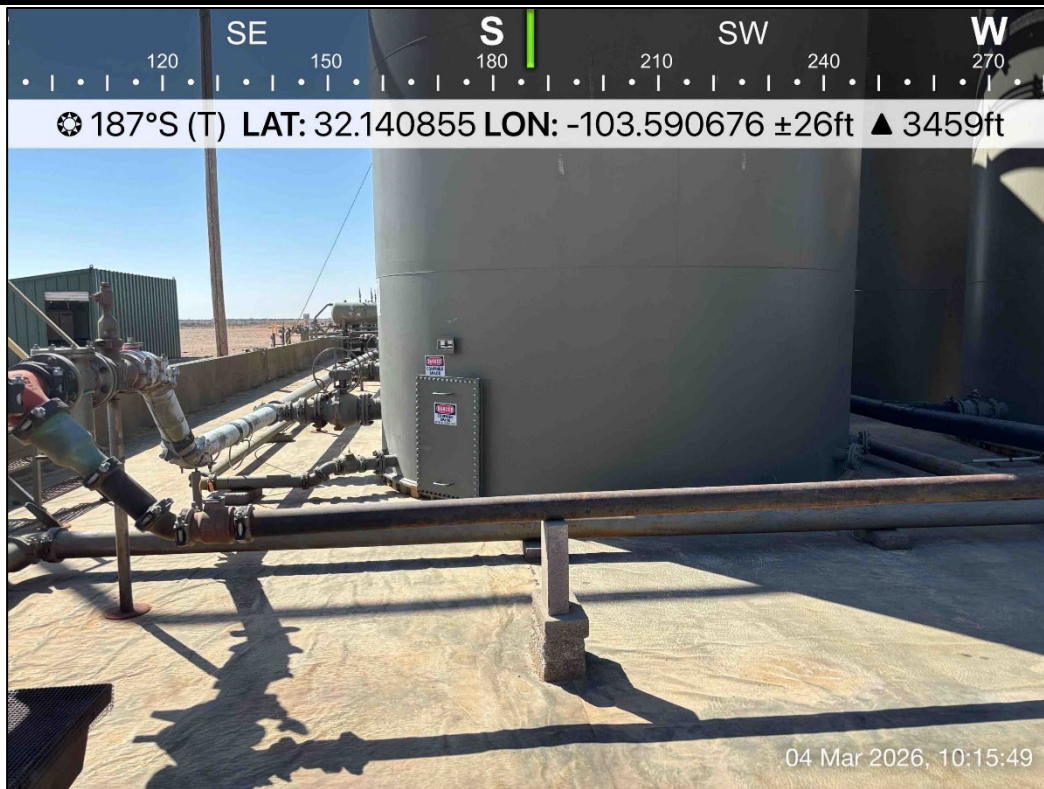
PHOTO 18: Southern view during liner inspection activities. 3/4/2026

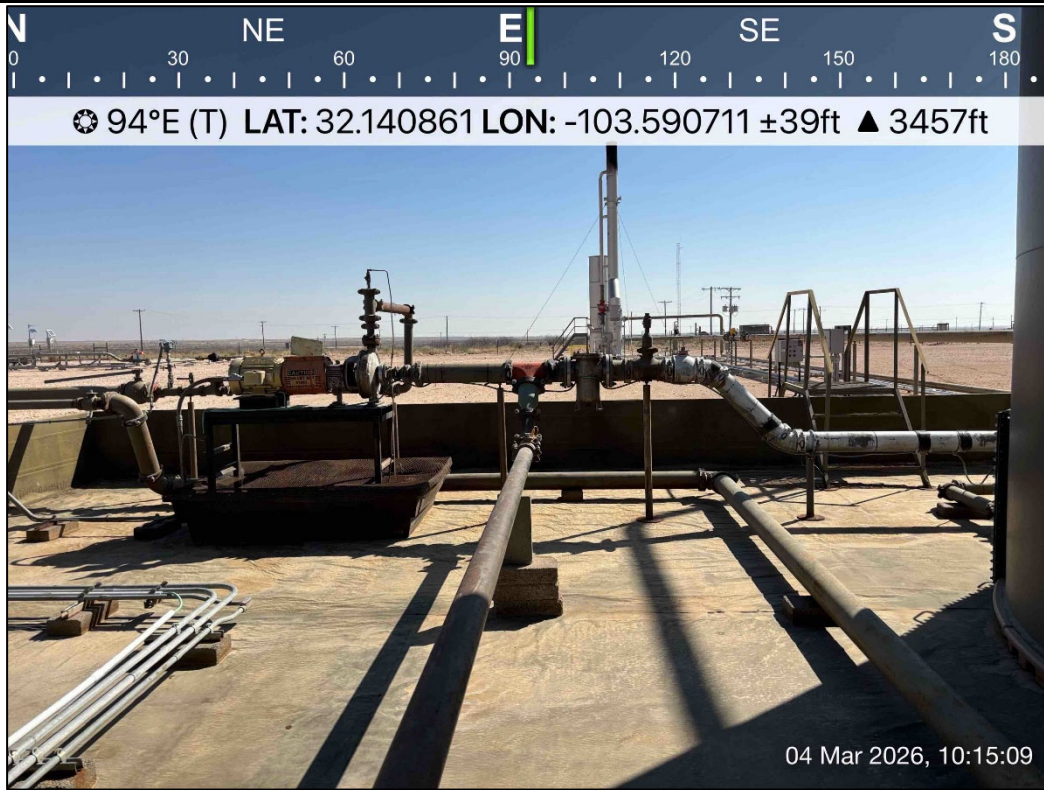
PHOTO 19: Eastern view during liner inspection activities. 3/4/2026

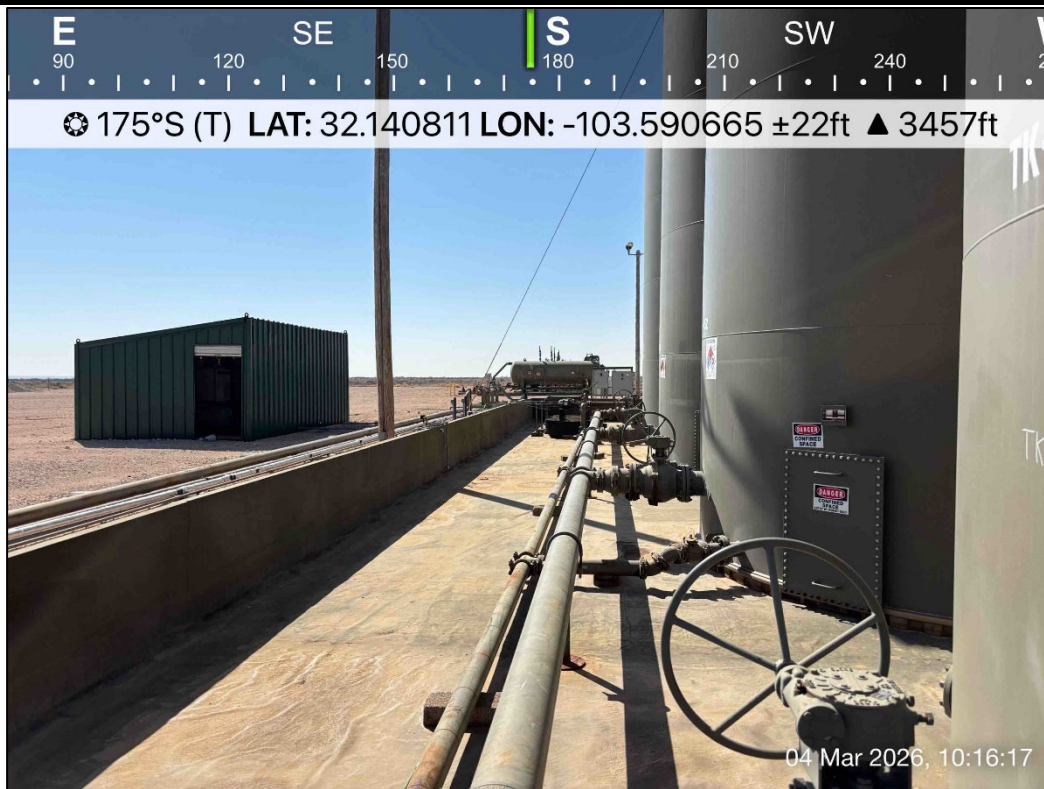
PHOTO 20: Southern view during liner inspection activities. 3/4/2026

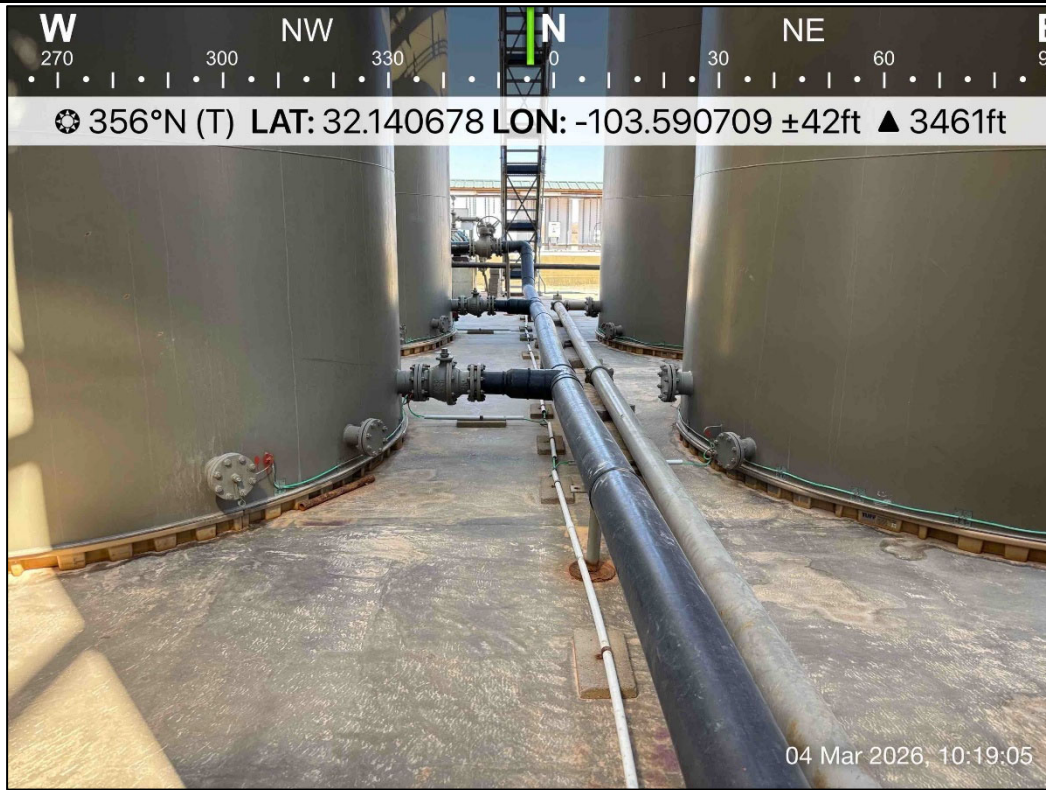
PHOTO 21: Northern view during liner inspection activities. 3/4/2026

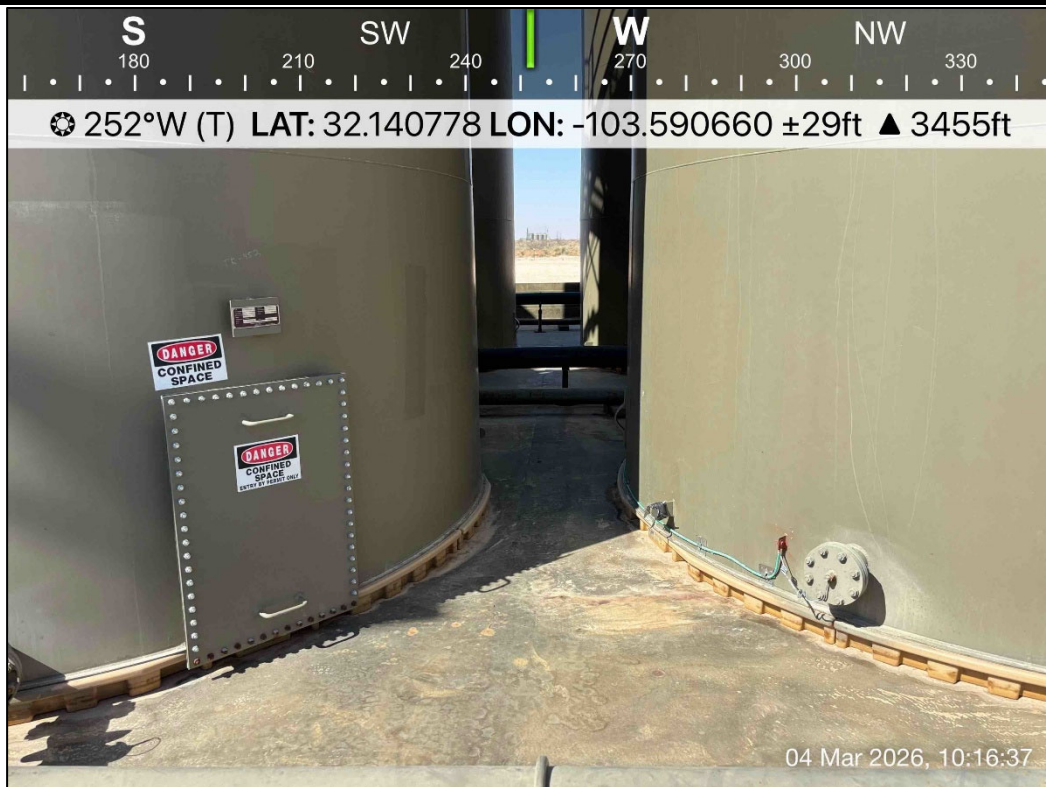
PHOTO 22: Southwestern view during liner inspection activities. 3/4/2026

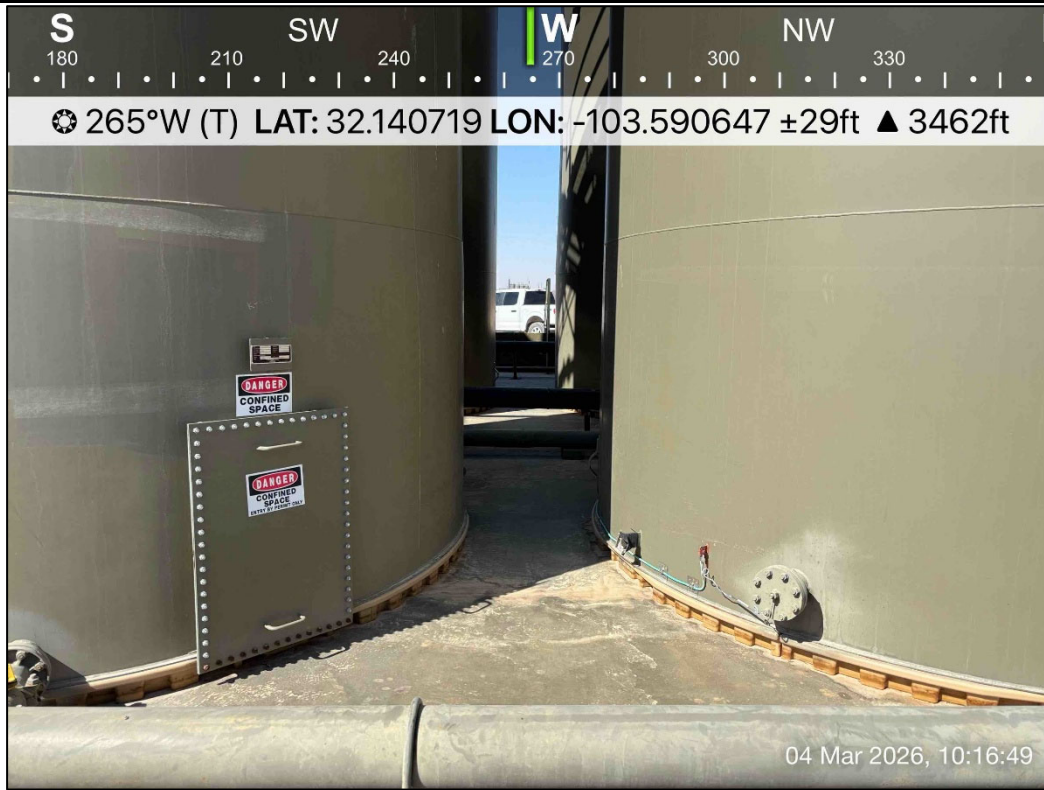
PHOTO 23: Western view during liner inspection activities. 3/4/2026

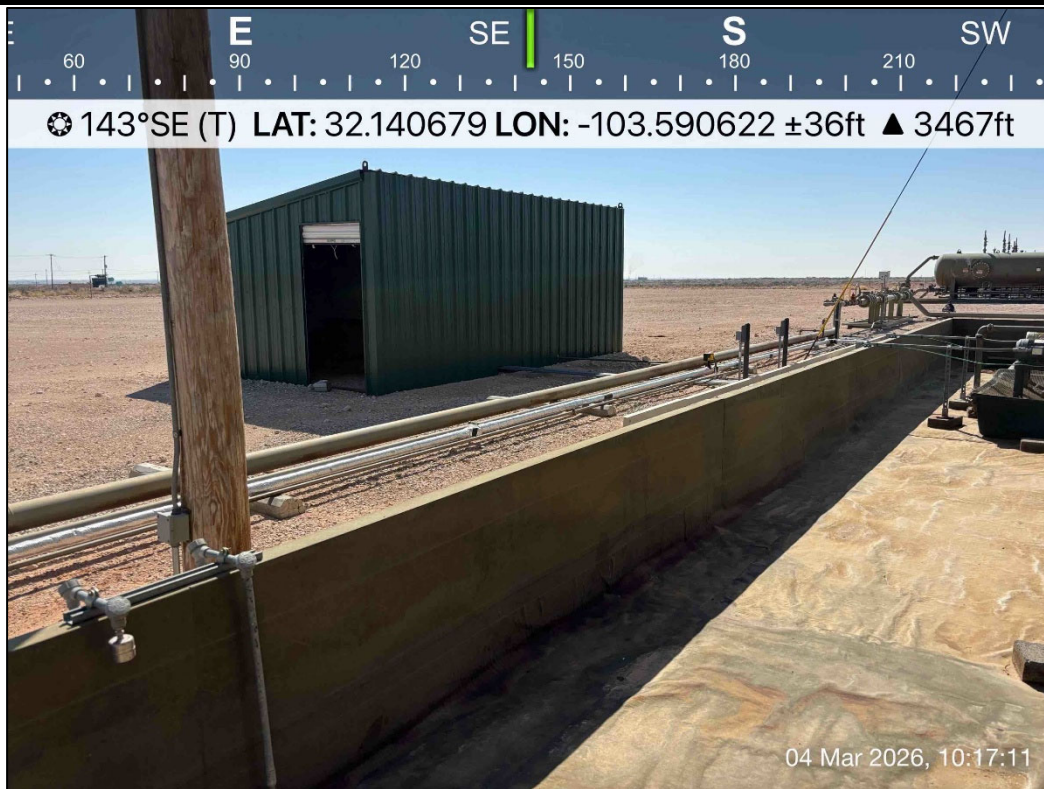
PHOTO 24: Southeastern view during liner inspection activities. 3/4/2026

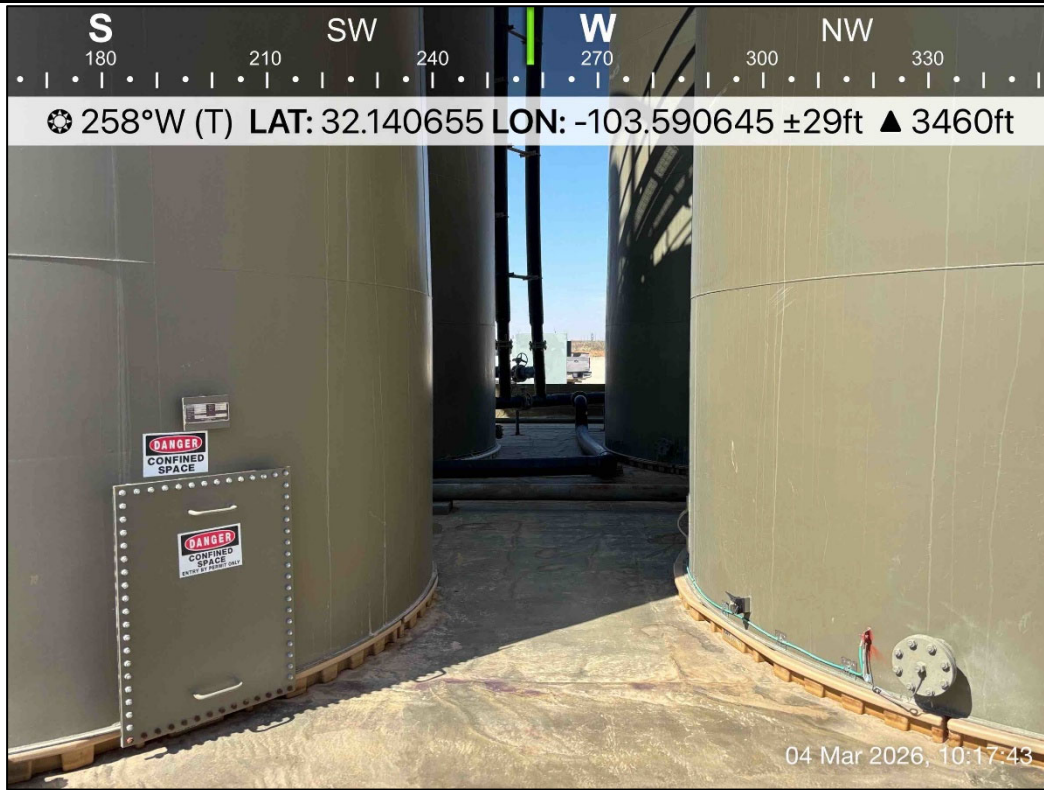
PHOTO 25: Southwestern view during liner inspection activities. 3/4/2026
