## Release Assessment and Closure

Mustang 8 CTB 3

FAPP2510041275

Devon Energy Production Company, LP

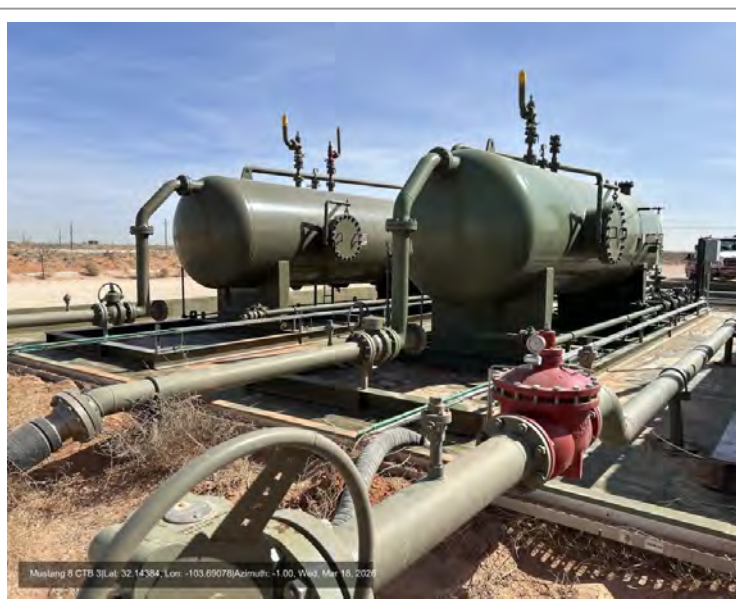
Date: 3/18/2026  
 Time: 10:35  
 Notes: Northwest section in lined containment. Integrity of liner and 1 ft walls are intact with no breachable areas or damage.  
 Latitude: 32.14384166666667  
 Longitude: -103.69078055555556  
 Direction: W

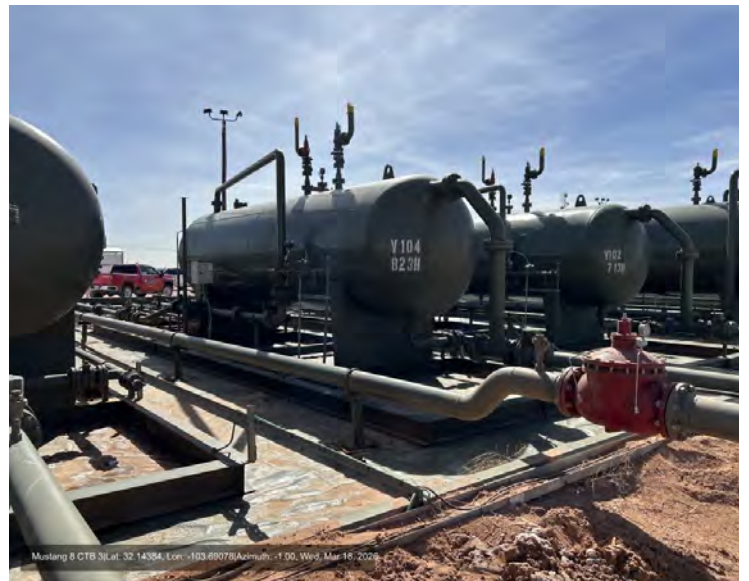
Date: 3/18/2026  
 Time: 10:35  
 Notes: West section on north between separators. Integrity of liner and walls are intact with no breachable areas or damage.  
 Latitude: 32.14384444444445  
 Longitude: -103.69078055555556  
 Direction: W

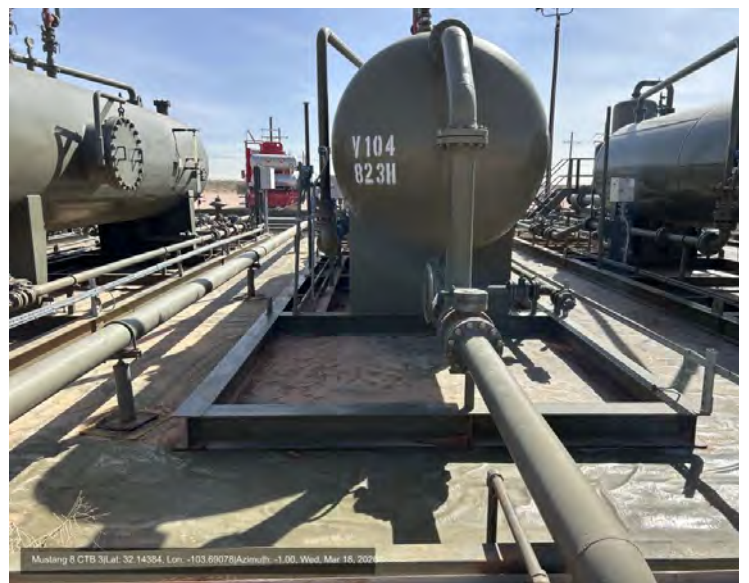
Date: 3/18/2026  
 Time: 10:35  
 Notes: West section on north end around separators. Integrity of liner and 1 ft walls are intact with no breachable areas or damage.  
 Latitude: 32.14384444444445  
 Longitude: -103.69078055555556  
 Direction: W

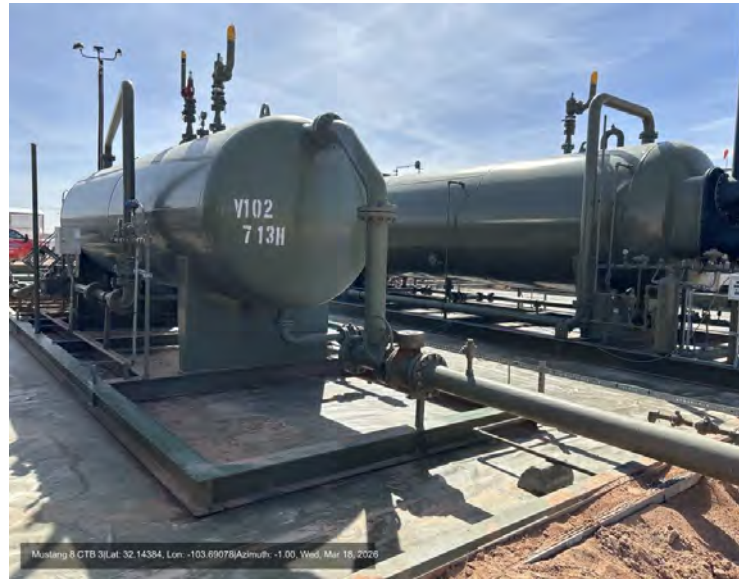
Date: 3/18/2026  
 Time: 10:36  
 Notes: West section on north end between separators. Integrity of liner and 1 ft walls are intact with no breachable areas or damage.  
 Latitude: 32.14384444444445  
 Longitude: -103.69078055555556  
 Direction: W

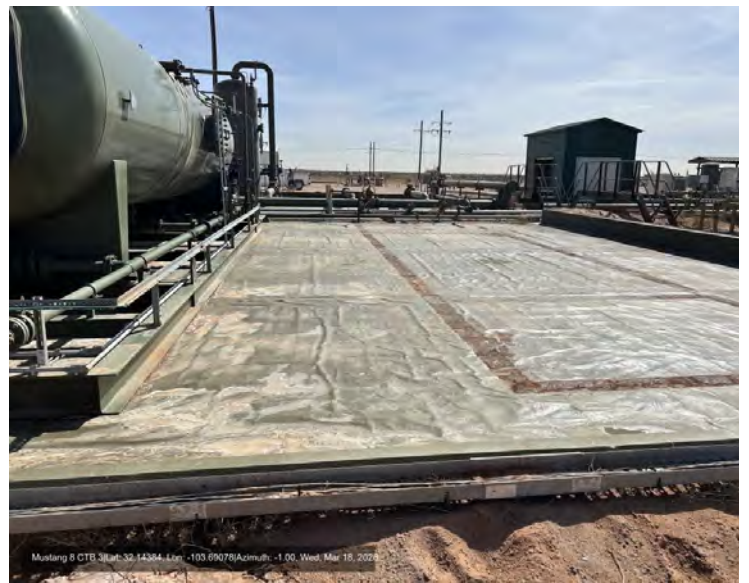
Date: 3/18/2026  
 Time: 10:36  
 Notes: West section on north end looking across liner to east 1 ft wall. Integrity of line and walls are intact with no breachable areas or damage.  
 Latitude: 32.14384444444445  
 Longitude: -103.69078055555556  
 Direction: W

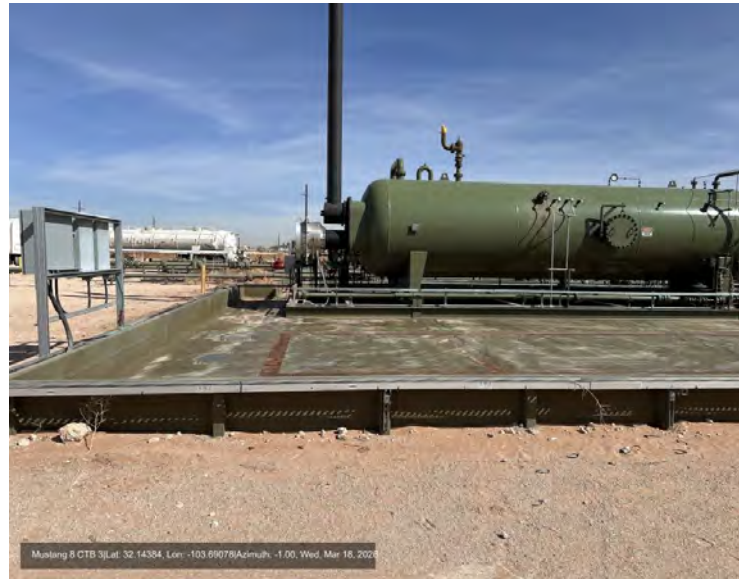
Date: 3/18/2026  
 Time: 10:37  
 Notes: West section on north end. Integrity of liner and 1 ft walls are intact with no breachable areas or damage.  
 Latitude: 32.14384444444445  
 Longitude: -103.69078055555556  
 Direction: W

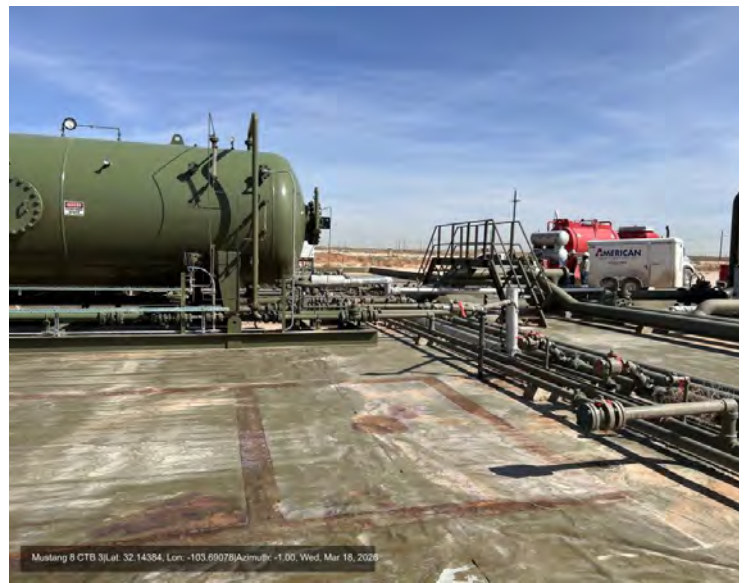
Date: 3/18/2026  
 Time: 10:37  
 Notes: Middle section on north end. Integrity of liner is intact with no breachable areas or damage. Seams in middle were inspected and are fully sealed.  
 Latitude: 32.14384444444445  
 Longitude: -103.69078055555556  
 Direction: W

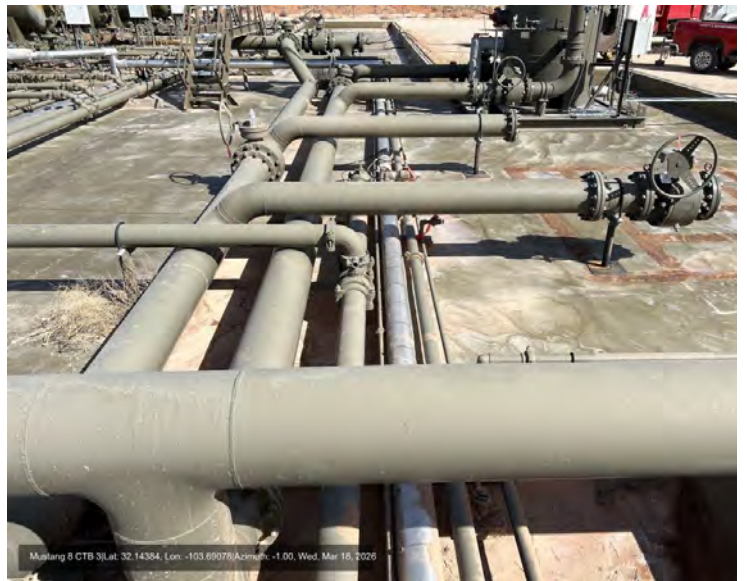
Date: 3/18/2026  
 Time: 10:38  
 Notes: Middle section on north end along pipe run. View north. Integrity of liner and 1ft walls are intact with no breachable areas or damage. Some blow sand exists.  
 Latitude: 32.14384444444445  
 Longitude: -103.69078055555556  
 Direction: W

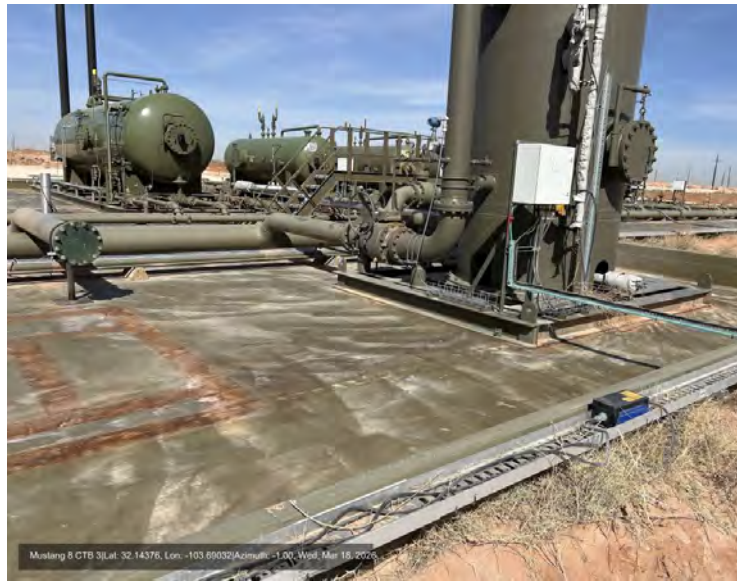
Date: 3/18/2026  
 Time: 10:39  
 Notes: East section on north end around Vertical separator. Integrity of line and 1 ft walls are intact with no breachable areas or damage.  
 Latitude: 32.14376111111111  
 Longitude: -103.69032222222222  
 Direction: W

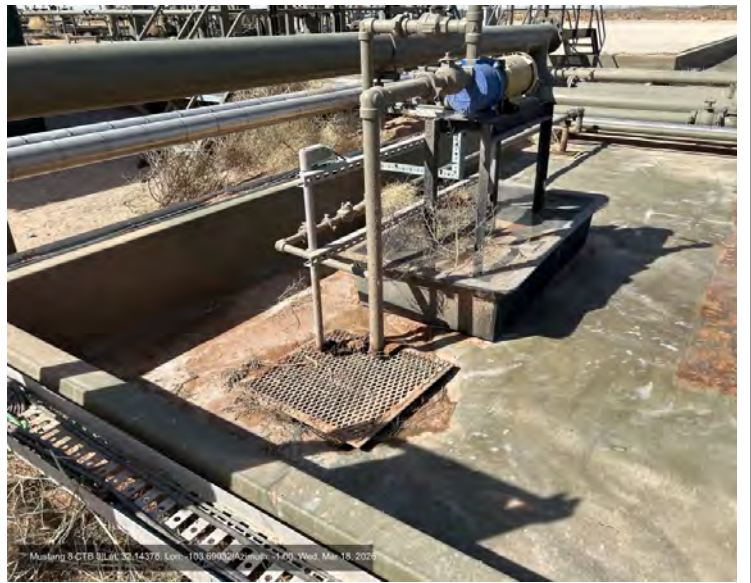
Date: 3/18/2026  
Time: 10:40  
Notes: Middle section on east side. Integrity of line and 1 ft walls are intact with no breachable areas or damage. Sump appears mostly clear, in working condition and not clogged.  
Latitude: 32.14376111111111  
Longitude: -103.69032222222222  
Direction: W

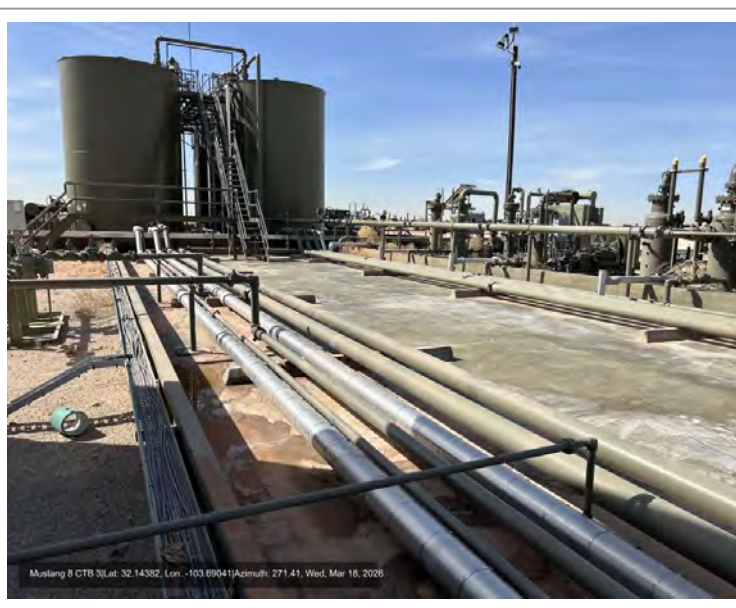
Date: 3/18/2026  
 Time: 10:42  
 Notes: Middle section on east side along pipes. Integrity of liner and 1 ft walls are intact with no breachable areas or damage. A small amount of water with blow sand exists against the wall of the containment remaining from power washing.  
 Latitude: 32.143816666666666  
 Longitude: -103.69040555555556  
 Direction: N

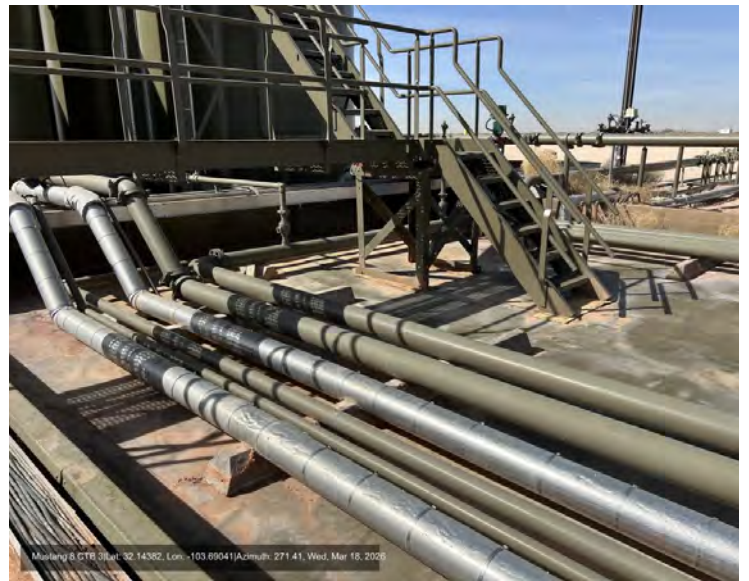
Date: 3/18/2026  
 Time: 10:42  
 Notes: South section of the 1 ft wall containment adjoining 2 ft wall. Integrity of liner and 1 ft walls are intact with no breachable areas or damage. Contact points with metal infrastructure such as the stairs contain a cushion barrier to protect liner.  
 Latitude: 32.143816666666666  
 Longitude: -103.69040555555556  
 Direction: N

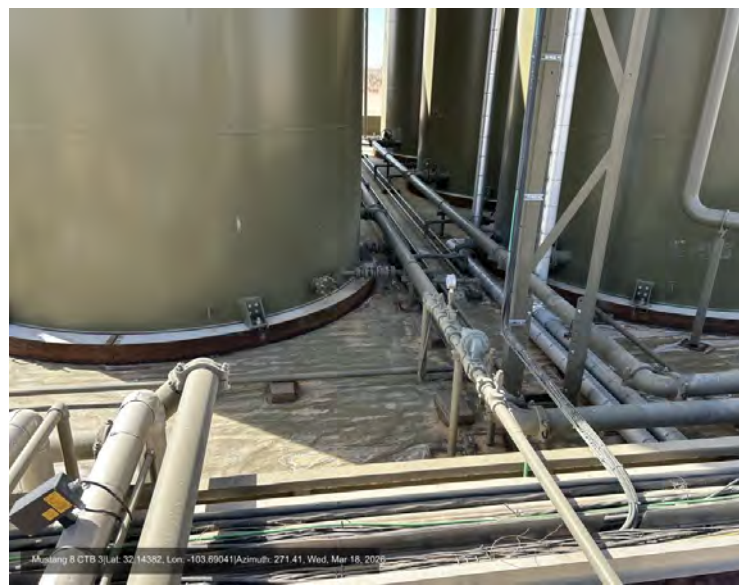
Date: 3/18/2026  
 Time: 10:43  
 Notes: West section of the 2 ft wall containment around tank batteries. Integrity of liner and 2 ft walls are intact with no breachable areas or damage. Contact points with metal infrastructure such as the stairs contain a cushion/barrier to protect liner.  
 Latitude: 32.143816666666666  
 Longitude: -103.69040555555556  
 Direction: N

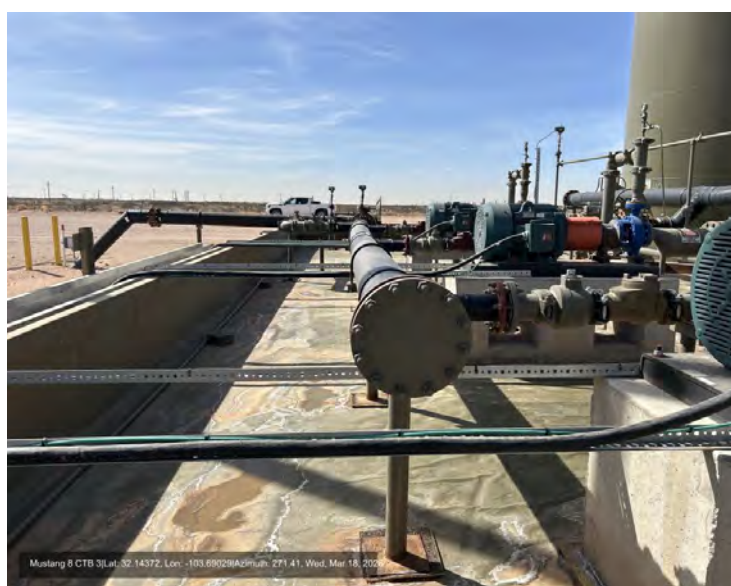
Date: 3/18/2026  
 Time: 10:44  
 Notes: East section of the 2 ft wall containment around tank batteries. Integrity of liner and 2 ft walls are intact with no breachable areas or damage. Contact points with metal infrastructure such as the stairs contain a cushion barrier to protect liner. Some small amount of water exists against the wall of the containment remaining from power washing.  
 Latitude: 32.14371944444444  
 Longitude: -103.69028611111112  
 Direction: N

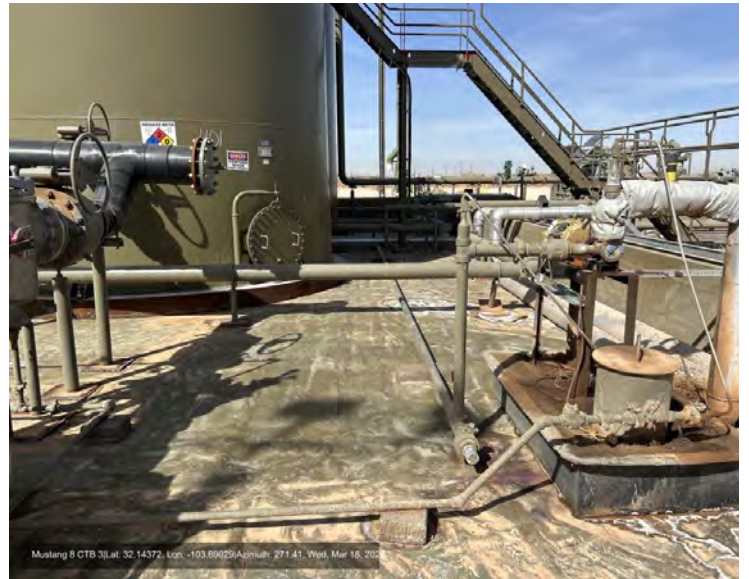
Date: 3/18/2026  
 Time: 10:44  
 Notes: North section of the 2 ft wall containment around tank batteries. Integrity of liner and 2 ft walls are intact with no breachable areas or damage. Contact points with metal infrastructure such as the stairs contain a cushion barrier to protect liner.  
 Latitude: 32.14371944444444  
 Longitude: -103.69028611111112  
 Direction: N

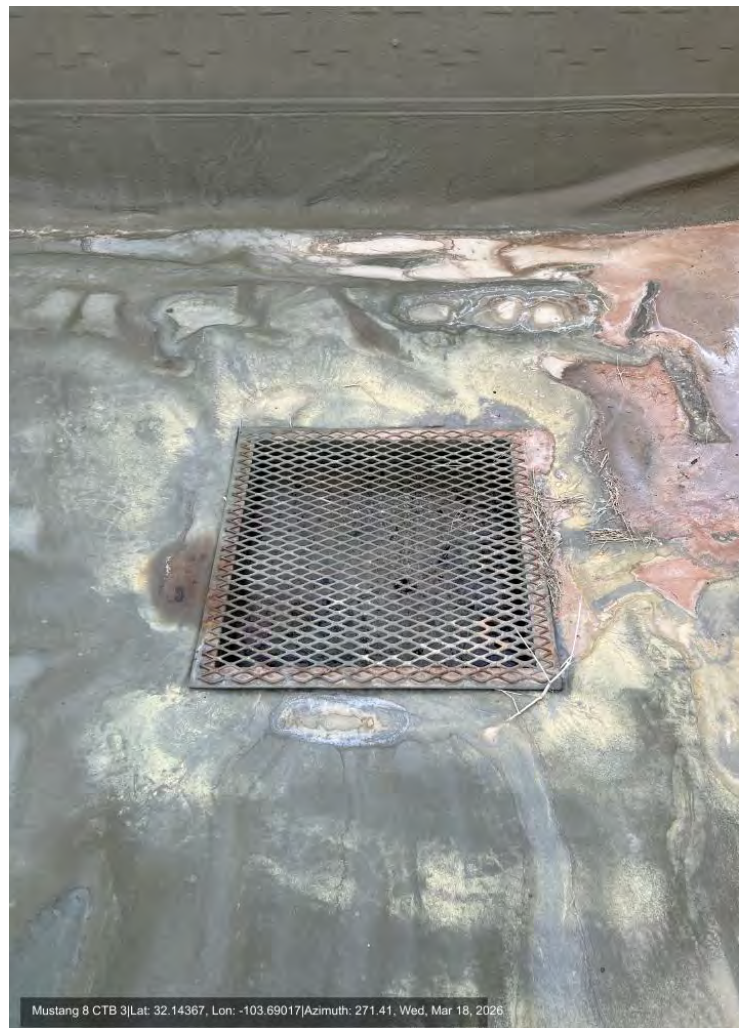
Date: 3/18/2026  
 Time: 10:44  
 Notes: North east section of the 2 ft wall containment around tank batteries. Sump appear clear of debris and in working order. Integrity of liner and 2 ft walls are intact with no breachable areas or damage.  
 Latitude: 32.14367222222222  
 Longitude: -103.69016944444445  
 Direction: N

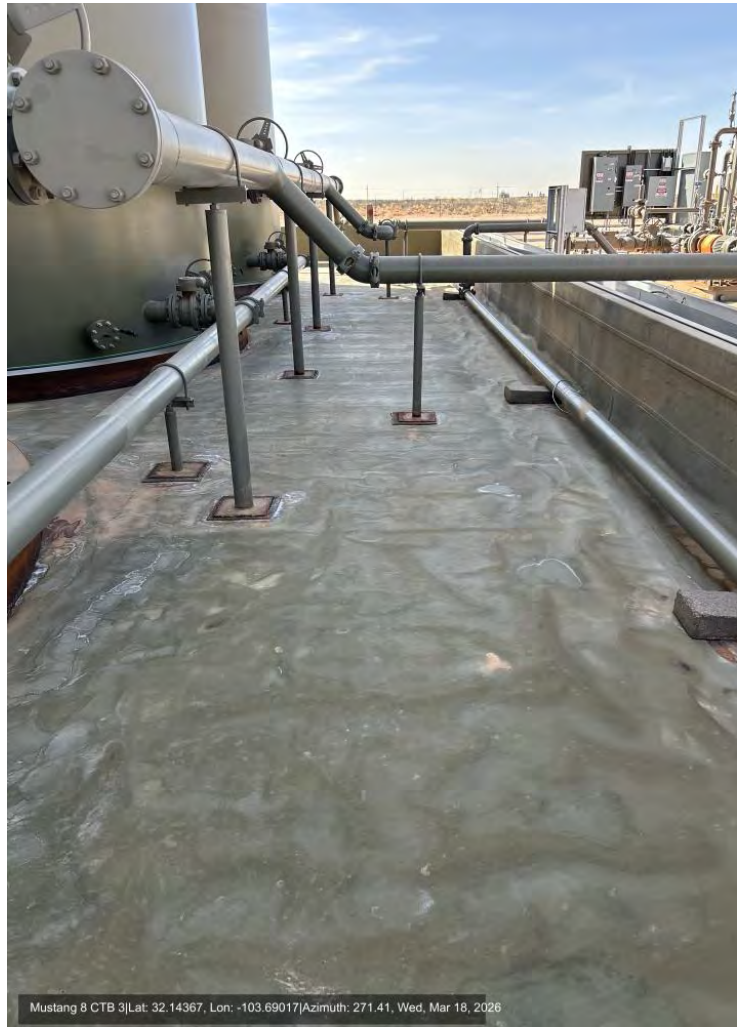
Date: 3/18/2026  
Time: 10:45  
Notes: West section of the 2 ft wall containment around tank batteries. Integrity of liner and 2 ft walls are intact with no breachable areas or damage. Contact points with metal infrastructure such as the stairs contain a cushion barrier to protect liner.  
Latitude: 32.14367222222222  
Longitude: -103.69016944444445  
Direction: N

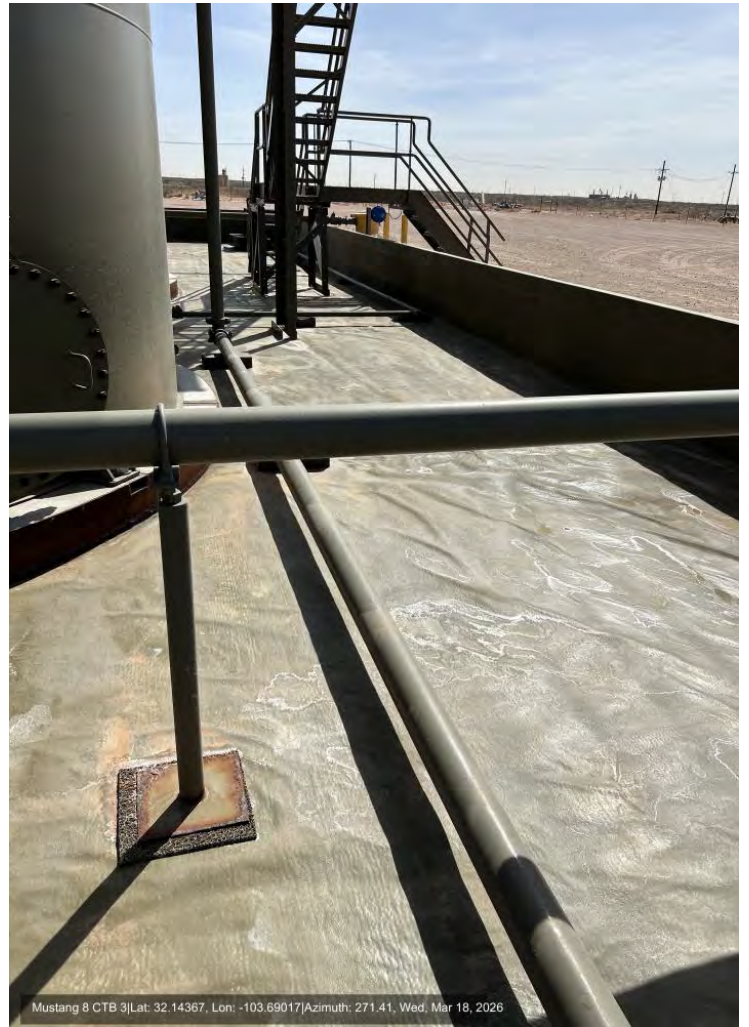
Date: 3/18/2026  
Time: 10:47  
Notes: South section of the 2 ft wall containment around tank batteries. Integrity of liner and 2 ft walls are intact with no breachable areas or damage. Contact points with metal infrastructure such as the stairs contain a cushion barrier to protect liner.  
Latitude: 32.14367222222222  
Longitude: -103.69016944444445  
Direction: N

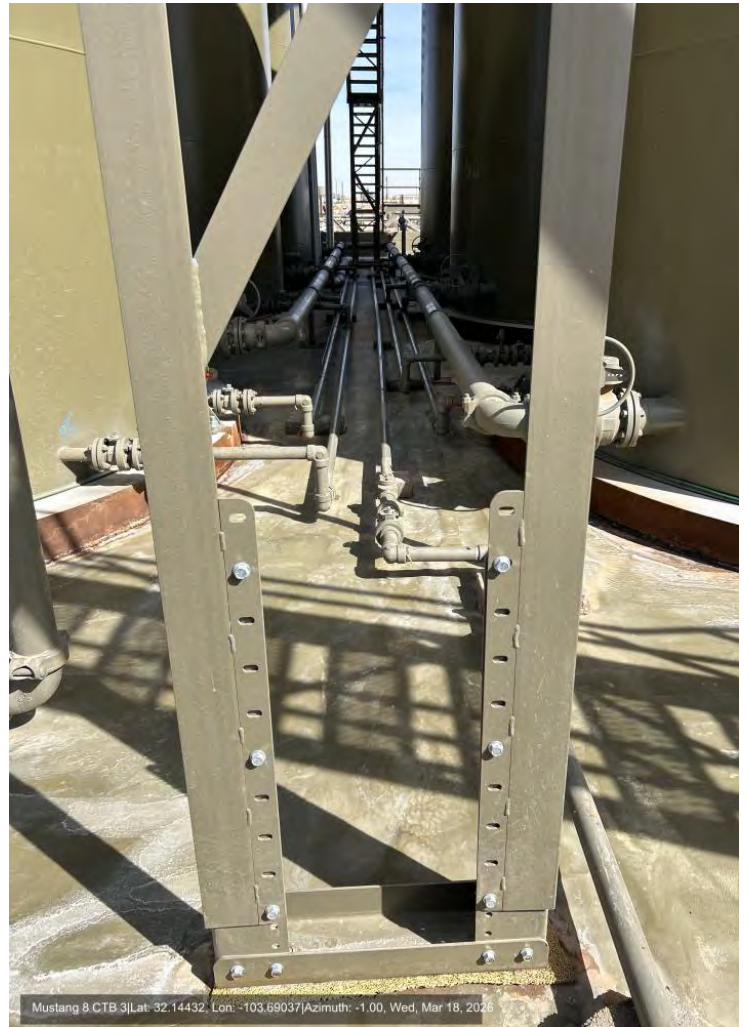
Date: 3/18/2026  
 Time: 10:51  
 Notes: Middle section of the 2 ft wall containment between tank batteries from south end. Integrity of liner and 2 ft walls are intact with no breachable areas or damage. Contact points with metal infrastructure contain a cushion barrier for protection.  
 Latitude: 32.14431666666667  
 Longitude: -103.69036944444444  
 Direction: N

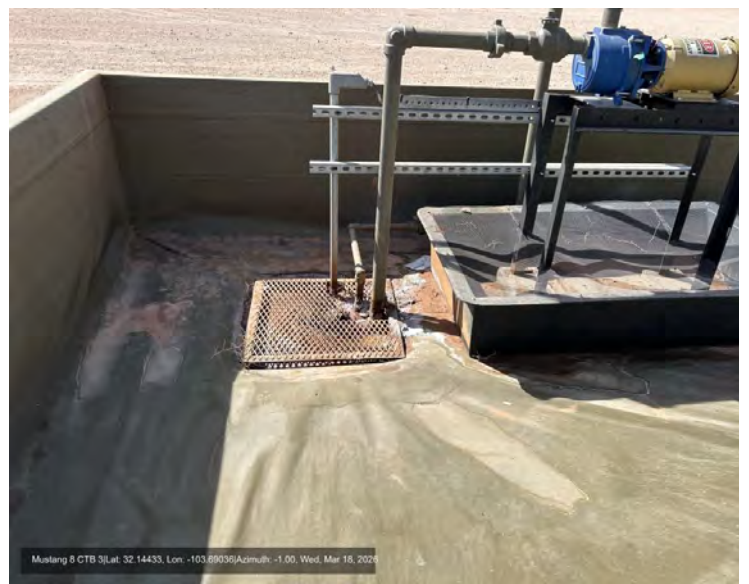
Date: 3/18/2026  
 Time: 10:52  
 Notes: Southeast corner of 2 ft wall containment around tank batteris. Sump appears functioning and mostly clear of debris.  
 Latitude: 32.144325  
 Longitude: -103.69036111111112  
 Direction: N

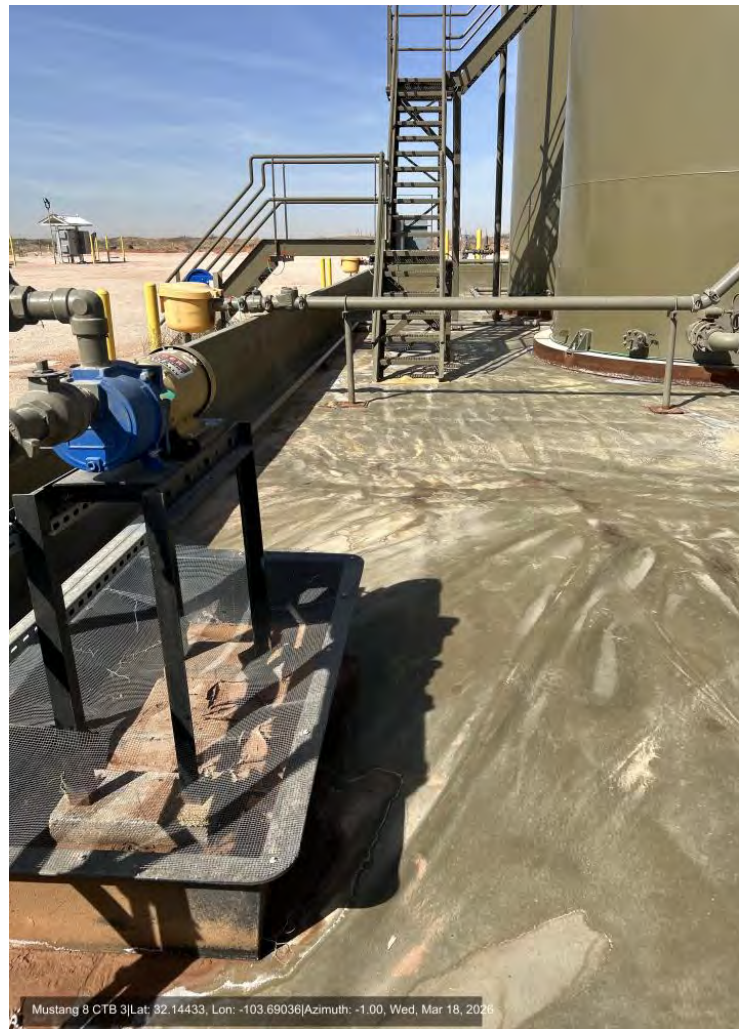
**Date:** 3/18/2026  
**Time:** 10:52  
**Notes:** South section of the 2 ft wall containment around tank batteries towards west. Integrity of liner and 2 ft walls are intact with no breachable areas or damage. Contact points with metal infrastructure contain a cushion barrier for protection.  
**Latitude:** 32.144325  
**Longitude:** -103.69036111111112  
**Direction:** N

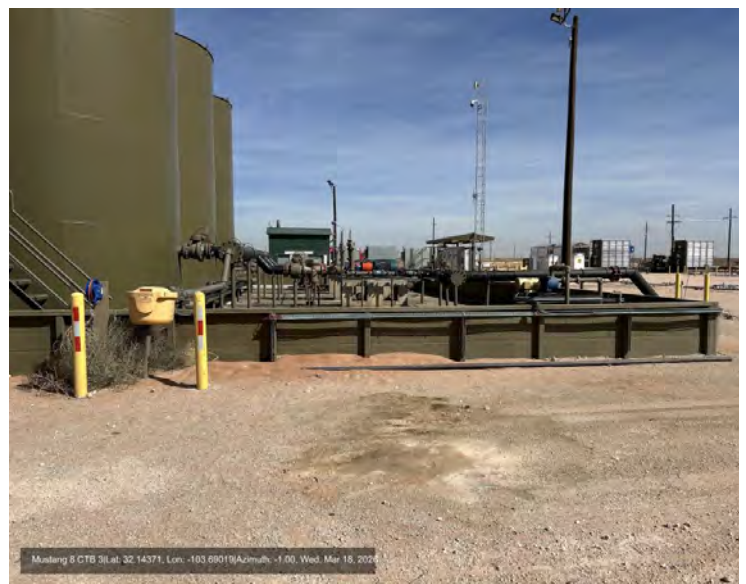
**Date:** 3/18/2026  
**Time:** 10:54  
**Notes:** South section outside of tank batteries of the 2 ft wall containment towards north. Integrity of 2 ft walls are intact with no breachable areas or damage.  
**Latitude:** 32.143711111111111  
**Longitude:** -103.69018611111112  
**Direction:** NE

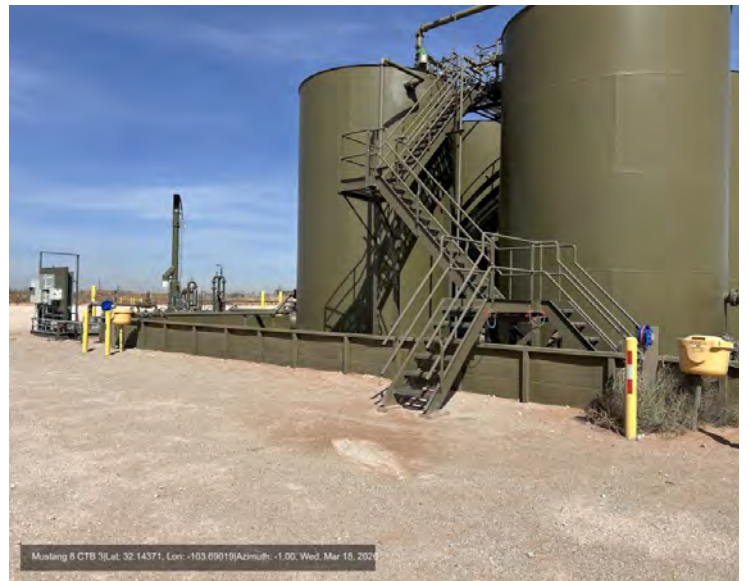
Date: 3/18/2026  
 Time: 10:54  
 Notes: South section outside of tank batteries of the 2 ft wall containment towards northwest. Integrity of 2 ft walls are intact with no breachable areas or damage.  
 Latitude: 32.14371111111111  
 Longitude: -103.69018611111112  
 Direction: NE

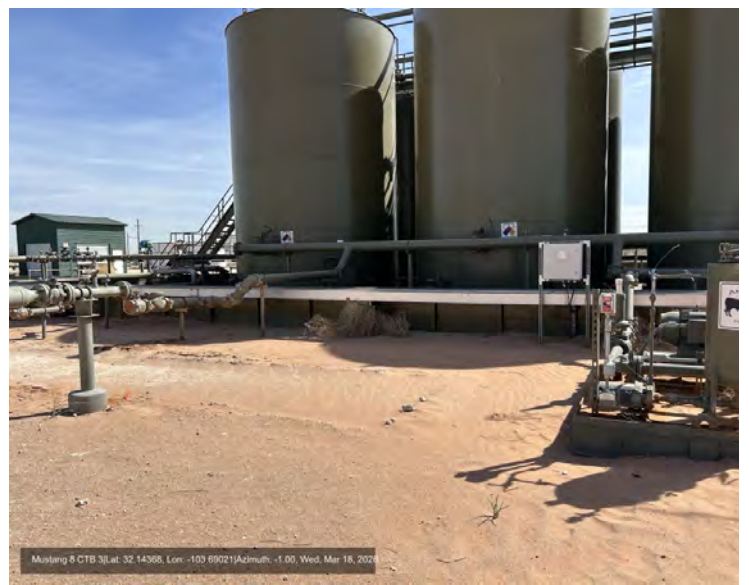
Date: 3/18/2026  
 Time: 10:55  
 Notes: West section outside of tank batteries of the 2 ft wall containment towards east. Integrity of 2 ft walls are intact with no breachable areas or damage.  
 Latitude: 32.143683333333335  
 Longitude: -103.69020833333333  
 Direction: E

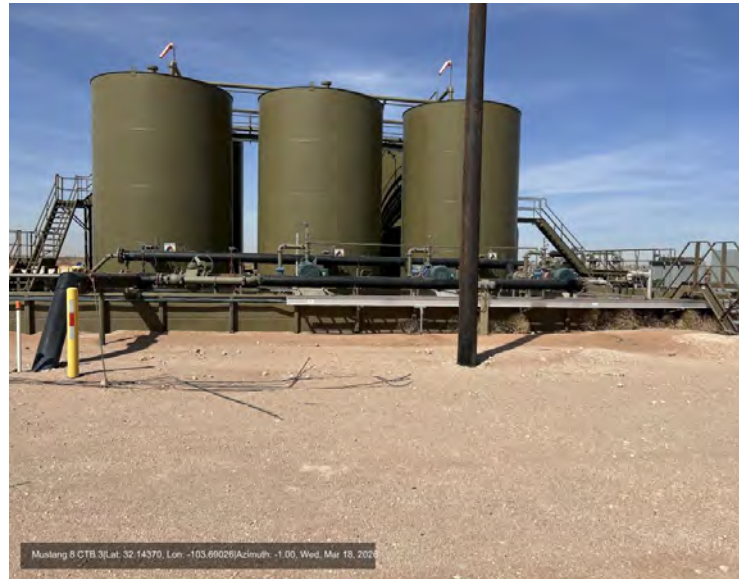
Date: 3/18/2026  
Time: 10:56  
Notes: East section outside of tank batteries of the 2 ft wall containment towards west. Integrity of 2 ft walls are intact with no breachable areas or damage.  
Latitude: 32.1437  
Longitude: -103.69026111111111  
Direction: NE
