Our Ref.: 12685224 – NMOCD – 1

April 13, 2026

Closure Report
Devon Energy Production Company, LP
Todd 36 CTB 3
Unit Letter N, Section 36, T23S, R31E
GPS: 32.256506, -103.728627
Eddy County, New Mexico

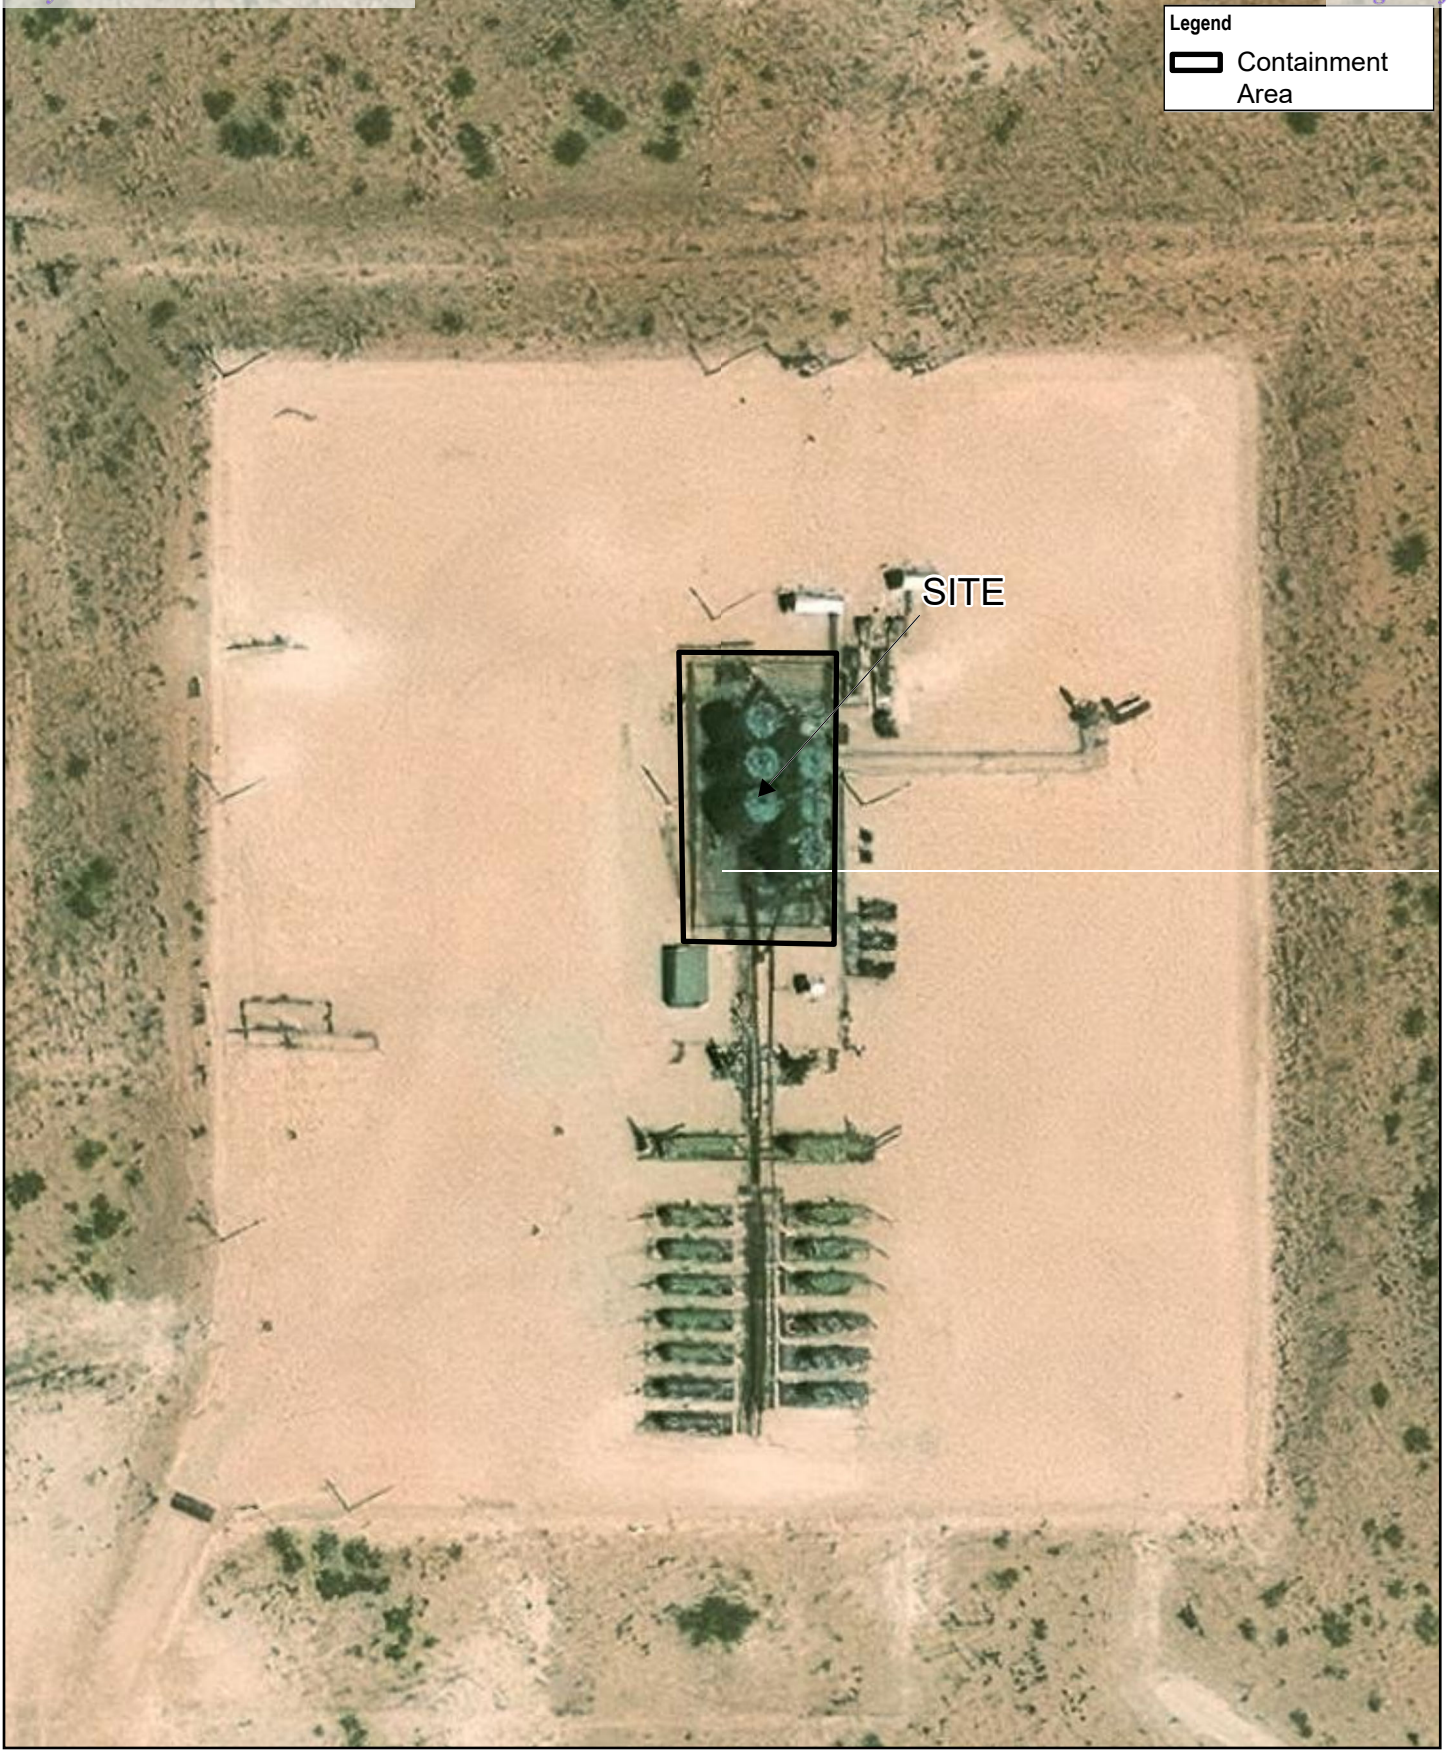
FIGURE 2

The liner inspection notice was provided on April 8, 2026. A liner integrity inspection was performed on April 10, 2026. The liner was visually inspected and no rips, tears, holes, or damage in the liner was observed. The liner was determined to be intact with no integrity issues. Photographic documentation of the liner inspection is presented in **Attachment 3**.

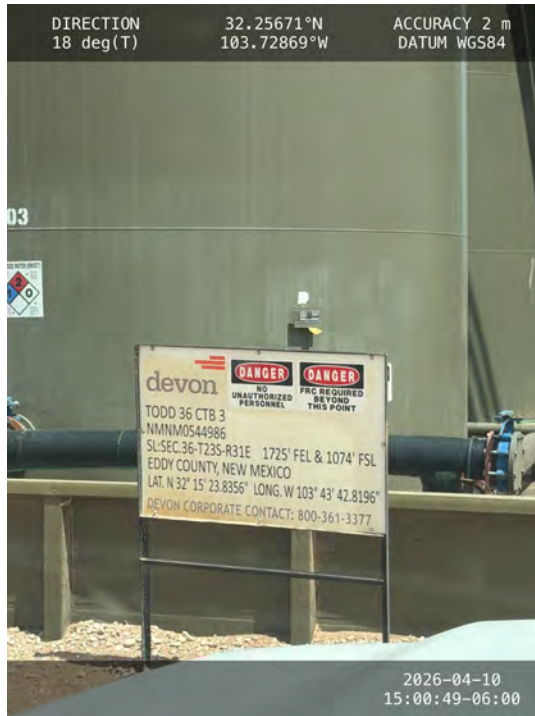
Photo 1 Photo of site location.

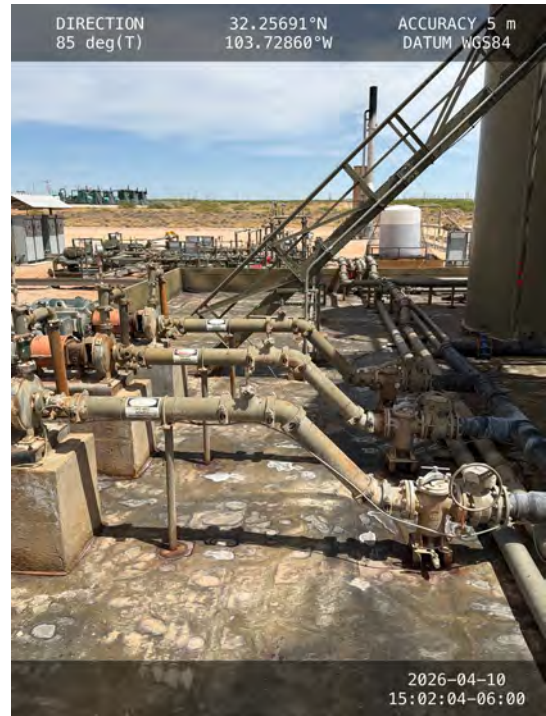
Photo 2 Photo of containment towards east.

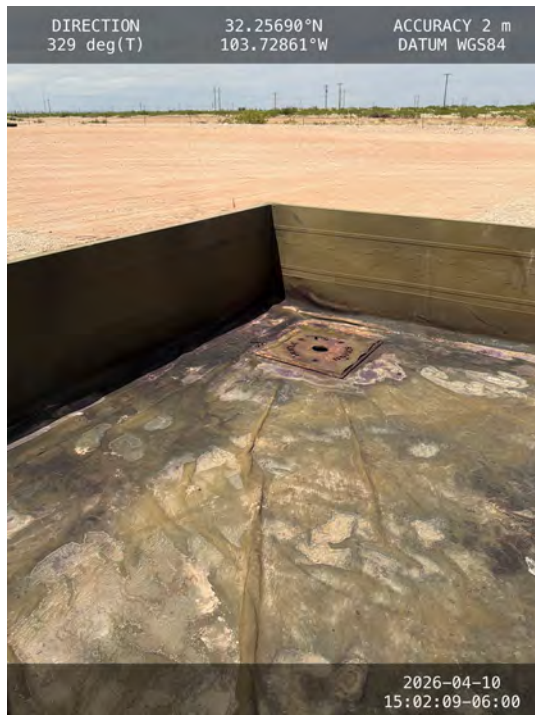
Photo 3 Photo of northwest corner of containment

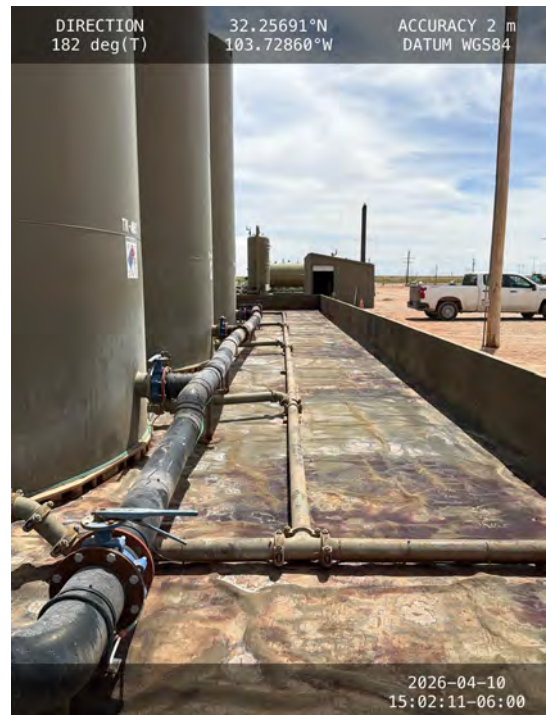
Photo 4 Photo of containment towards south.

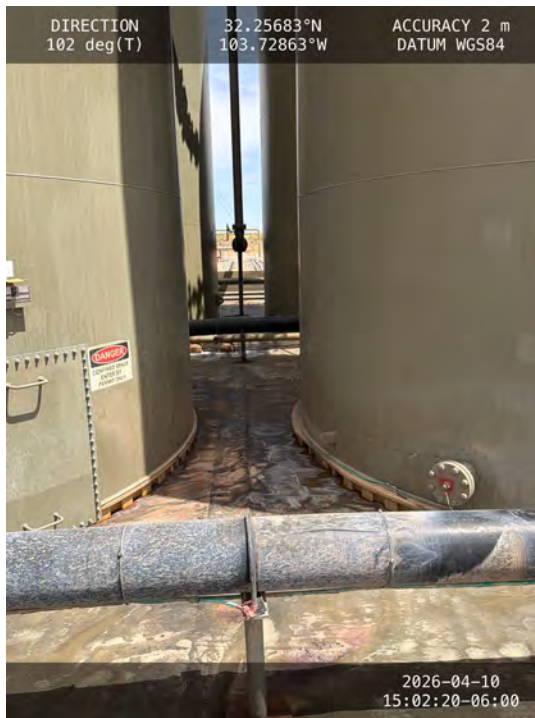
Photo 5 Photo of containment towards east.

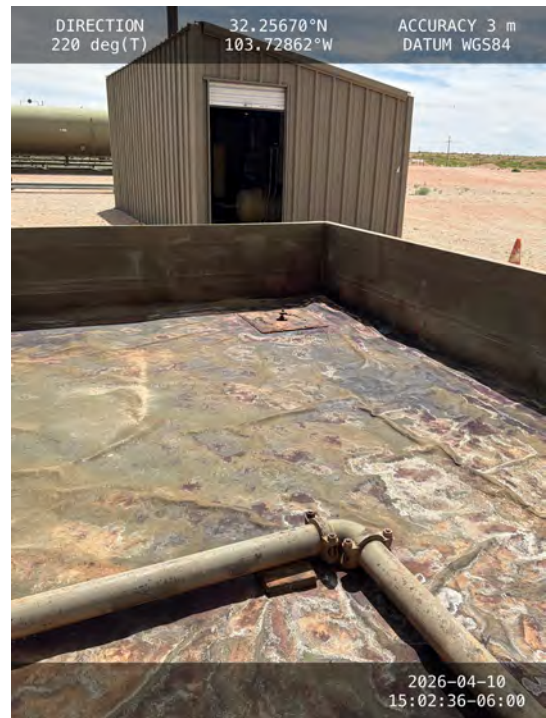
Photo 6 Photo of southwest corner of containment.

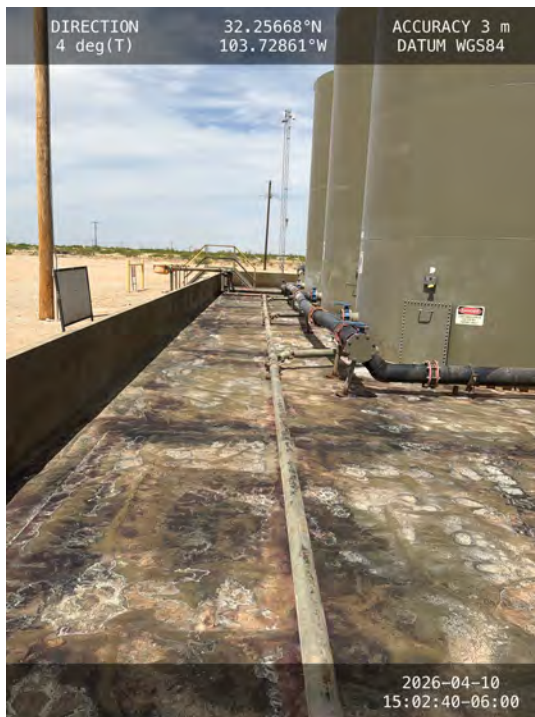
Photo 7 Photo of containment towards north.

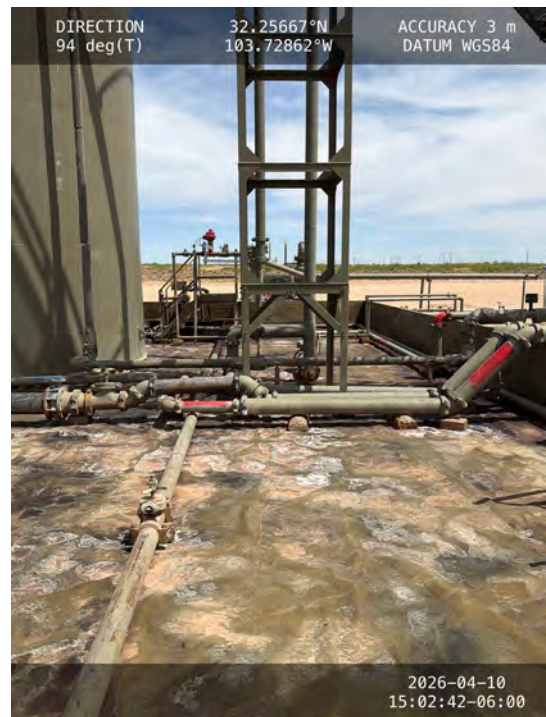
Photo 8 Photo of containment towards east.

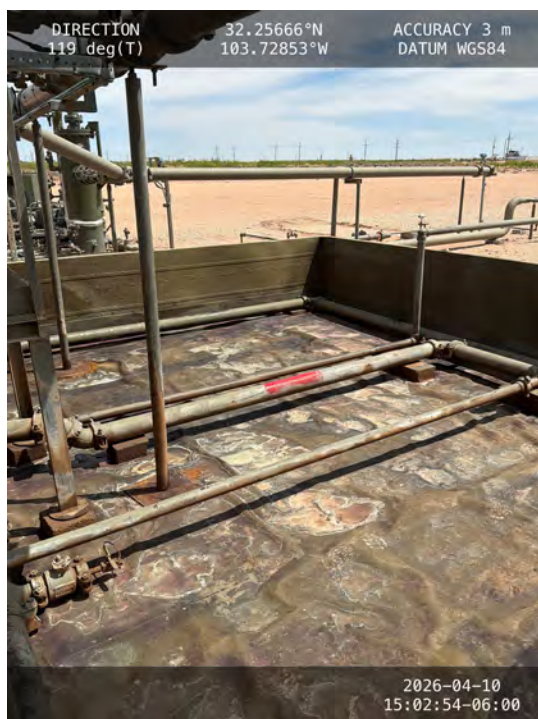
Photo 7 Photo of southeast corner of containment.

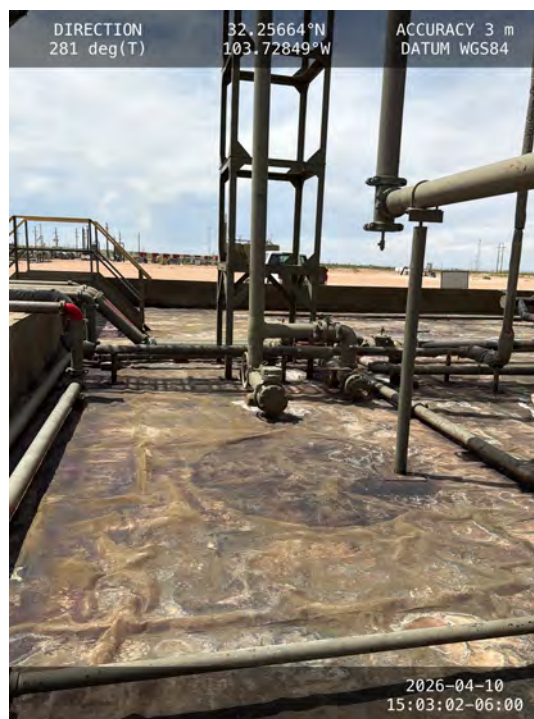
Photo 8 Photo of containment towards west.
