**Shelby 23 TB**

PREPARED BY:  
PIMA ENVIRONMENTAL SERVICES, LLC

PREPARED FOR:  
Spur Energy

## Liner Inspection and Closure Report

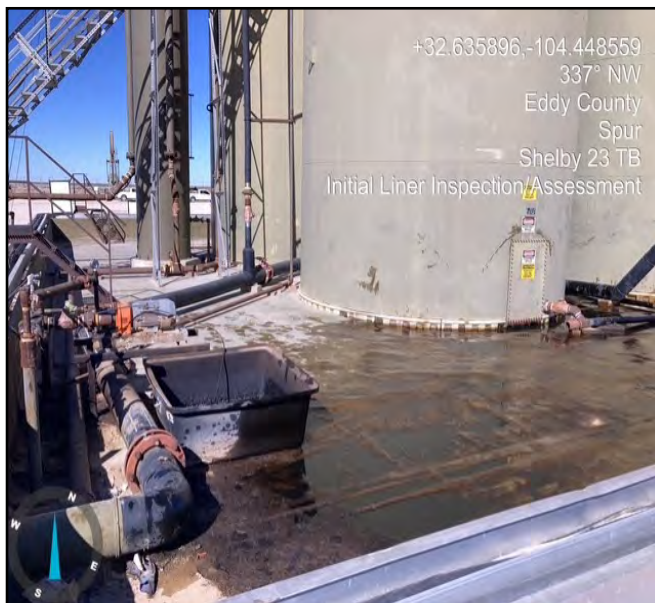
Photo taken during the initial assessment facing northwest.

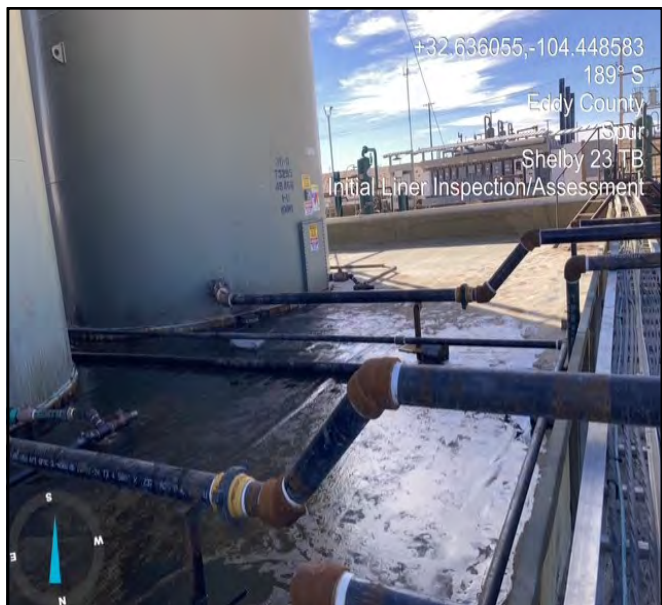
Photo taken during the initial assessment facing south.

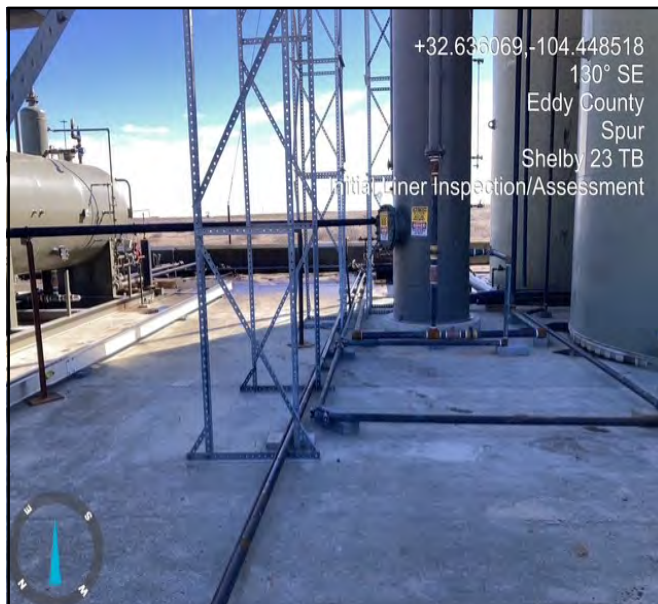
Photo taken during the initial assessment facing southeast.

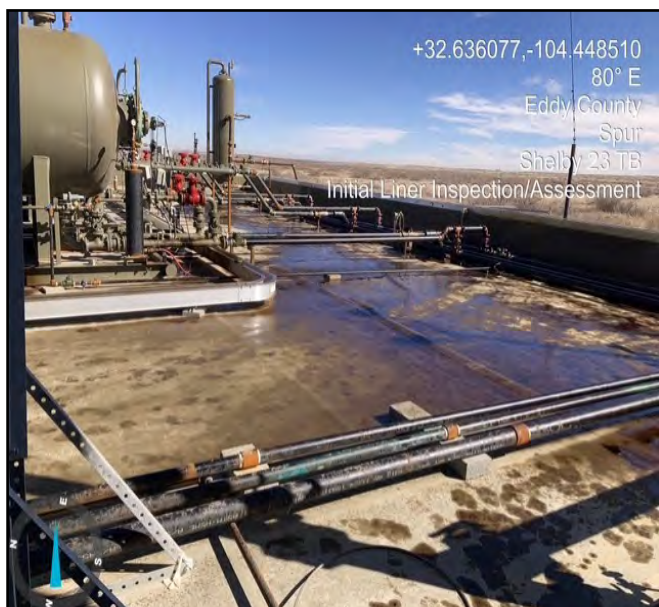
Photo taken during the initial assessment facing east.

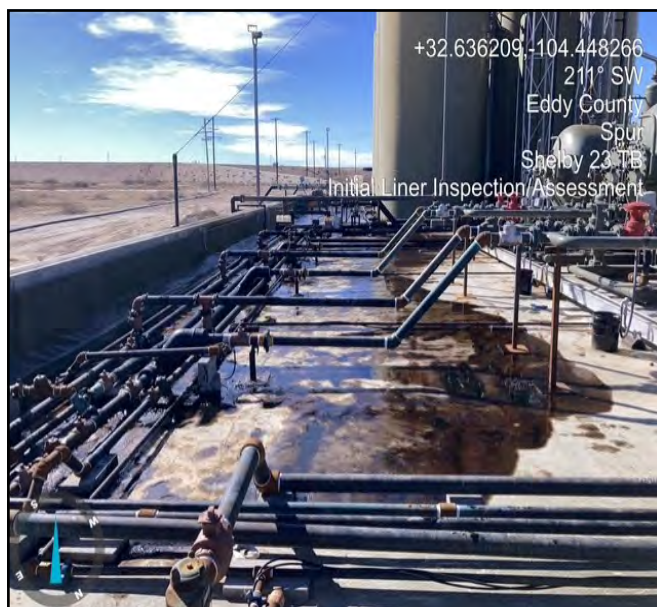
Photo taken during the initial assessment facing southwest.

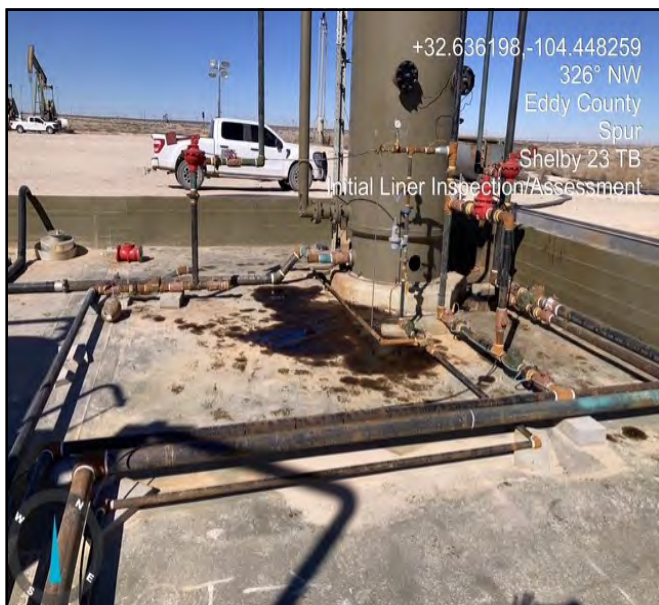
Photo taken during the initial assessment facing northwest.

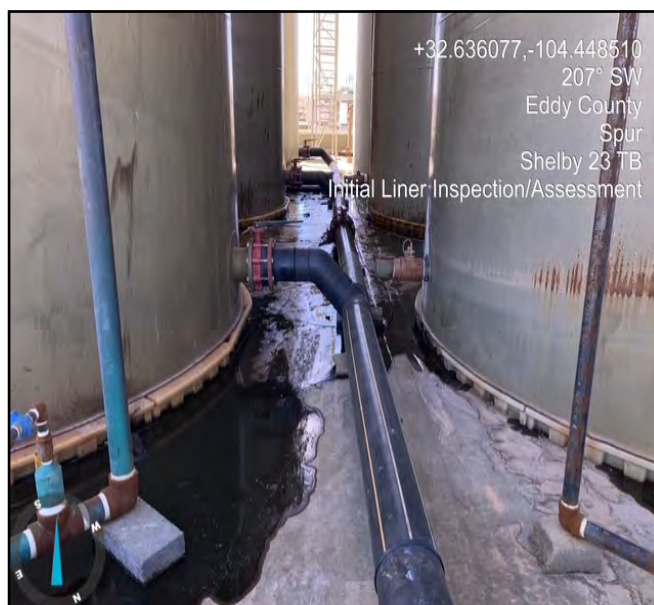
Photo taken during the initial assessment facing southwest.

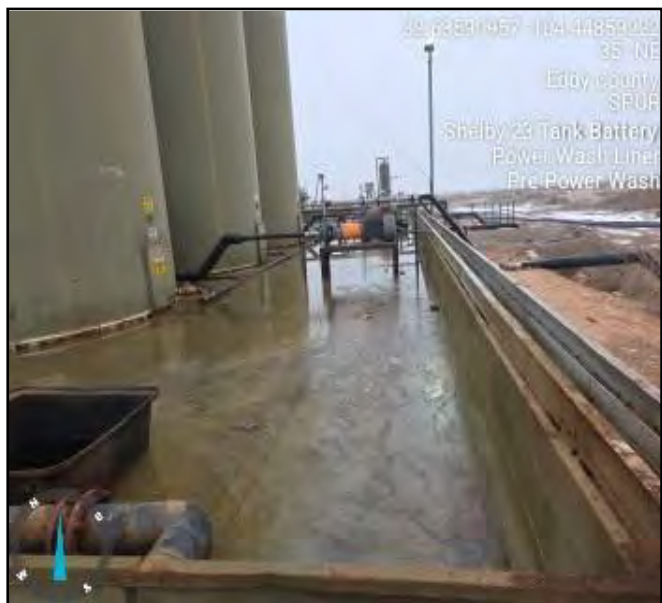
Photo taken pre powerwash facing northeast.

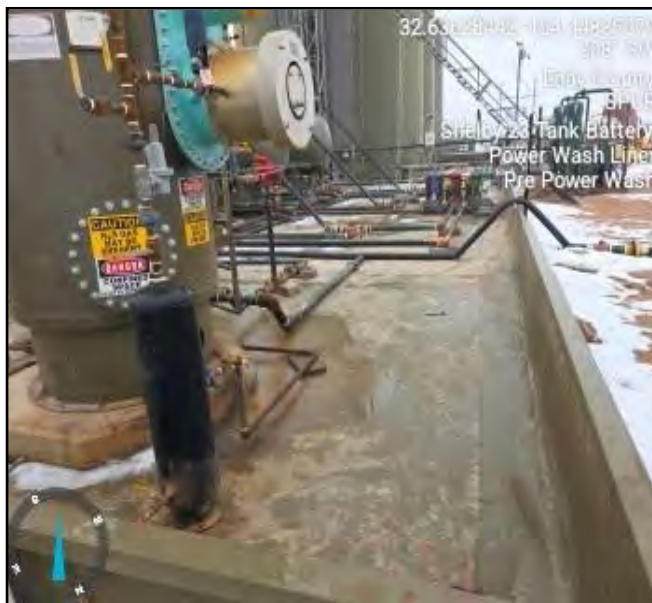
Photo taken pre powerwash facing southwest.

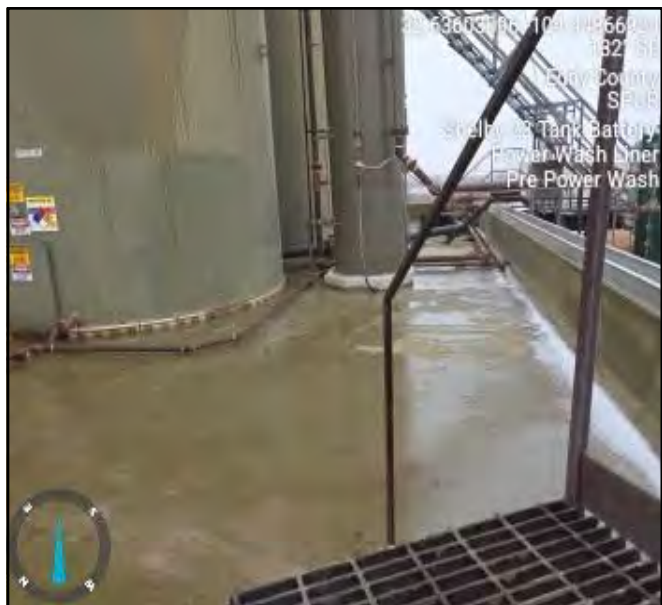
Photo taken pre powerwash facing southeast.

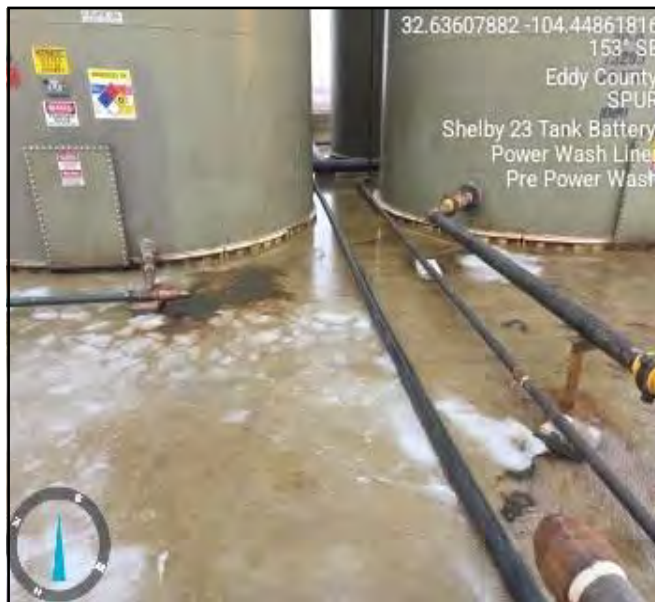
Photo taken pre powerwash facing southeast.

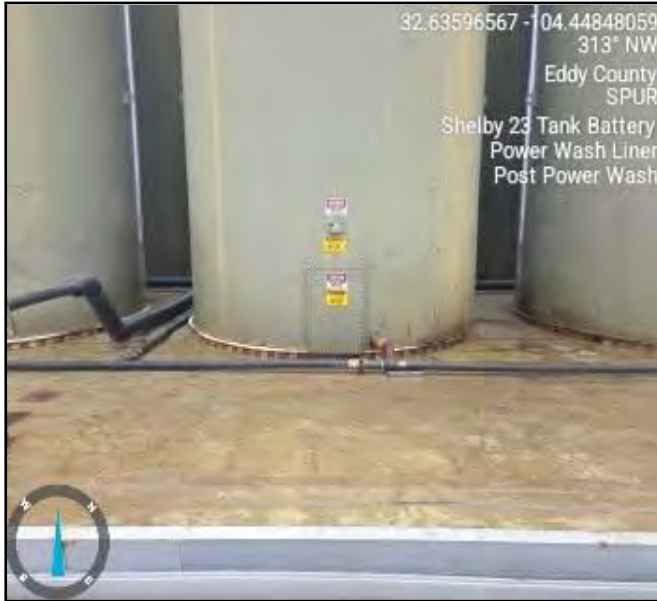
Photos taken post powerwash facing northwest.

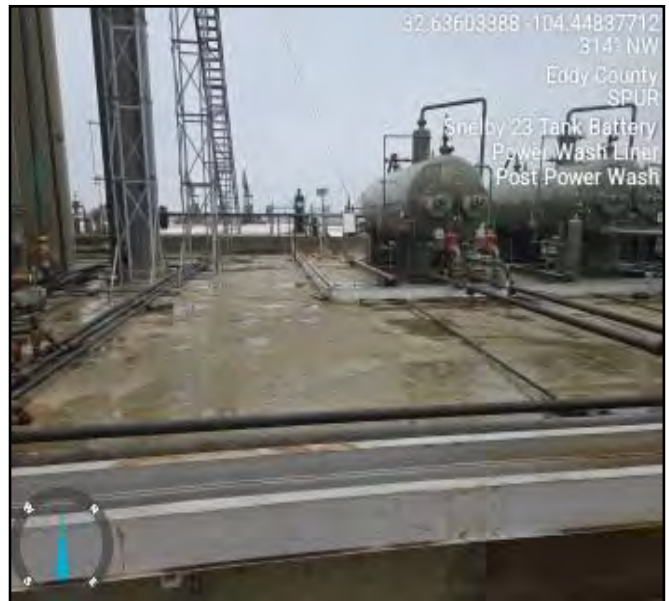
Photos taken post powerwash facing northwest.

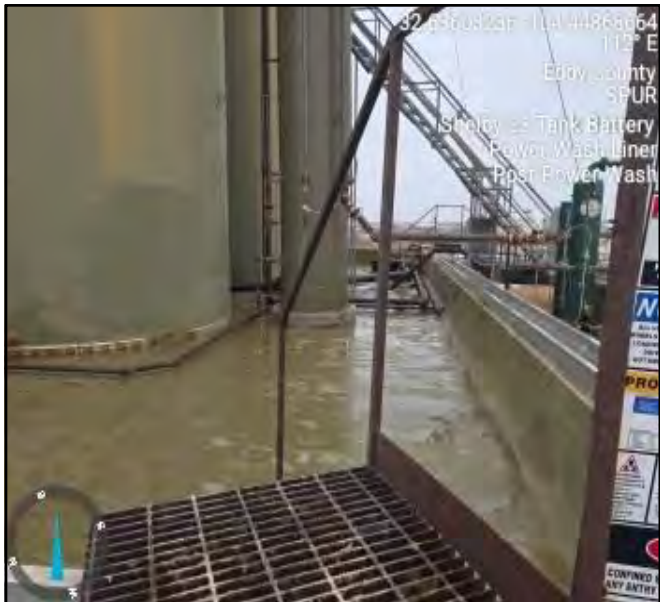
Photos taken post powerwash facing east.

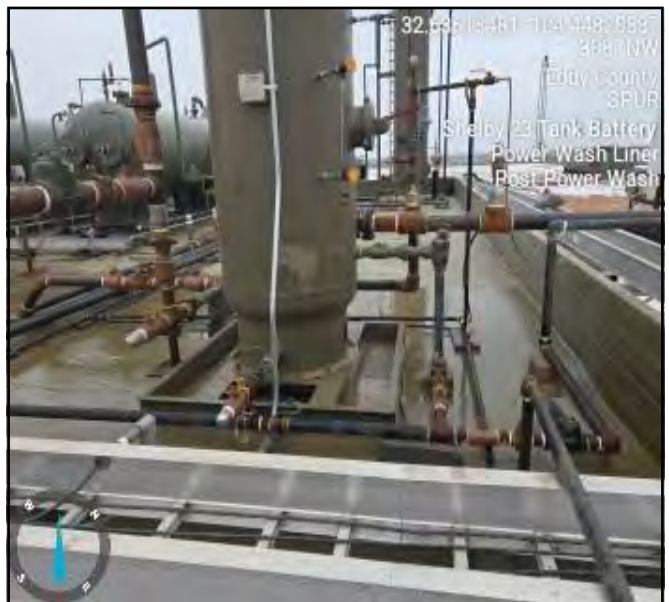
Photos taken post powerwash facing northwest.

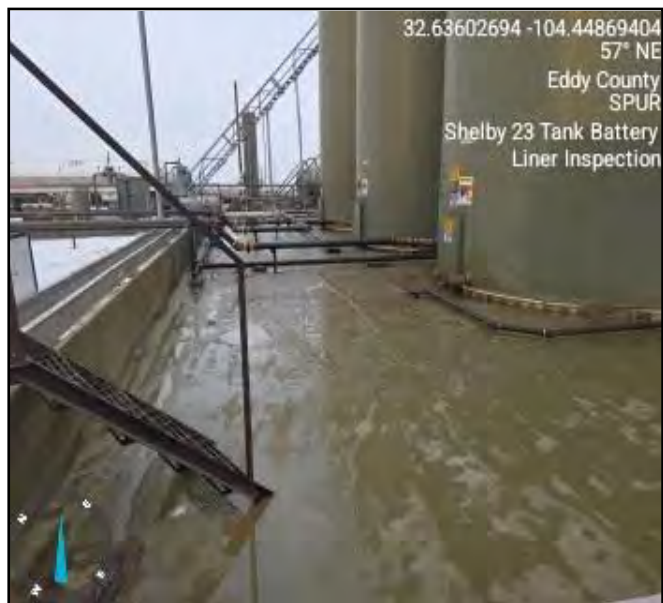
Photograph taken during liner inspection facing northeast.

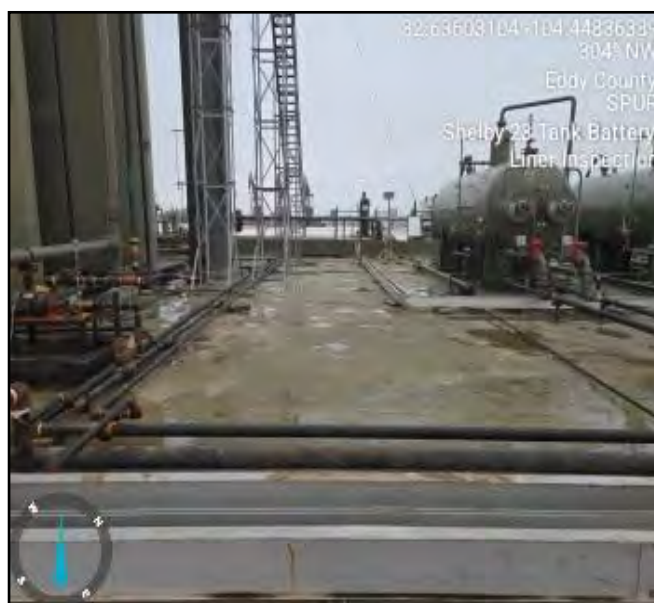
Photograph taken during liner inspection facing northwest.

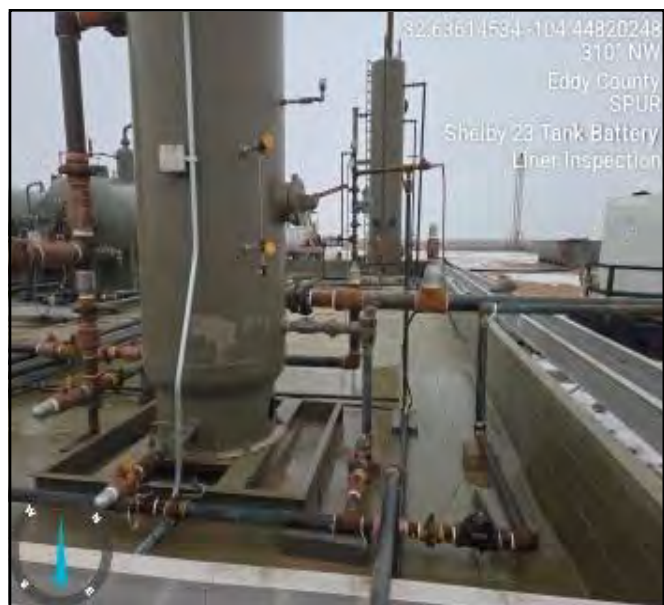
Photograph taken during liner inspection facing northwest.

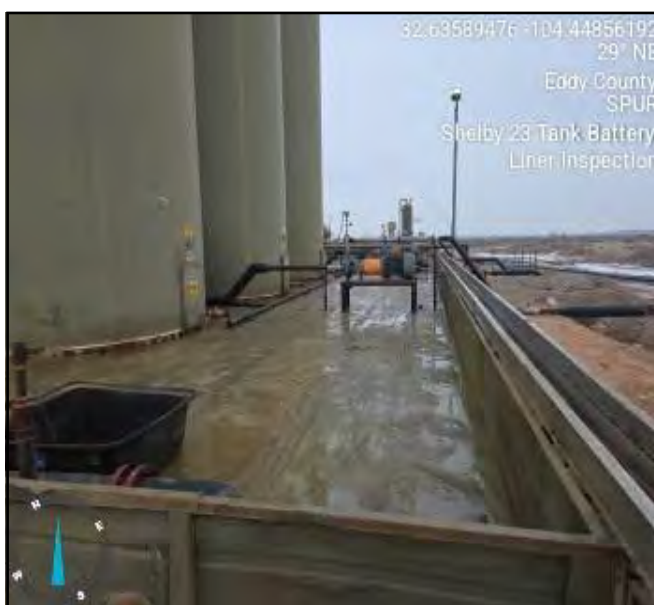
Photograph taken during liner inspection facing northeast.
