Our Ref.: 12679377 – NMOCD – 2

April 15, 2026

Closure Report
Devon Energy Production Company, LP
Exmoor 15 CTB 2
Unit Letter A, Section 15, TS25, R31E
GPS: 32.134225, -103.757538
Eddy County, New Mexico

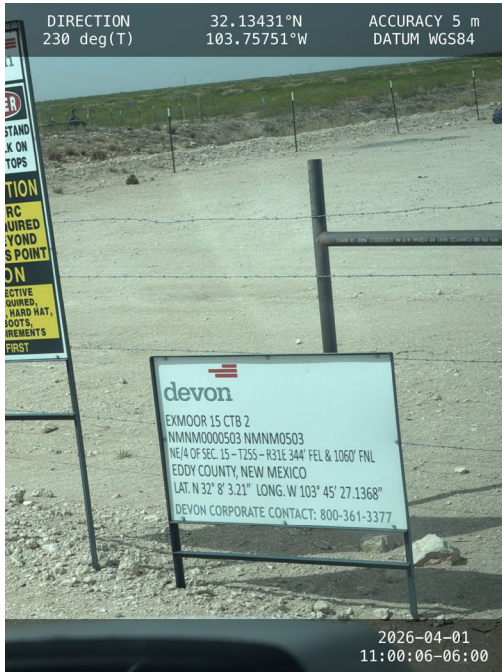
Photo 1 Photo of site location.

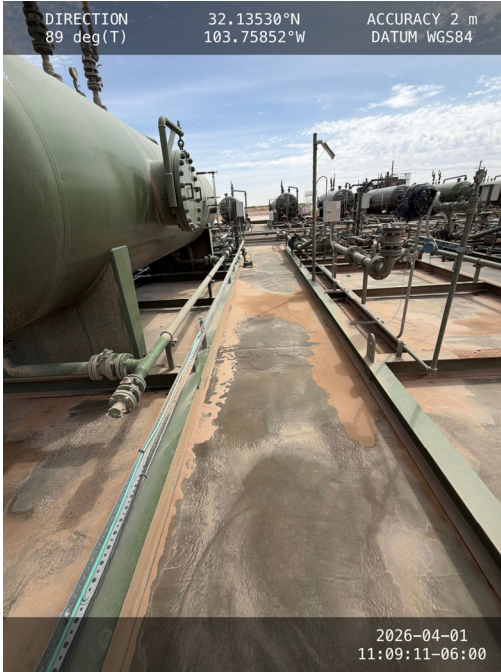
Photo 5 Photo of containment towards west.

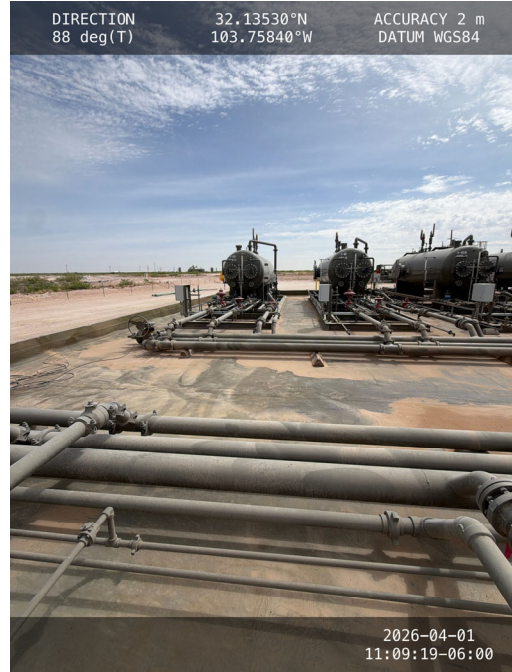
Photo 6 Photo of containment towards west.

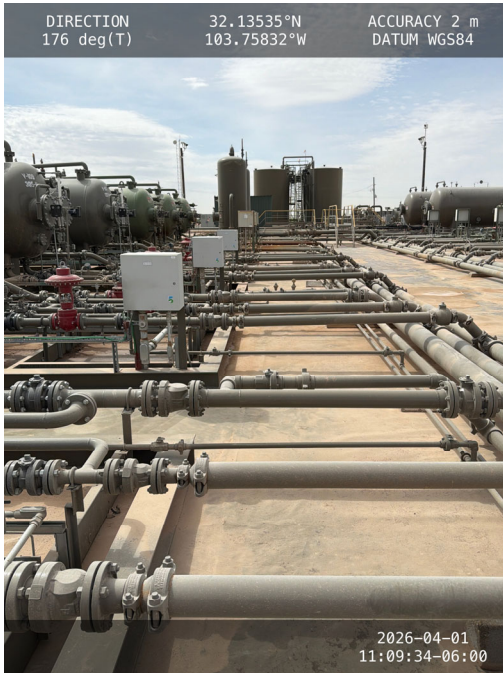
Photo 7 Photo of containment towards south.

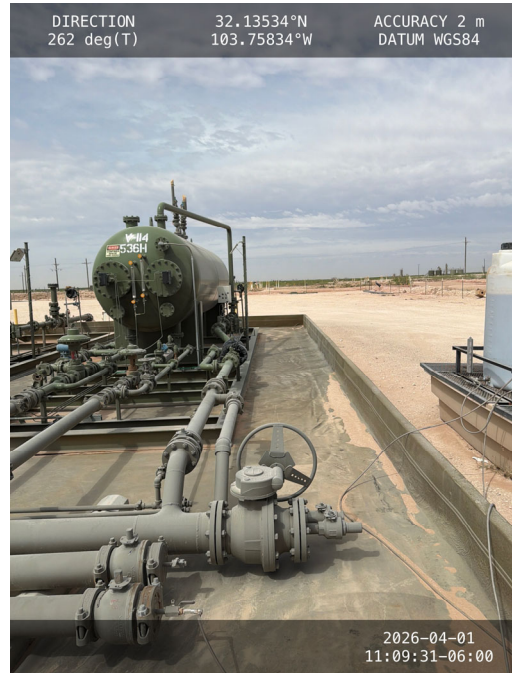
Photo 8 Photo of containment towards west.

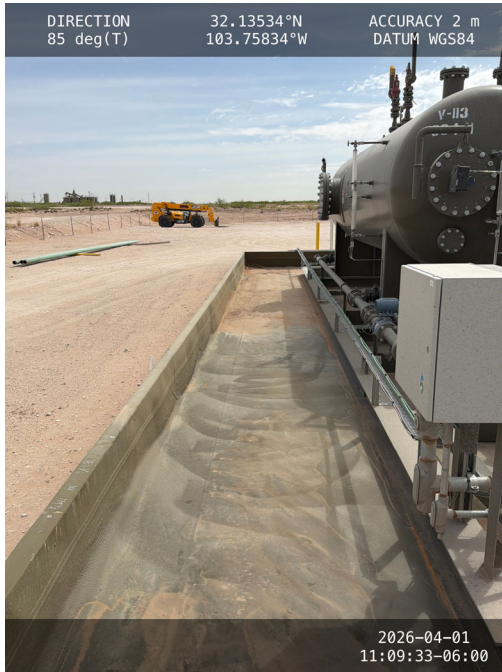
Photo 9 Photo of containment towards east.

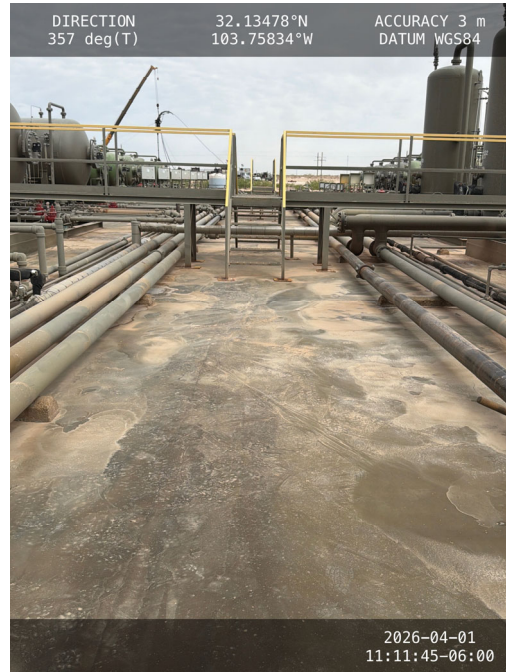
Photo 10 Photo of containment towards north.
