Our Ref.: 12670741 – NMOCD – 1

May 18, 2026

Closure Report
Devon Energy Production Company, LP
Stray Cat 8 CTB 5
Unit Letter P, Section 08, T23S, R32E
GPS: 32.31449095, -103.6916407
Lea County, New Mexico

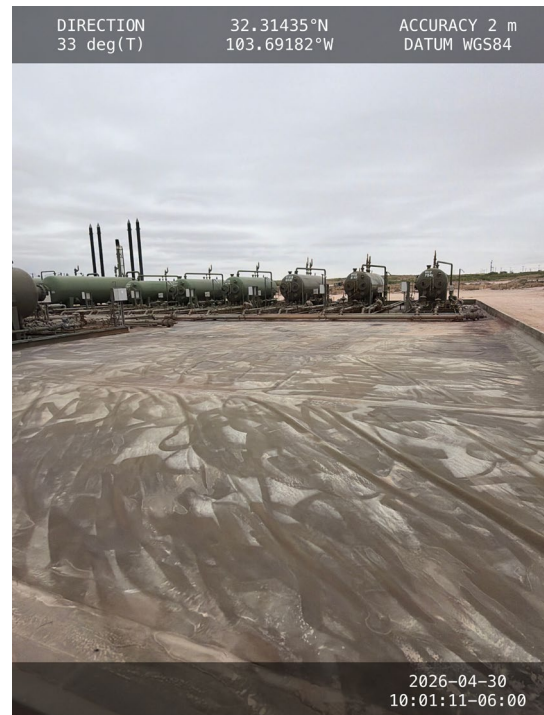
Photo 2 View of north-northeast side of containment.

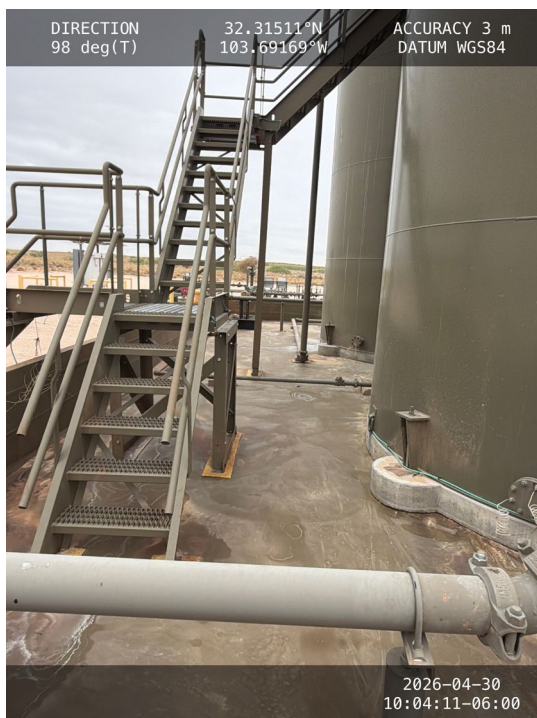
Photo 3 View of containment towards east.

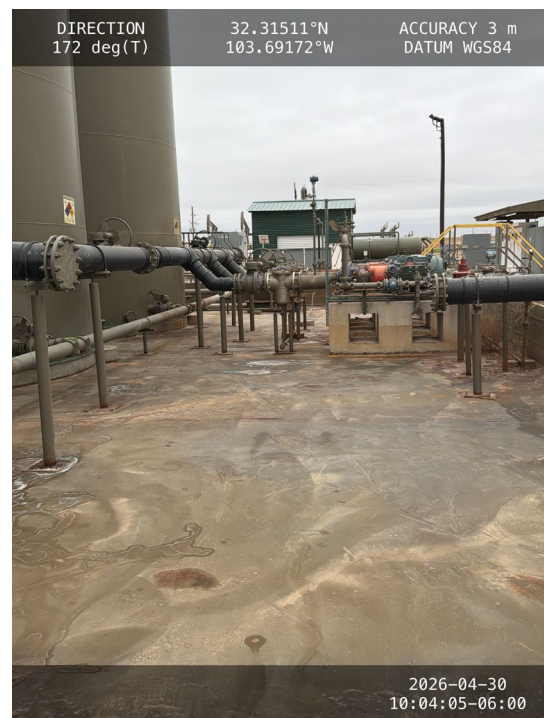
Photo 4 View of containment towards south.

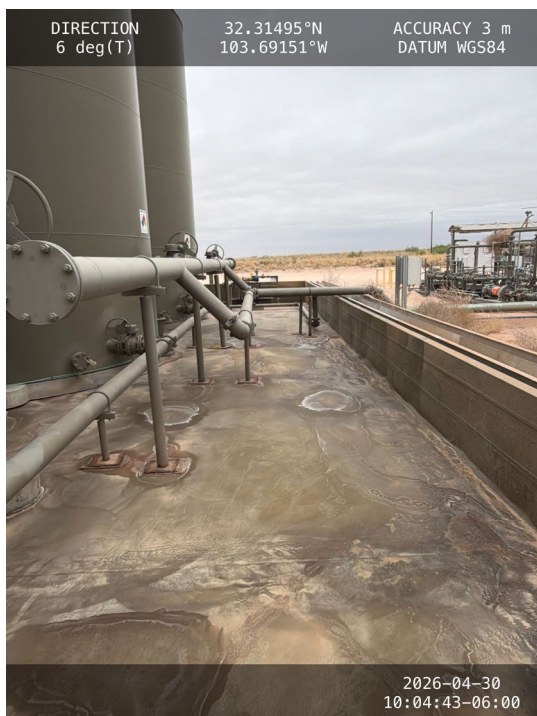
Photo 11 View of containment towards north.

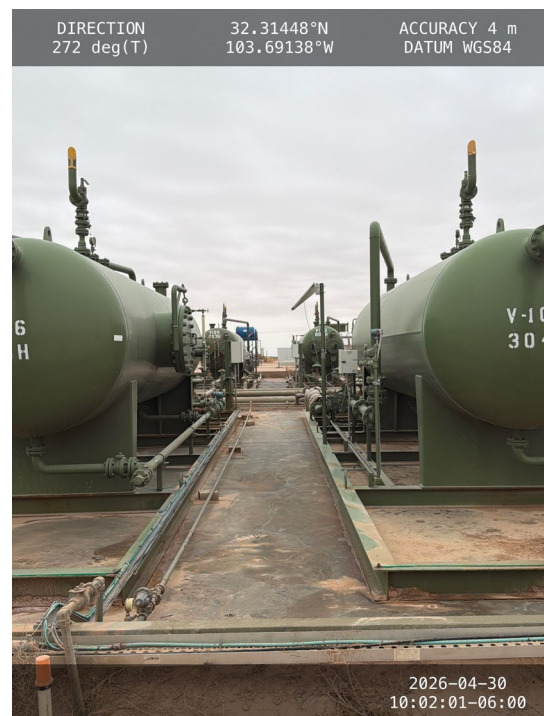
Photo 12 View of the central area of the secondary containment towards west.
