Our ref.: 12679157-NMOCD-3

June 2, 2026

Closure Report
Devon Energy Production Company, LP
Arena Roja 28 CTB 2
Unit Letter B, Section 28, T26S, R35E
Lea County, New Mexico
(32.0186376, -103.3724479)

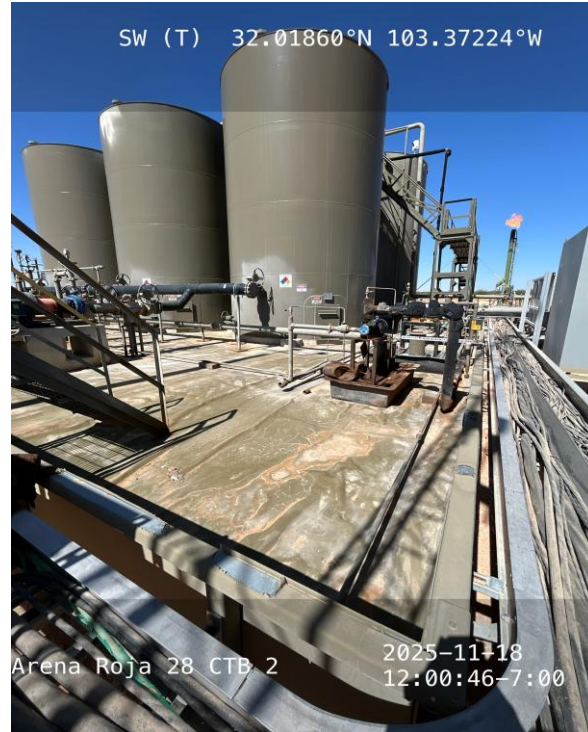
The liner inspection notice was provided on November 13, 2025. A liner integrity inspection was completed on November 18, 2025. The liner was visually inspected and no rips, tears, holes, or damages in the liner were observed. The liner was determined to be intact with no integrity issues. Photographic documentation of the liner inspection is presented in **Attachment 3**.

Photo 2 View of northeast corner of secondary containment.

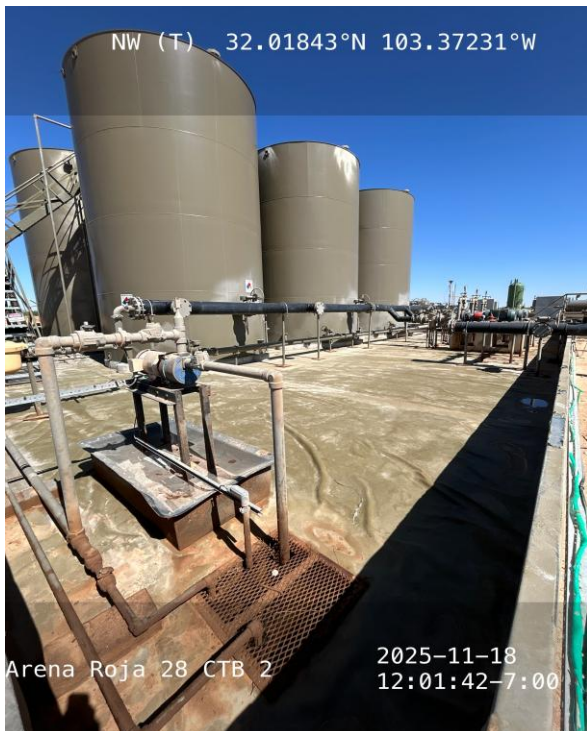
Photo 3 View of southeast corner of secondary containment.

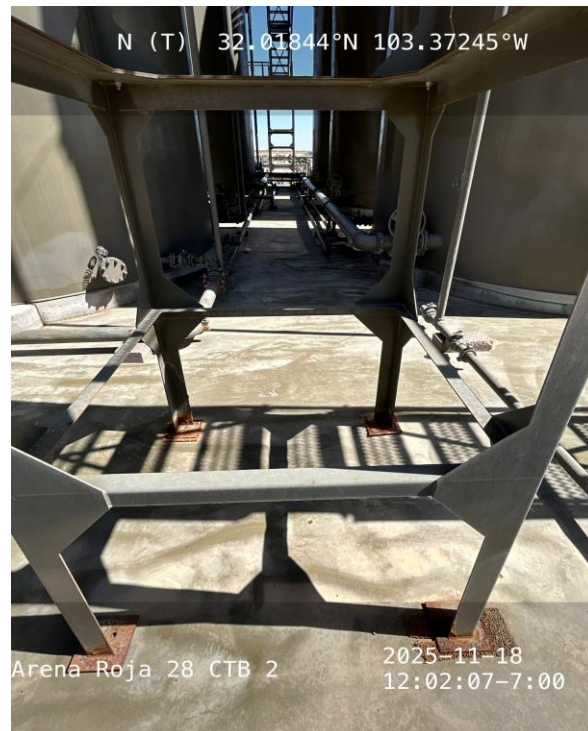
Photo 4 View of central portion of secondary containment towards north.

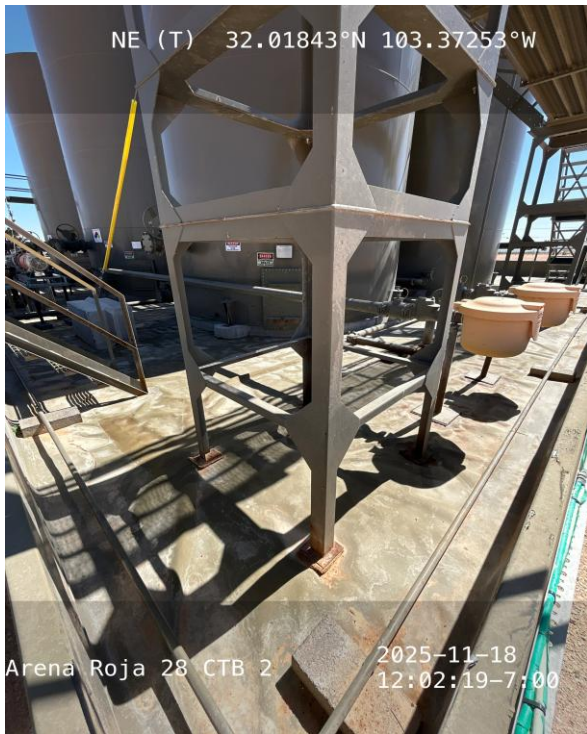
Photo 5 View of southwest corner of secondary containment.

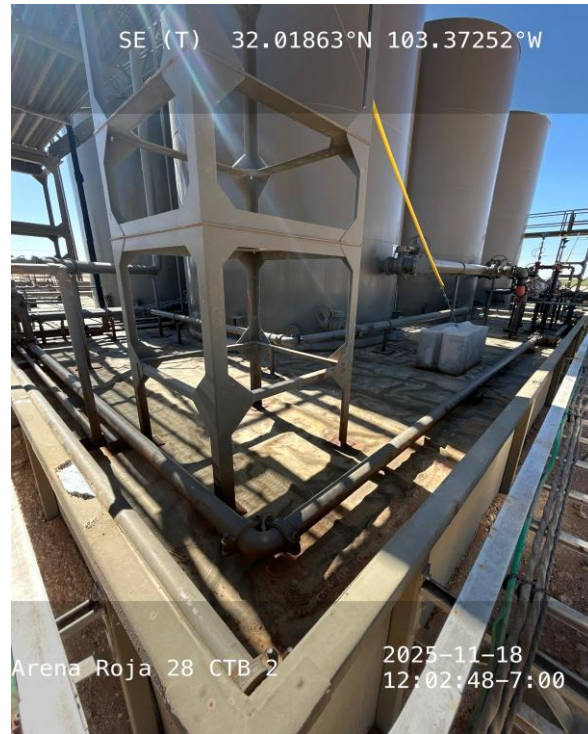
Photo 6 View of northwest corner of secondary containment.

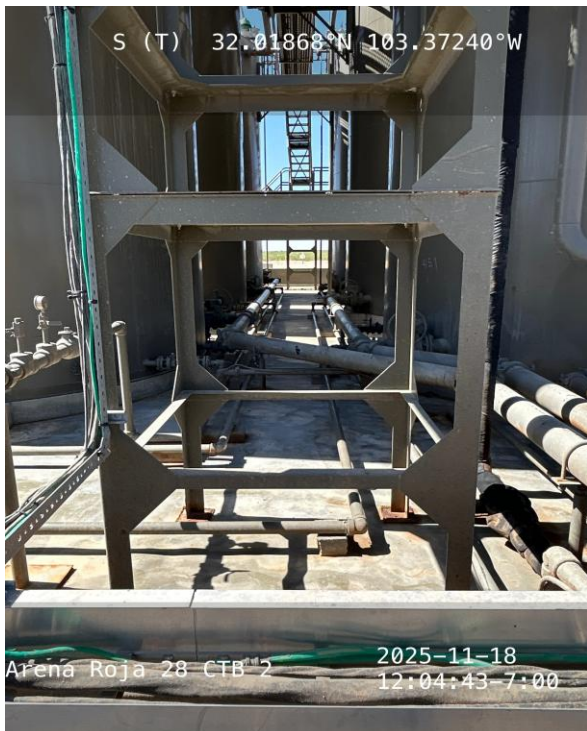
Photo 7 View of central portion of secondary containment towards south.
