Re: Closure Report
Bora Bora 13 CTB 2
Incident Number nAPP2607927390
Incident Number nAPP2609628554
Incident Number nAPP2611730726
Eddy County, New Mexico

Safety & Environmental Solutions (SESI), on behalf of Devon Energy Production Company, LP (Devon), has prepared this Closure Report to document the findings of the liner integrity inspections covering three (3) reported incidents at the Bora Bora 13 CTB 2 (Site) following the releases of produced water within the secondary lined containments. Based on the liner integrity inspection activities, Devon is submitting this Closure Report, describing the inspection results for Incident Number nAPP2607927390, nAPP2609628554, nAPP2611730726 that occurred in the Separator and Process Equipment Containment.

Liner Integrity Inspection | May 14, 2026 | Photos 1-20 (chronological)

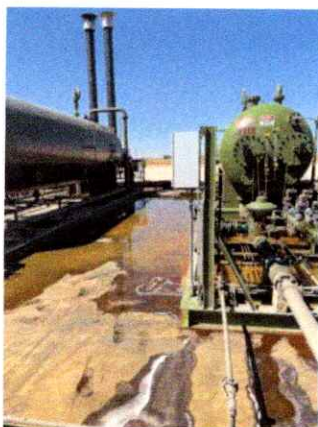
Photo 4 of 5 - Spill Condition on Skid Deck

Pooling observed across full deck surface.
Green pressure vessel with confined space labeling visible at right.
Black horizontal tanks visible in background.

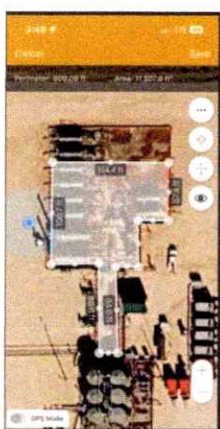
Photo 2 of 5 - Aerial Spill Area Measurement

Largest spill of the three incidents documented.

Aerial view shows extensive spill polygon across full pipeline skid area.

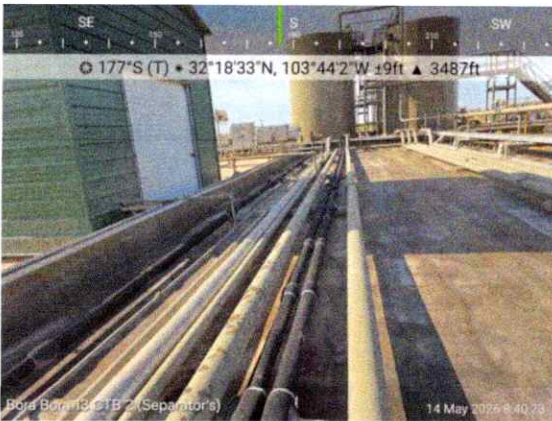
Photo 4 of 20

Description: South-facing view along east edge of containment adjacent to green building. Multi-diameter pipe bundle exits containment. Inspection of the liner surface and east berm interface identified no breaches, tears, punctures, uplift, or other indications of compromised liner integrity.

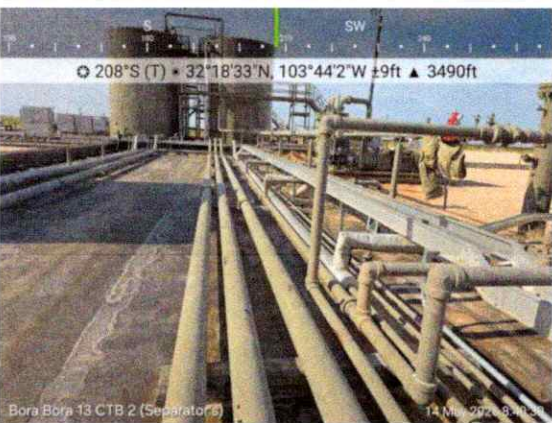
Photo 5 of 20

Description: South-southwest view showing large storage tank beyond containment berm. Pipe rack and liner surface in foreground. Inspection of the liner surface interface identified no breaches, tears, punctures, uplift, or other indications of compromised liner integrity.

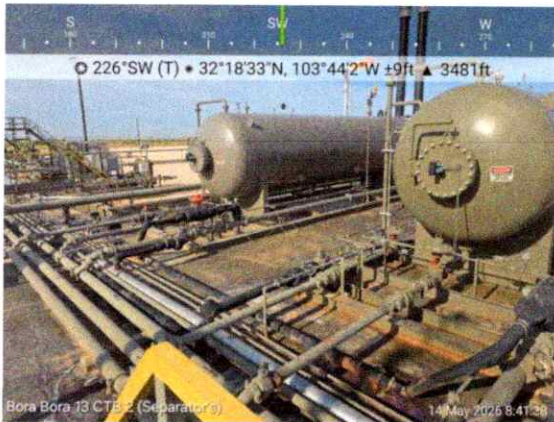
Photo 10 of 20

Description: Southwest view showing horizontal inlet separator and process vessel (confined space placard visible). Pipe rack and manifold in foreground. Liner surface inspected along west equipment and no breaches, tears, punctures, uplift, or other indications of compromised liner integrity were found.

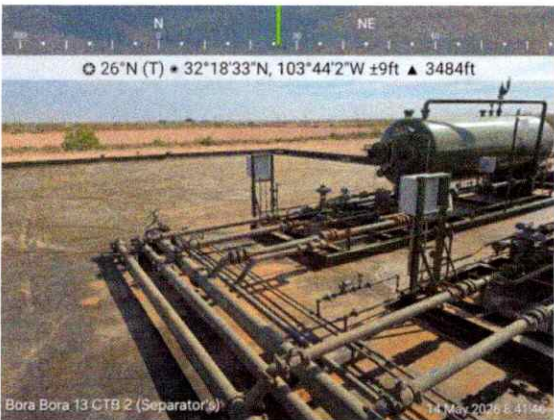
Photo 11 of 20

Description: North-facing view of northeast corner of green separator skid. Single separator vessel and inlet/outlet piping manifold. The secondary containment liner along the equipment perimeter was inspected and determined to be intact, with no evidence of breaches, tears, punctures, uplift, seam separation, or other conditions indicative of compromised liner integrity.

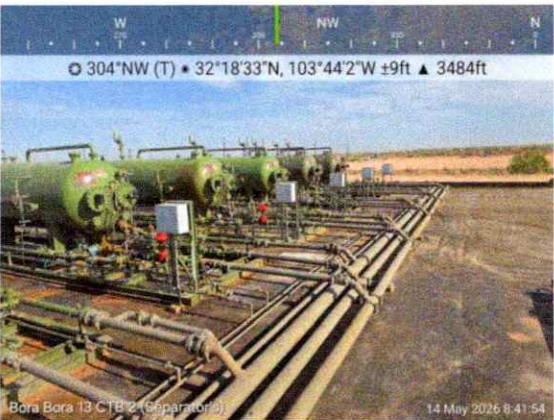
Photo 12 of 20

Description: Northwest overview of the green separator battery depicting all vessels, piping, and instrument enclosures. Inspection of the liner surface identified no tears, seam failures, or compromised penetration integrity.

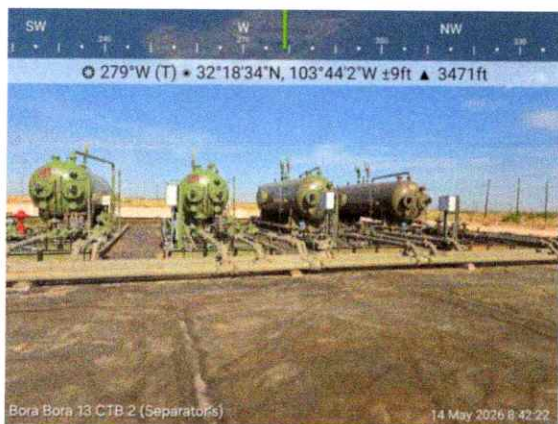
Photo 13 of 20

Description: West-facing view of green separator vessels Y106, Y108, Y110, and Y112 on the process skid, including the inlet manifold and outlet piping. Inspection of the liner surface identified no tears, seam failures, or compromised penetration integrity.

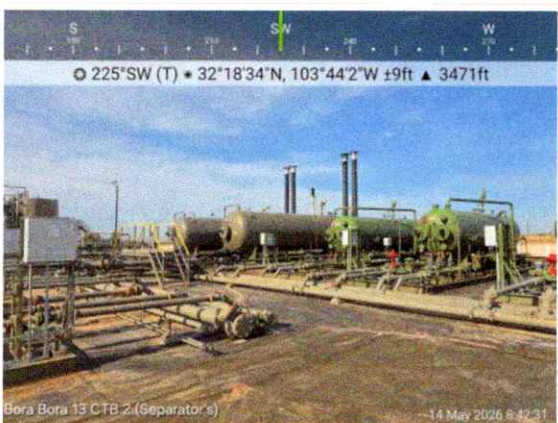
Photo 14 of 20

Description: Horizontal inlet separator and vertical separator vessels with combustor stack assemblies and yellow safety access platform. The liner was inspected along the west and south berms and found to be intact, with no observed tears, seam failures, or compromised penetration integrity.

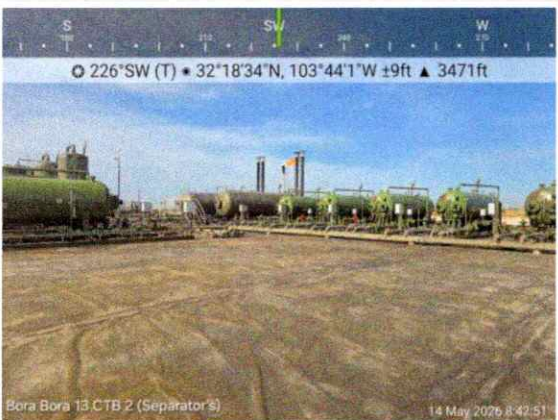
Photo 15 of 20

Description: Overview of the full lateral extent of the green separator battery with the active combustor flare visible at center. Inspection of the liner surface identified no tears, seam failures, or compromised penetration integrity.
