PREPARED BY:  
PIMA ENVIRONMENTAL SERVICES, LLC

PREPARED FOR:  
Spur Energy

**BKU 13B TB**

## Liner Inspection and Closure Report

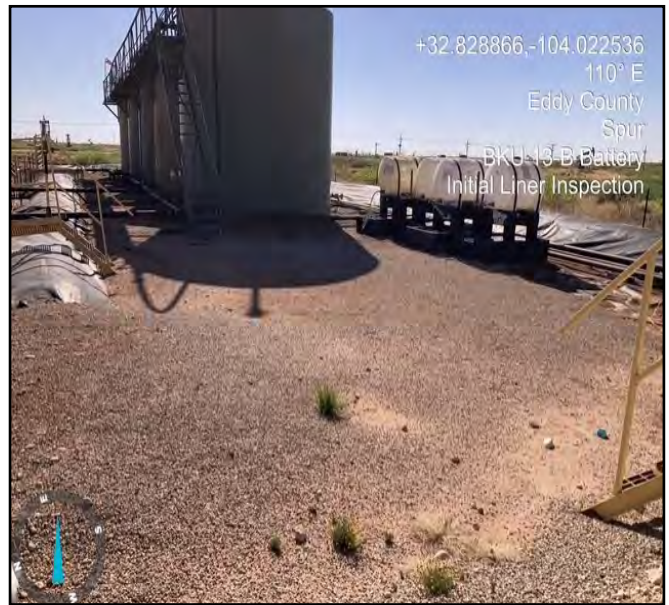
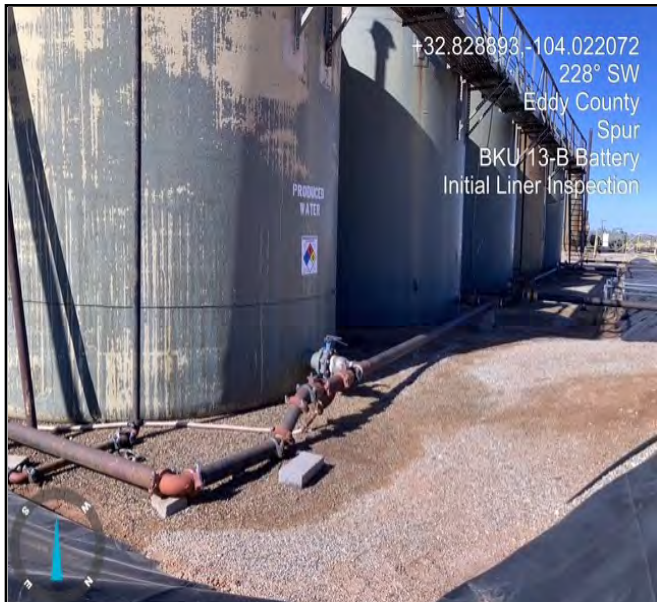
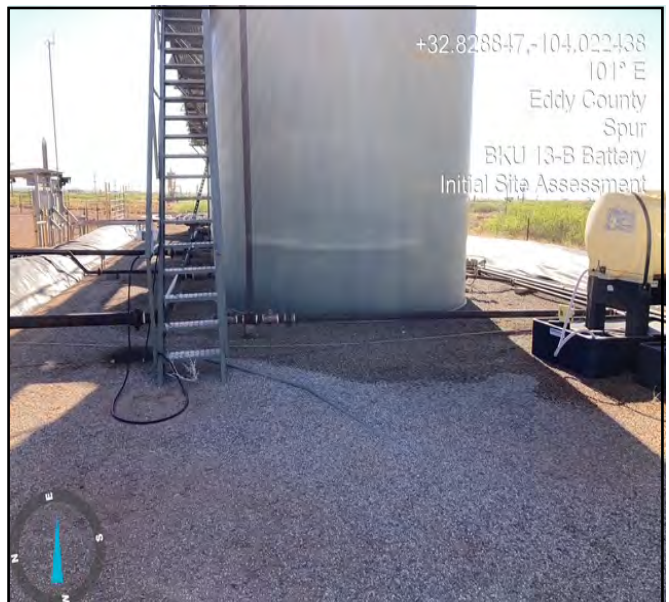
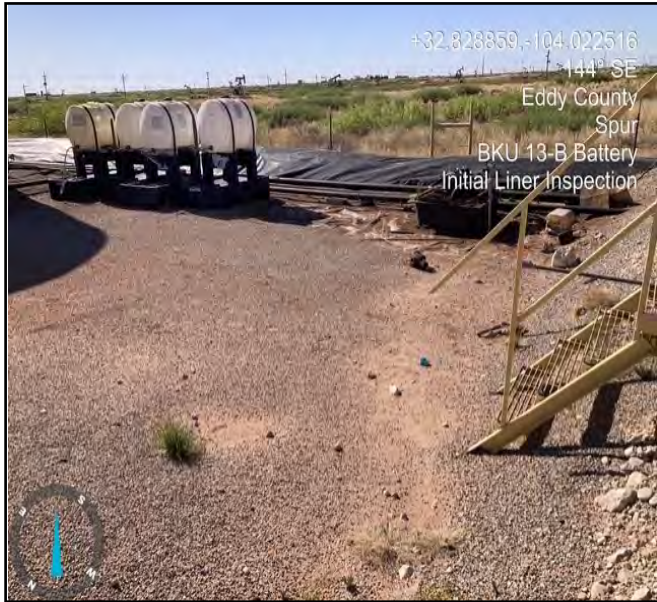
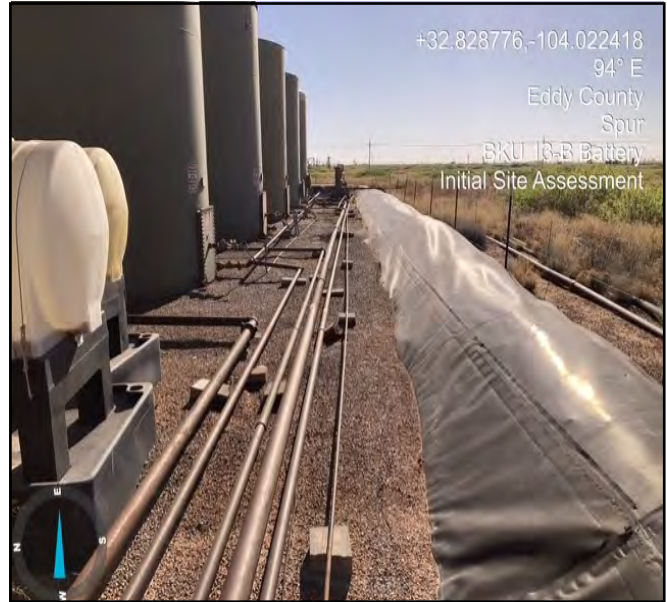
#### Initial Liner Assessment :

**nAPP2613142967:** On March 30, 2026, elevated pressure conditions caused the water tank pump seal to fail, resulting in the release of produced water into the lined containment area. Upon discovery, Spur personnel immediately initiated response and recovery actions to minimize the duration and extent of the release. Vacuum truck operations were mobilized and successfully recovered all released fluids from the containment area. Approximately 8 barrels of produced water were released within the lined containment. Recovery efforts were completed, and no impacts were observed outside of the lined containment system. Based on field observations, the secondary containment functioned as designed and effectively prevented migration of fluids beyond the contained area. A site map is provided in Figure 4.

Photograph taken during initial site assessment facing east.

Photograph taken during initial site assessment facing southwest.

Photograph taken during initial site assessment facing southeast.

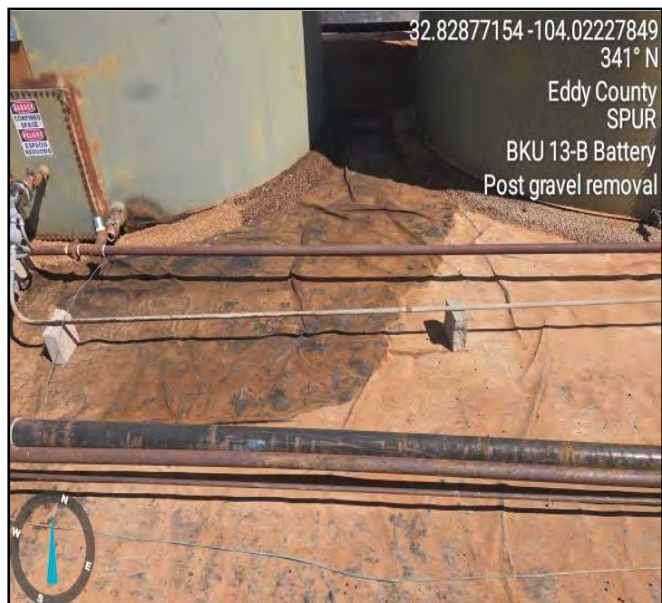
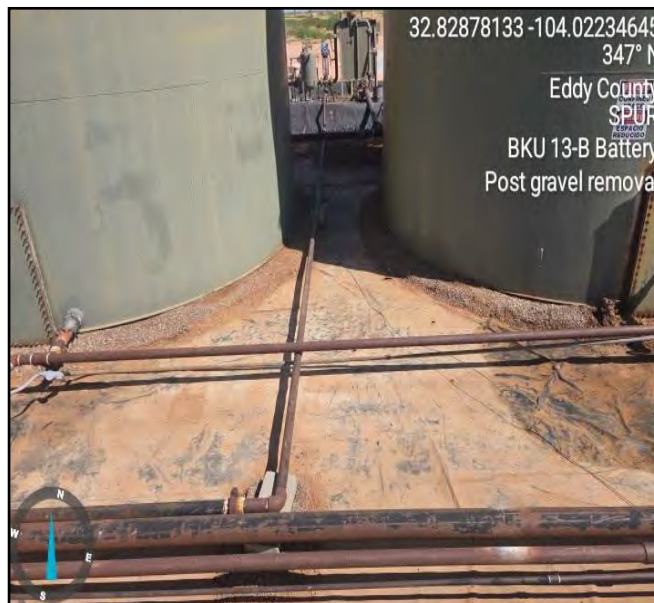
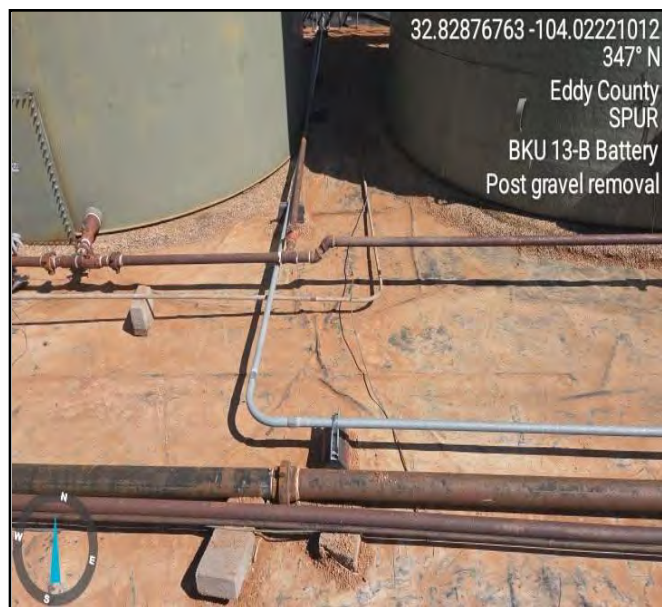
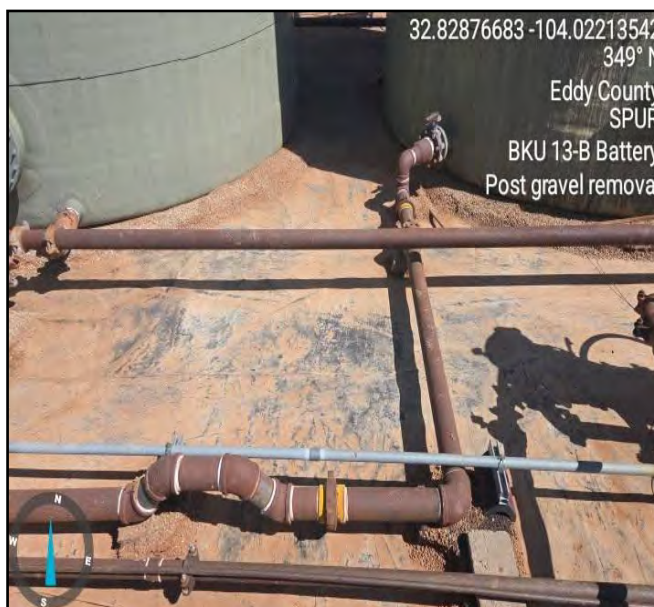
Pre- Powerwash :

Photograph taken pre powerwash facing north.

On May 27, 2026, Pima Environmental removed the impacted gravel from within the lined containment area to expose the underlying liner for inspection. Following gravel removal, the liner was thoroughly cleaned using a power washer, and a vacuum truck was utilized to recover all residual fluids and wash water generated during the cleaning process. These activities were conducted to facilitate a detailed evaluation of the containment system and verify that no residual contamination remained within the lined containment.

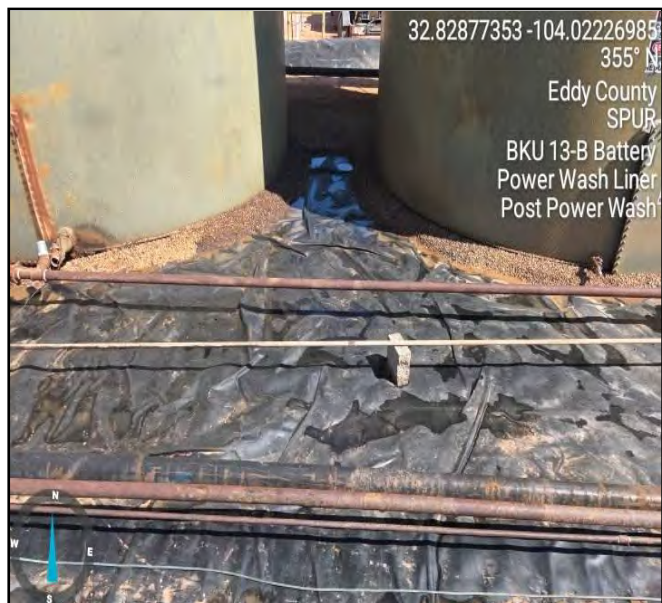
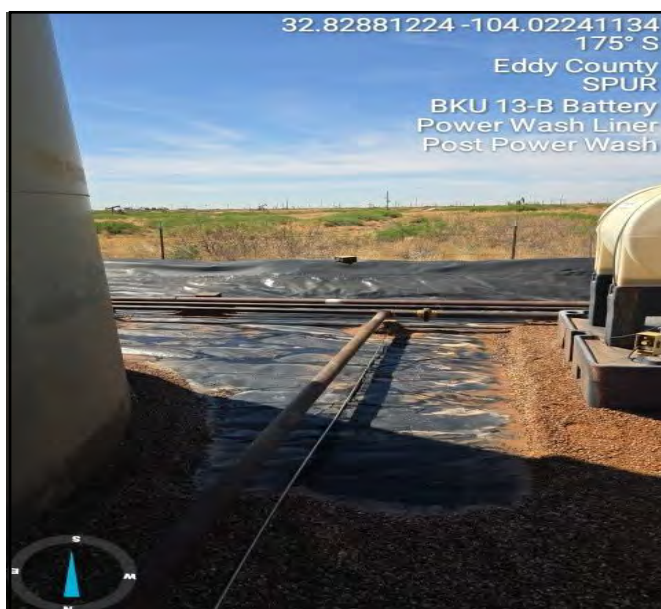
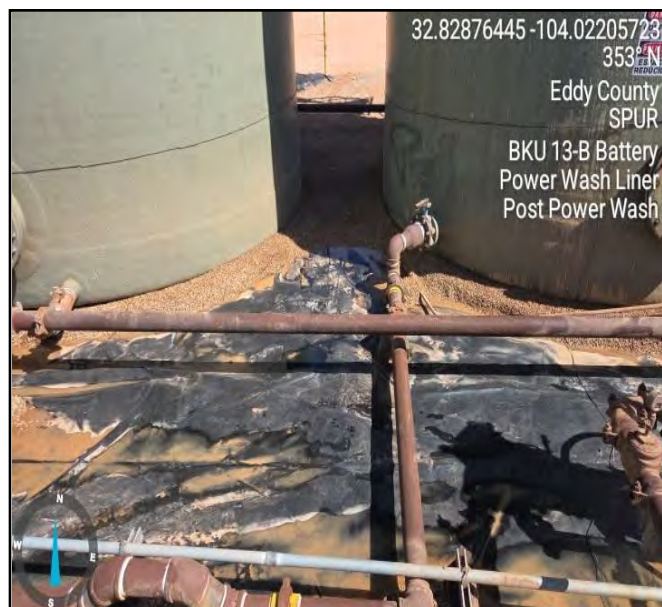
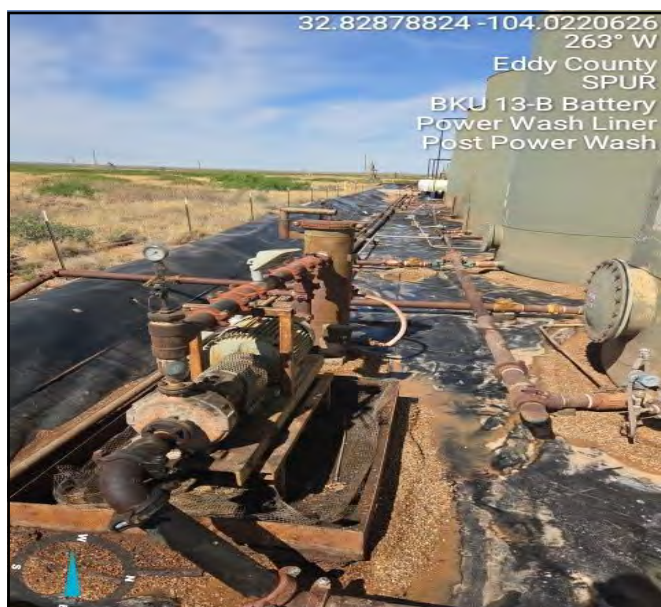
**Post- Powerwash :**

Photograph taken post powerwash process facing north.

Photograph taken post powerwash process facing south.

Photograph taken post powerwash process facing west.

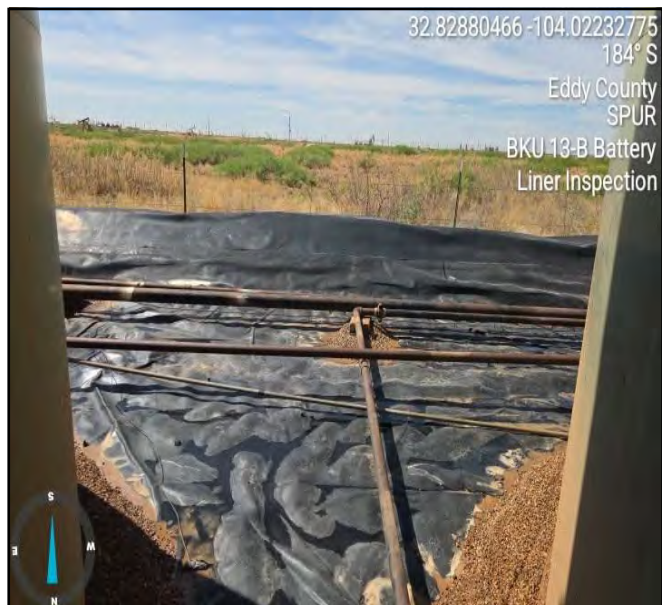
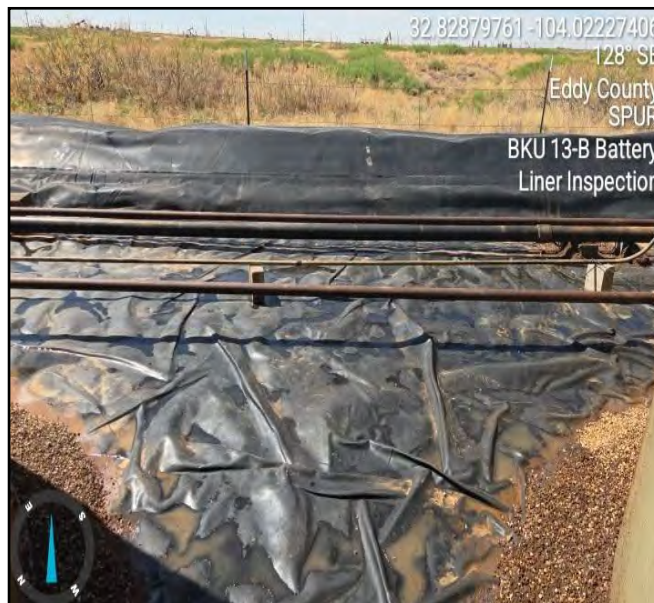
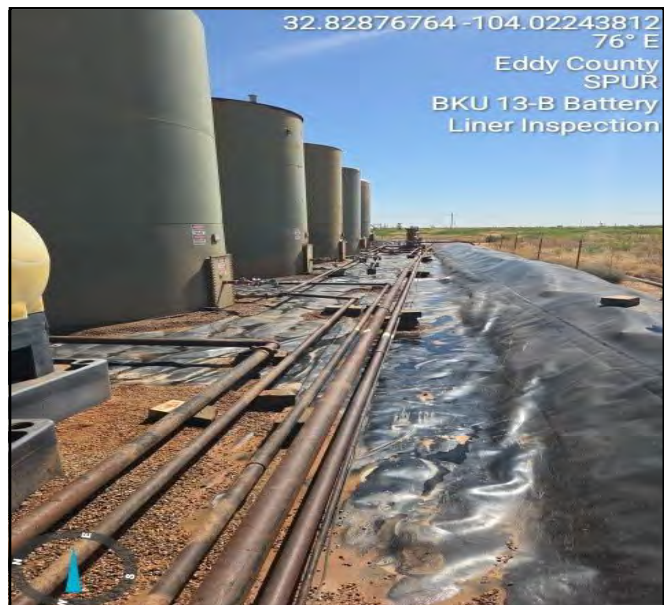
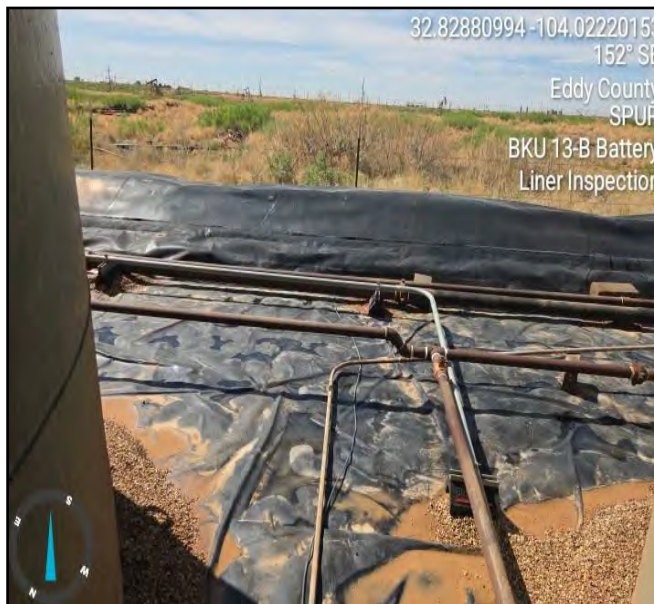
#### Liner Inspection :

Upon completion of the cleaning activities, the exposed liner was inspected for signs of tears, punctures, or other deficiencies that could compromise containment performance. The inspection confirmed that the liner remained intact and functioned as designed, successfully containing all released fluids within the lined containment area. No evidence of fluid migration beyond the containment system was observed. Based on these findings, the containment system was determined to be fully functional and effective in preventing environmental impacts. Documentation of the inspection activities, including photographic evidence, is provided in Appendices C and D.

Photograph taken during liner inspection facing south.

Photograph taken during liner inspection facing southeast.

Photograph taken during liner inspection facing east.

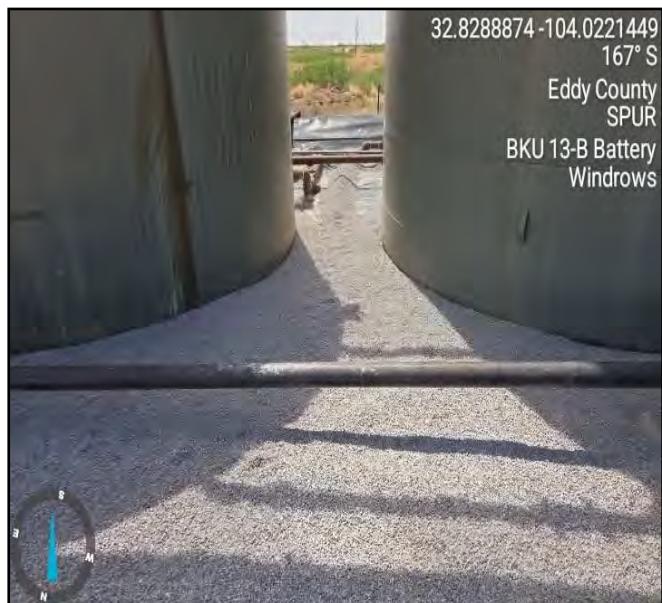
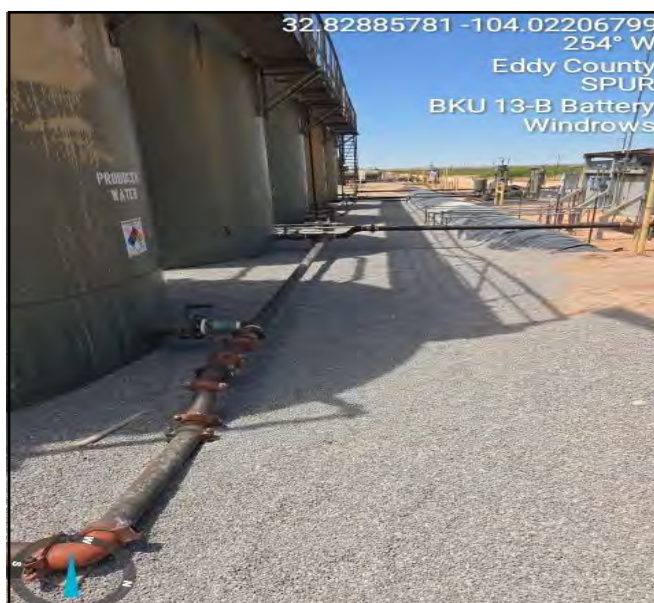
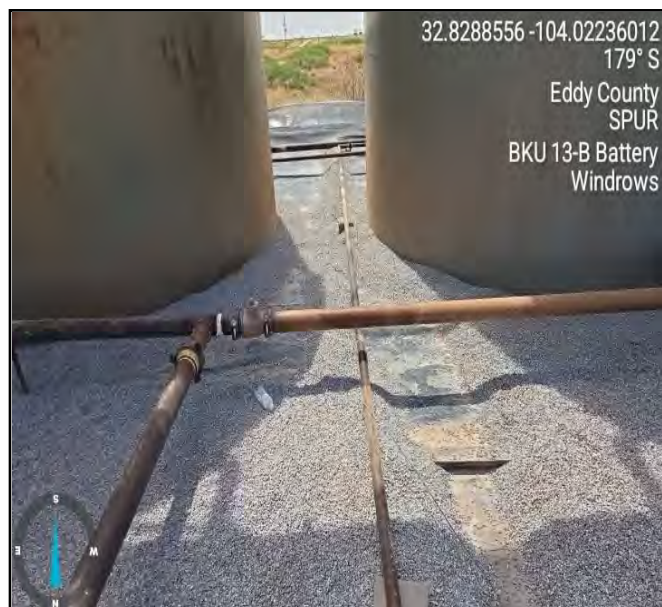
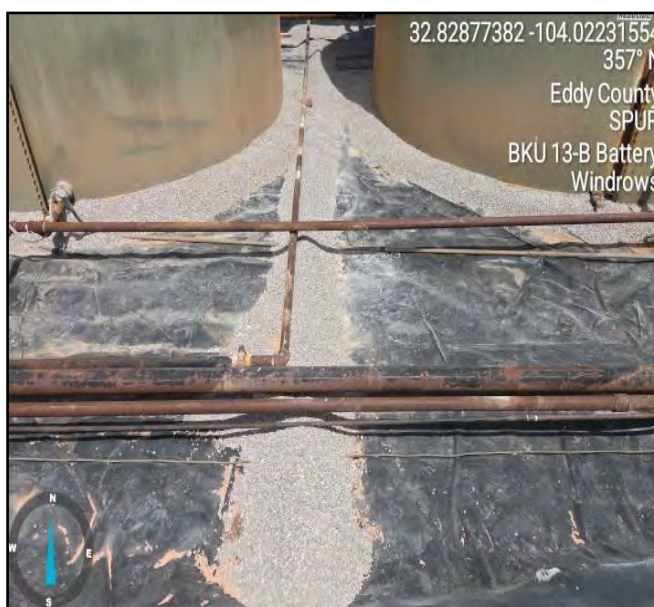
**Windrows :**

Photograph taken post windrows facing south.

Photograph taken post windrows facing west.

Photograph taken post windrows facing north.
