UNITED STATES DEPARTMENT OF THE INTERIOR BUREAU OF LAND MANAGEMENT

NOTICE OF WRITTEN ORDER

Number	21MBH0016W	
Dags 1	of 3

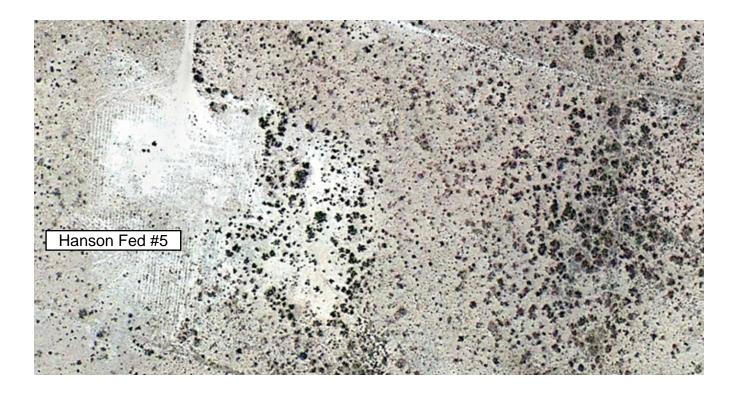
The subject well was P&A by Hanson Operating in May of 2009, and the location was ripped and seeded with berms built to dissuade travel onto the old pad. If you will look at the attached aerial taken shortly after P&A, and you will notice the north-south striations which are a result of the ripping. You will also note that there was no other construction near our site.

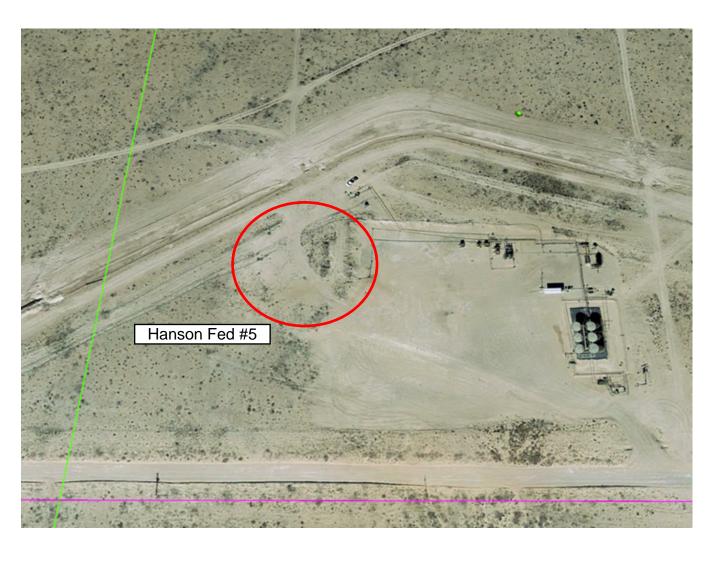
Now look at the recent aerial below the old one. You will notice that the remediation that we performed has been completely destroyed by either the operator who drilled the adjacent well in 2011, the current operator that took over operations in 2012, or possibly a pipeline contractor associated with what appears to be new ROW. I noted in the OCD file on for the first operator that when they spud the original adjacent well, they had mechanical trouble and had to plug the surface hole, skid the rig 107' to the west closer to our old location, and spud a new well. The pad extension to the west which encroached on our location was approved by Jim Amos w/ the BLM on 11/17/11. This caused additional disturbance, as there has been a lot of construction in the area after we completed our remediation. Basically we remediated the location approximately 10 years ago, and through actions by one of the aforementioned operators our work was basically obliterated. For this reason I have not executed the subject order, and we will not be remediating a second time due to actions of others outside our control.
