Procedure Description: Hilcorp Energy is requesting approval to repair the communication between the intermediate and production casing in the subject well per the attached procedure and wellbore diagram.

HILCORP ENERGY COMPANY
SAN JUAN 32-7 UNIT 11
Inter. Casing Pressure Remediation NOTICE OF INTENT

WELL INFORMATION			
Well Name:	SAN JUAN 32-7 UNIT 11	State:	NM
API #:	3004511344	County:	SAN JUAN
Area:	5	Location:	2127' FNL & 916' FEL - Unit H - Section 20 - T 032N - R 007W
Route:	0504	Latitude:	36.968265 N
Spud Date:	10/25/1955	Longitude:	-107.584798 W

PROJECT DESCRIPTION
Evaluate/repair wellhead for potential leak path. Locate and squeeze the hole in casing to isolate communication between the Intermediate and Production Casing strings

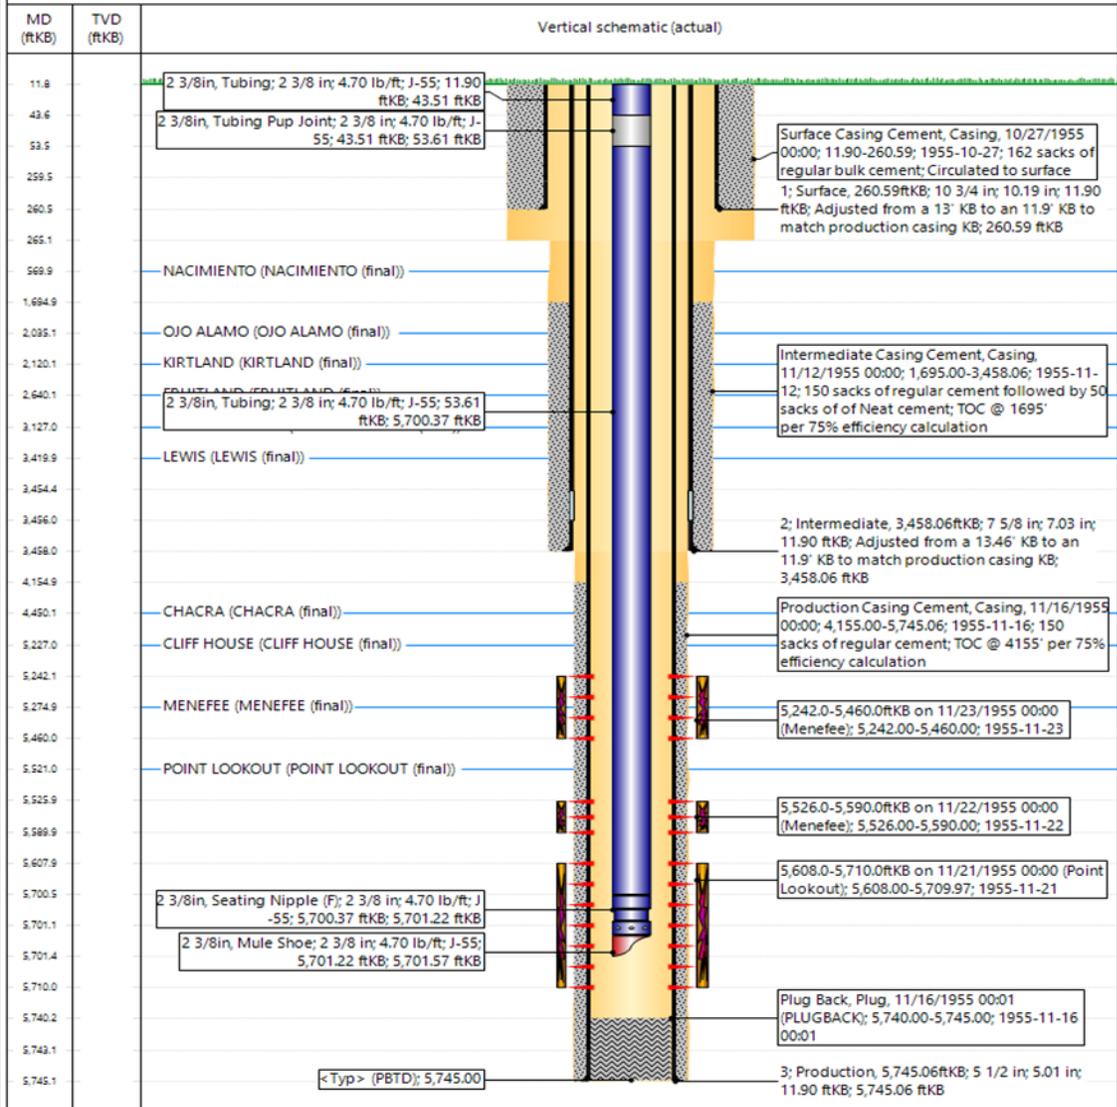
SAN JUAN 32-7 UNIT 11 - CURRENT WELLBORE SCHEMATIC

Gas analysis and wellbore schematic have been received. Gas analysis shows same gas on intermediate and production casing. Direct communication was not observed. There is low pressure on the bradenhead however, it visible flow for 30 seconds.
