SUBJECT: Reclamation Report for the Artesia Metex Unit #006, Eddy County, New Mexico

## Artesia Metex Unit #006 Reclamation Report

Artesia Metex Unit #006  
Reclamation and Reseeding

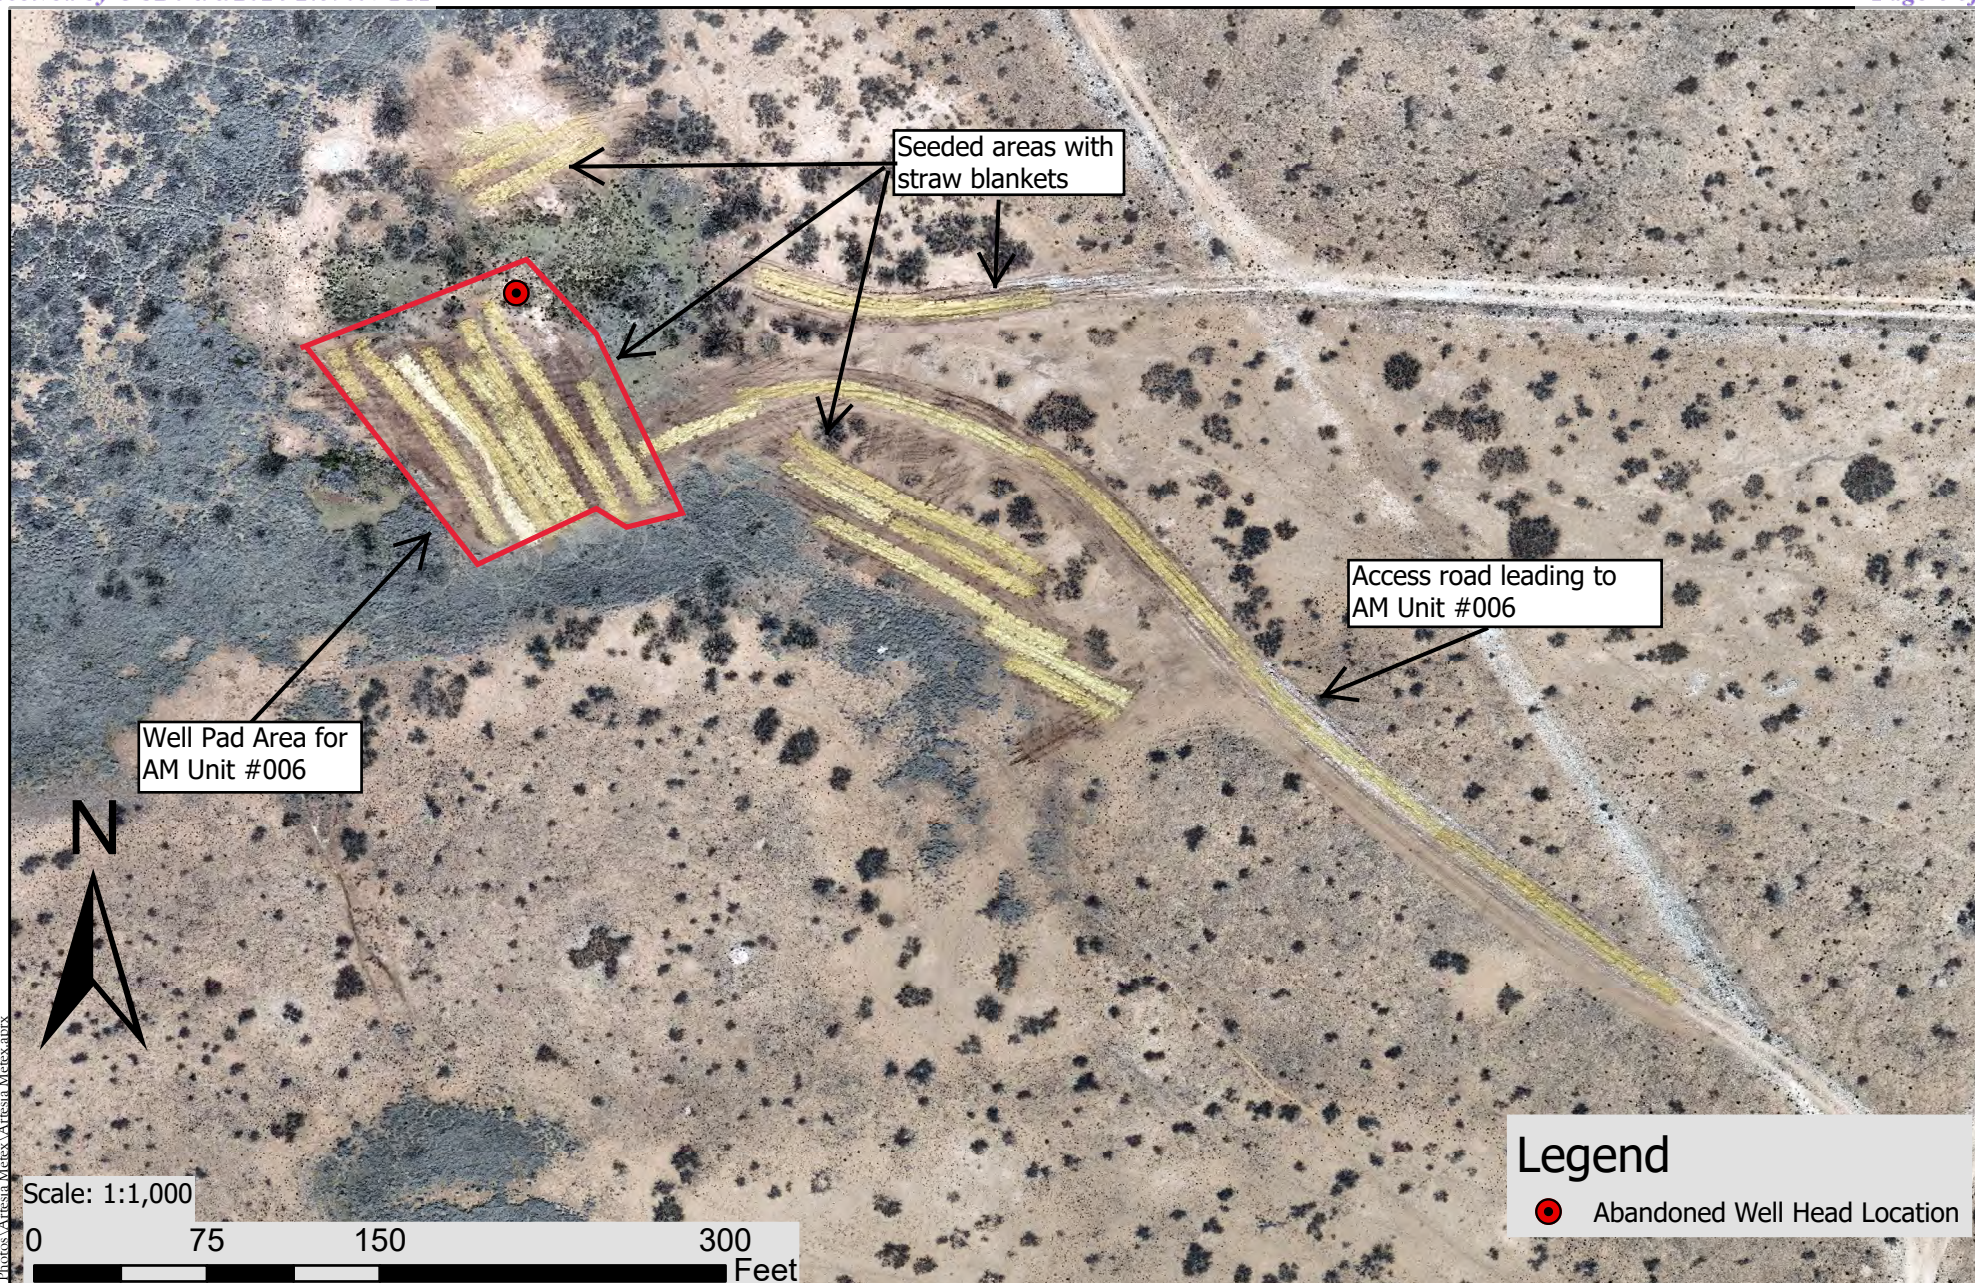
Figure 2

Artesia Metex Unit #006  
and Road Leading to AM 006  
Post - Reclamation and Reseeding

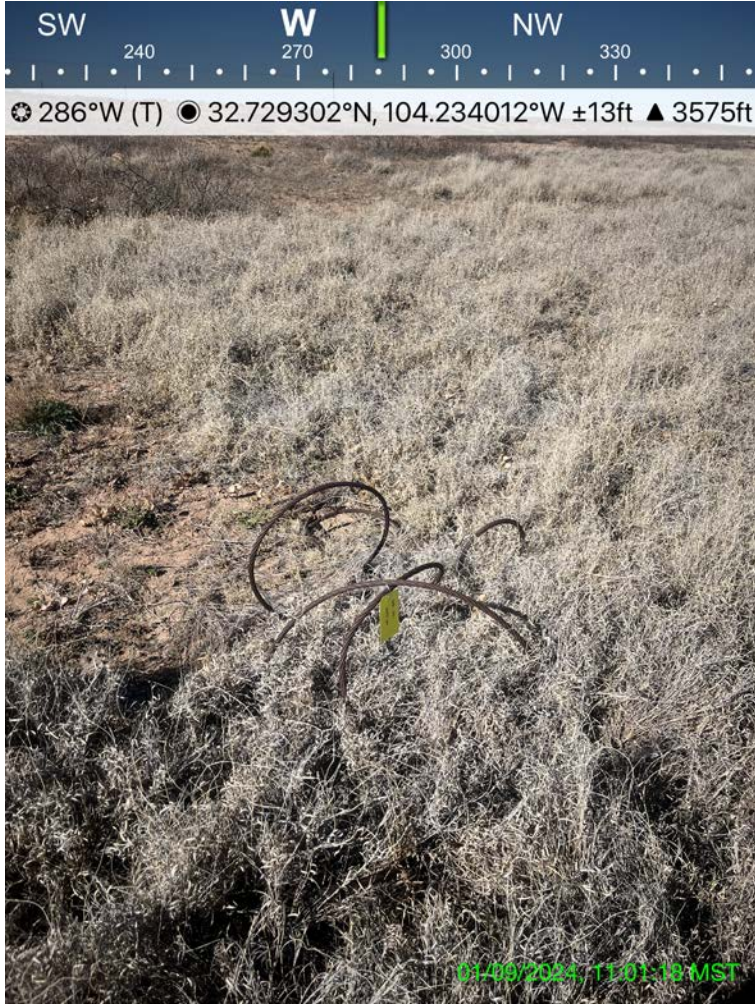
| Photograph #1 | |

| Photo Taken by:<br>Sarahmay Schlea | Description: Unit #006 debris, metal cable, NORM = 2000 cpm. |
