May 6, 2024

SUBJECT: Reclamation Report for the Artesia Metex Unit #005, Eddy County, New Mexico

Artesia Metex Unit #005 Reclamation Report

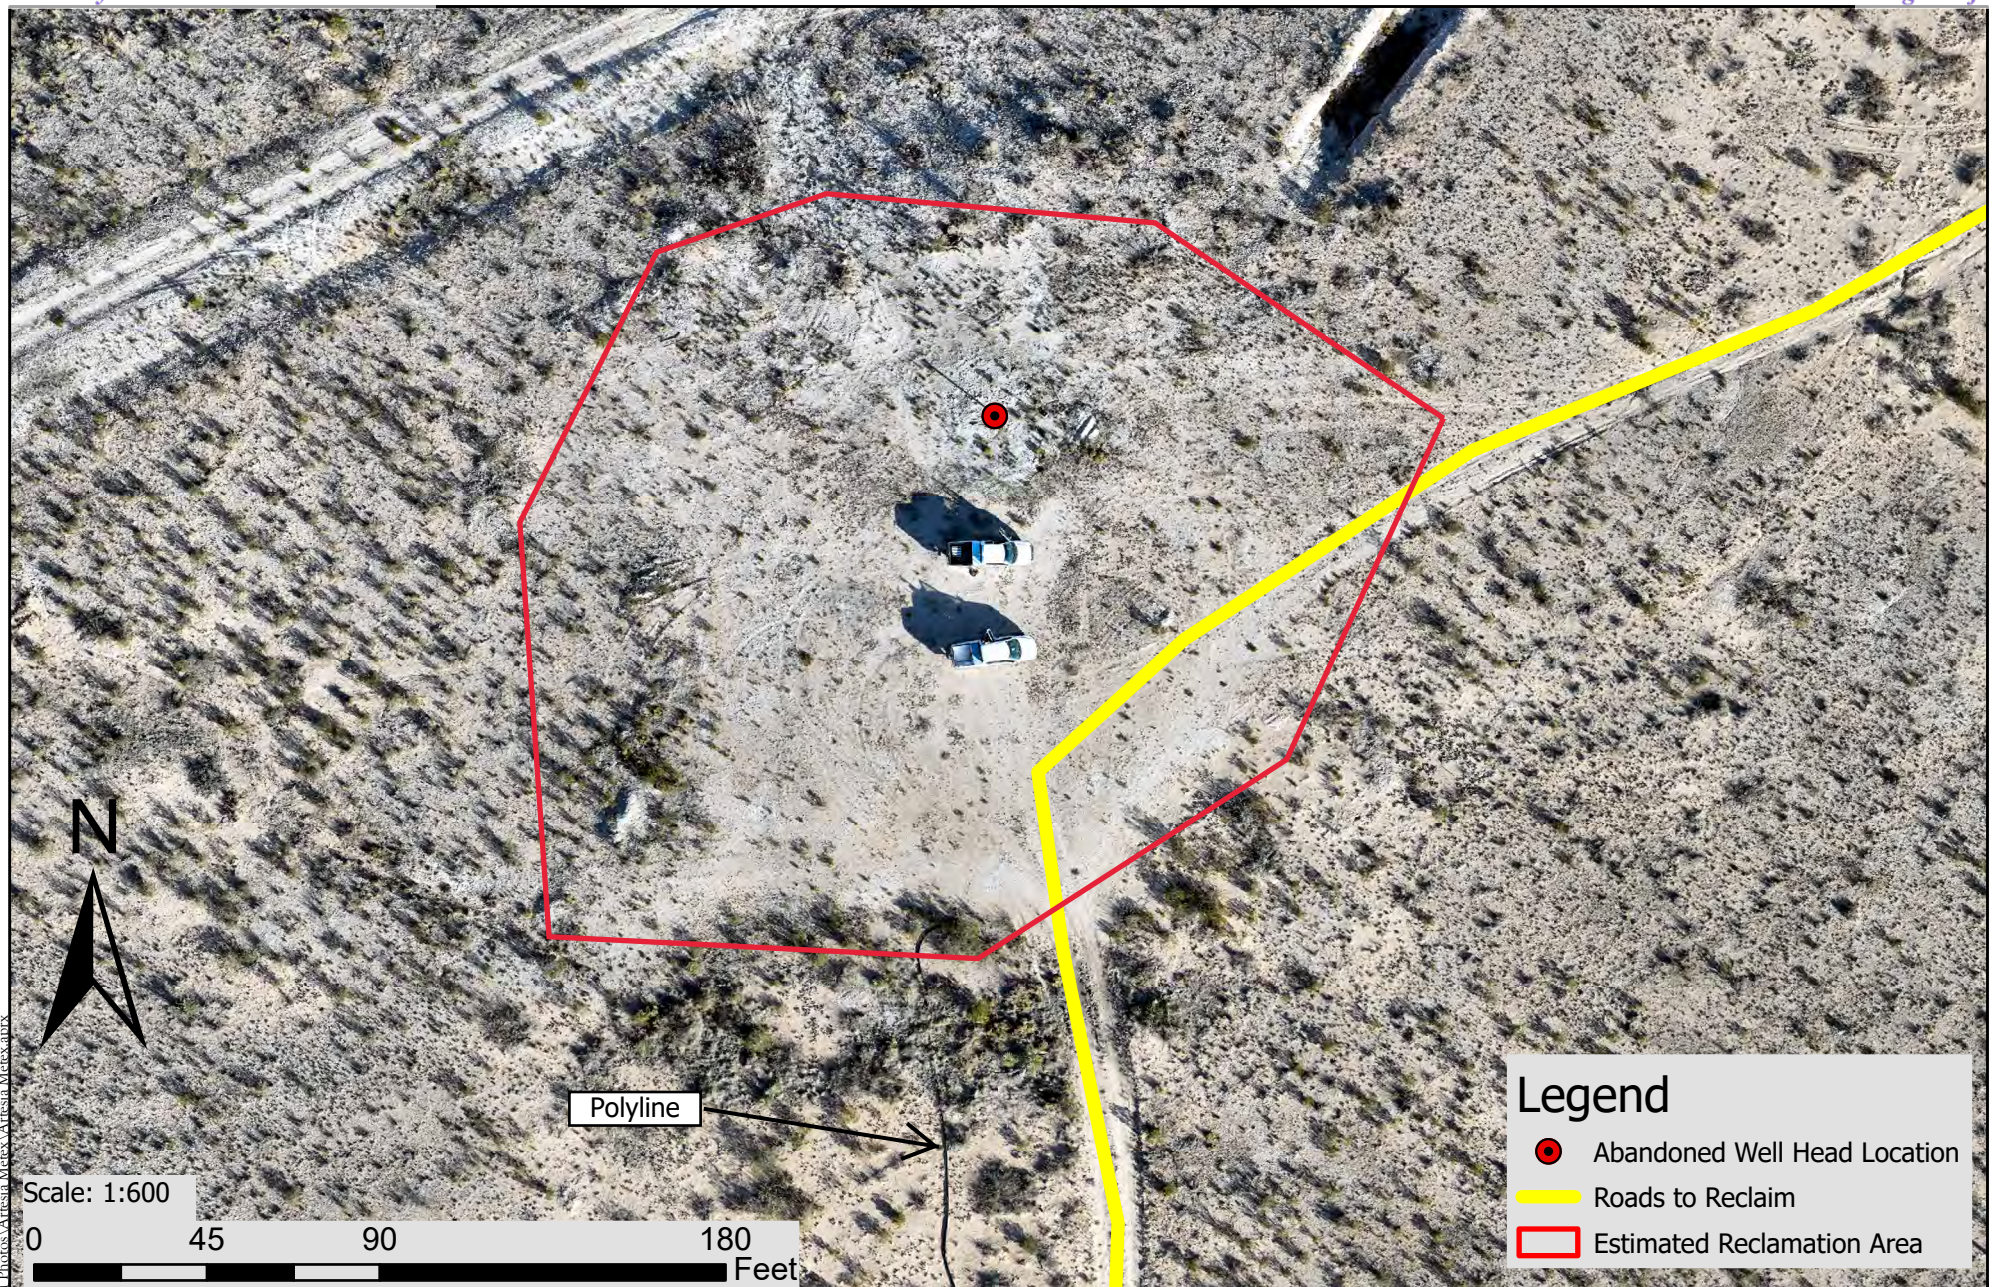
Figure 1

Along with the NORM assessment, on January 9, 2024, SMA performed a drone sweep of the area to obtain an aerial image prior to reclamation, as shown in Figure 1. Upon completion of reclamation activities, a second drone sweep was completed on April 3, 2024, to show the completion of reclamation activities at the AM Unit #005 well pad, as shown in Figure 2. Figures 3 and 4 depict post-reclamation of the access road that connects AM Unit #005 to AM Unit #017.

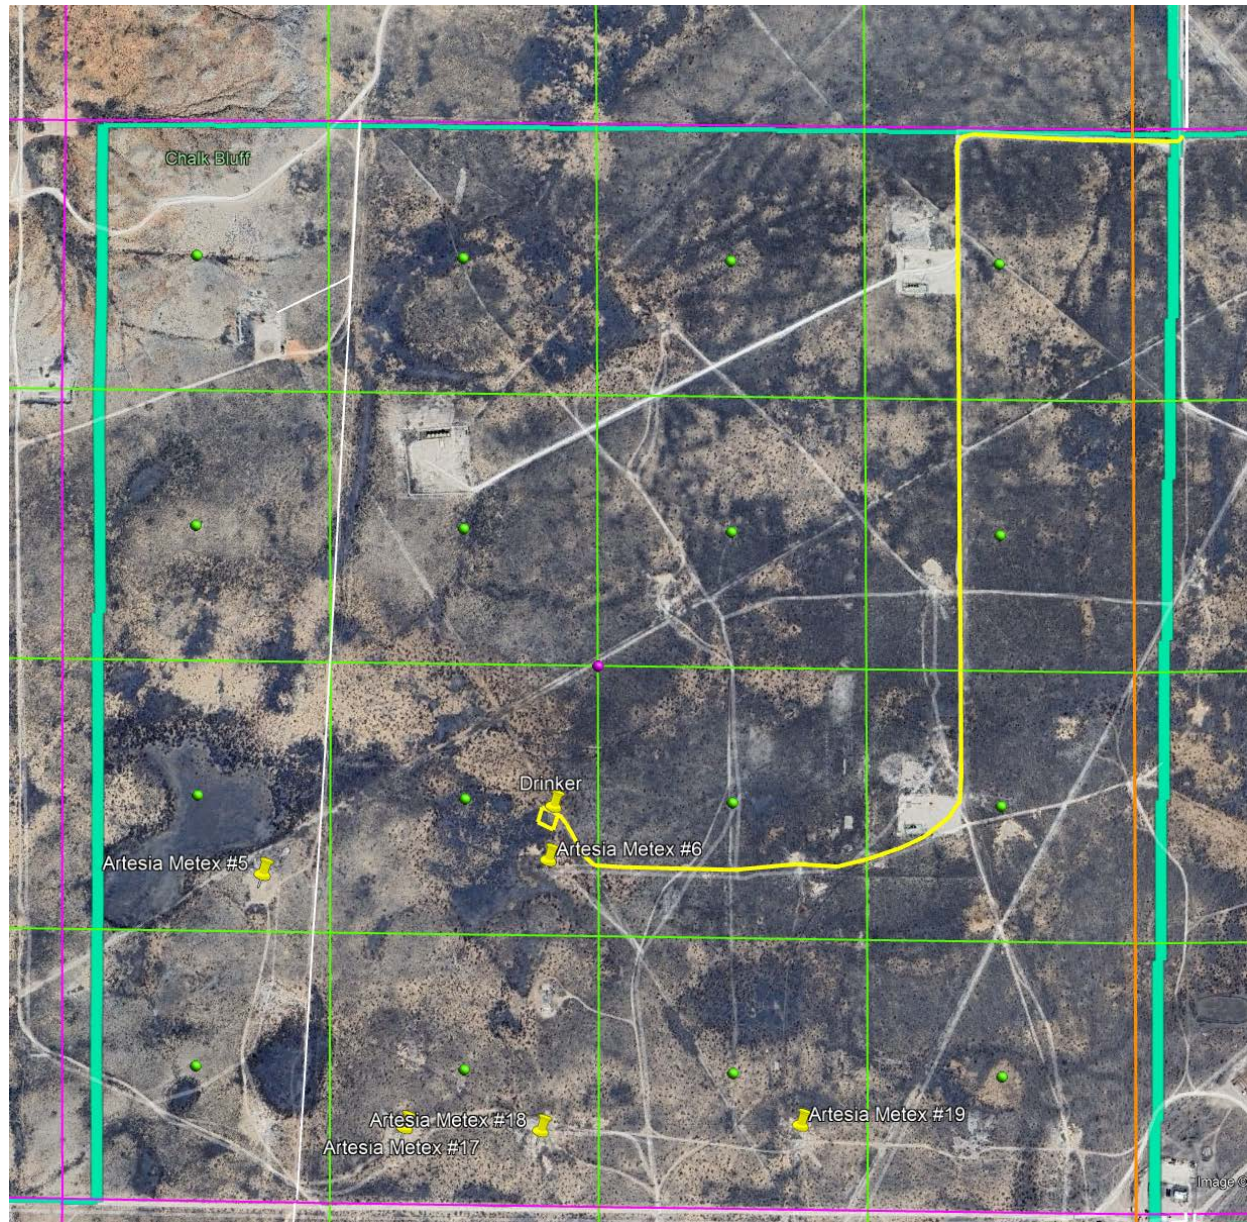
Per the land owner, **DO NOT** disturb the yellow highlighted road below:

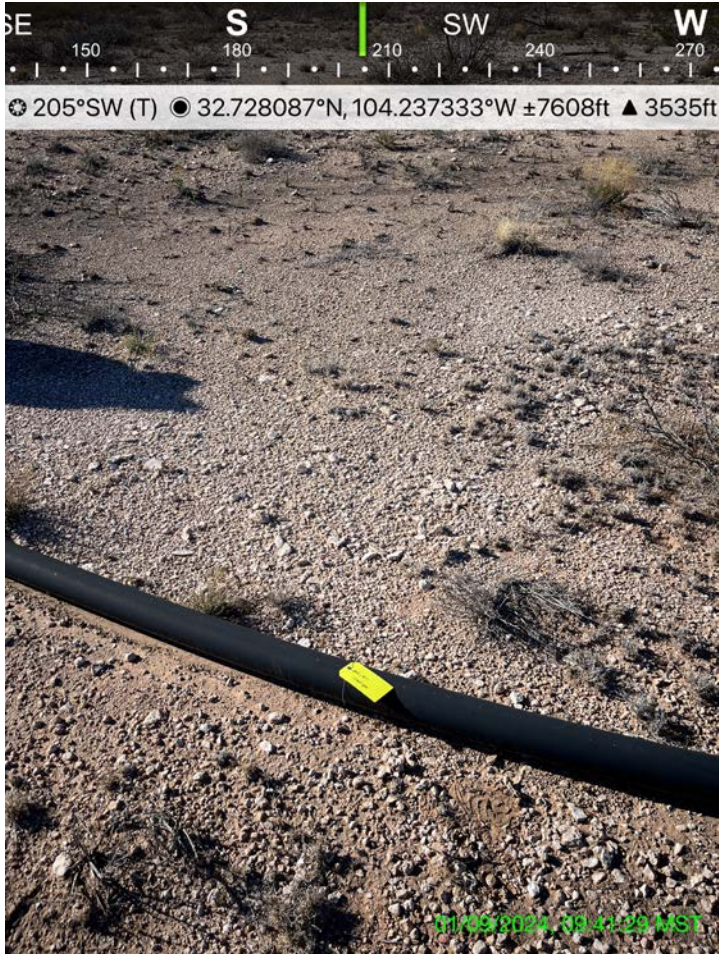
Photograph #11

Client: New Mexico OCD	
Site Name: Artesia Metex Unit #005	
Date Photo Taken: 01.09.2024	
Equipment Location: 32.728087N -104.237333W S: 24 T: 18S R: 37E Eddy County, New Mexico	
Photo Taken by: Sarahmay Schlea	Description: Unit #005 debris, polyline, NORM = 1200 cpm.

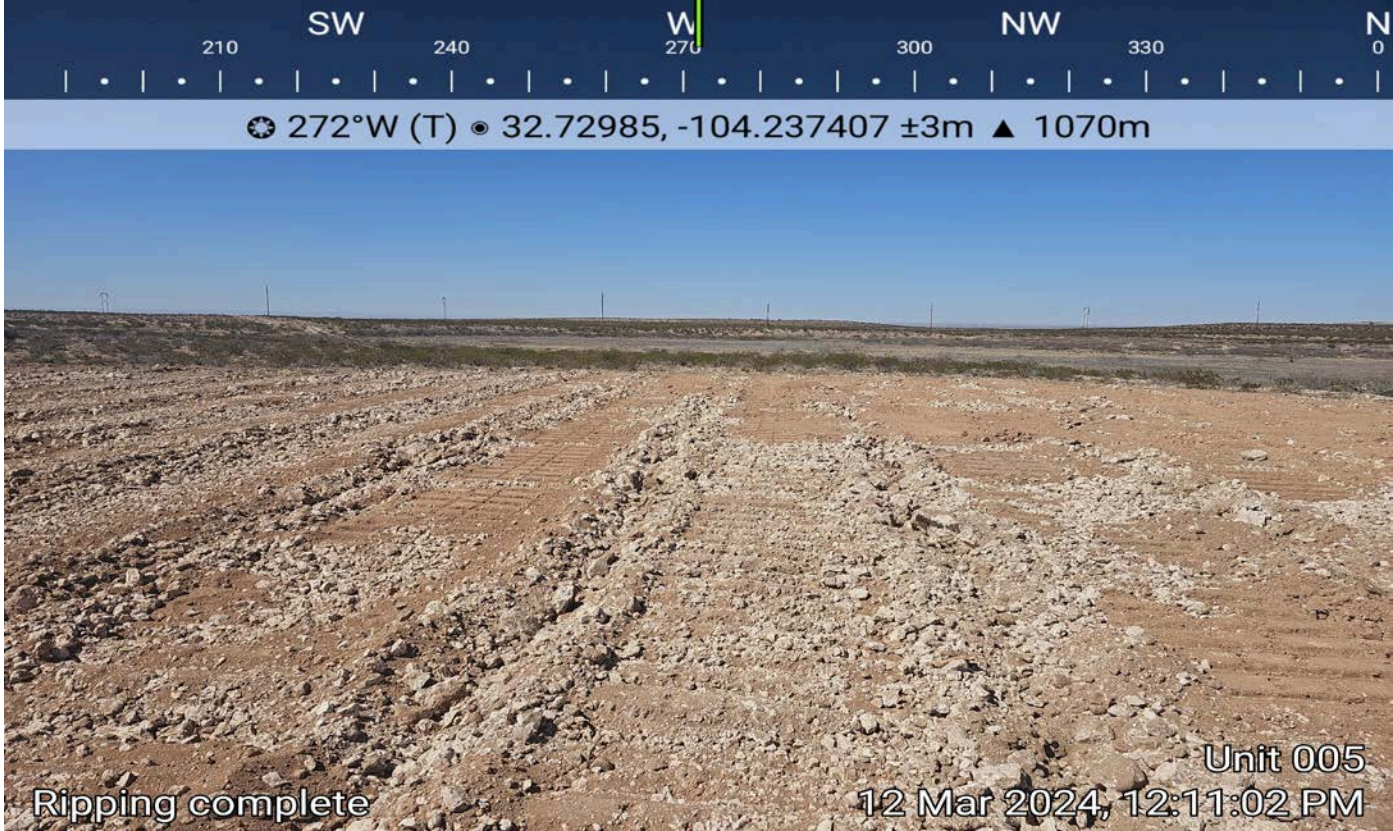
Photograph #21

Client: New Mexico OCD	
Site Name: Artesia Metex Unit #005	
Date Photo Taken: 03.12.2024	
Equipment Location: 32.72985N -104.237407W S: 24 T: 18S R: 37E Eddy County, New Mexico	
Photo Taken by: Georgeann Goodman	Description: West view of completed ripping.
