From: Fred Holmes [fred@etechenv.com]
Sent: Wednesday, September 21, 2011 12:46 PM
To: Bratcher, Mike, EMNRD; tgregsto@blm.gov
Cc: 'Daniel Frick'; 'Ron Ragland'; 'Joe Hernandez'
Subject: LINN Energy - JL Keel B #61 Flowline Release - Initial C-141
Attachments: LINN Energy - JL Keel B #61 Flowline Release - Initial C-141 092111.pdf; JL Keel 61 Release Assessment Map 091911.pdf; JL Keel B 61 Photo Log 091911.pdf; LINN ENergy - J.L. Keel 61 FL Corrective Action Plan - Short Form 092111.pdf

Corrective Action Report – Short Form

Lease Name: J.L. Keel Well #61

Cause of Release: Over-pressure of line from scale buildup causing line to rupture

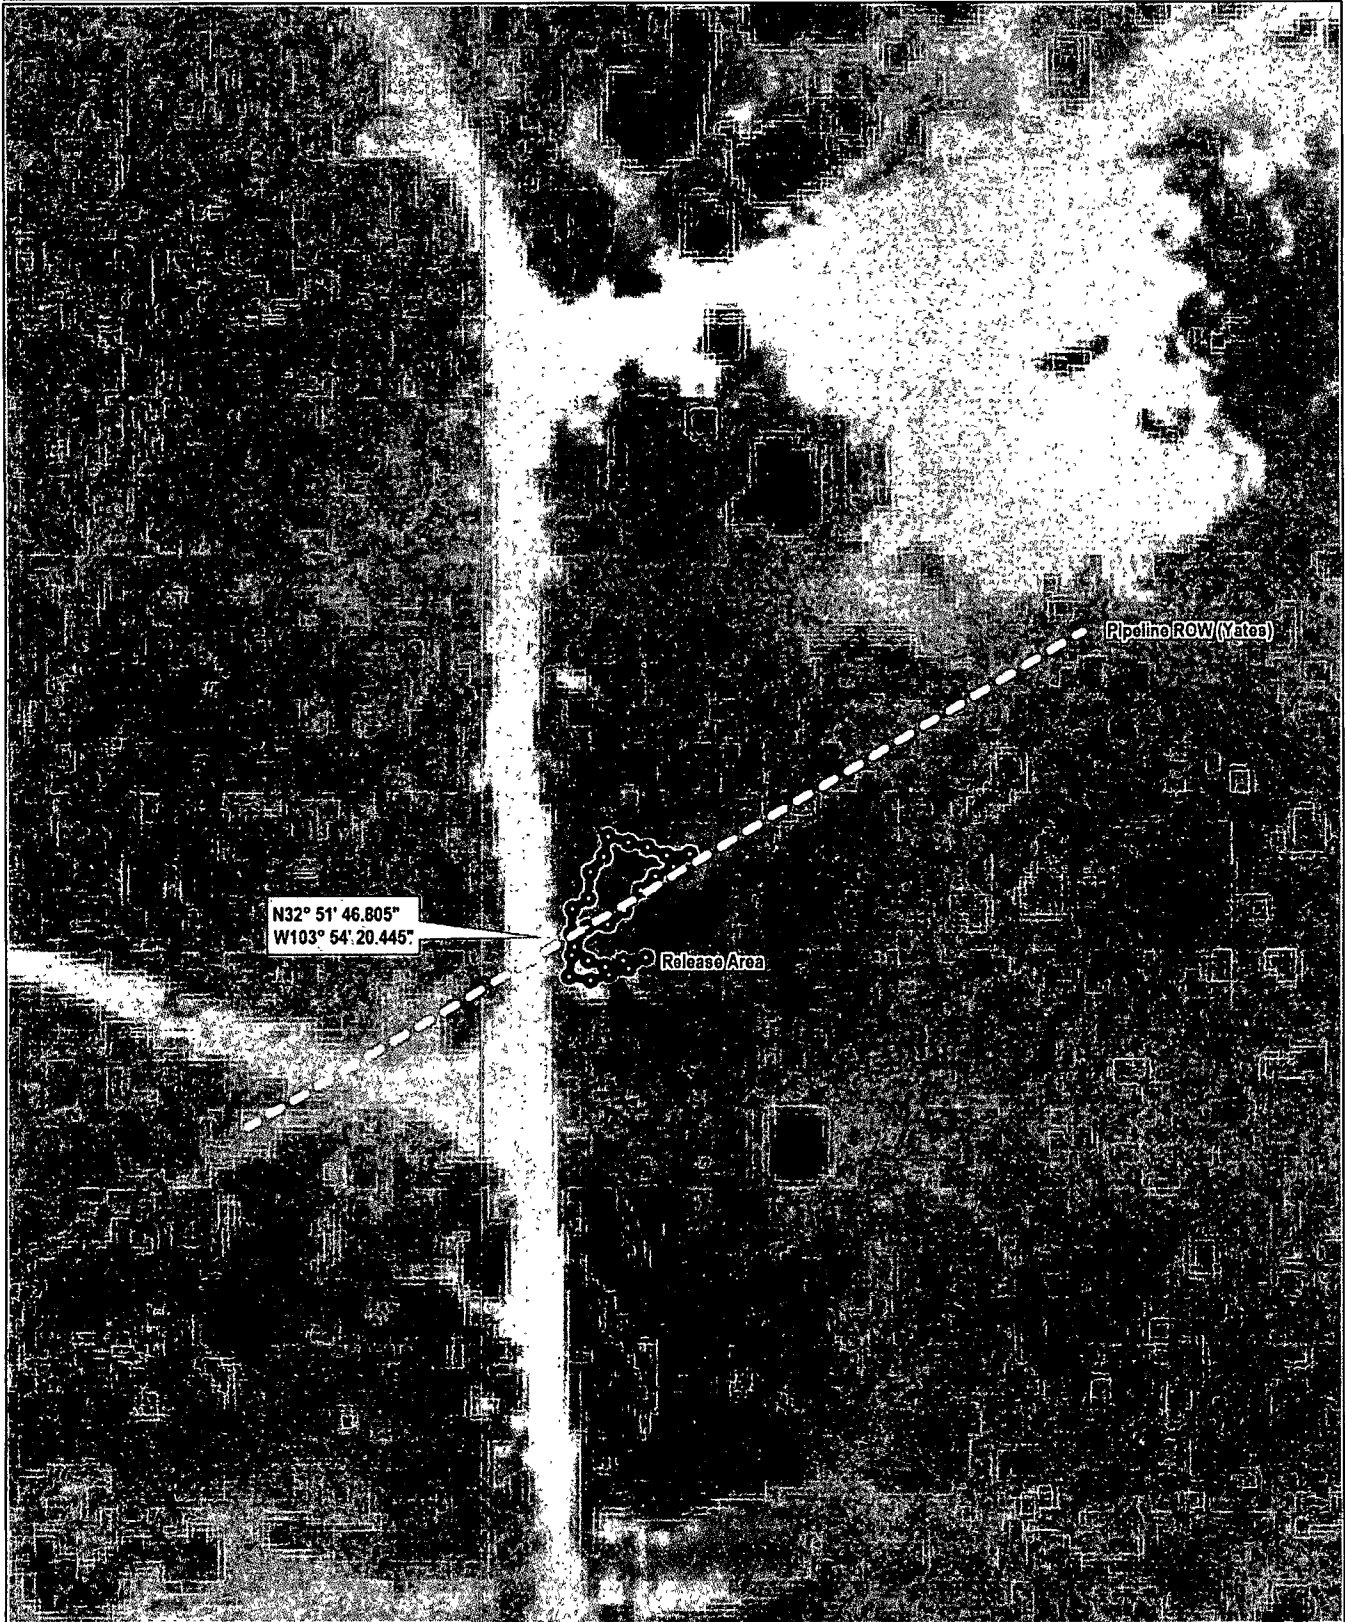
J.L. Keel B #61 Flowline Release Assessment Map

Spill area resides in a potential historical spill site present prior to acquisition of the lease. This area will be investigated and remediated if required at the time this release is remediated. Also, spill is in a pipeline ROW operated by Yates. Line is marked as a "Water Line". Photos and site map attached.

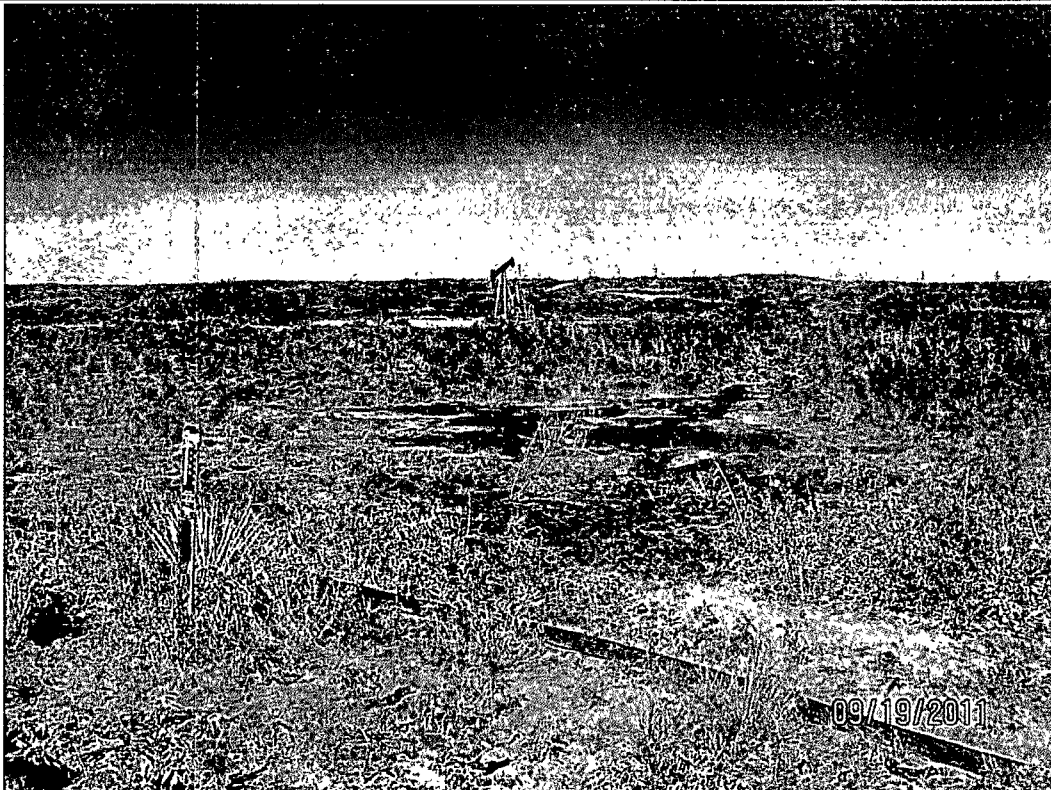
Photo No: 2.

Direction Taken: Northeast	
Description: View of spill area from road side. Not pipeline ROW Marker in left foreground.
