Annual GW Mon. REPORTS

RE: Annual Report

Rice Operating Company Vacuum K-35-1 Boot, UL K, Sec 35, T17S, R35E OCD Case Number 1R0425-03

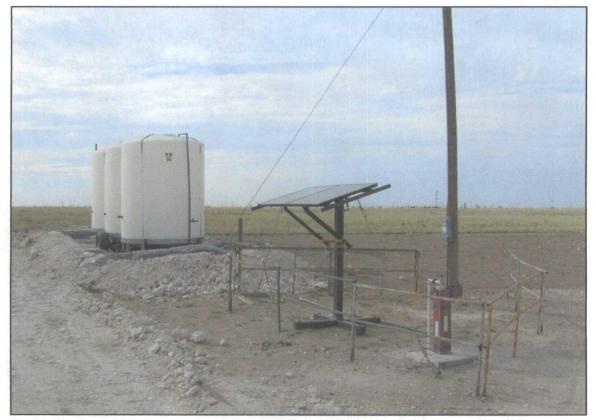
- Approximately 14,779 barrels of chloride affected groundwater have been withdrawn from a near-source recovery well (RW-1) over the period June 2008 through December 2010 (Figure 3). A portion of this water has been treated on-site using reverse osmosis and used for site irrigation. The balance has been used for Rice SWD line and well maintenance purposes.
- Groundwater chloride concentrations in the at-source monitor well (MW-4) have declined from approximately 6,770 ppm in February 2007 to 520 ppm by October of 2010 (Figure 4).
- The ground surface has been effectively restored to native vegetation (Figures 5 and 6).

Figure 3 – Vac K-35-1 solar-powered groundwater recovery system.

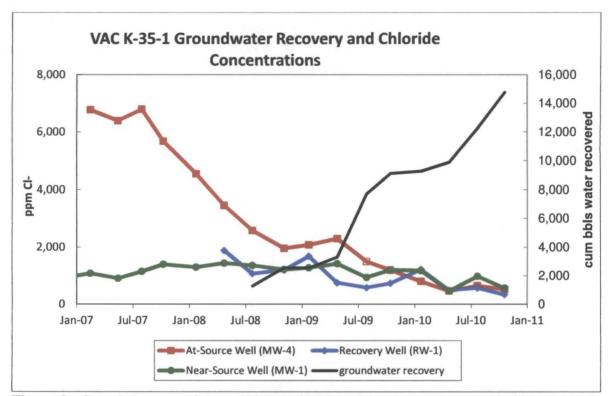
It appears that we are approaching a point of diminishing returns with respect to the chloride concentration (and thus mass removed) from the recovery well and the change in chloride concentrations in groundwater sampled from the affected wells (MW-1 & MW-4). As such, we plan to continue groundwater withdrawal during 2011 and to propose a path forward or a termination request after we have compiled and analyzed this additional data.

Figure 4 – Cumulative groundwater withdrawal (right axis) and groundwater chloride concentrations at VAC K-35-1.

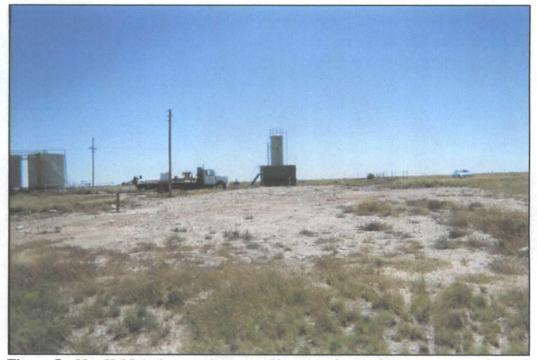
Figure 5 – Vac K-35-1 view south across affected surface before restoration efforts, October 2006.

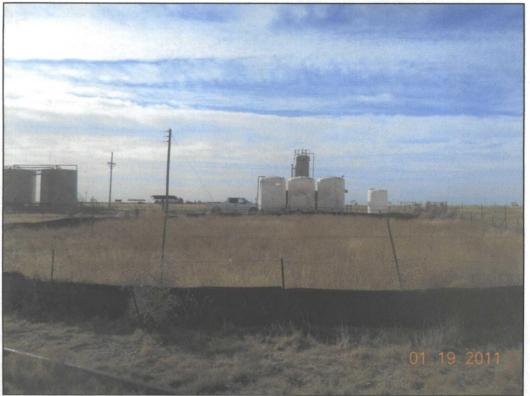
Figure 6 – Vac K-35-1 view south across affected surface following surface restoration, January 2011.
