**Wingate Fractioner BGT
Retrofit Proposal**

RE: Wingate Fractionator Below Grade Tank Retrofit Proposal

Wastewater Below Grade Tank Retrofit Closure Report Outline

Ground Water Discharge Plan – GW 54

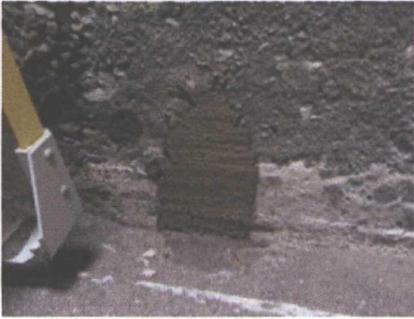
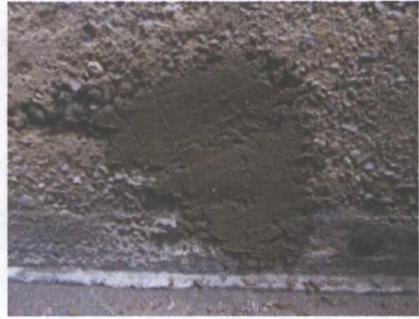
7. The bgt walls, floor and extruding pipes were sand blasted to remove loose concrete, scale and to etch the surface. (**Appendix B**)
8. A large area of scale was removed by the sandblasting work and a slight weep was detected. This area was cleaned, a sealant applied and filled with cement. (**Appendix C; C1 & C2**)

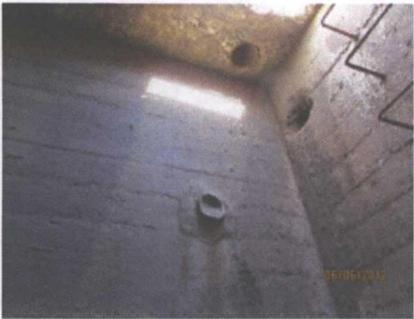
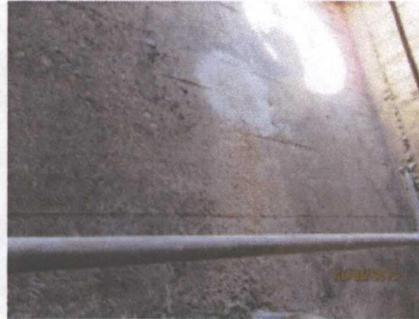
1. Job Safety Analysis (JSA), Lock out Tag out component review/witness and CSE monitoring was performed prior to work and entry into the bgt.
2. An old out of service line in the NW corner leaked back rinse water from the previous day. Prior to the start of the project this line was detached/severed several feet away

from the bgt. The protruding portion of this line will be cut flush with the wall and sealed during the cement patch phase of the project. (**Appendix C; C3 & C4**)

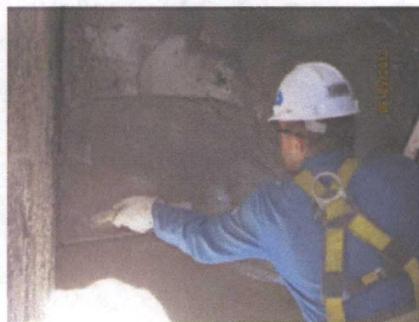
C6

5. Using the NE corner of the sump floor as the high point, the floor was framed out with the slop going to the SW corner. (**Appendix C; C7 & C8**)
6. Cement was applied by hand and leveled to the framing. One diagonal side was poured and allowed to set up; then the other diagonal side was poured and allowed to set up. (**Appendix C; C6-C8**)

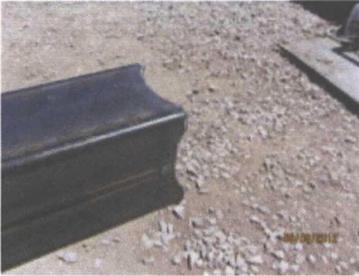
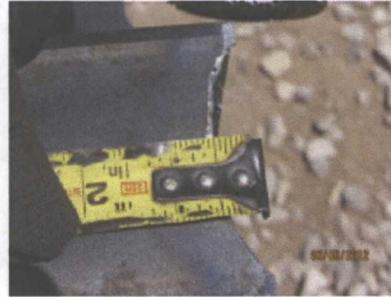
3. Half moon arches were cut out of two sides of bottom of the 4-inch square tubing pipe. This arch will allow liquid to flow into the pipe which will be positioned in the corner of the low point (SW corner). (**Appendix G; G1 & G2**)

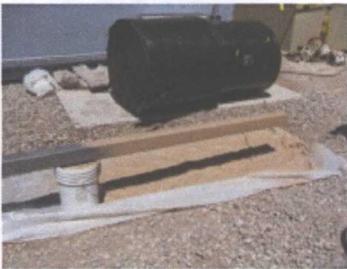
G3

7. Applied VF380 to the 4-inch square tubing pipe. (**Appendix G; G3**)
8. Started installation of the Terra Drain system.
 - a. Cut Terra Drain sheets to size and starting installing. (**Appendix H**)

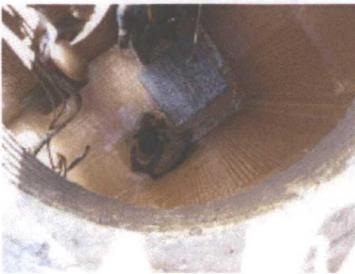
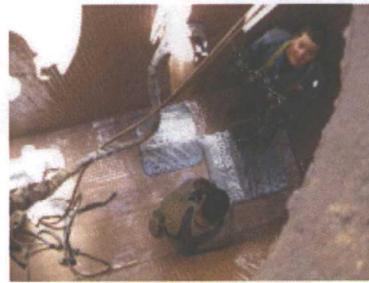
5. An evaluation of the completed liner system was conducted and determined an extra layer of protection would be added directly under the discharge of the primary wastewater line and the transfer pump suction line. Two steel plates approximately 3/16-inch thick was cut and the surfaces were roughed up to prepare the surface for VF380 application. These two plates will be positioned directly below the pump suction and the discharge of the primary wastewater line. **(Appendix I; I7 & I8)**

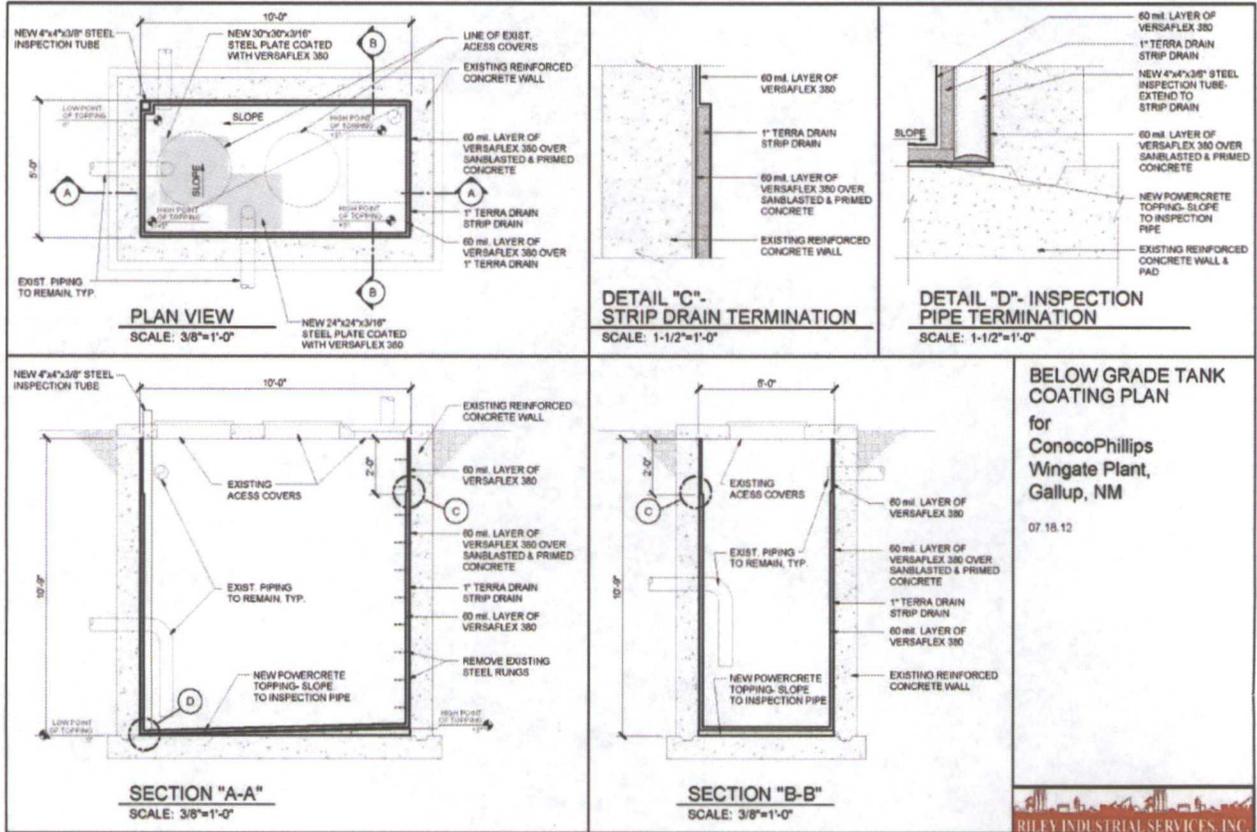
Appendix J
Below Grade Tank Drawing

3. Started filling in the pitting areas and cracks with cement.
4. Cement floor installers performed inspection of floor and found that the high point of the floor was at the designed low point. The designed was reversed and the low point of the sump will now be on the SW corner (opposite of the original design low point). The switching of the low point area does not affect the construction of the project. The new drawing is located as **Appendix J**.
